MEMORANDUM

Project: 2025051 - 1711 Arbor Street, Alameda

Re: 1711 Arbor Street, Alameda – Historic Resource Evaluation and Condition Assessment Memorandum

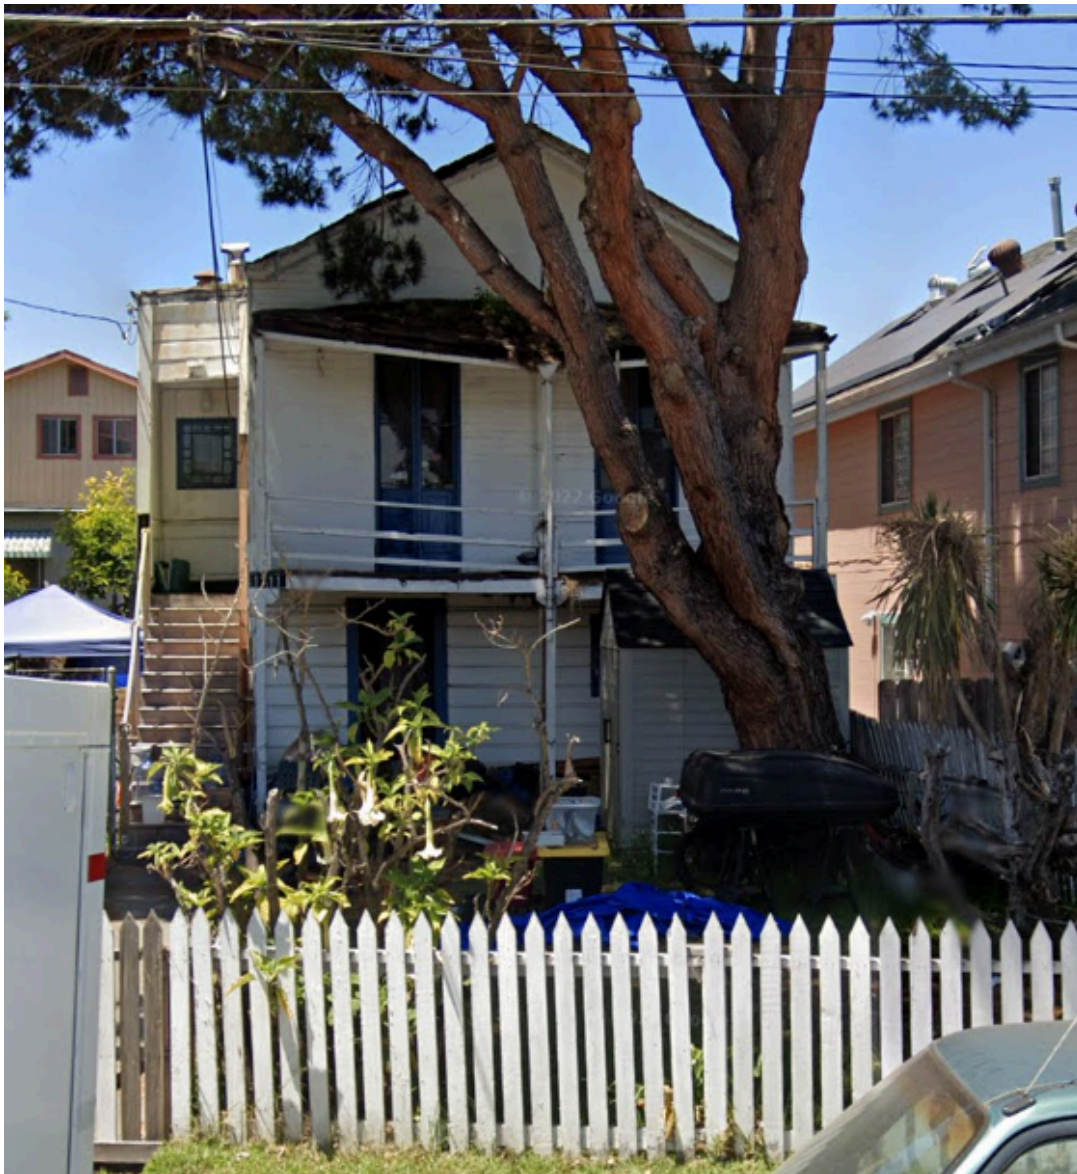
Figure 6. Front porch in 2022; note that the tree is leaning onto the porch, compromising its structural integrity (Google Maps)

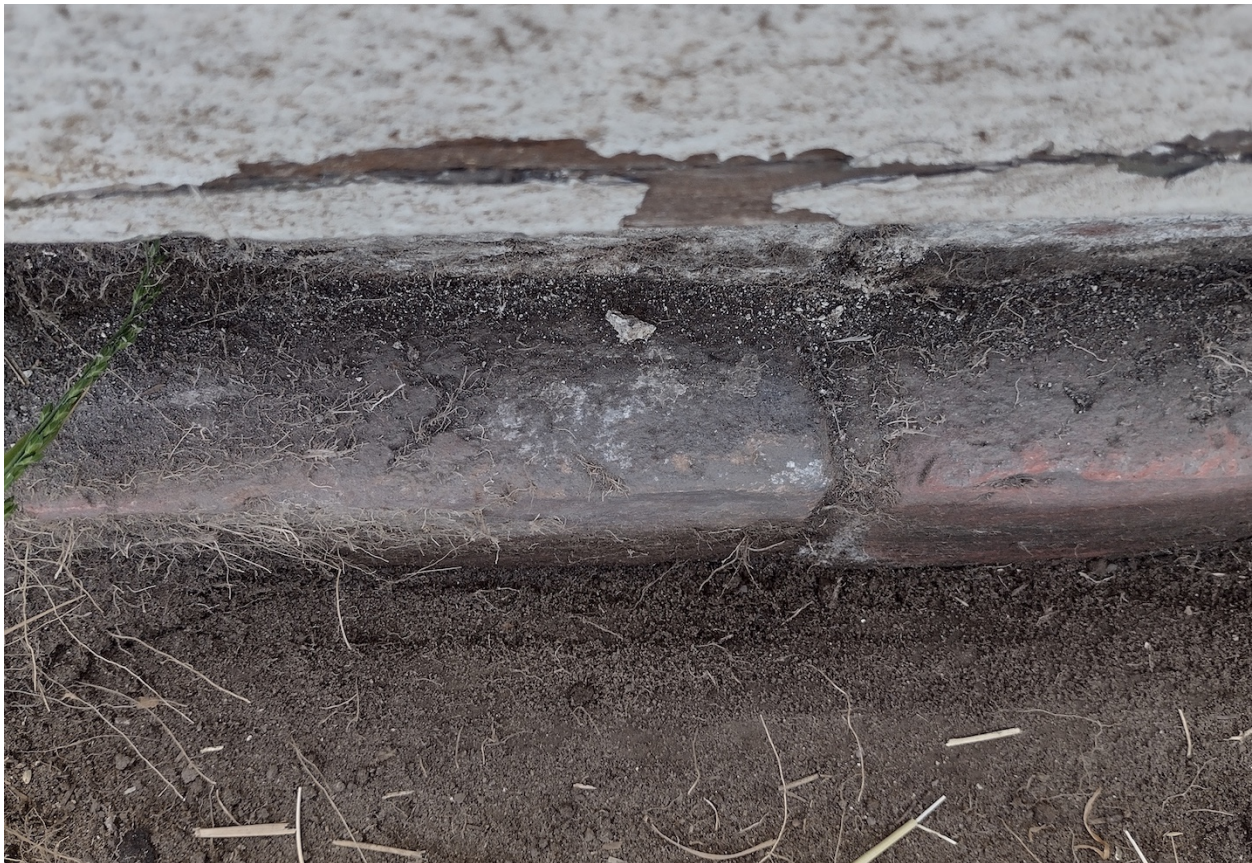
- Brick foundation at main portion of the building appears to be in good condition
 - Vegetation is overgrown at building base on North elevation
- There is earth-to-wood contact around the entire base of the building, which is likely leading to excess moisture and pest infiltration
- Concrete foundation at rear shed addition is in poor condition
 - The foundation at the rear of the building is sinking
- A portion of the 2nd story is supported by a pier and post foundation on the South elevation

Figure 7. View of the brick foundation at the front (East) facade of 1711 Arbor Street (GA, June 2025)

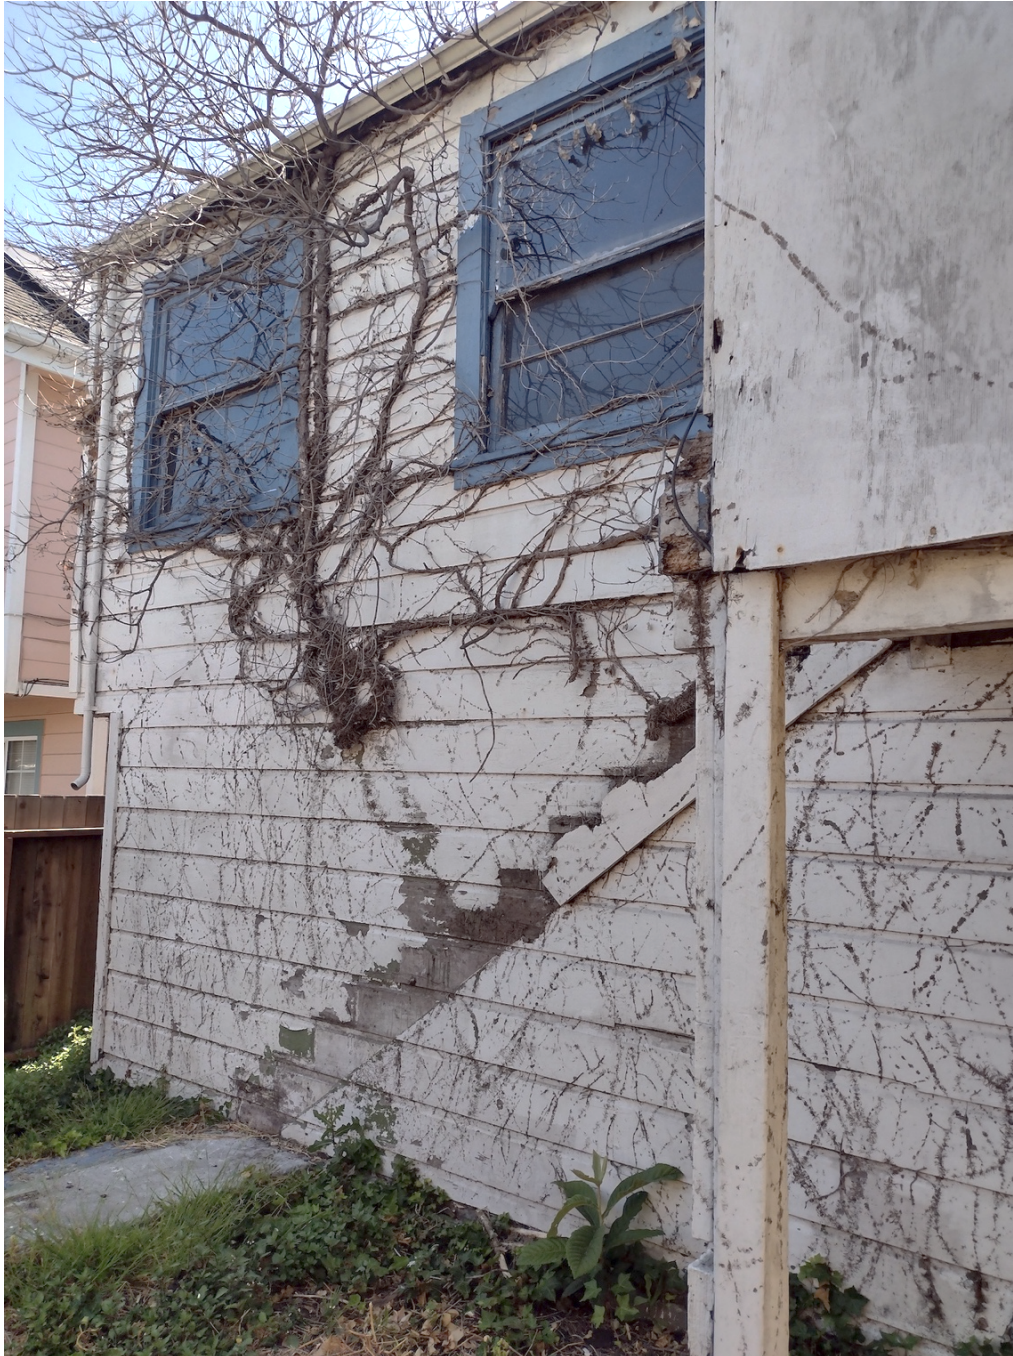
- Channel rustic and tongue-and-groove wood siding is in fair-poor condition throughout
 - Peeling paint throughout
 - There is significant damage from vines on North and West elevations, where vines had started growing behind the siding
- The structure appears to be platform-framed
 - There is out-of-plane displacement on the South elevation near the window on the 2nd floor, which may indicate a structural issue with the framing or post supports

Figure 8. View of vine damage at the rear (West) facade of 1711 Arbor Street (GA, June 2025)

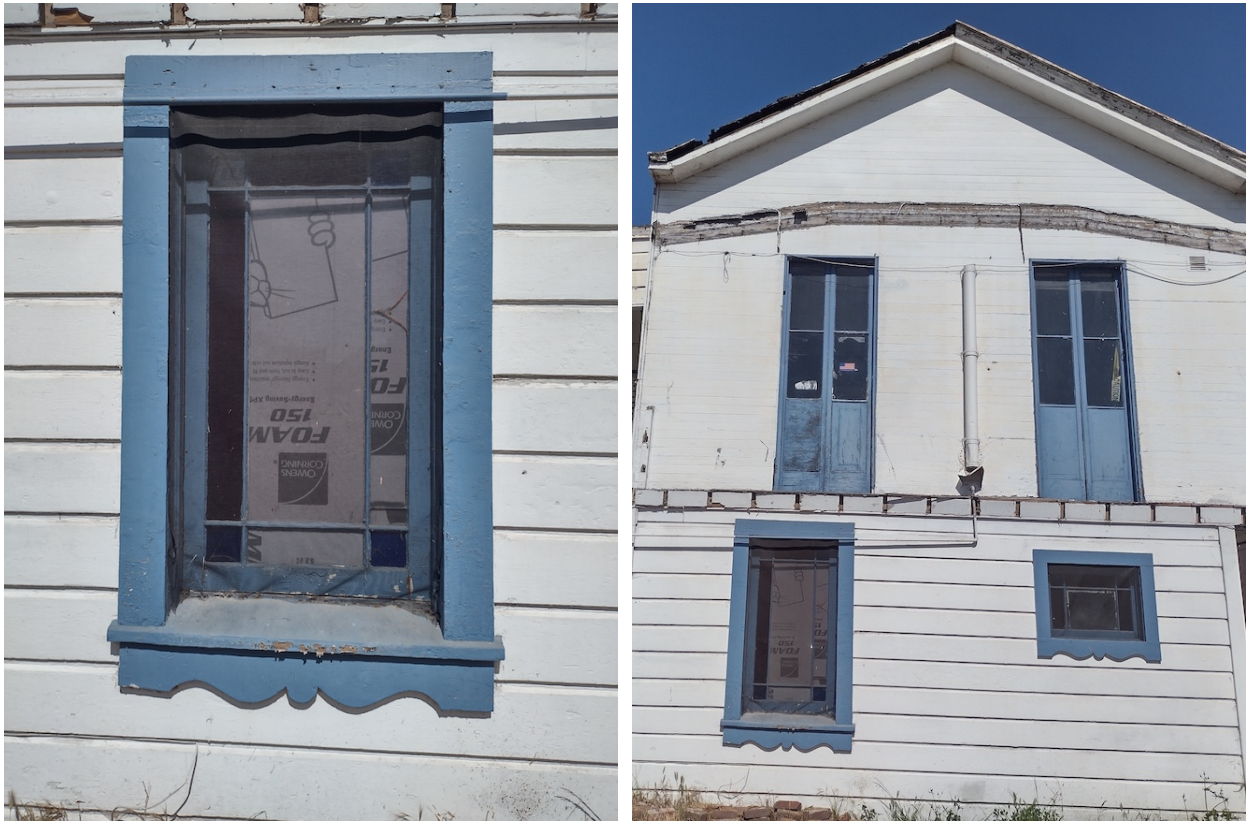
- The extant windows on the North and West facades are in poor condition due to deterioration caused by the vine growth on both elevations
 - Other windows on the South and East facades are in fair condition due to hardened or missing glazing putty, broken or missing panes, racking, failing paint, and/or deteriorated wood sash elements

- One of the half-glazed wood double doors on the East elevation is in poor condition due to deteriorated wood elements, hardened or missing glazing putty, and failing paint; the lower panel of the South-side door was replaced with plywood

Figure 9. (Left) View of 1st floor window at East elevation. Note window is boarded up from the interior due to missing panes (GA, June 2025); **(Right)** View of window windows and doors on the East elevation (GA, June 2025).

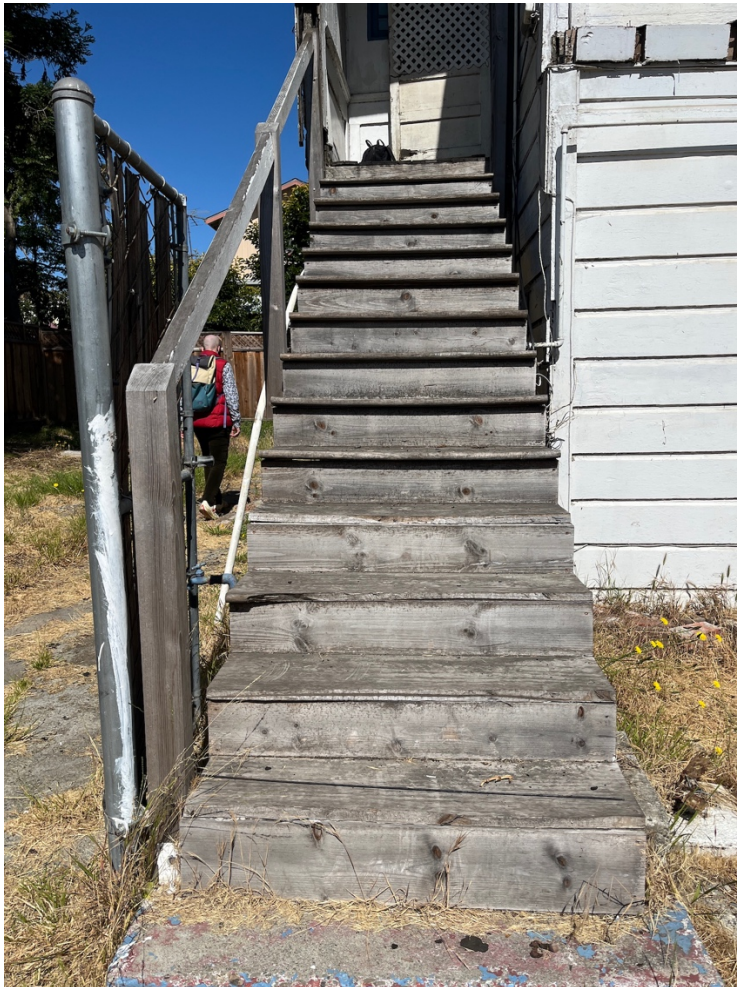
- The wood stairs leading to the 2nd floor are in poor condition due to loose boards, deteriorated and cracked wood, and gaps between the boards

Figure 10. View of exterior staircase at East elevation. Note deteriorated and cracked wood (GA, June 2025)

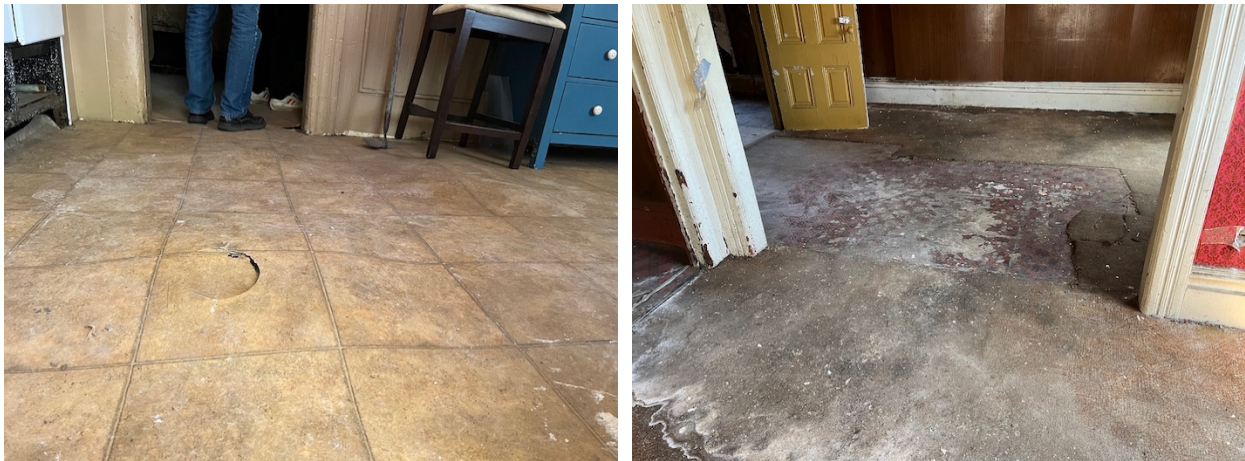
- Flooring throughout the 1st floor is a mix of linoleum and wood laminate, all in fair-poor condition
 - The linoleum is in poor condition, likely due to excess moisture and/or sinking of the foundation causing it to peel or bubble; the linoleum in the kitchen is particularly bad, as it has become extremely warped

- The linoleum and carpeting are in poor condition, due to excess moisture causing peeling and failure of the linoleum and staining and deterioration of the carpeting

Figure 11. (Left) View of bubbling and warped linoleum at 1st floor kitchen (GA, June 2025); **(Right)** View of stained and deteriorated carpeting and linoleum at 2nd floor reception hall and living room (GA, June 2025).

- Complete gutting of the interior, due to extensive interior finish damage and the presence of mold and lead paint
- Replacement of the majority—if not all—of the 1st floor framing and roof framing, due to significant damage from wood rot
- Complete removal of rear staircase landing/porch elements due to deteriorated condition
- Complete rehabilitation or replacement of all doors and windows
- Repair or replacement of damaged or deteriorated siding that is coated with lead paint

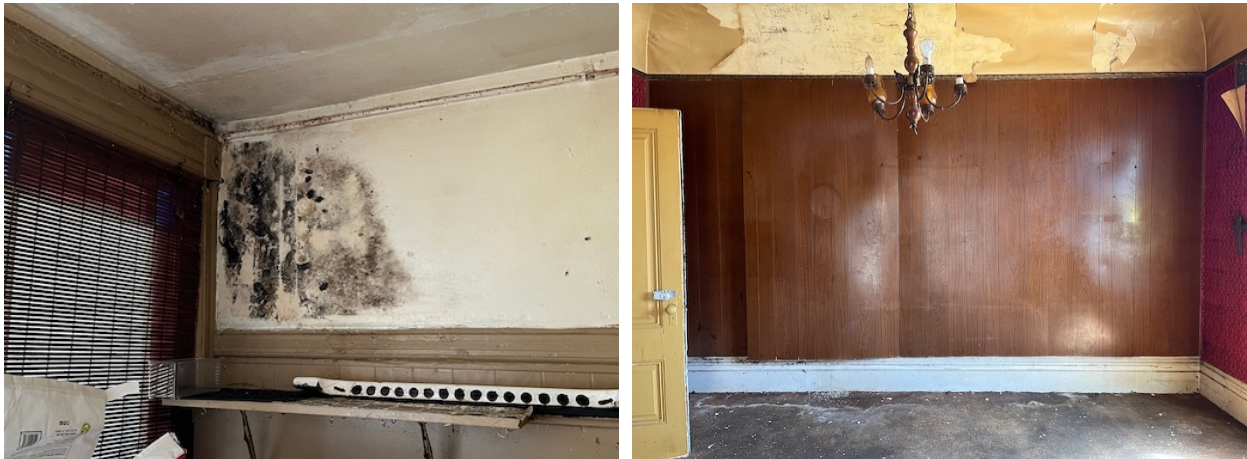
- Where the wood lath is exposed, there are signs of rot and deterioration of the wood
- The presence of mold in the kitchen and the bedroom to the North of the kitchen, along with delaminated plaster, peeling/stained wallpaper, warping/delaminating paneling, and rot in the wood lath, indicate that there is excess moisture in the walls

- The thin wood paneling is in poor condition throughout, as most of it is warped or delaminating
 - The porcelain tile backsplash and wainscoting is in poor condition throughout, as it has delaminated in many areas

Figure 12. (Left) View of mold on West wall of 1st floor kitchen (GA, June 2025); **(Right)** View of warped wood paneling at North wall of 2nd floor living room (GA, June 2025).

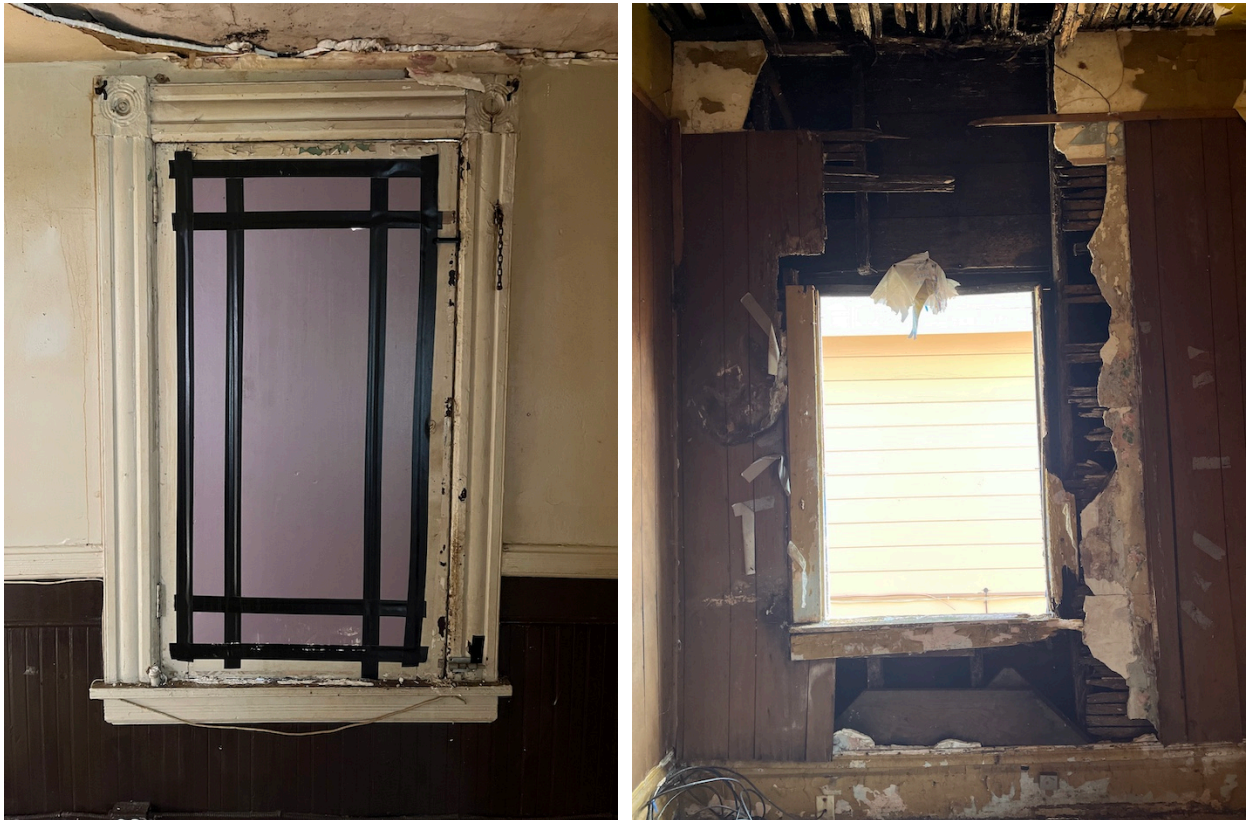
- See section above for exterior window conditions
 - A window on 2nd floor of North elevation is missing (likely one of the double-hung units based on the size of the opening), leaving the interior exposed to the elements; wood rot was visible in the exposed window framing around the opening from the interior

- The extant windows on the North and West facades are in poor condition due to deterioration caused by the vine growth on both elevations; wood rot and deterioration are visible at the interior sills and sashes of these windows

Figure 13. (Left) View of 1st floor window from the East wall interior. Note window is racked and boarded up from the interior due to missing panes (GA, June 2025); **(Right)** View of 2nd floor window from the North wall interior. Note missing window and framing damage (GA, June 2025).

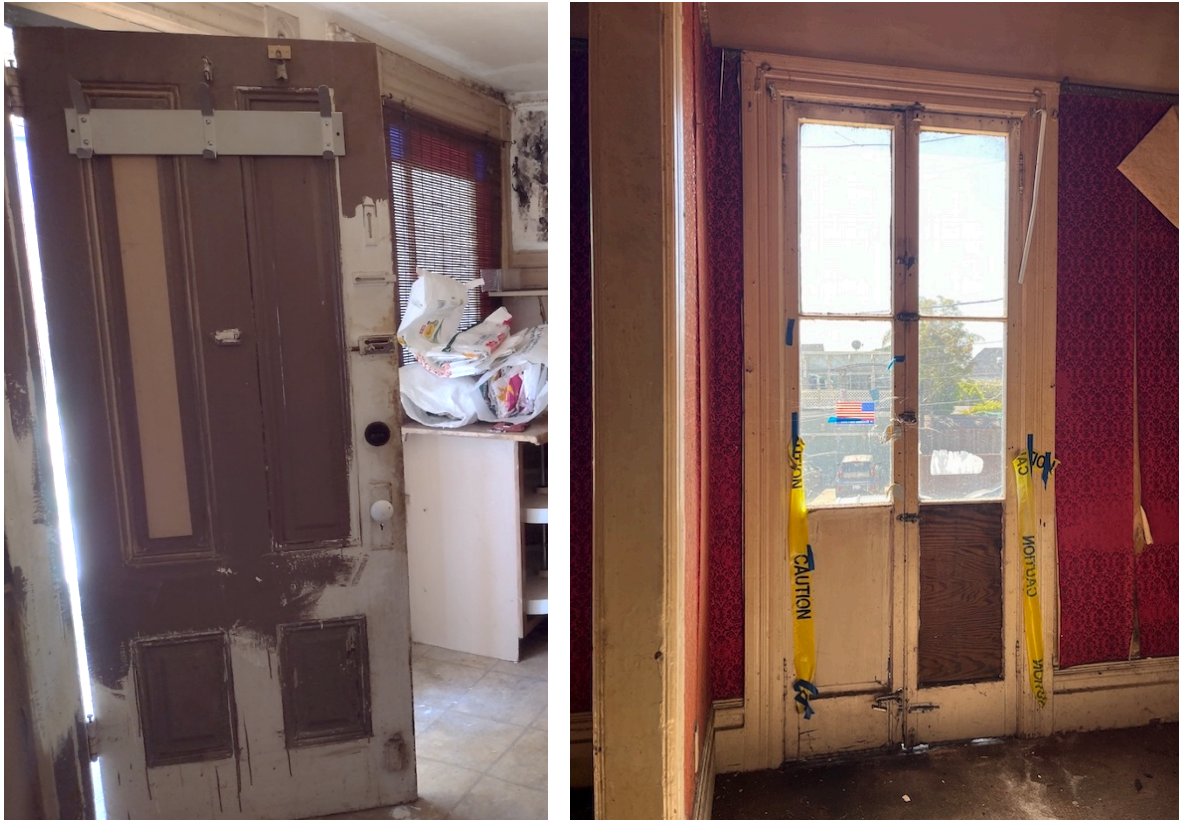
- See section above for exterior door conditions
 - Interior doors are all in fair condition due to deterioration of wood elements and failed paint

Figure 14. (Left) View of 1st floor entrance door from the South wall interior. Note failing paint and weathered wood elements (GA, June 2025); **(Right)** View of 2nd floor door from the East wall interior. Note deteriorated wood elements, failing paint, and plywood at the lower panel of the South-side door (GA, June 2025).

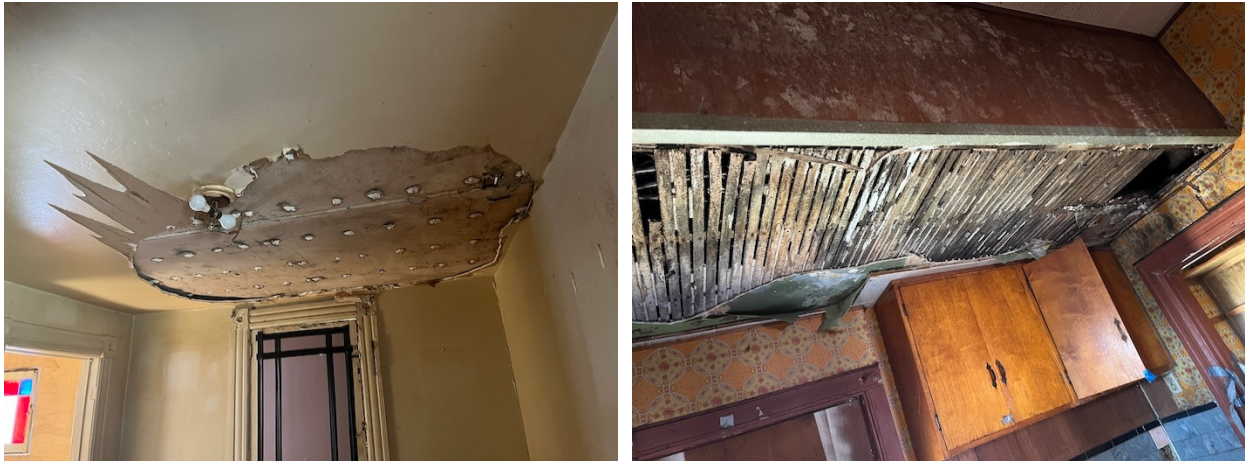
- Plaster appears to be in poor condition throughout, as it has delaminated in many areas
 - Wallpaper is in poor condition throughout, as most of it is peeling or water-stained

- Acoustic tiles appear to be in good condition throughout
 - Where the wood lath is exposed, there are signs of rot and deterioration of the wood
 - Delaminated plaster, peeling/stained wallpaper, and rot in the wood lath, indicate that there is excess moisture in the ceiling and/or roof framing

Figure 15. (Left) View of failed plaster at ceiling of 1st floor living room (GA, June 2025); **(Right)** View of failed plaster and deteriorated wood lath at ceiling of 2nd floor kitchen (GA, June 2025).
