January 18, 2017

Subject: Assessment of Impacts to Trees
1208 Saint Charles Street, Alameda, CA

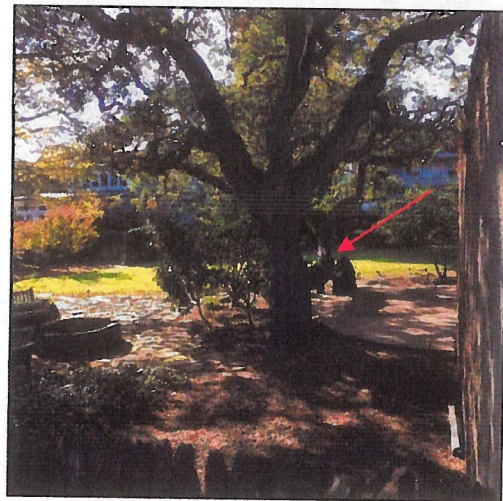
The oaks were mature with diameters of 36" and 33", respectively. Both oaks were in good condition, with full crowns and spreading forms. Oak #2 had a long lateral limb extending out to the east and held up by a prop (Photo1). Both trees had been over pruned and lion tailed within the past year. Lion tailing is a form of pruning that greatly reduces the green foliage, leaving growth only at the ends of each branch. Lion tailing is particularly detrimental to coast live oaks because they are susceptible to sunscald and sunburn.

Photo 1. Tree #2 was in good condition with a long lateral limb that extended out into the yard (arrow).

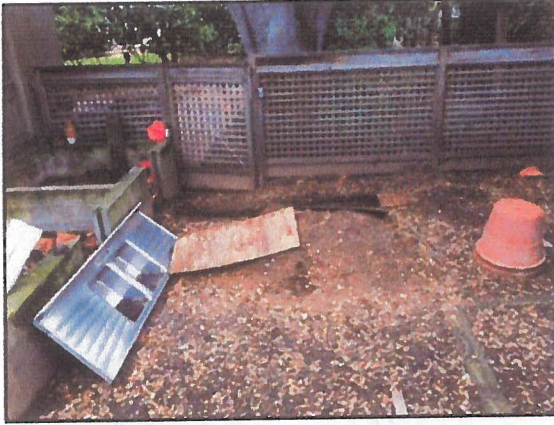
Two exploratory trenches were dug with an air spade adjacent to trees 1 and 2. The trenches were 1' wide and 36" deep. The trench dug for tree #1 runs north-south and was excavated where the footprint of the building is proposed (Photo 2 and 3, next page). The trench dug for tree #2 runs east

Photo 2, left. Tree #1 with the trench in the location of the proposed building.

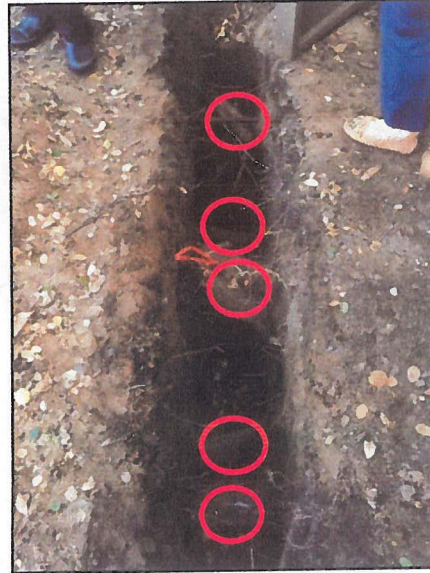
Photo 3, right. Looking into the trench adjacent to tree #1.

The trench adjacent to tree #1 had five roots larger than 2" that can be seen in Photo 3. I do not recommend any work be done in this area, cutting of roots this large and this close to the tree has the potential to impact health, compromise stability.

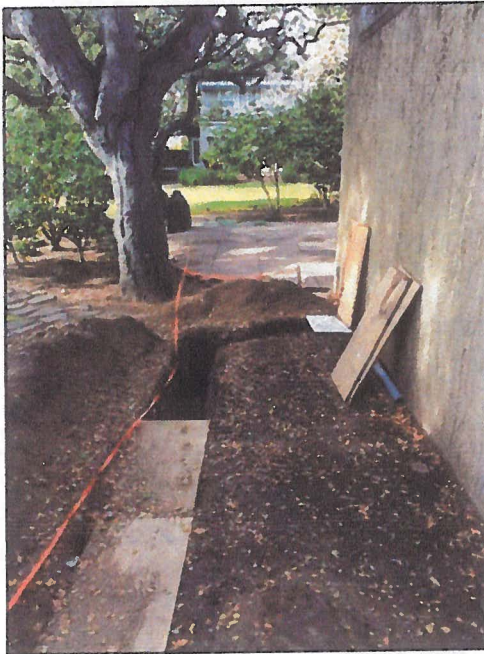
Photo 4, left. Trench adjacent to tree #2.

The trench adjacent to tree #2 shows no roots larger than 2". Work in this area could be completed as is directed in the Thomas Arborist Report dated October 6, 2016.

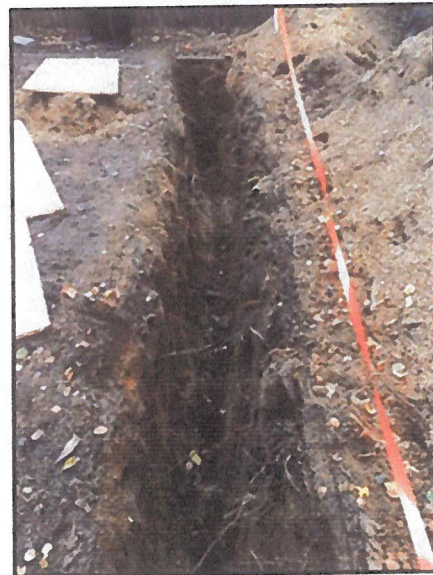
Photo 4, right. Close up of the trench adjacent to tree #2.
