Re: Alameda Point - Building 114 Evaluation Update (2024)
2450 Saratoga St.
Alameda, CA 94501
Job No. 2022.040.02

ALAMEDA POINT - BUILDING 114 UPDATED EVALUATION

ALAMEDA POINT - W. MIDWAY AVENUE FACADE & ROOF DETERIORATION TIMELINE

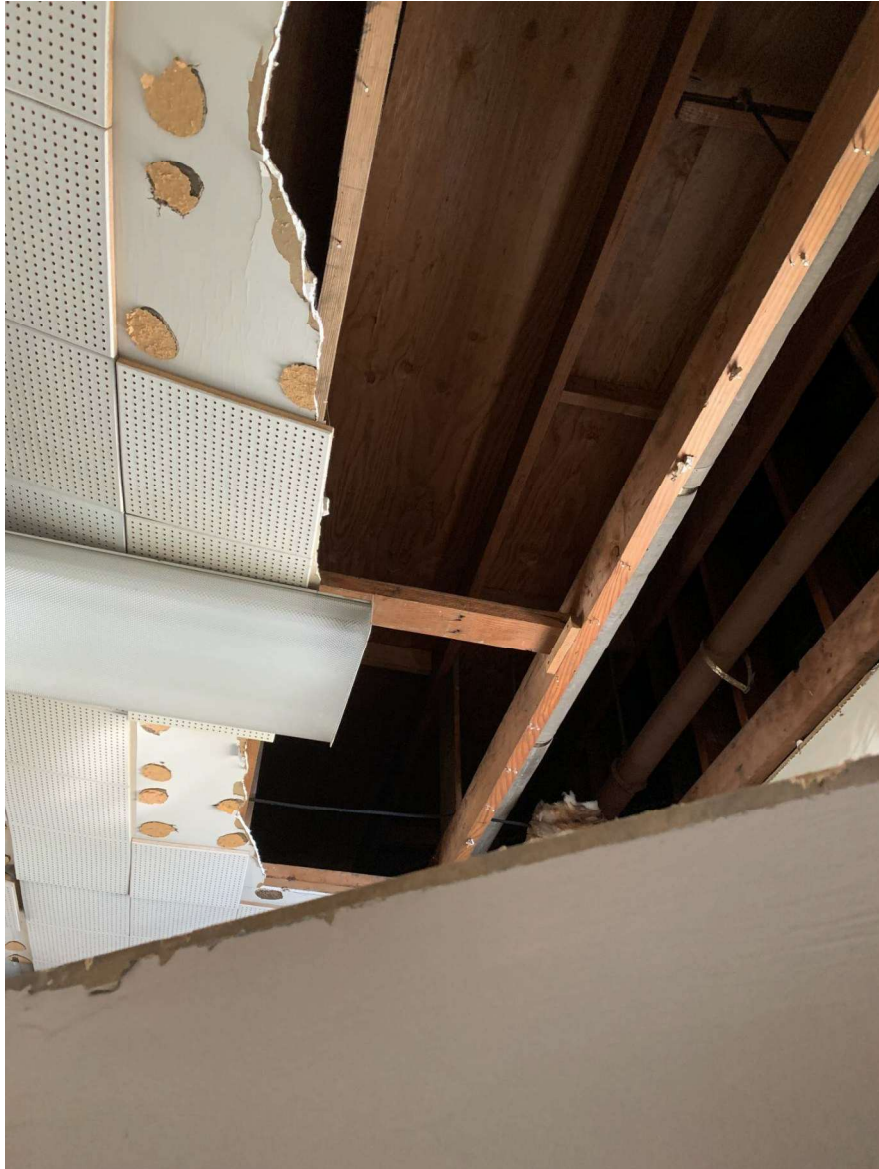
At the office area on the West side of the building, we were able to view a portion of the existing roof framing and wall framing that was exposed in this area. The joists, roof sheathing and wall studs all appeared to be in good condition (Figure A.1 and A.2). The slab-on-grade at the ground floor exhibited significant cracking and is worn down at the entrance area (Figure A.3). We were unable to observe the condition of the sheathing and studs at the exterior walls at the office area.

vandalism during its vacancy. The exterior siding is deteriorating and peeling at all sides of the building. The glass in many of the windows at the exterior walls are broken (Figures A.8 and A.9). There are holes in the gypsum board at the interior walls and ceiling in many locations (Figure A.1 and A.2). The floor finishes in the office areas are damaged (Figure A.10).

Figure A.1 - Exposed roof framing and sheathing.

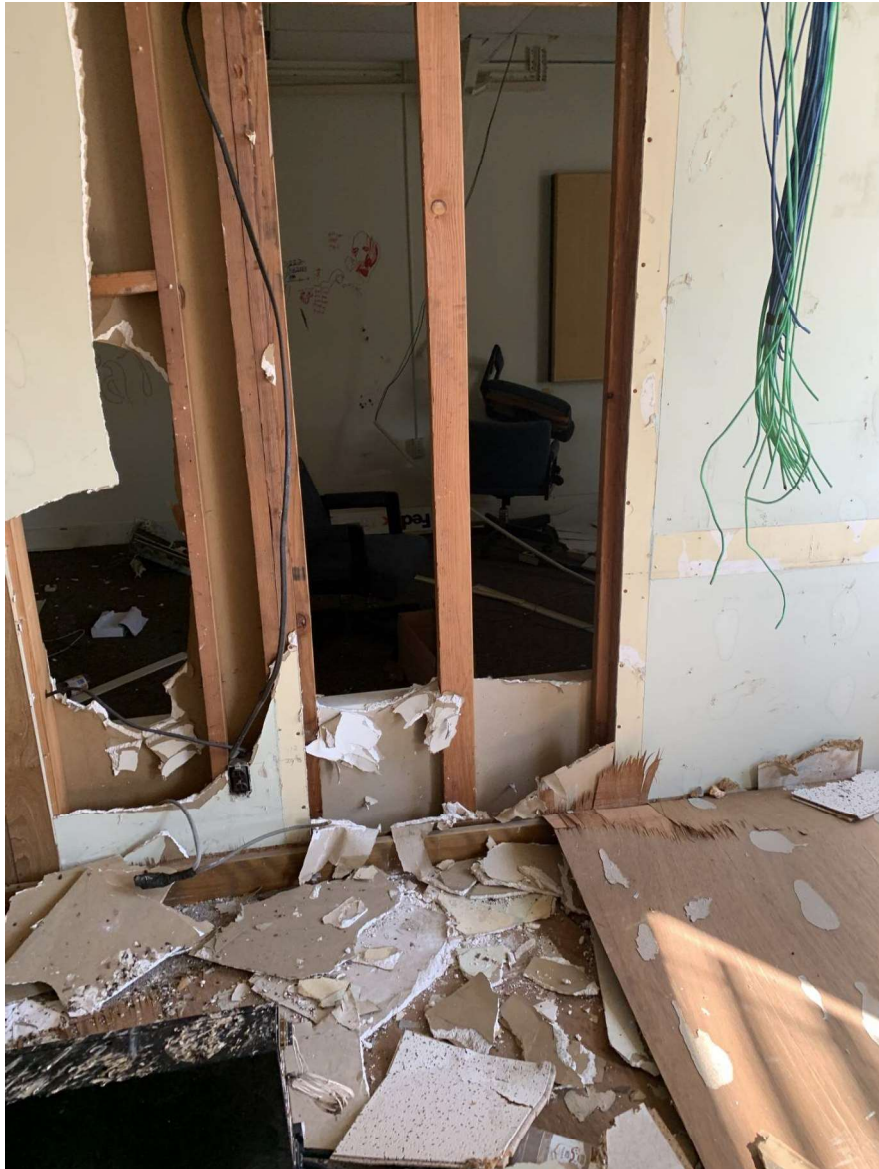
Figure A.2 - Exposed wall studs.

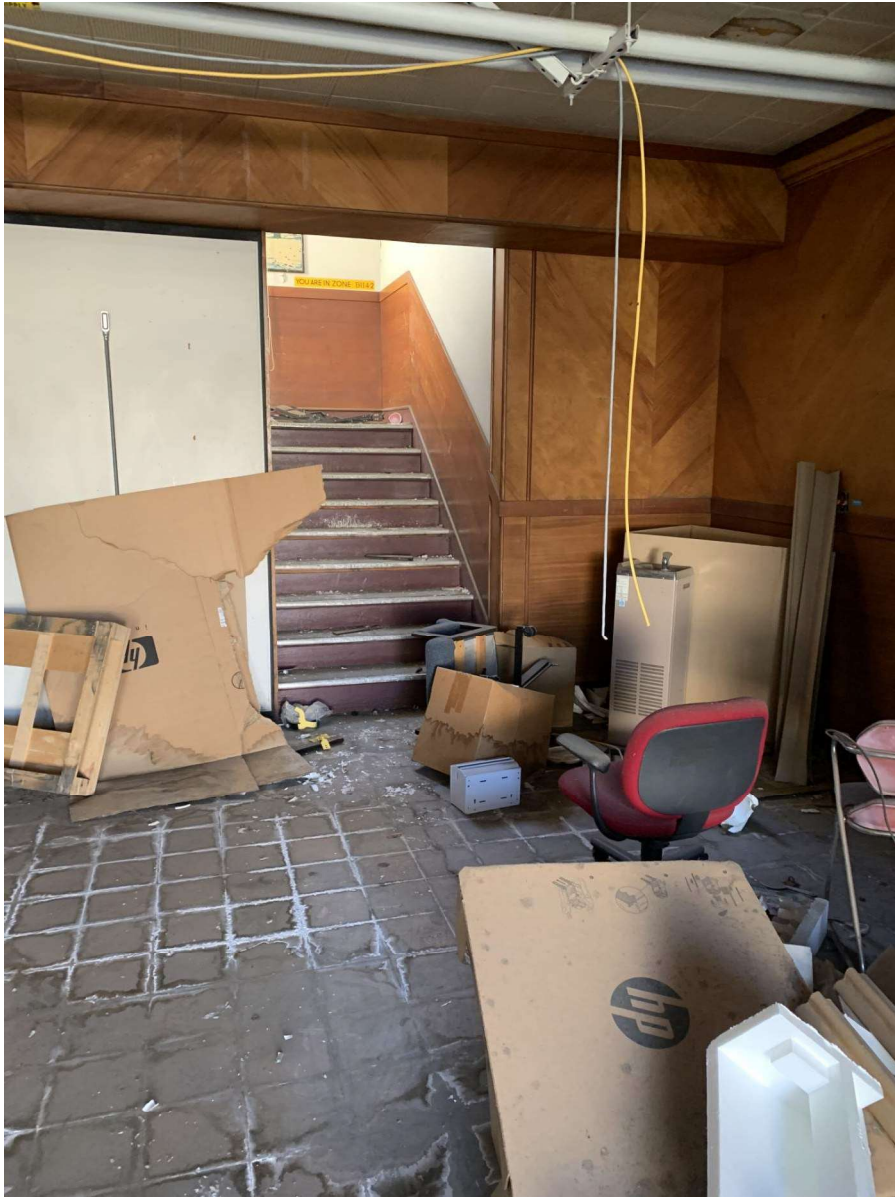
Figure A.3 - Slab-on-grade at ground floor.

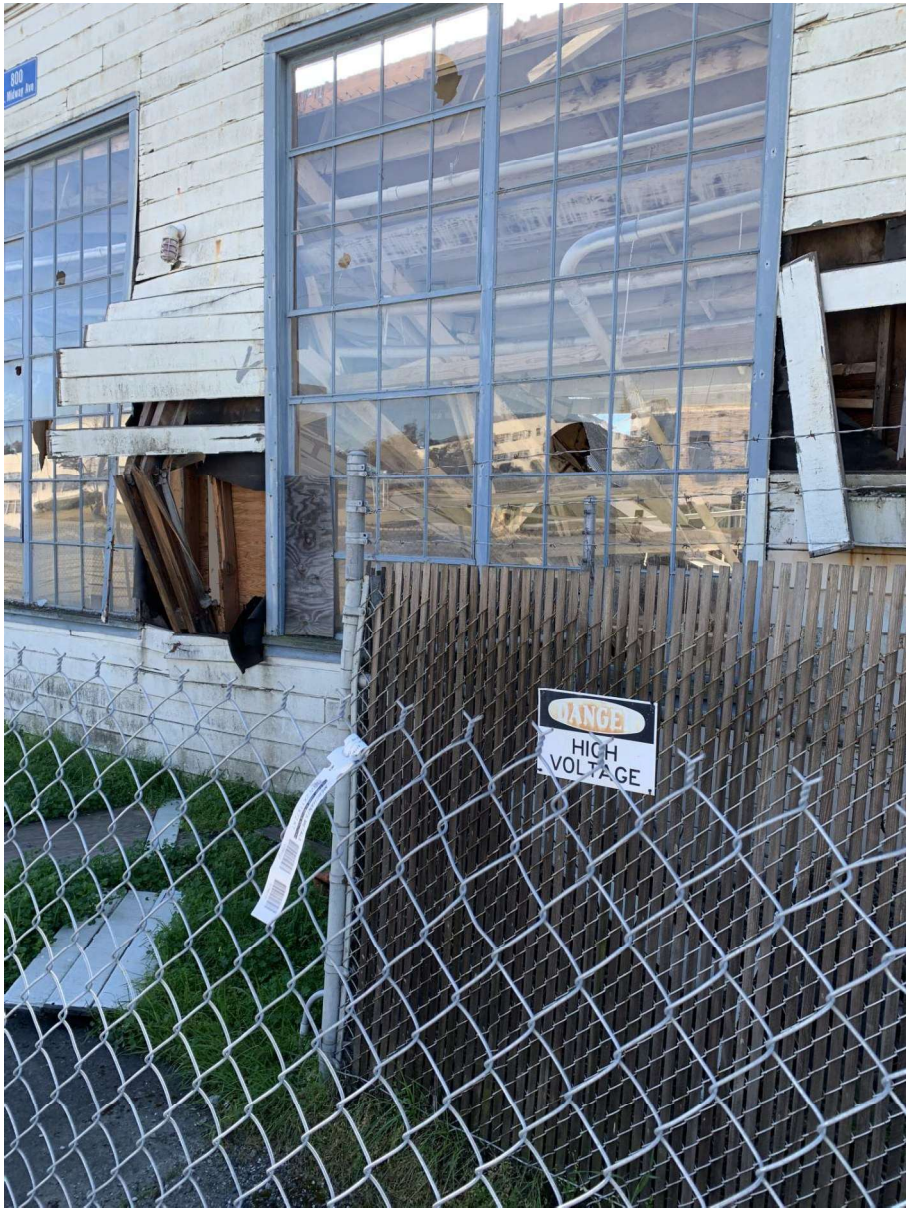
At the East side of the building, we observed a partial roof collapse at the north wing. It appears a wood truss has failed, causing several roof beams and roof sheathing to fall. The collapsed roof structure has also caused damage to an adjacent exterior wall (Figure A.4, and Appendix B), which has been getting progressively worse over the past several years, and poses a collapse hazard to the adjacent sidewalk and site areas if not properly shored.

Figure A.4 - Collapsed roof at East side of building.

- **Remove and Replace Damaged Roof Framing and Additional Fire Damage:** Repair the roof framing that was damaged due to the partial collapse (north wing), fire (south wing), and other water-damaged framing elements. At the partially collapsed north wing, and fire-damaged south wing, framing, trusses and damaged wall and column supports should be replaced in the same configuration and designed to meet current code provisions.
- **Add Roof Sheathing:** Provide a new plywood sheathing overlay with sufficient nailing to provide a modern-code compliant diaphragm. This will improve the overall strength and stiffness of the

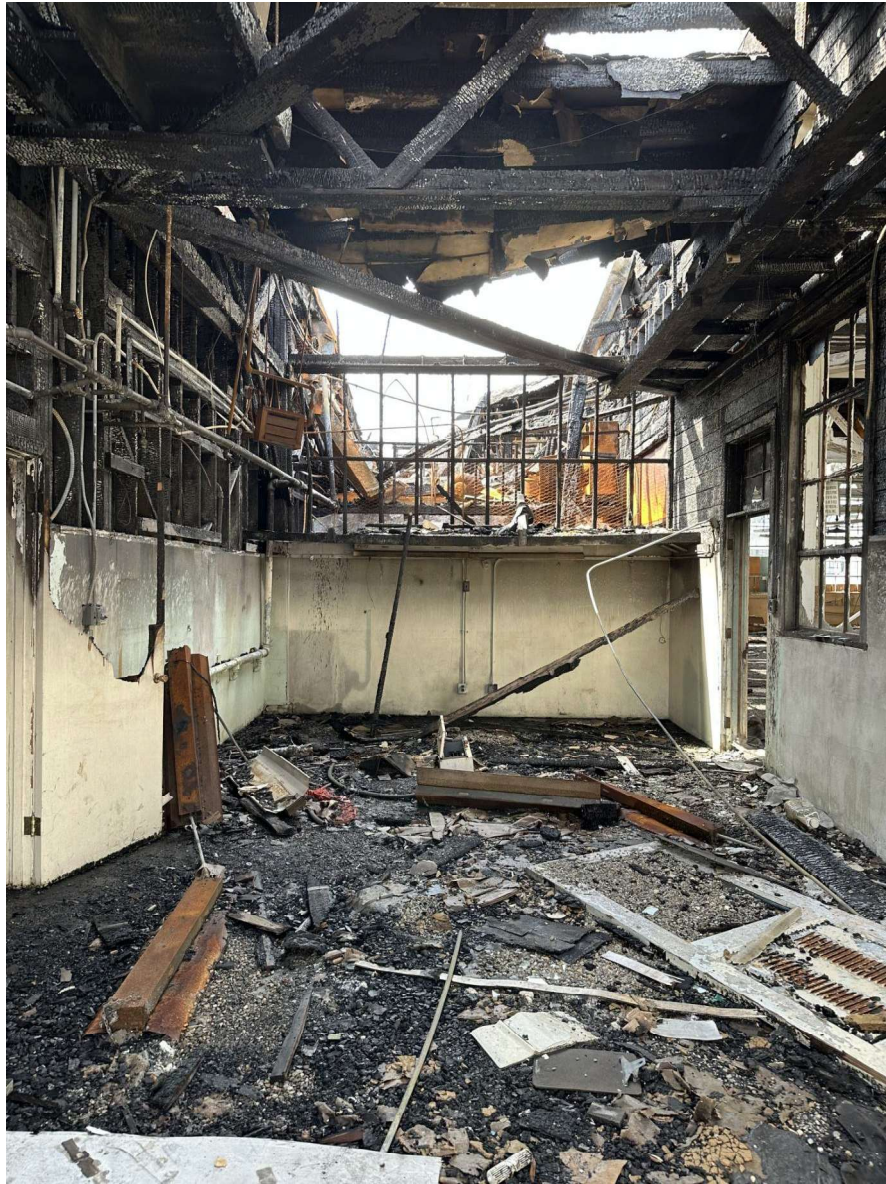
At the south wing of the building, the 2022 fire led to the destruction of the roof structure over a whole bay of framing (Figure A.5). The remaining walls and framing in this bay were significantly charred leaving them in a state where structural integrity is questionable, and replacement is required (Figure A.6). Firefighting activities adjacent to the fire created additional damage to the roof structure in the vicinity (Figure A.7).

Figure A.5 - Fire damaged roof bay at East end of South wing.

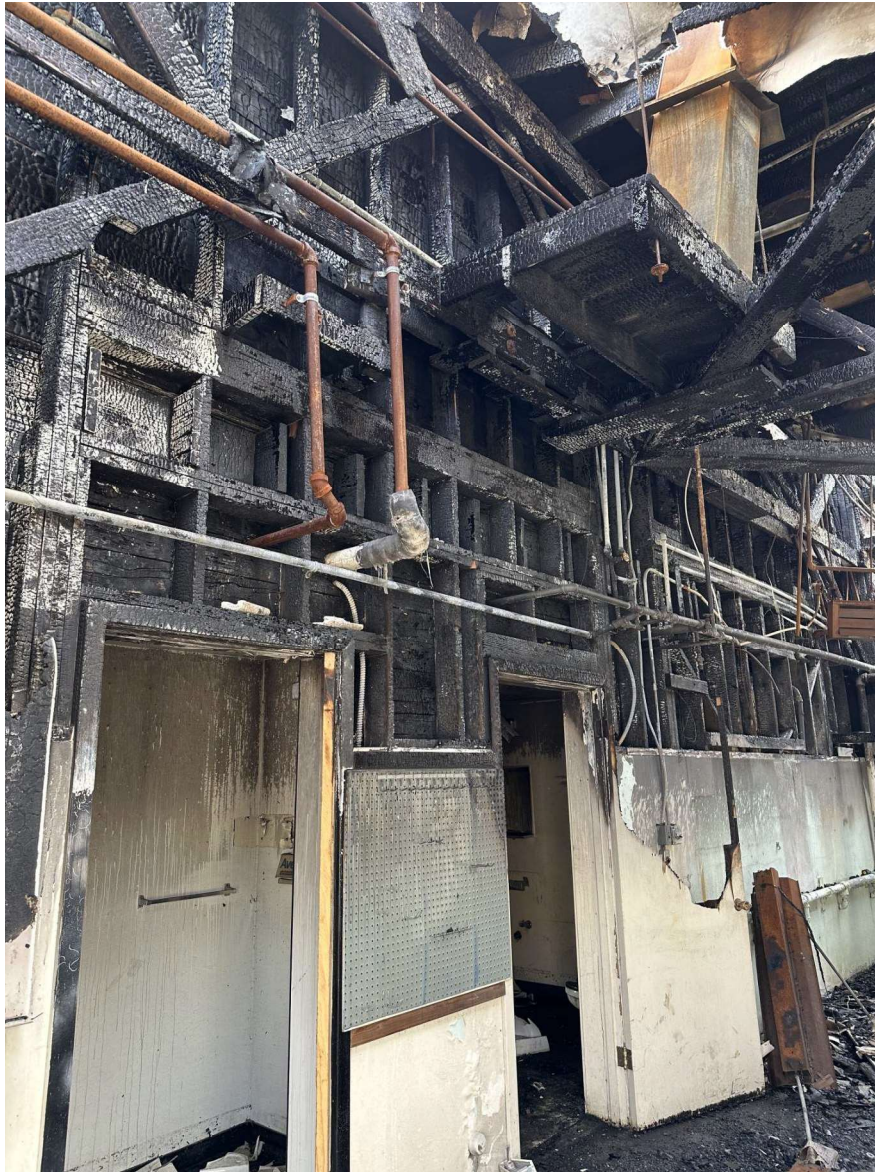
Figure A.6 - Fire damaged wall framing at East end of South wing.

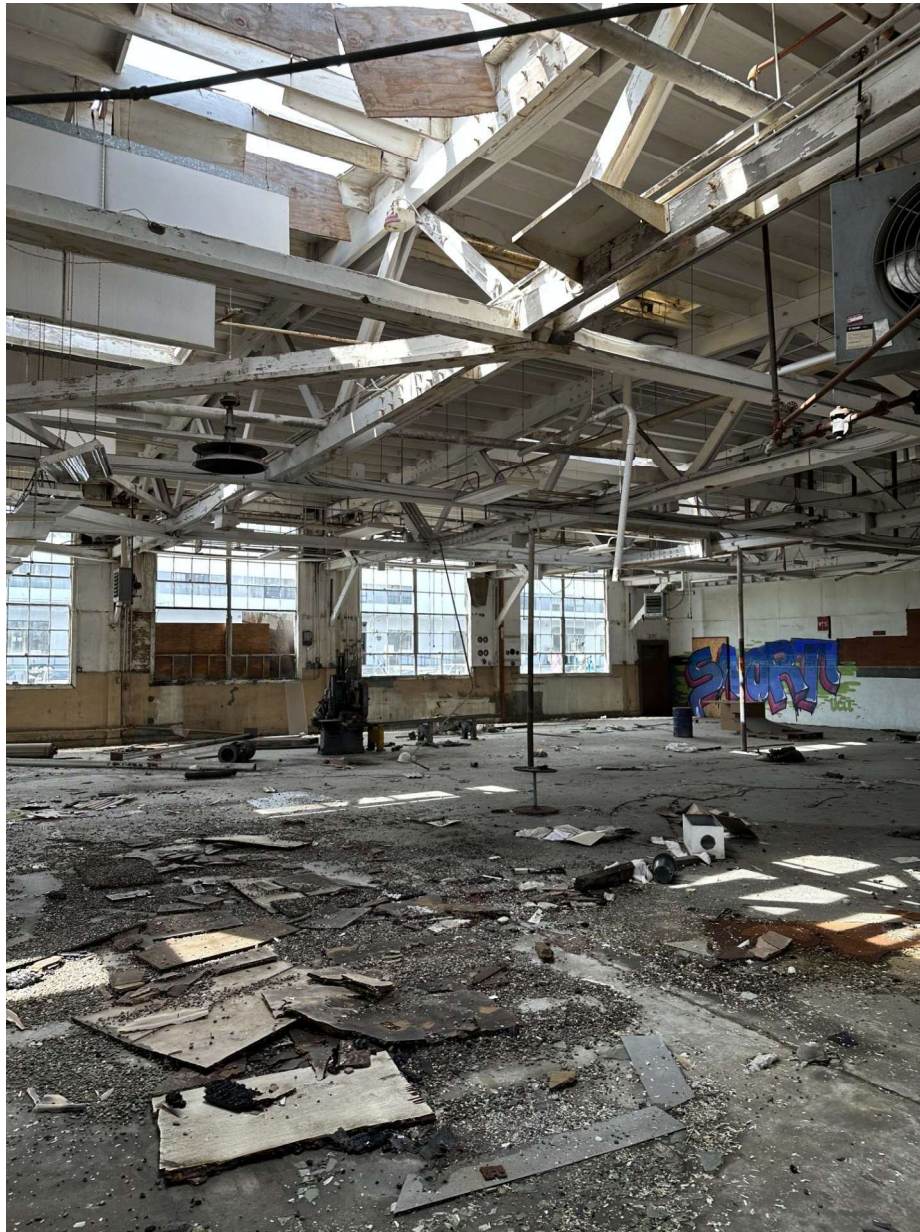
Figure A.7 - South wing high bay typical structure and damage from firefighting activity; suspected temporary truss shoring columns in view.

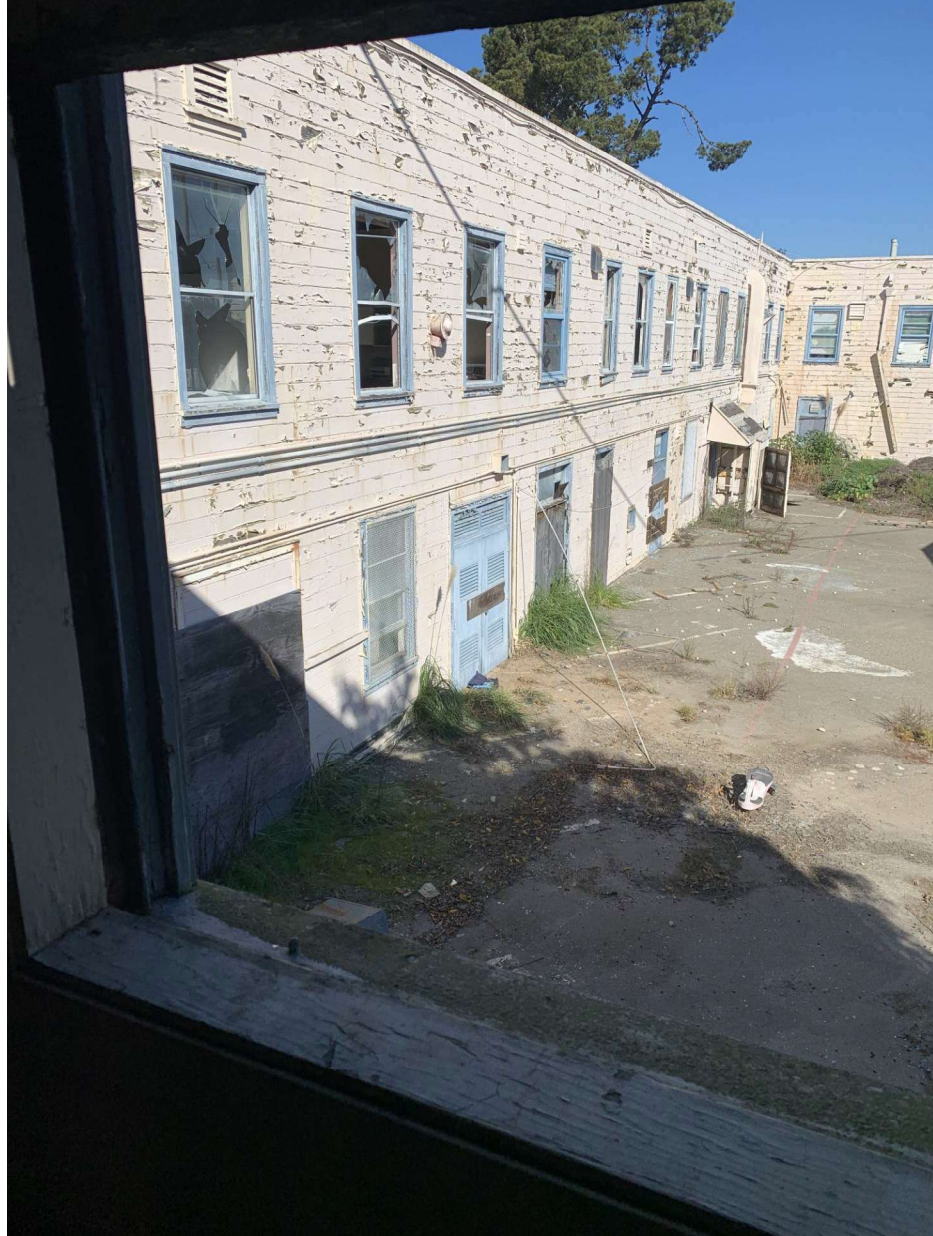
Figure A.8 - Exterior siding and windows.

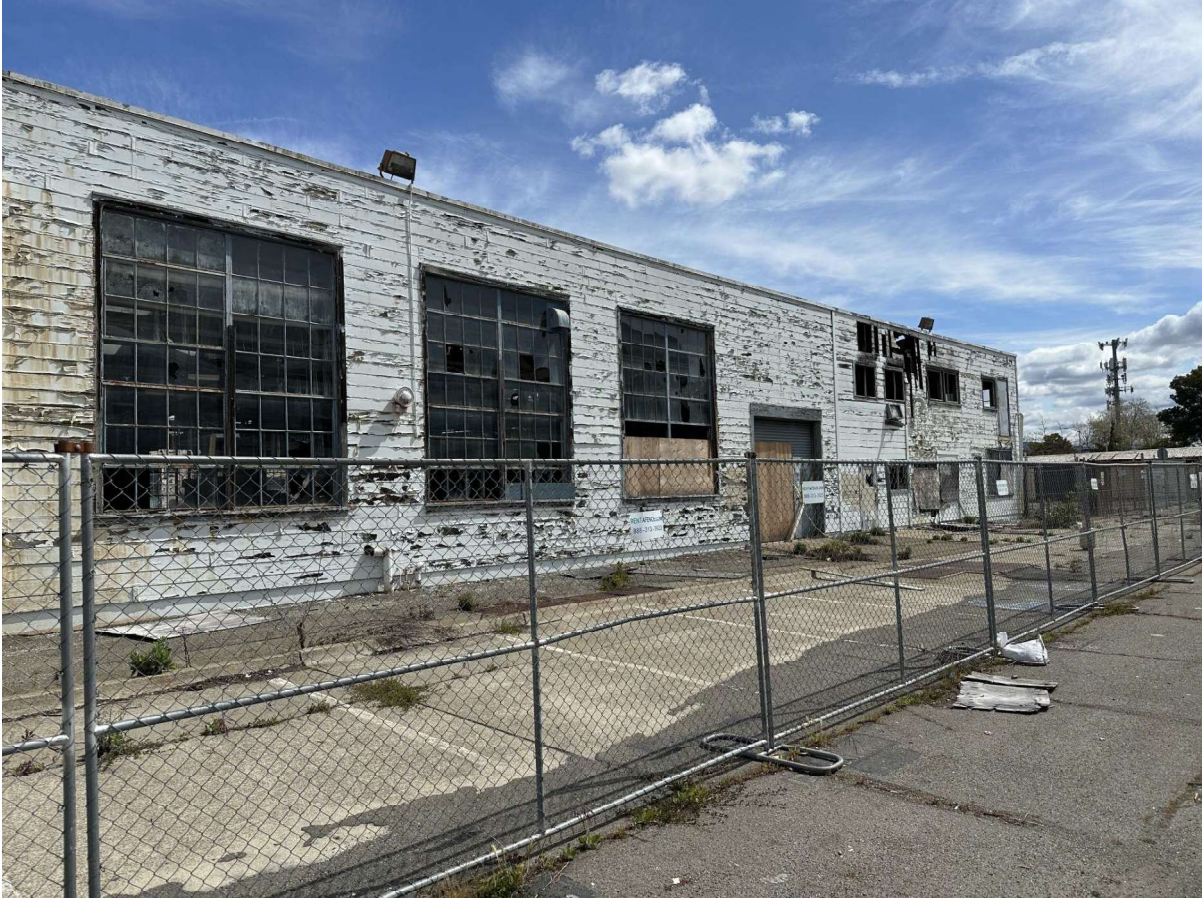
Figure A.9 - Exterior Siding and Windows.

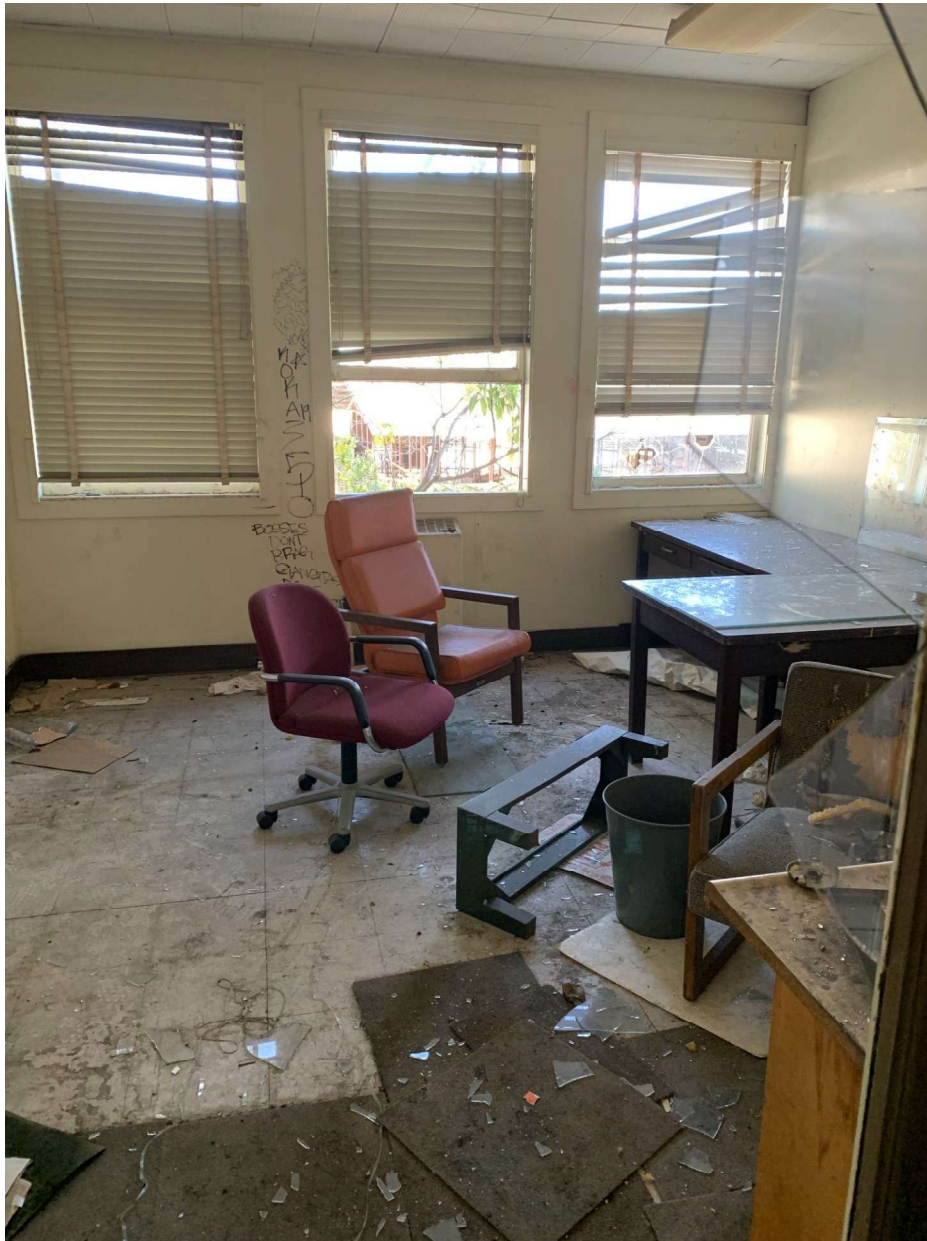
Figure A.10 - Interior floor finishes.

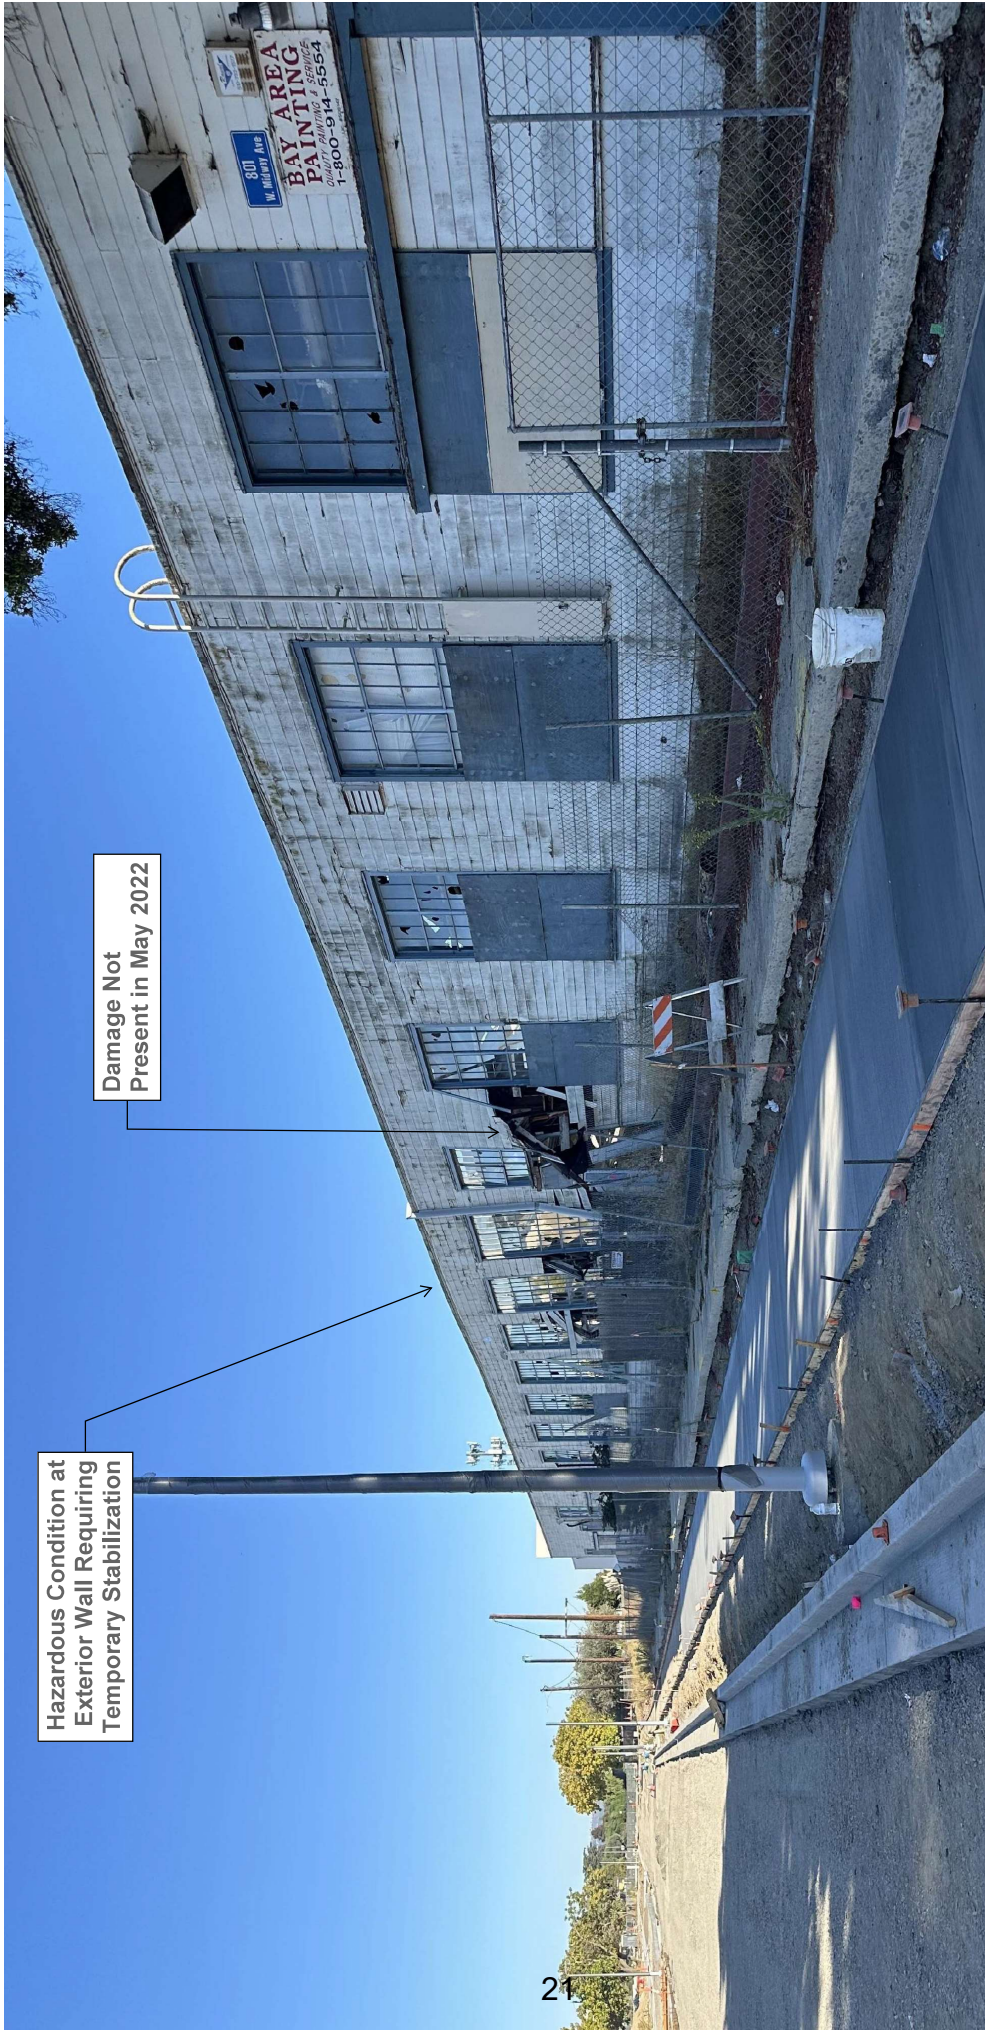
Figure B.1 - West Midway Avenue Facade Photo Taken October 3, 2024

We performed a third site visit on October 3, 2024 to walk around the perimeter of the building. We specifically reviewed the exterior wall along W. Midway Avenue, where the building has partially collapsed and the exterior wall is bowing out toward the street and newly placed sidewalk. We were able to look through open doors and broken windows to view the exposed high-bay roof truss framing at both the fire damage south wing and partially collapsed north wing. The extent of the roof collapse and damage at the north wing had visibly increased since our previous visits (see Appendix B for visual documentation of the progressive disrepair over time). The bowing and damage of the north perimeter wall along W. Midway clearly was more pronounced and more extensive in area than in years past. It appears that the extent of roof collapse had increased as well. We understand that the building has been given a “Declaration of Unsafe Building and Notice to Vacate” order by Alameda’s Chief Building

Hazardous Condition at Exterior Wall Requiring Temporary Stabilization

Damage Not Present in May 2022

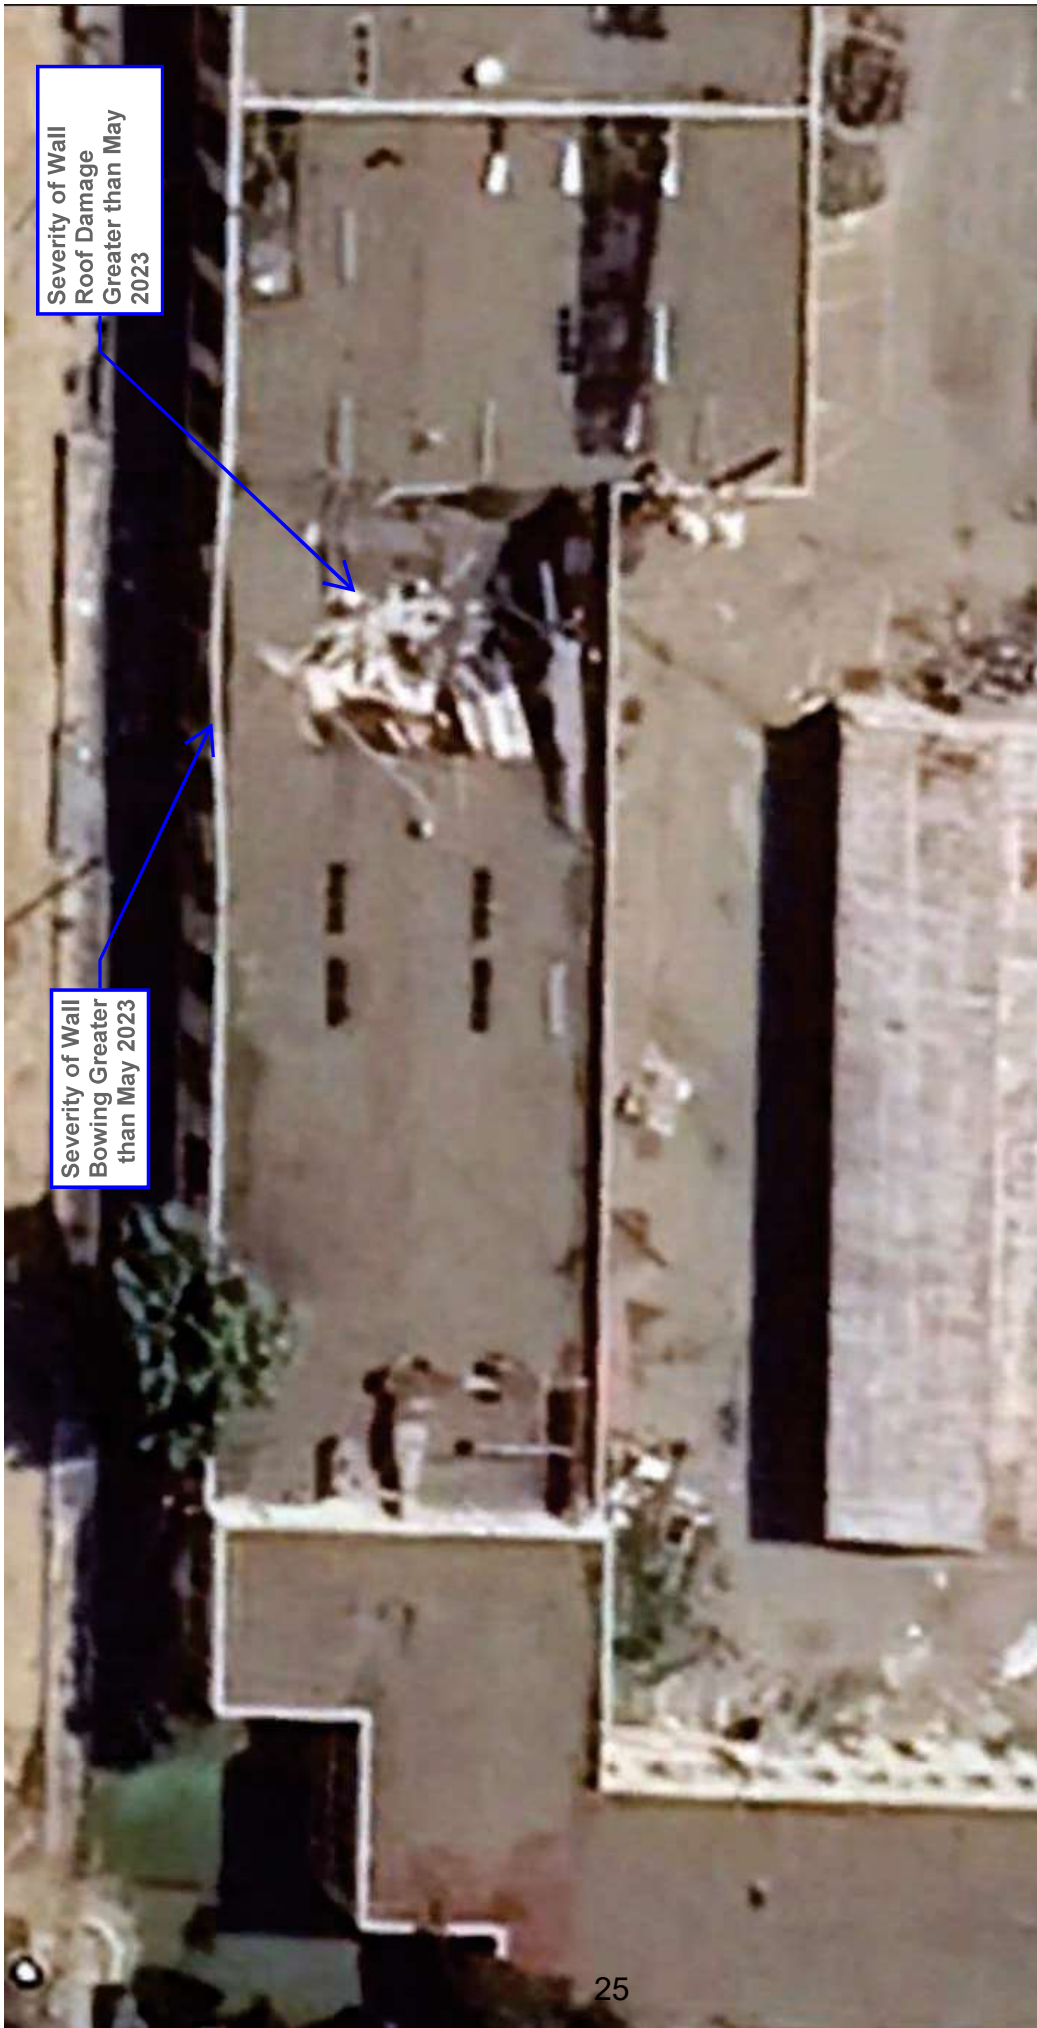
Figure B.5 - Aerial Google Earth Photo Taken April, 2024

Severity of Wall
Roof Damage
Greater than May
2023

Severity of Wall
Bowing Greater
than May 2023

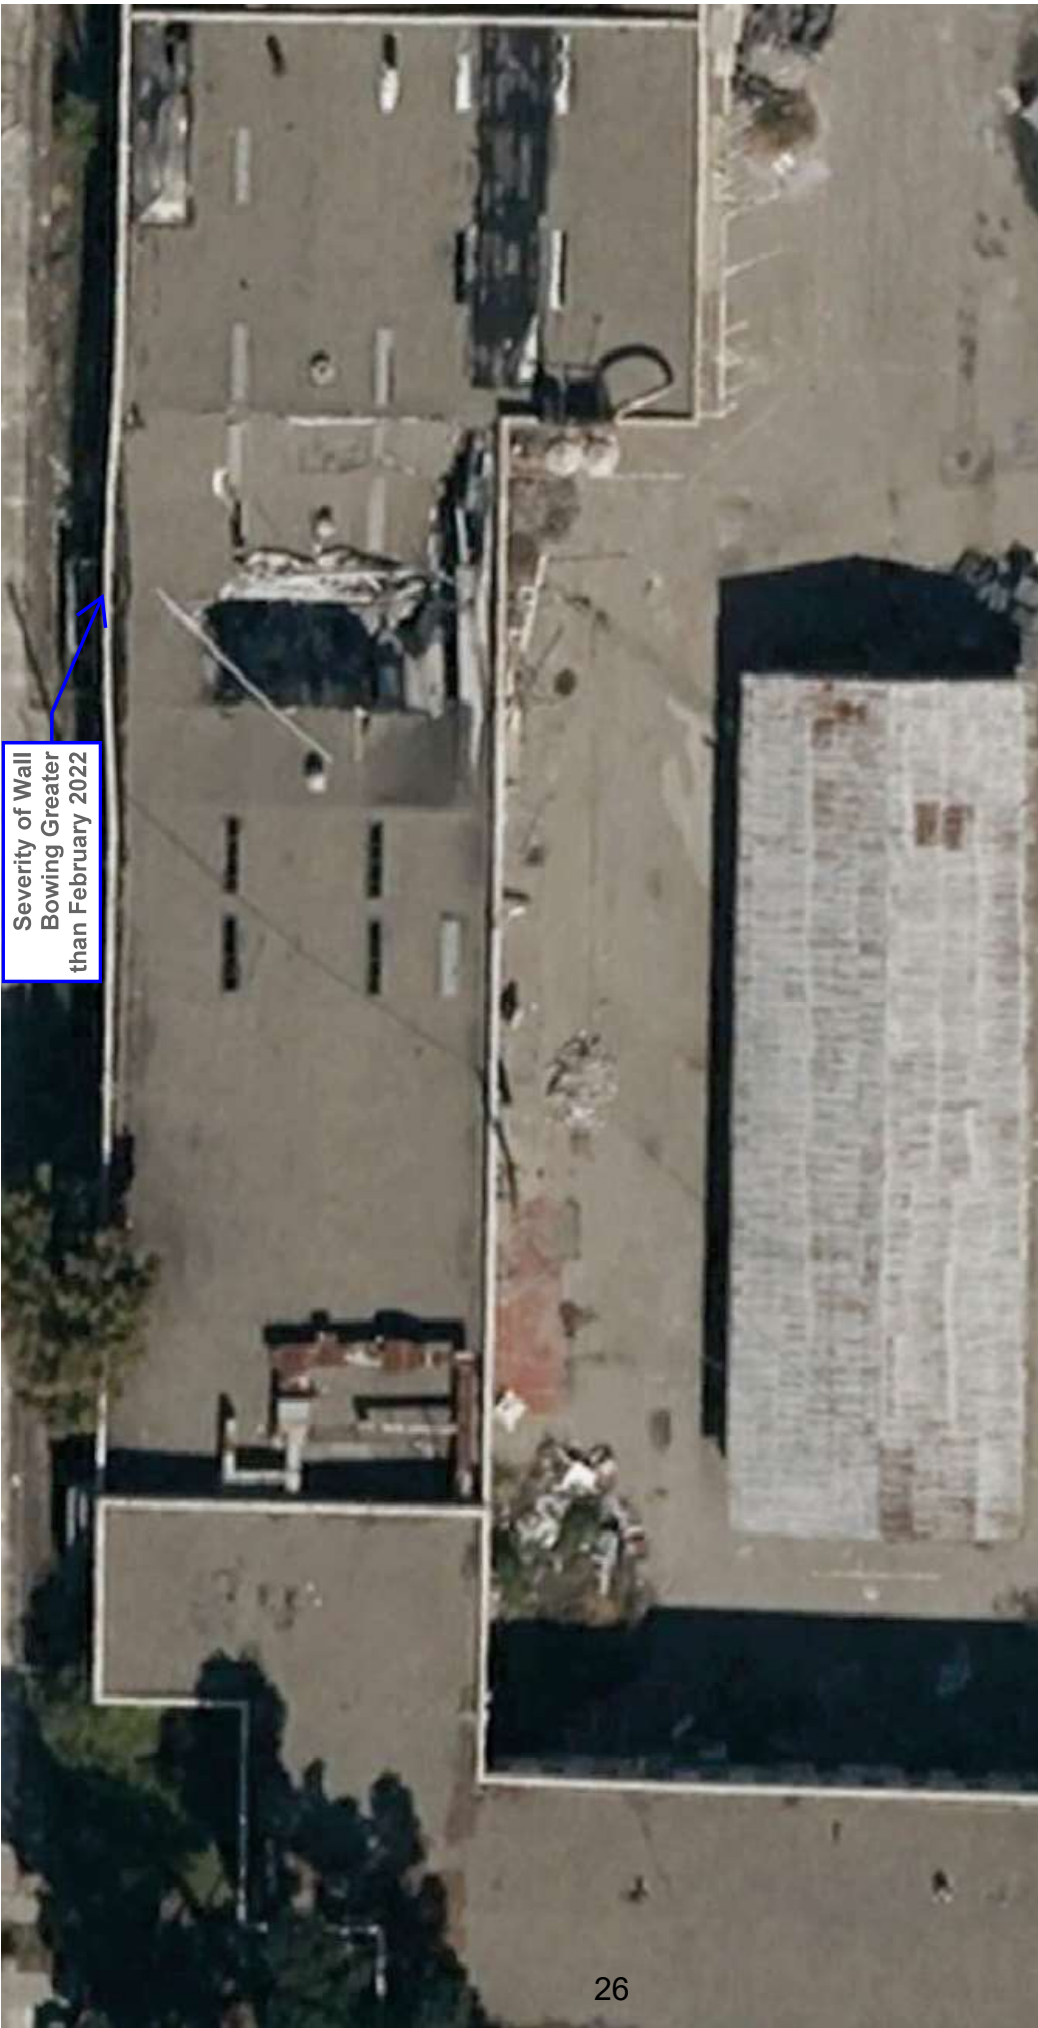
Figure B.6 - Aerial Google Earth Photo Taken May, 2023

Severity of Wall
Bowing Greater
than February 2022

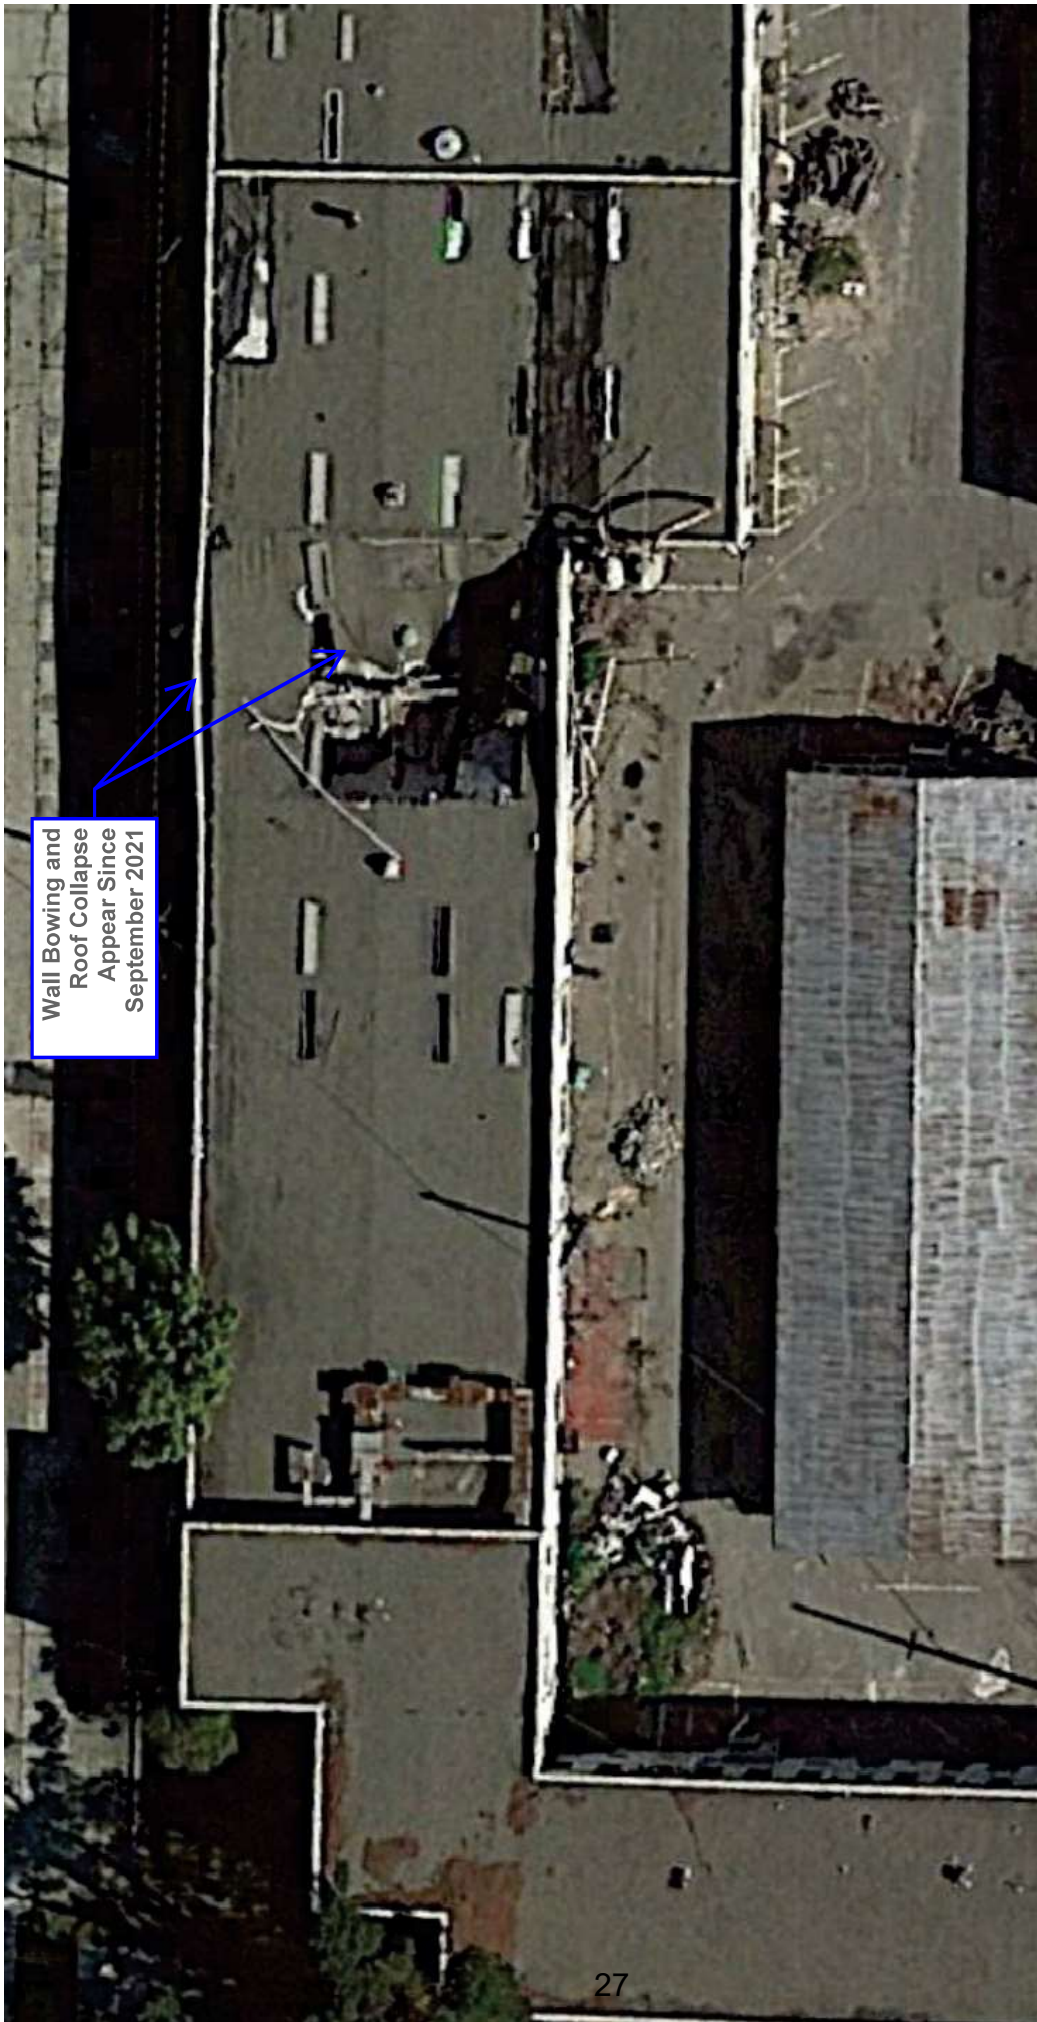
Figure B.7 - Aerial Google Earth Photo Taken February, 2022

Wall Bowing and
Roof Collapse
Appear Since
September 2021
