Arborist Report

**Mariner Square
Alameda, CA**

May 2025

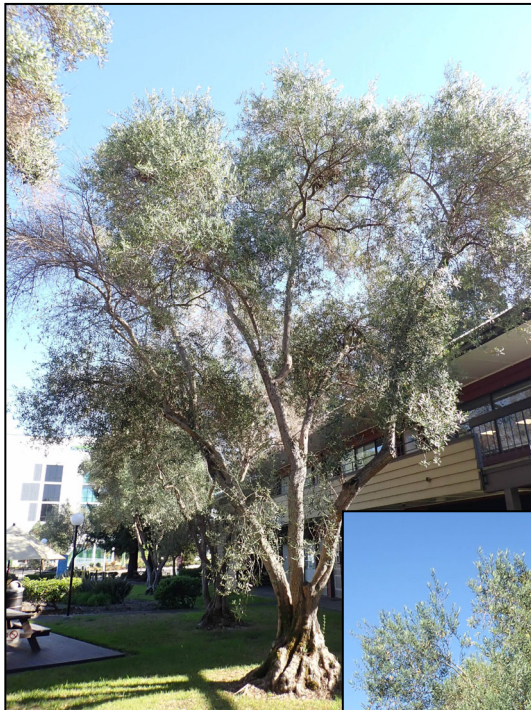
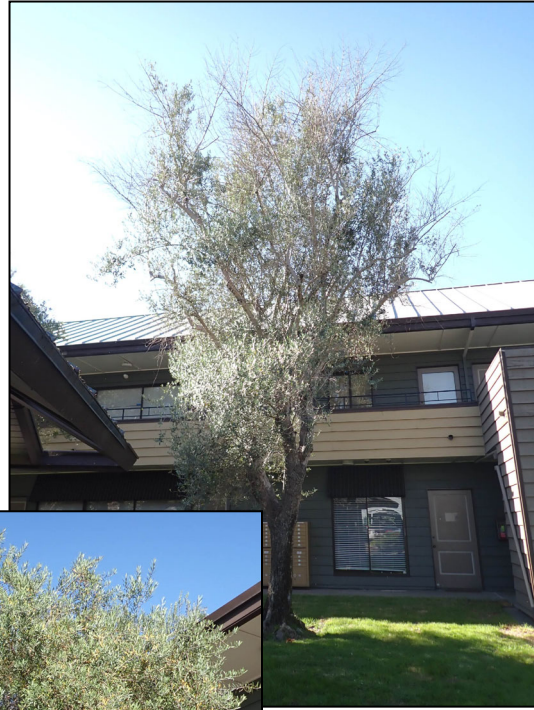
Photo 1 (above L) and **Photo 2** (above R): Show olives #363 and 365, respectively. These semi-mature trees were growing in irrigated turf and were in fair condition. Both trees were fruiting and had dieback in their crowns.

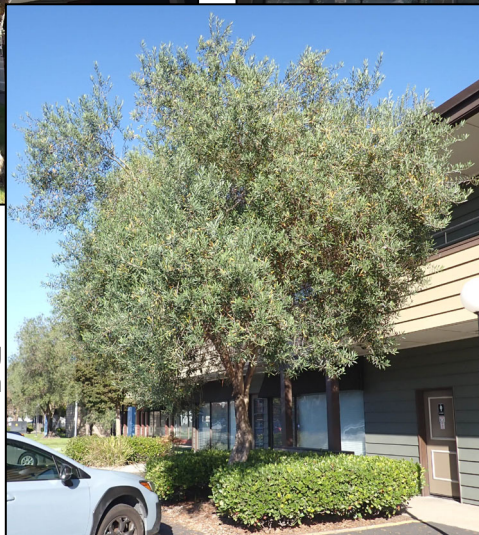
Photo 3 (L): Show olive #383. This young tree was growing in an un-irrigated landscape bed and was in excellent condition. The tree was fruiting but had no dieback in the crown.

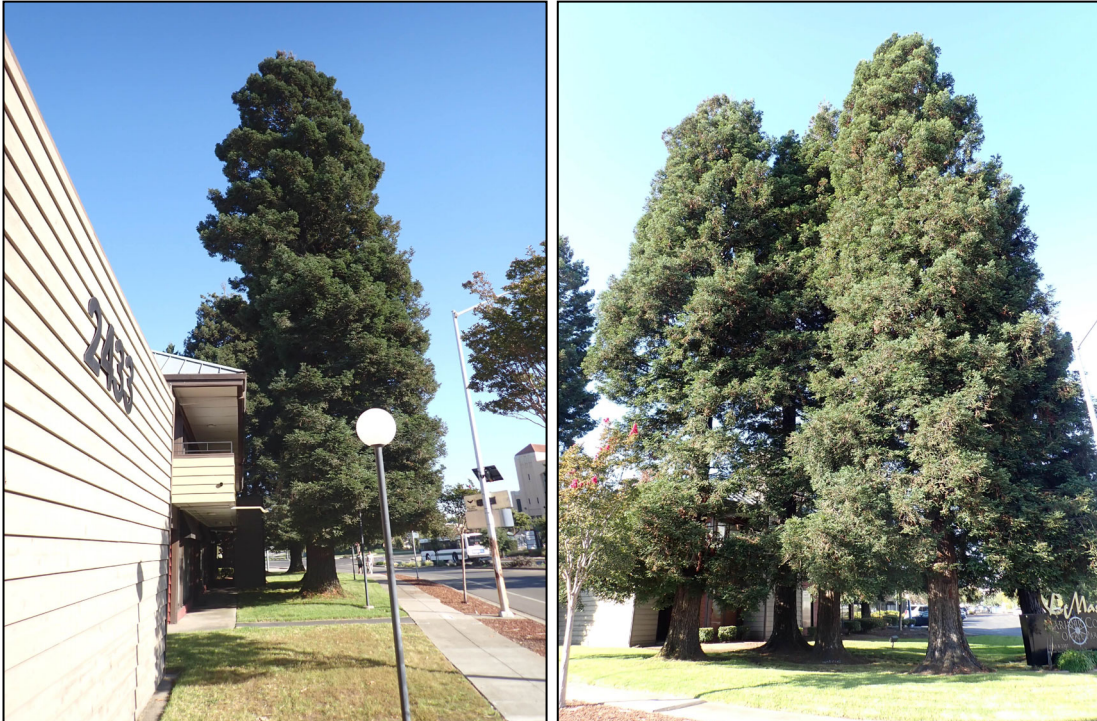
Photos 4 (above L) shows coast redwood #383, growing on the south/Mariner Square Loop side of the property. **Photo 5** (above R): Show the group of 5 coast redwoods (#389-392 - L to R), growing at the corners of Mariner Square Loop and Mariner Square Drive. Coast redwoods at the site were mature, with trunk diameters between 26" and 42". #386, 387 and 389 had their crowns lifted on the building side to ~35', presumably to keep needles and duff off the building's roofs.

All of the coast redwoods were in good to excellent condition, in part due to the regular irrigation they are receiving in the irrigated turf. This practice will need to continue if the trees are to remain alive and an asset to the site.

- Consider supplying the coast redwoods with supplemental irrigation. These trees developed with regular supplemental irrigation and will require ongoing supplemental irrigation during the demolition and construction phases if they are to remain an asset to the site.

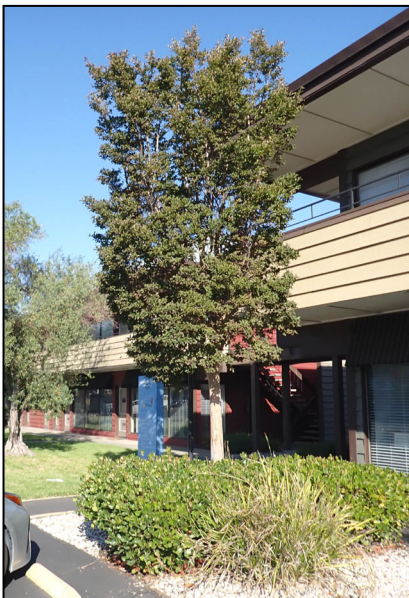
Photo 6 (L): Looking northeast at crape myrtle #375. On-site crape myrtles #375 and 382 were young and in excellent condition.

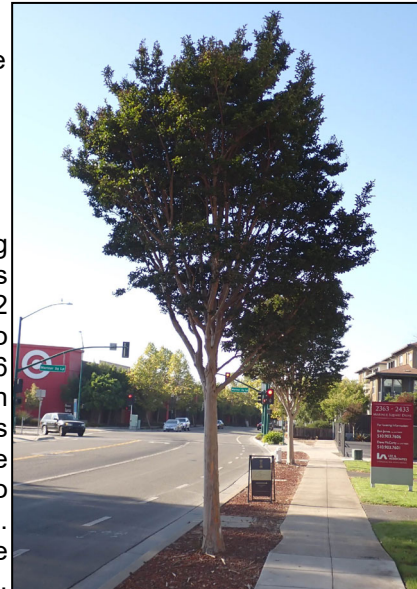
Photo 7 (R): Looking west at crape myrtles #393 and 392 (foreground to background). A row of 6 crape myrtles had been planted as street trees along Mariner Square Loop and were in fair to excellent condition. Some had displaced the sidewalk from 2" to 3".
