## **MEMORANDUM**

**Project:** 2025051 - 1711 Arbor Street, Alameda

**Re:** 1711 Arbor Street, Alameda – Historic Resource Evaluation and Condition Assessment Memorandum

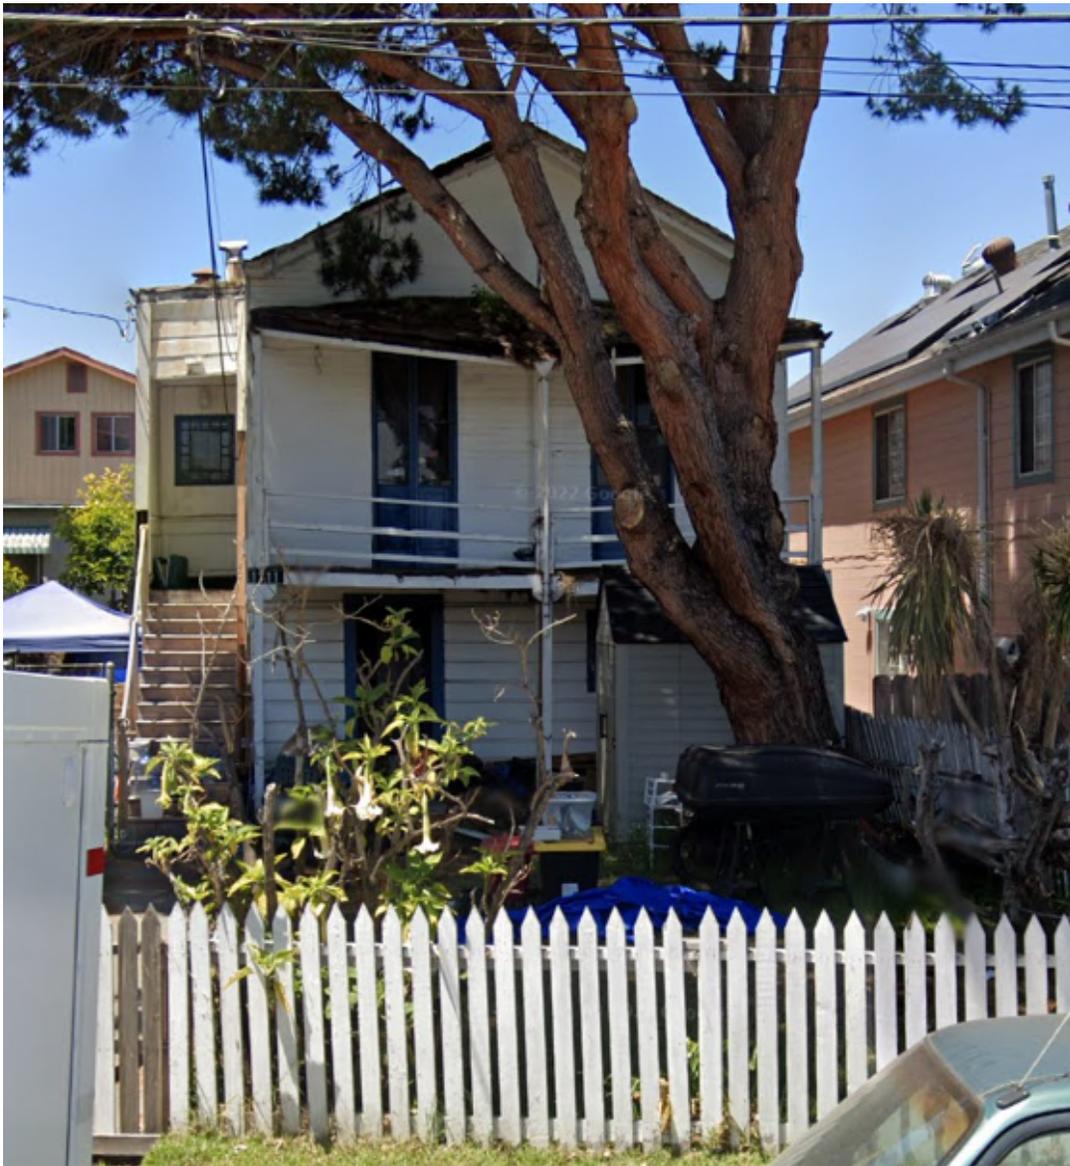
**Figure 6.** Front porch in 2022; note that the tree is leaning onto the porch, compromising its structural integrity (Google Maps)

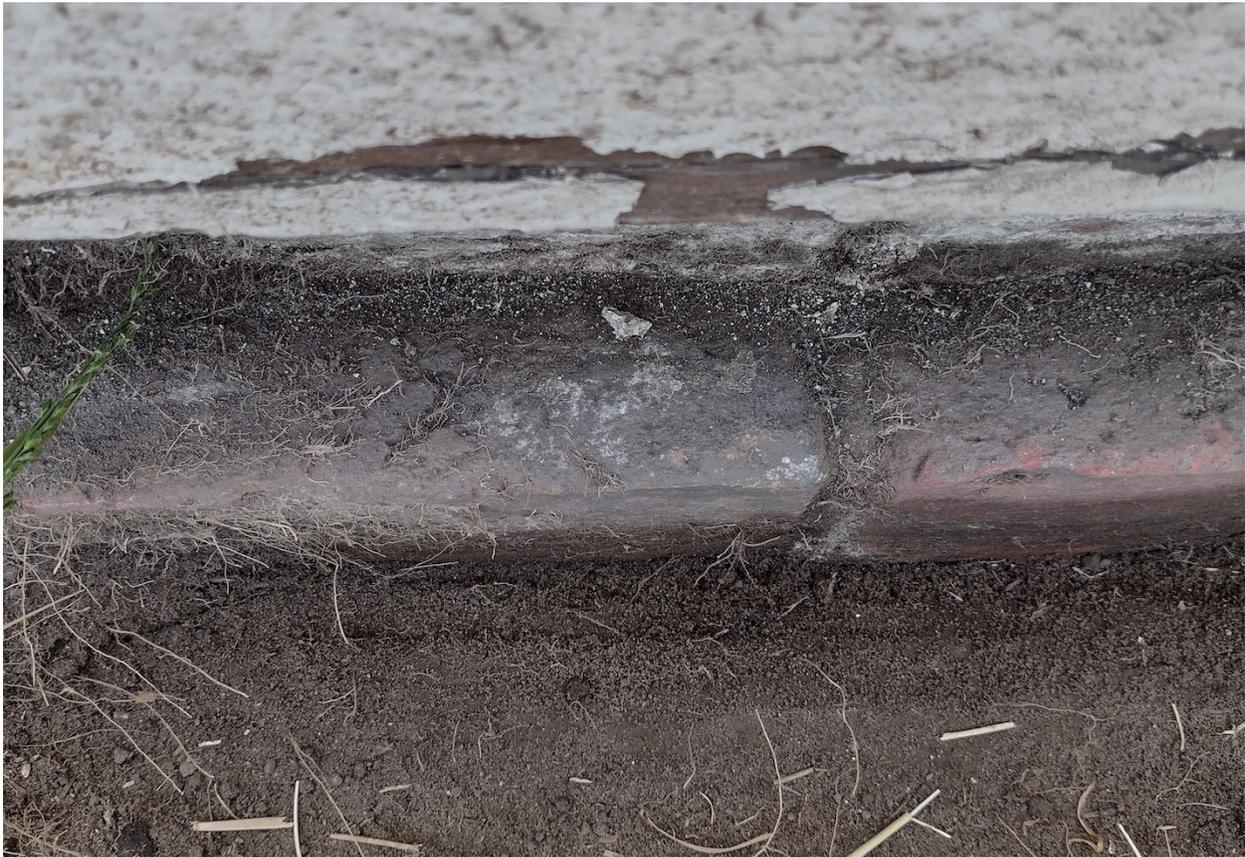
- Brick foundation at main portion of the building appears to be in good condition
  - Vegetation is overgrown at building base on North elevation
- There is earth-to-wood contact around the entire base of the building, which is likely leading to excess moisture and pest infiltration
- Concrete foundation at rear shed addition is in poor condition
  - The foundation at the rear of the building is sinking
- A portion of the 2nd story is supported by a pier and post foundation on the South elevation

Figure 7. View of the brick foundation at the front (East) facade of 1711 Arbor Street (GA, June 2025)

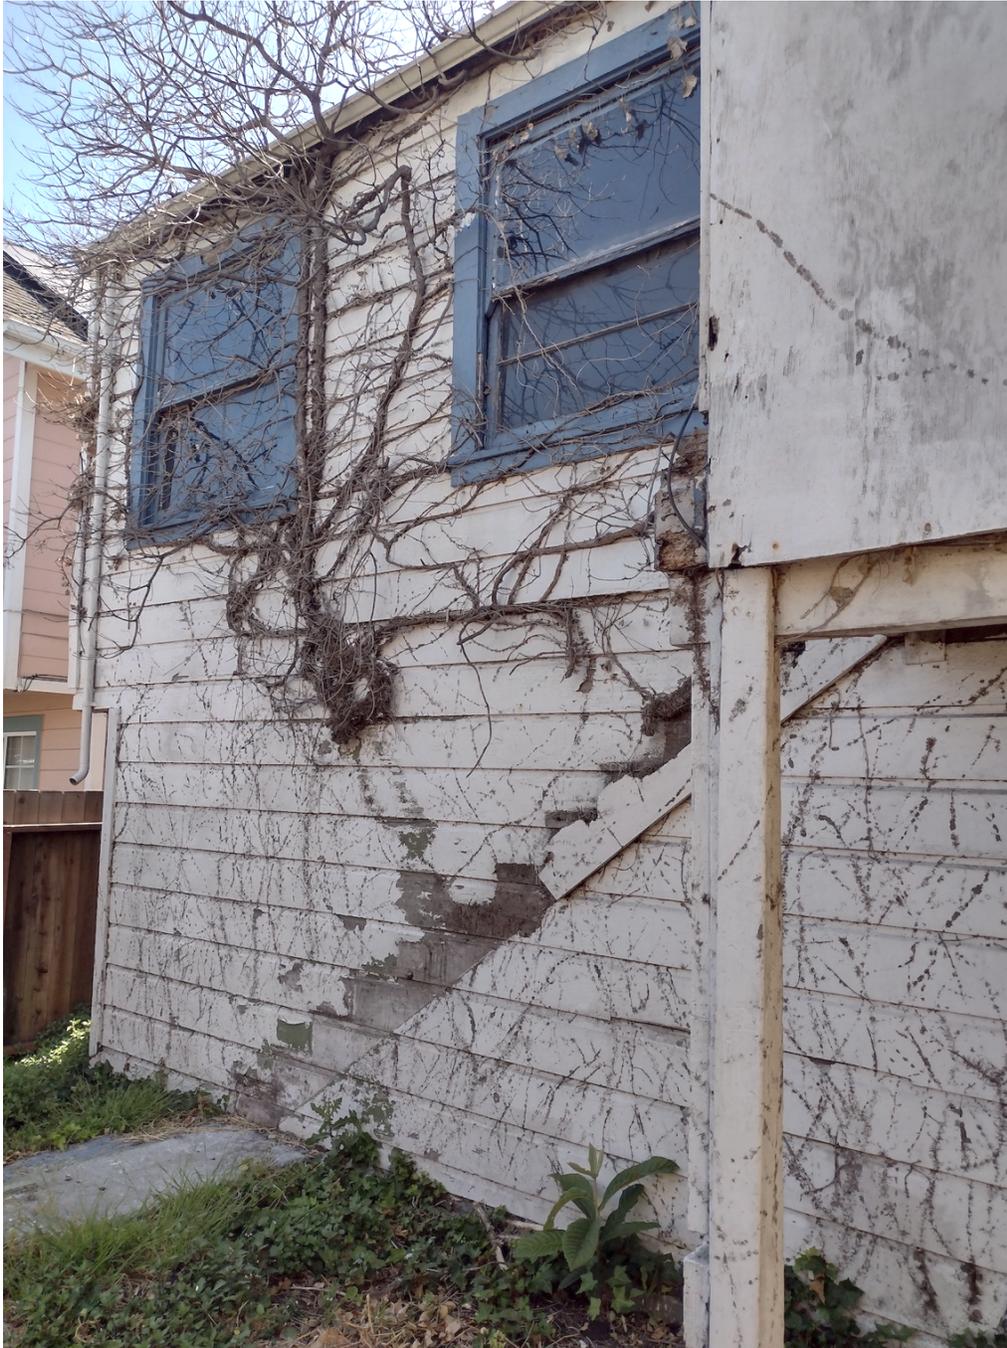
- There is significant damage from vines on North and West elevations, where vines had started growing behind the siding
- The structure appears to be platform-framed
  - There is out-of-plane displacement on the South elevation near the window on the 2nd floor, which may indicate a structural issue with the framing or post supports

**Figure 8.** View of vine damage at the rear (West) facade of 1711 Arbor Street (GA, June 2025)

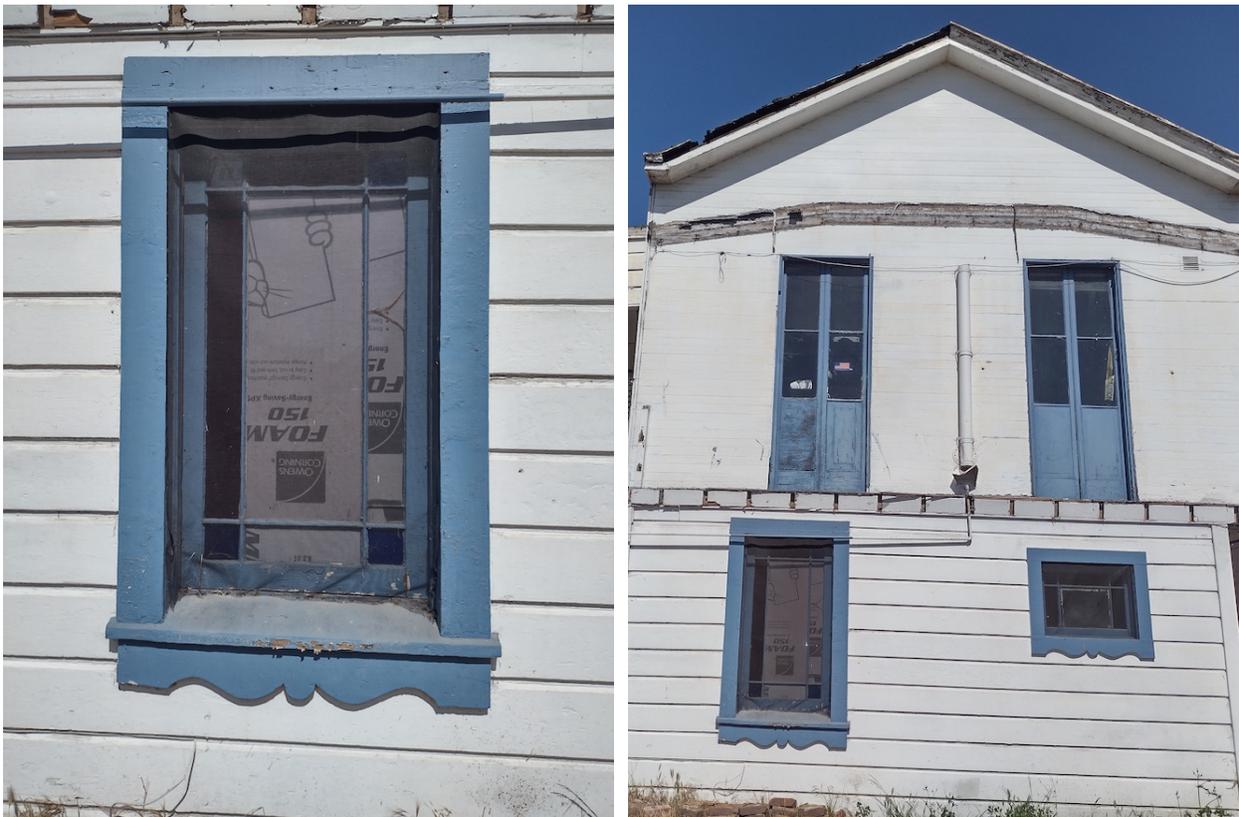
- The extant windows on the North and West facades are in poor condition due to deterioration caused by the vine growth on both elevations
  - Other windows on the South and East facades are in fair condition due to hardened or missing glazing putty, broken or missing panes, racking, failing paint, and/or deteriorated wood sash elements

- One of the half-glazed wood double doors on the East elevation is in poor condition due to deteriorated wood elements, hardened or missing glazing putty, and failing paint; the lower panel of the South-side door was replaced with plywood

**Figure 9. (Left)** View of 1st floor window at East elevation. Note window is boarded up from the interior due to missing panes (GA, June 2025); **(Right)** View of window windows and doors on the East elevation (GA, June 2025).

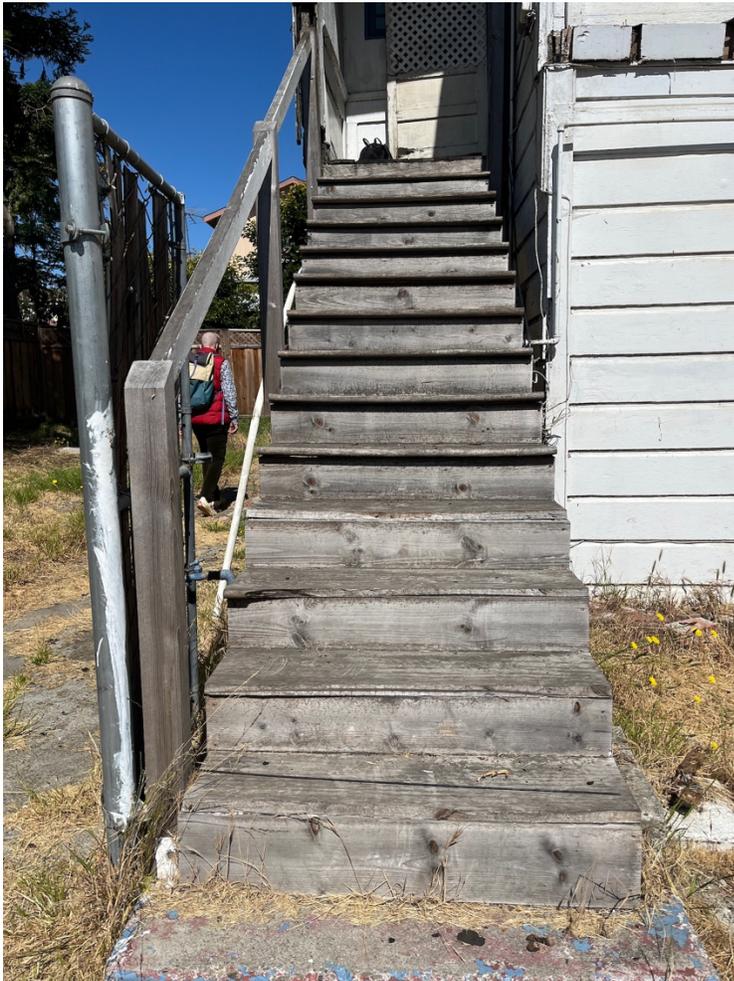
- The wood stairs leading to the 2nd floor are in poor condition due to loose boards, deteriorated and cracked wood, and gaps between the boards

**Figure 10.** View of exterior staircase at East elevation. Note deteriorated and cracked wood (GA, June 2025)

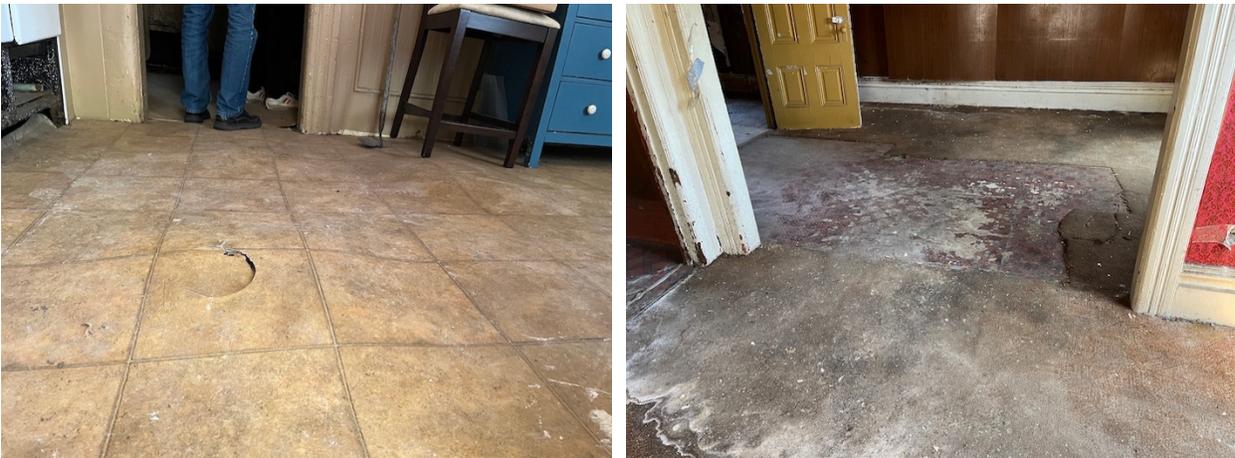
- Flooring throughout the 1st floor is a mix of linoleum and wood laminate, all in fair-poor condition
  - The linoleum is in poor condition, likely due to excess moisture and/or sinking of the foundation causing it to peel or bubble; the linoleum in the kitchen is particularly bad, as it has become extremely warped

- The linoleum and carpeting are in poor condition, due to excess moisture causing peeling and failure of the linoleum and staining and deterioration of the carpeting

**Figure 11. (Left)** View of bubbling and warped linoleum at 1st floor kitchen (GA, June 2025); **(Right)** View of stained and deteriorated carpeting and linoleum at 2nd floor reception hall and living room (GA, June 2025).

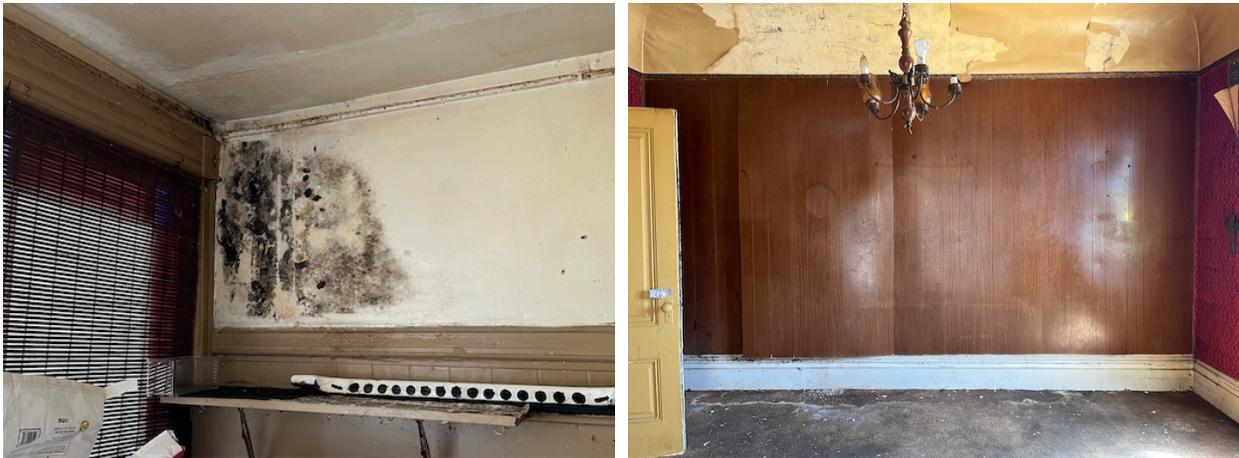
- The thin wood paneling is in poor condition throughout, as most of it is warped or delaminating
- The beadboard wainscoting appears to be in good condition throughout, though some paint is failing

- Where the wood lath is exposed, there are signs of rot and deterioration of the wood
- The presence of mold in the kitchen and the bedroom to the North of the kitchen, along with delaminated plaster, peeling/stained wallpaper, warping/delaminating paneling, and rot in the wood lath, indicate that there is excess moisture in the walls

**Figure 12.** (Left) View of mold on West wall of 1st floor kitchen (GA, June 2025); (Right) View of warped wood paneling at North wall of 2nd floor living room (GA, June 2025).

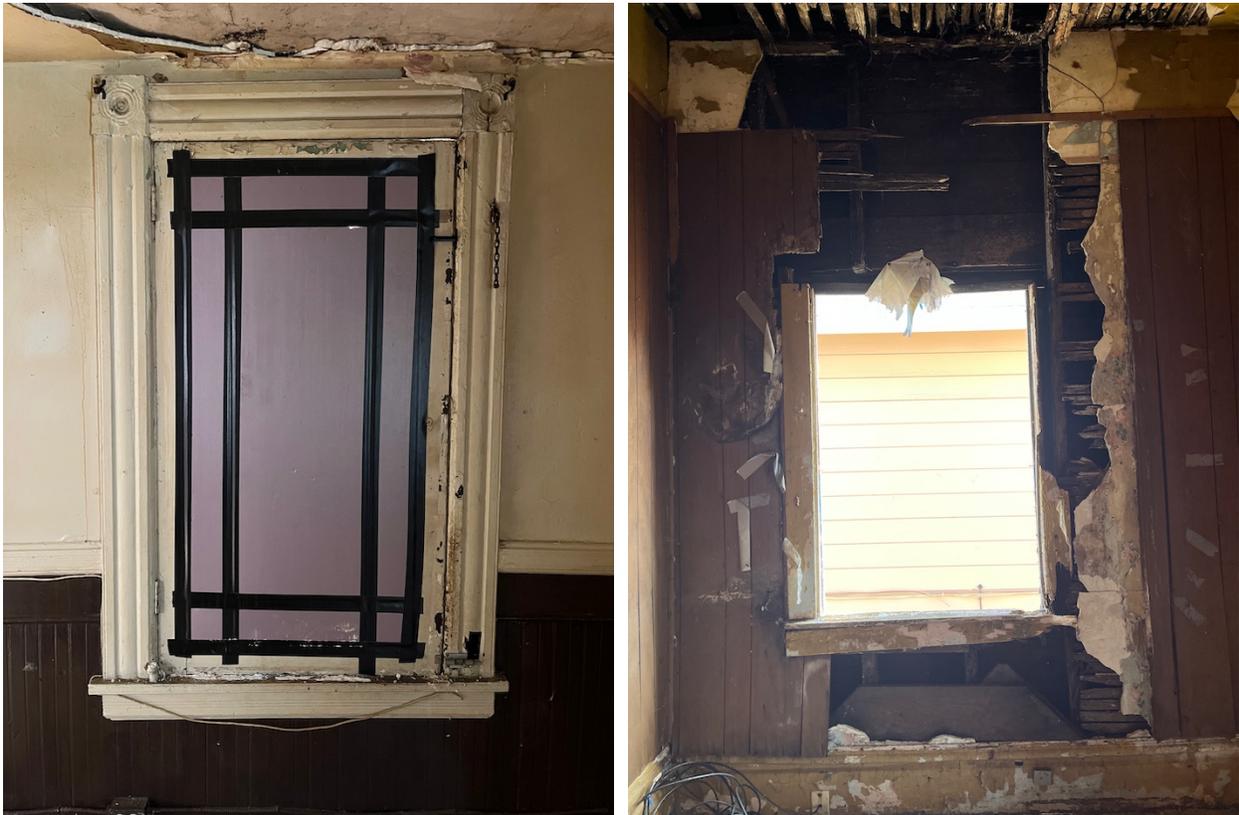
- See section above for exterior window conditions
  - A window on 2nd floor of North elevation is missing (likely one of the double-hung units based on the size of the opening), leaving the interior exposed to the elements; wood rot was visible in the exposed window framing around the opening from the interior

**Figure 13. (Left)** View of 1st floor window from the East wall interior. Note window is racked and boarded up from the interior due to missing panes (GA, June 2025); **(Right)** View of 2nd floor window from the North wall interior. Note missing window and framing damage (GA, June 2025).

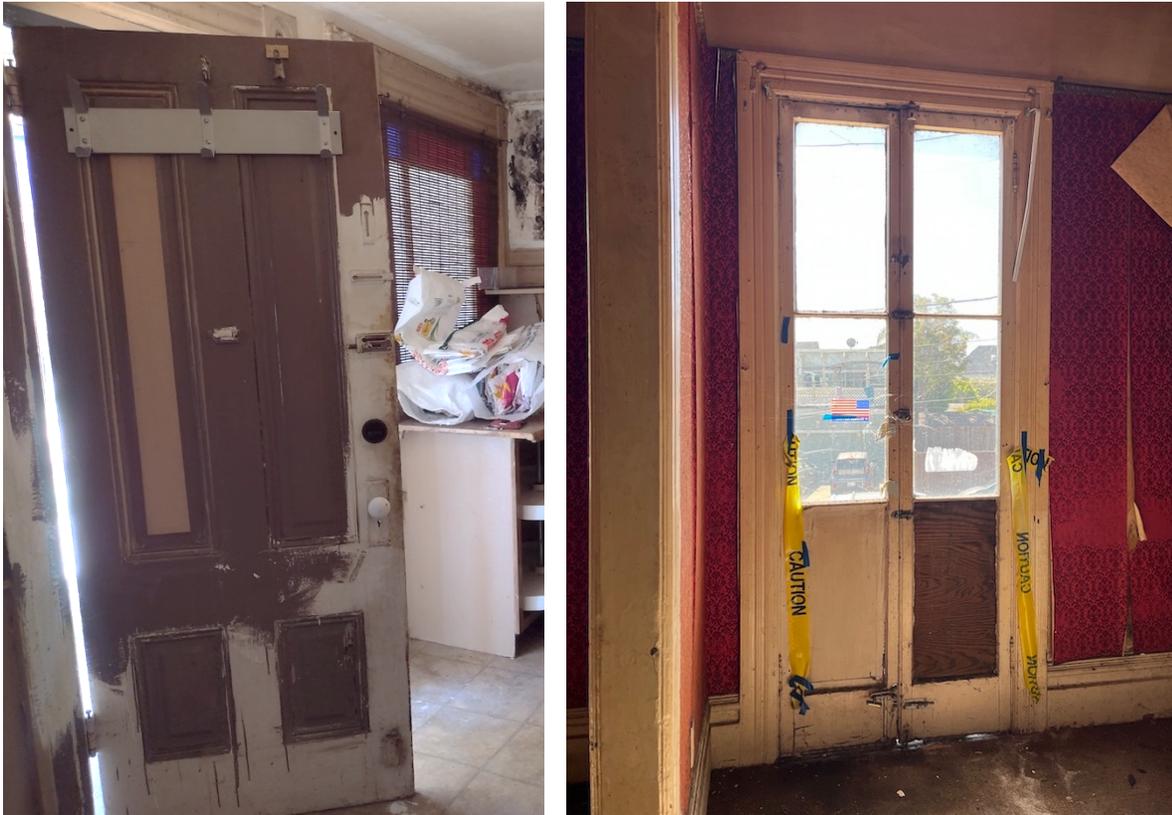
- See section above for exterior door conditions
  - Interior doors are all in fair condition due to deterioration of wood elements and failed paint

**Figure 14. (Left)** View of 1st floor entrance door from the South wall interior. Note failing paint and weathered wood elements (GA, June 2025); **(Right)** View of 2nd floor door from the East wall interior. Note deteriorated wood elements, failing paint, and plywood at the lower panel of the South-side door (GA, June 2025).

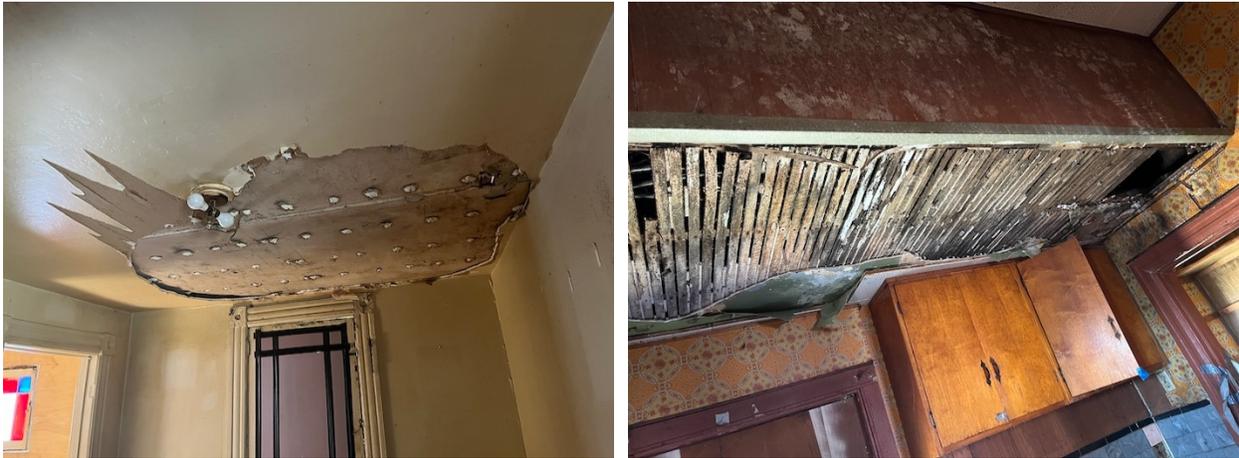
- Plaster appears to be in poor condition throughout, as it has delaminated in many areas
  - Wallpaper is in poor condition throughout, as most of it is peeling or water-stained

- Acoustic tiles appear to be in good condition throughout
  - Where the wood lath is exposed, there are signs of rot and deterioration of the wood
  - Delaminated plaster, peeling/stained wallpaper, and rot in the wood lath, indicate that there is excess moisture in the ceiling and/or roof framing

**Figure 15. (Left)** View of failed plaster at ceiling of 1st floor living room (GA, June 2025); **(Right)** View of failed plaster and deteriorated wood lath at ceiling of 2nd floor kitchen (GA, June 2025).

- Complete gutting of the interior, due to extensive interior finish damage and the presence of mold and lead paint
- Replacement of the majority—if not all—of the 1st floor framing and roof framing, due to significant damage from wood rot
- Complete removal of rear staircase landing/porch elements due to deteriorated condition
- Complete rehabilitation or replacement of all doors and windows
- Repair or replacement of damaged or deteriorated siding that is coated with lead paint
