JUDITH L. THOMAS  
 BAY AREA PLANT CONSULTANTS  
 Arboricultural Consultant, Horticultural Advisor  
 83 Mission Hills Street  
 Oakland CA 94605-4612  
 1(510) 568-2960 (phone), 1(510) 878-2744 (fax)  
<http://bayareaplantconsultants.blogspot.com>

Paula Mathis and Thomas Ellebie Jr.  
 1208 St. Charles Street  
 Alameda CA 94501  
 Cell: 1(949) 466-5162 (Paula), [pkmathis@gmail.com](mailto:pkmathis@gmail.com)  
 Cell: 1(949) 294-0122 (Tom), [tellebie@gmail.com](mailto:tellebie@gmail.com)

10/6/16

## BACKGROUND AND ASSIGNMENT

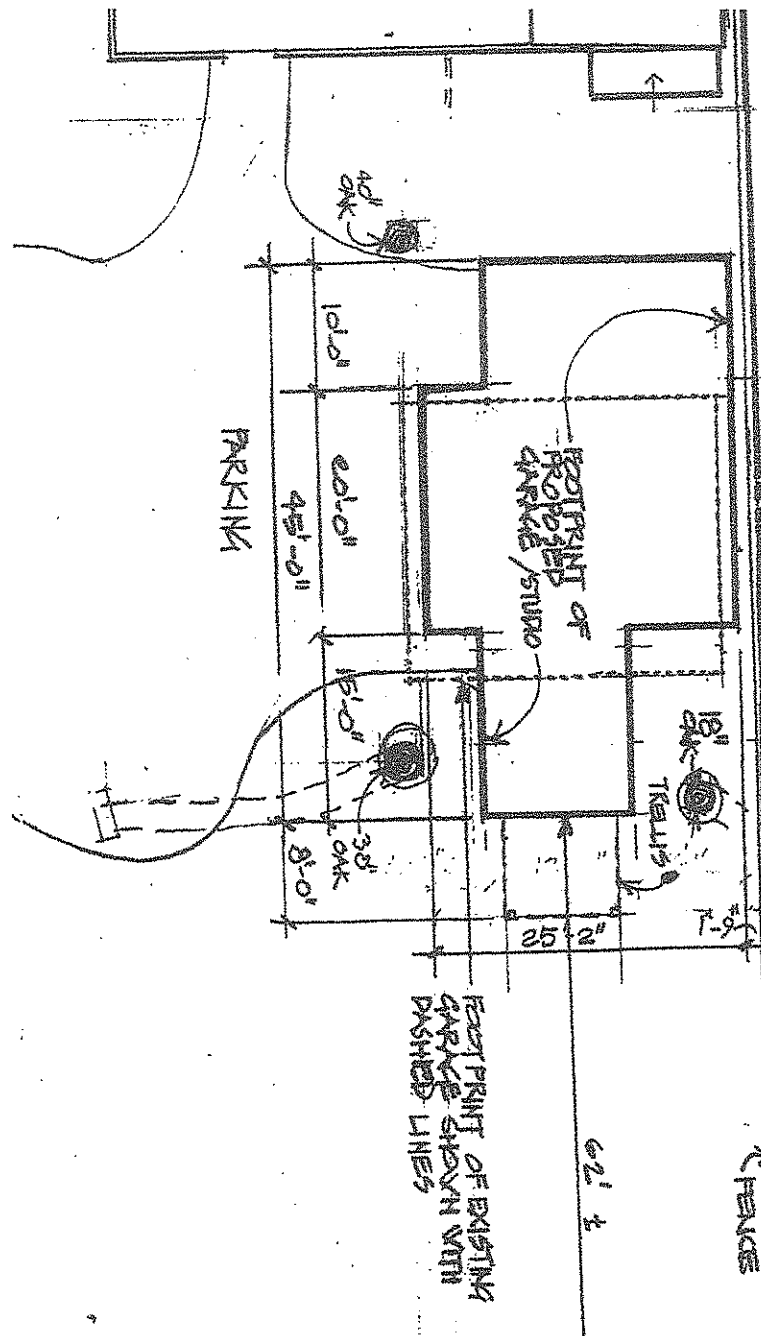
This site sketch pdf file, blown up from the drawing provided by you on 9/15/16, shows the solid lines of the proposed new garage relative to the three oaks that will require protection. Tree #1 is shown above, near the path to the swimming pool gate. Tree #2 is below on the left, near the paved area. The large lower limb on it, extending toward the house, is indicated with dashed lines. Tree #3 is below on the right, near the fence to the property.

For all three trees, protective fencing shall enclose the entire critical root radius areas shown in the chart on page 1 of this letter. Snow fencing and 4-6" of mulch with metal plates on top of the mulch shall be installed within the critical root areas of the trees, shown in the chart on page 1, to protect the soil around the base of the trees from the impacts of the construction work. This fencing should be done prior to any grading or construction. Fences are to remain until all grading and construction is complete, in order to protect the soil and roots beneath the trees from trampling by construction workers. This fencing shall enclose low branches, and shall protect the trunk. No fill soil should be added to this area. Where traffic cannot be diverted in soil areas beneath the trees to be retained, the soil surface shall be protected with thick mulch and steel plates. The steel plates should be anchored into the ground where possible, and placed on top of the mulch.

The Air Spade<sup>R</sup> work for tree #1 will be needed 25" from the corner of the new proposed garage, in both directions along the new foundation.

The Air Spade<sup>R</sup> work for tree #2 will be needed 76" (6.33') from the front corner of the new proposed garage, and 51" (4'3") from the wall of the new proposed studio in the new garage, in both directions along the new foundation.

The Air Spade<sup>R</sup> work for tree #3 will be needed 48" (4') from the wall of the new proposed studio in the new garage, in both directions along the new foundation.
