**Date:** December 5, 2022

**Project Name:** Chuck Corica Golf Course Drainage

**Subject:** Project Technical Memorandum

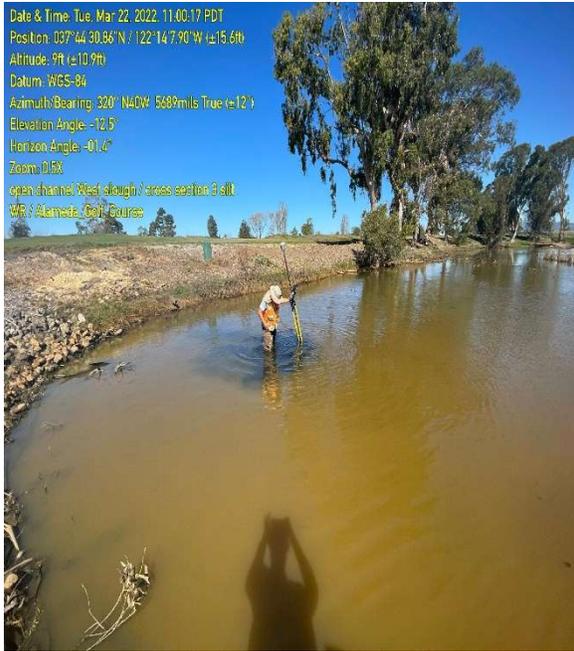
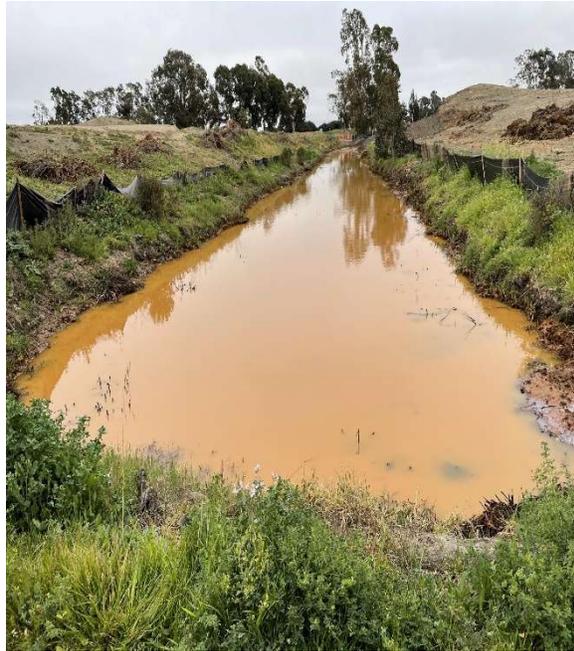
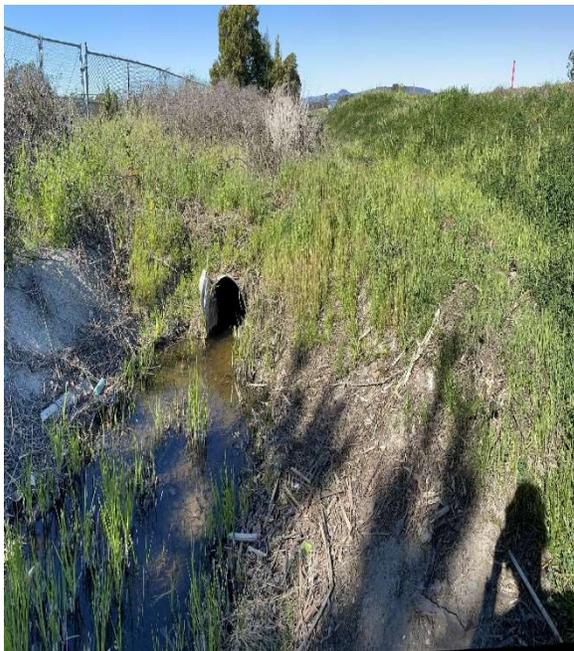
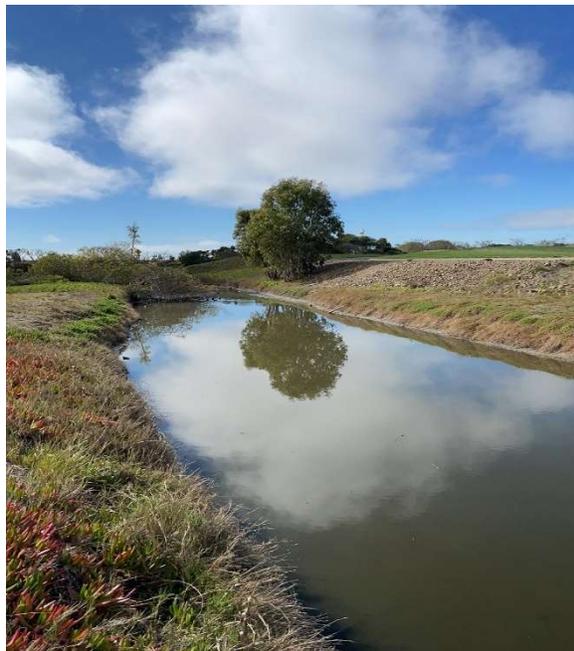
**Figure 4 – Golf Course Drainage System Photos (a) Downstream West Slough (b) Downstream East Slough (c) Upstream West Slough (d) Upstream East Slough**

The sloughs are prone to sediment collecting at the bottom of the channel due to multiple low points in the slough's profile (Appendix A), and standing water caused by backwater from the Golf Course SDPS (Figure 4). Referencing the 1995 slough dredging plan (Section 5.1) and Appendix A, approximately 1.5 ft – 2 ft of sediment has accumulated in the sloughs over the past 27 years.

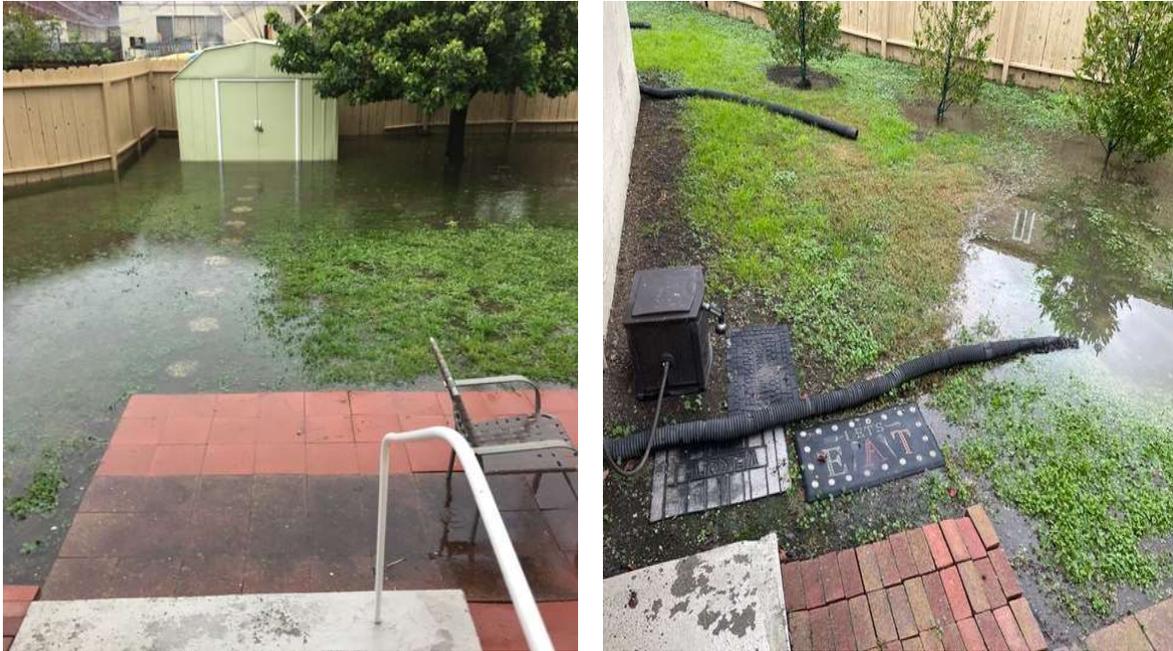
Over the past two years, reports of flooding in residential neighborhoods adjacent to the Golf Course have been brought to the attention of the City of Alameda (City) Public Works Department. Concerned citizens on Maitland Drive and Garden Road have observed a significant increase in the frequency of property flooding during rainfall events (Figure 5), while City crews have also observed frequent flooding on Harbor Bay Parkway (Figure 6), sometimes resulting in the closure of the street.

**Figure 5 – December 2021 Property Flooding at 3 Garden Road**

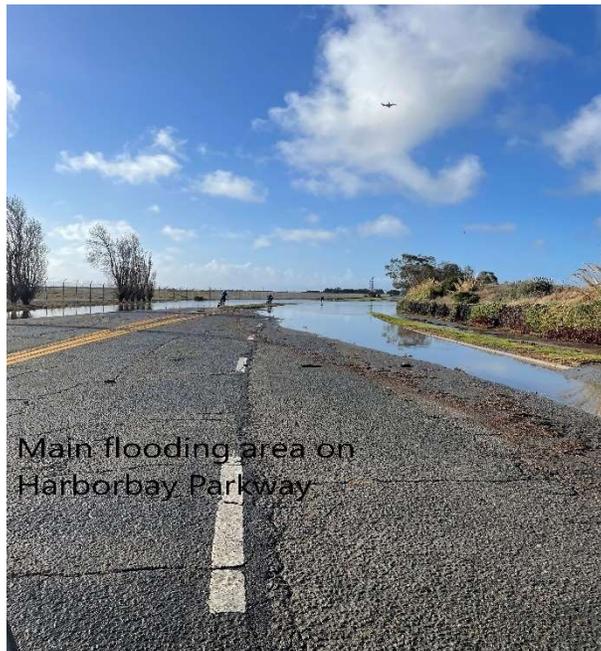
**Figure 6 – December 2021 Flooding of Harbor Bay Parkway 1,500 feet North of Maitland Drive**

6. A picture of the Harbor Bay flooding was provided to WR. It was taken the day after the rainfall event in December 2021. Manny stated it took approximately 3 days to drain.

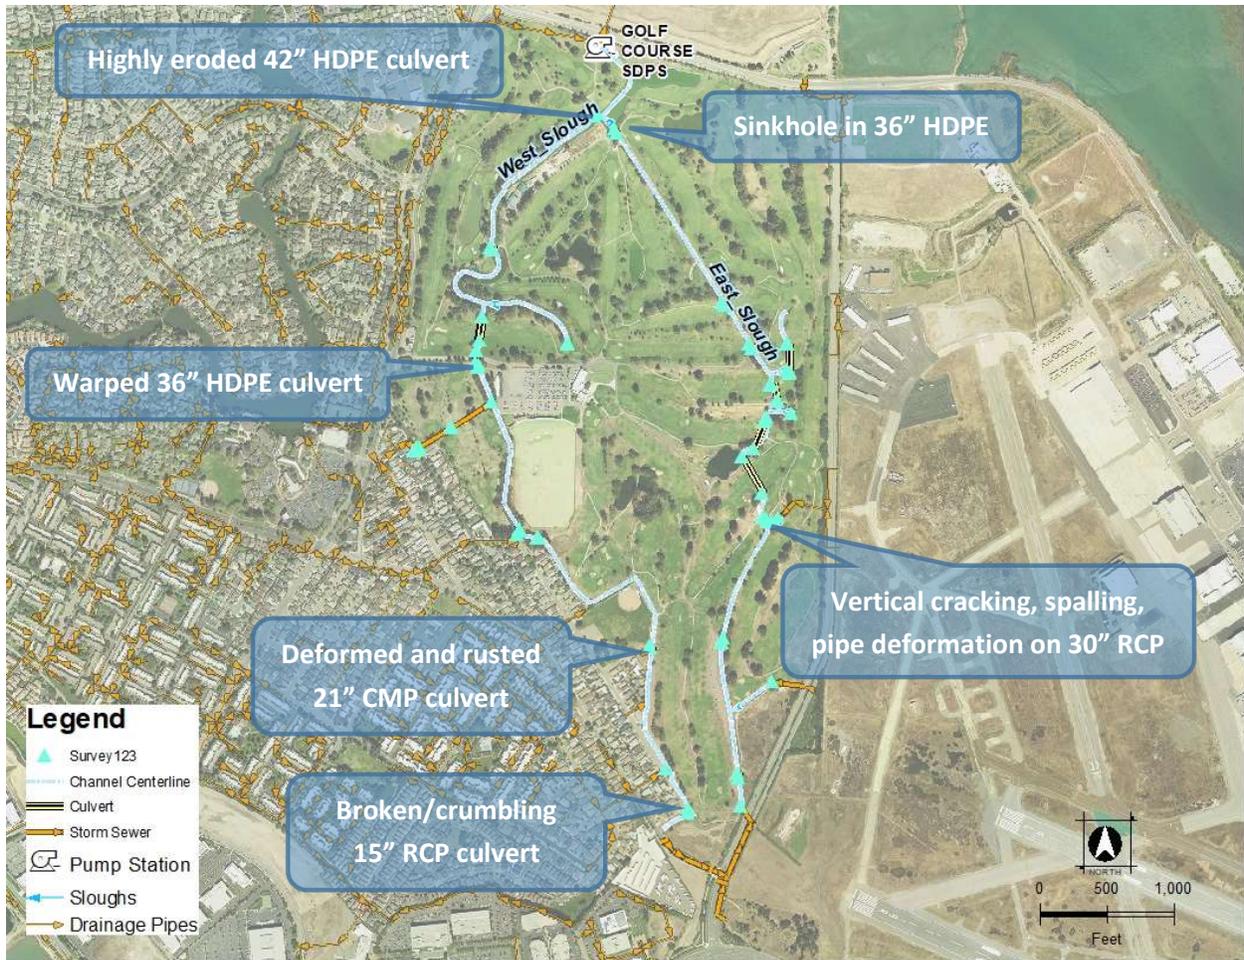
Figure 16 – Survey123 Structural Assessment Locations (Poor Condition Rating Called Out)

4. Repair structurally compromised culverts. Like sediment-filled culverts, structurally compromised culverts have a reduced hydraulic capacity. It is recommended culverts called out in Figure 16 be replaced or repaired.

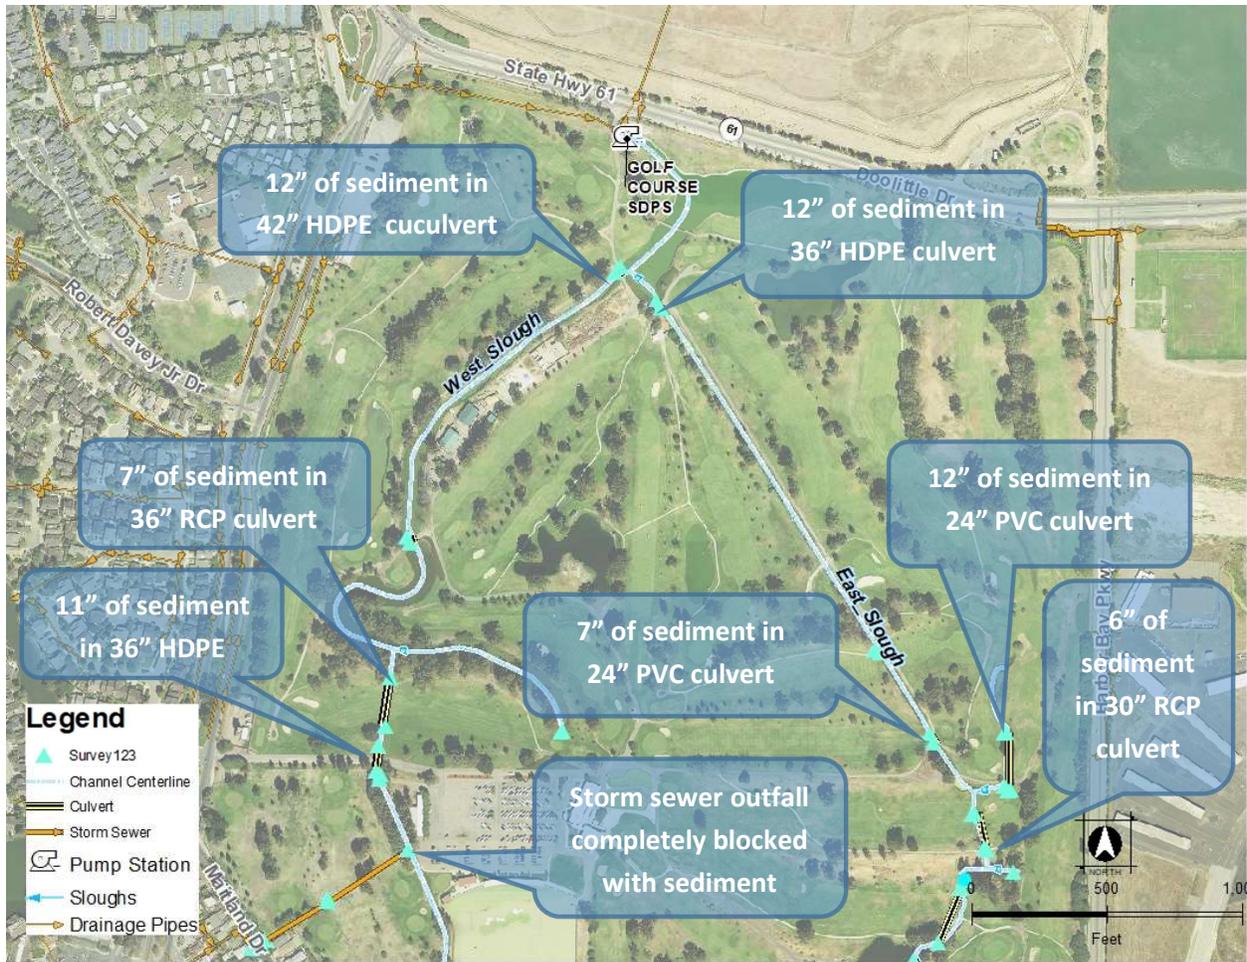
Figure 17 – Survey123 O&M Assessment Locations - North ("Immediate" O&M Condition Rating Called Out)

As shown in Figure 17 and Figure 18, sedimentation accumulated inside the slough's culverts, reducing the hydraulic capacity by 20% to 50%. This has a similar effect as the reduced slough capacity described above. HGLs upstream of the culvert will increase, potentially affecting low-lying areas adjacent to the culvert.

2. Remove sediment from slough culverts. As shown in Figure 17 and Figure 18, several slough culverts have significant sediment accumulation, reducing its conveyance capacity from 20% to 50% less than design capacity. Removing the sediment will allow runoff to drain through the culverts in a more hydraulically efficient manner, thus reducing the HGL upstream.

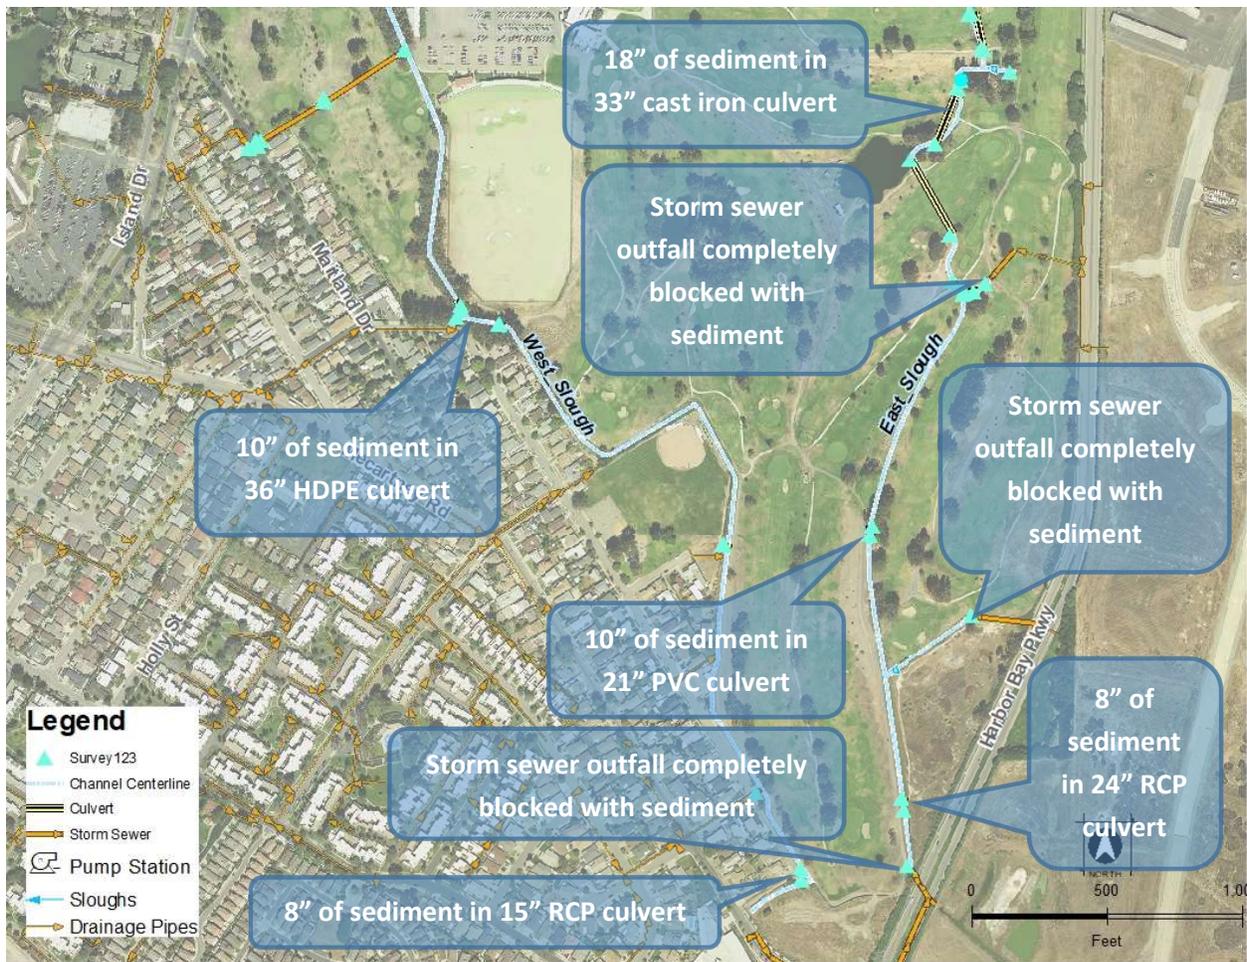
Figure 18 – Survey123 O&M Assessment Locations - South ("Immediate" O&M Condition Rating Called Out)

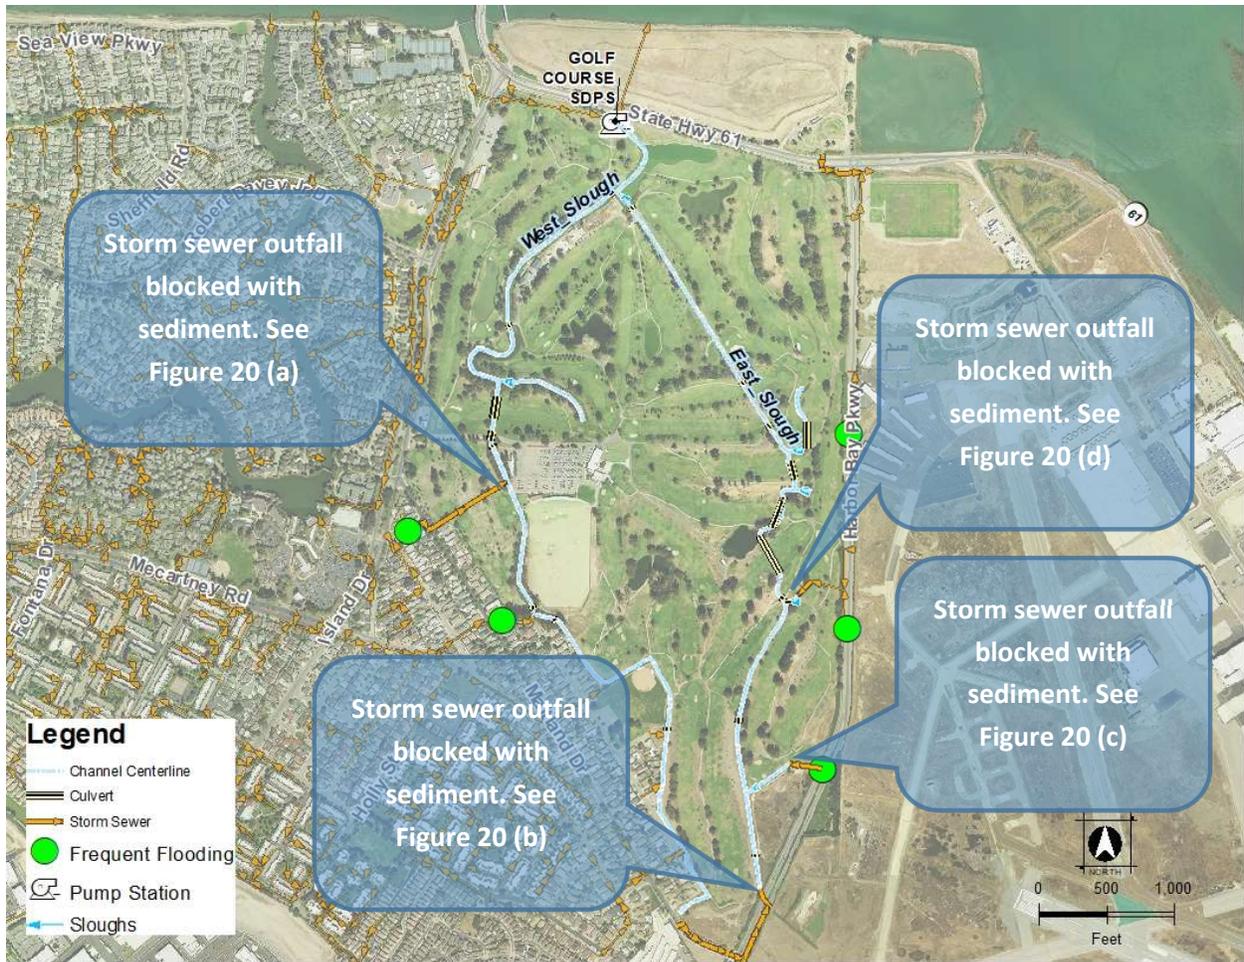
Storm sewers draining residential and street drainage from Maitland Drive and Harbor Bay Parkway were observed to be partially or completely blocked with sediment at their outfall to the Golf Course sloughs. Figure 19 shows the location of the outfalls, while Figure 20 show their images (Images in Figure 20 were taken after exploratory excavation by City staff in early March of 2022. The drawn red line shows the approximate level of sediment prior to excavation). The ability of the outfall to discharge the runoff collected by storm sewers upstream is severely reduced by the sediment. Observations by City staff of the ponding on Harbor Bay Parkway draining in 3+ days is explained by Figure 20 (b), (c), and (d). The runoff cannot get into the sloughs because the sediment blocking the outfall.

Figure 19 – Locations of Storm Sewers Outfalls Blocked with Sediment

1. Remove sediment blocking the outfalls of storm sewers discharging into the sloughs. In March of 2022, City crews have already completed this task, but it is stated in this report to signify its importance.

5. Install duck-billed flap gates at outfalls of storm sewers discharging into the sloughs. The flap gates will prevent sediment from collecting inside City-owned storm sewers, reducing the annual maintenance of the asset.

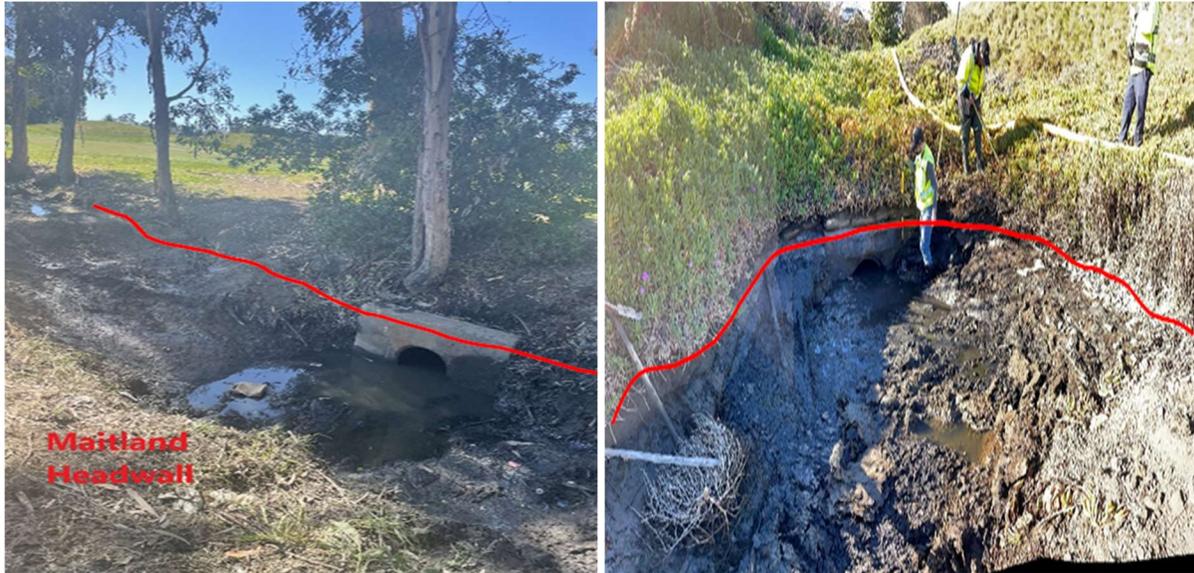
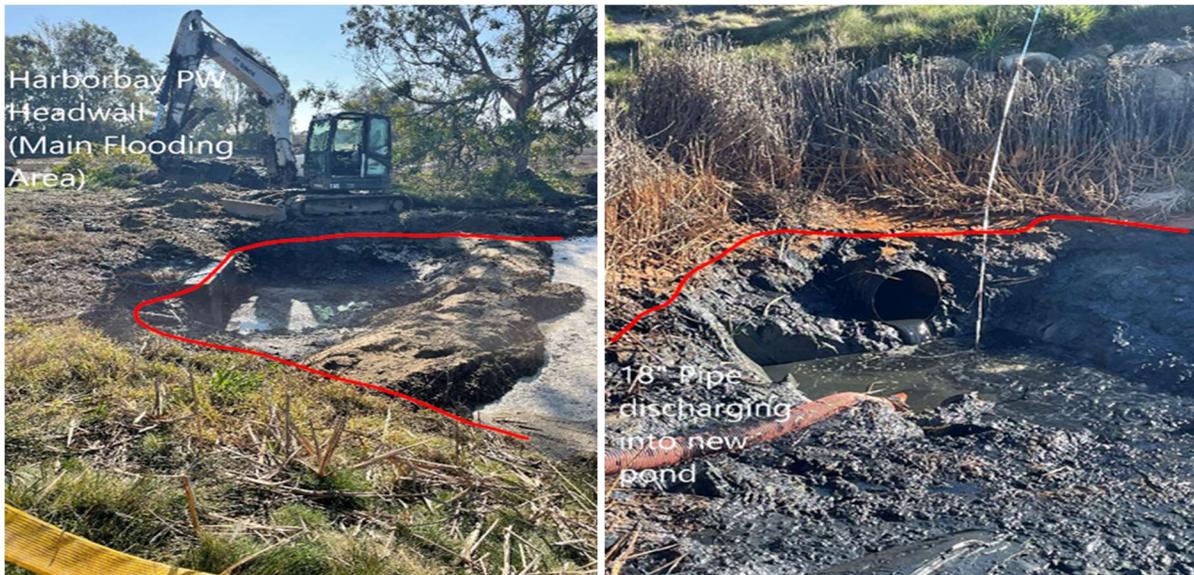
**Figure 20 – Images of Storm Sewer Outfalls Blocked with Sediment (Red Line Shows Approximate Level of Sediment Prior to Excavation)**

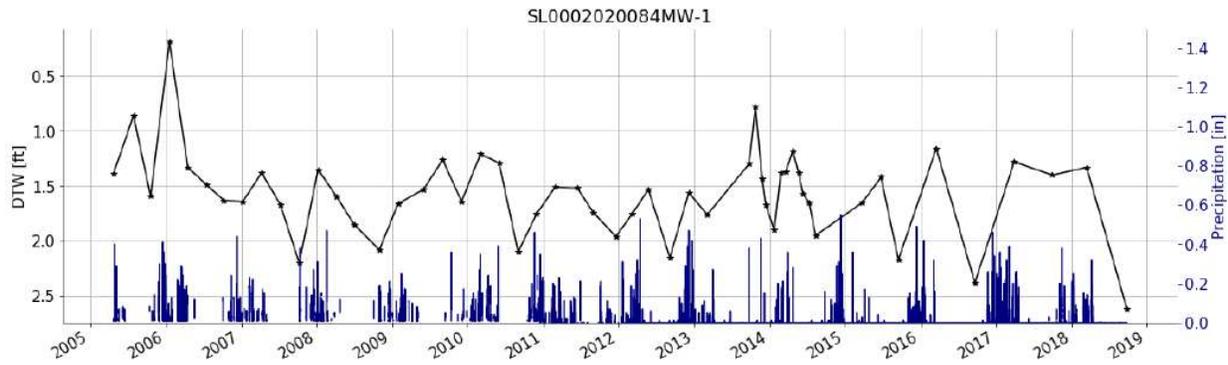
To a lesser extent, other factors such as groundwater and structurally compromised assets contribute to the Golf Course storm system’s flooding. The 2020 groundwater report published by Silvestrum Climate Associates (Section 5.2) concluded the City is highly susceptible to shallow groundwater. Figure 21, taken from their report, shows the depth to shallow groundwater adjacent to Doolittle Drive on Bay Farm Island can range between 0.5 feet and 2.5 feet, depending on the time of year. Any location in the slough with a depth larger than 2.5 feet below its bank will most likely experience groundwater intrusion throughout

the calendar year. In fact, water surface elevations measured in the field were shown to be within the depth tolerance of Figure 21, concluding the standing water observed in the northern portion of the sloughs is most likely from shallow groundwater intrusion. The consequence of groundwater draining into the sloughs is that the capacity is further reduced. Groundwater is occupying hydraulic capacity and storage which, if not present, could be used to convey and store storm runoff.

**Figure 21 – Depth to Groundwater (DTW) at Doolittle Drive on Bay Farm Island<sup>1</sup>**

3. Lower the Golf Course SDPS “pump-on” elevation. As stated in Section 8, groundwater drains into the sloughs, reducing its hydraulic capacity. Lowering the pump-on elevation will continuously pump the groundwater out of the sloughs, leaving more conveyance and storage for runoff during storm events. This new pump station operation can be seasonally implemented in the winter, or before known rainstorms. During summer months, the pump station can be operated as it is now to keep standing water in the sloughs for aesthetic purposes.

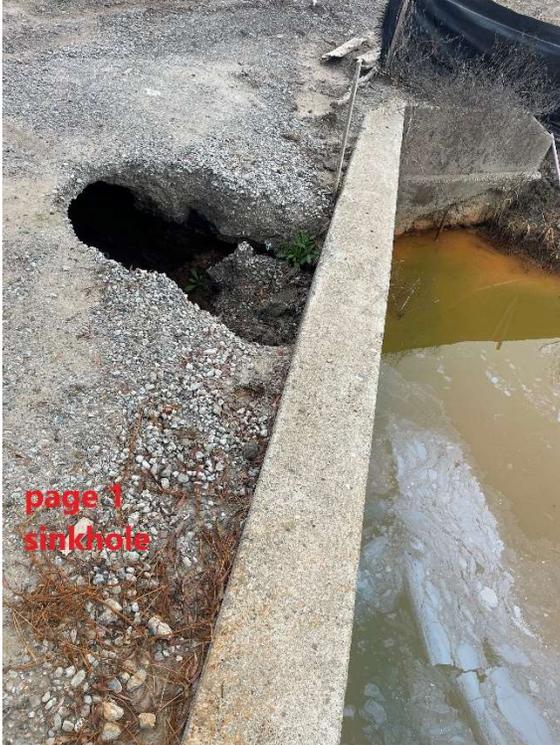
4. Manny's crew observed the Golf Course SDPS turning off during the December 2021 storm when Harbor Bay Parkway was still flooded.
5. Manny's crew observed a chokepoint in the slough system at the culvert draining into the pump station retention pond from the east slough. There is a noticeable sinkhole in the culvert. Crew observed water backing up on the upstream side, but water was barely trickling out of the culvert at the downstream side. Marc Logan, the Golf Course Maintenance Supervisor, has informed the City the sink hole will be fixed in May or June of 2022.

Lastly, several slough culverts were observed to have structural deficiencies (Section 7.2). Sinkholes and deformations reduce a culverts hydraulic capacity resulting in increased HGLs upstream. See Figure 22. Spalling concrete and rusting corrugated metal pipes can result in a complete failure of the culvert, resulting in sinkholes and increased upstream HGLs.

Figure 22 – Sinkhole in 36" PVC Culvert Just Upstream of the Golf Course SDPS Retention Pond on the East Slough
