**Date:** December 5, 2022

**Project Name:** Chuck Corica Golf Course Drainage

**Subject:** Project Technical Memorandum

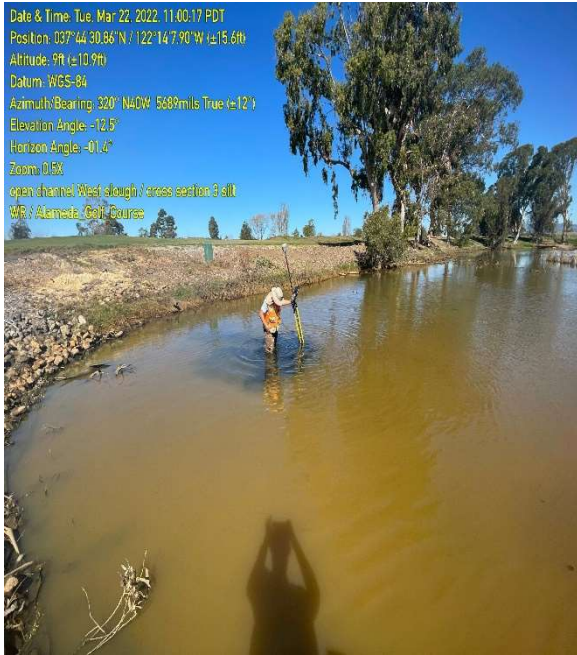
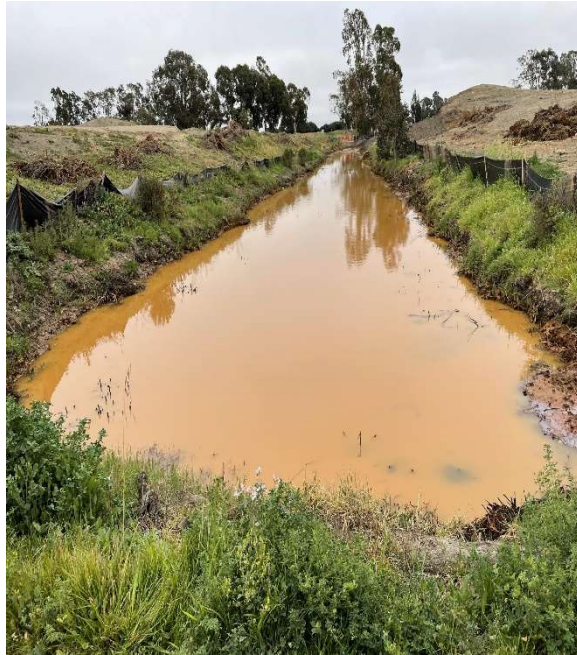
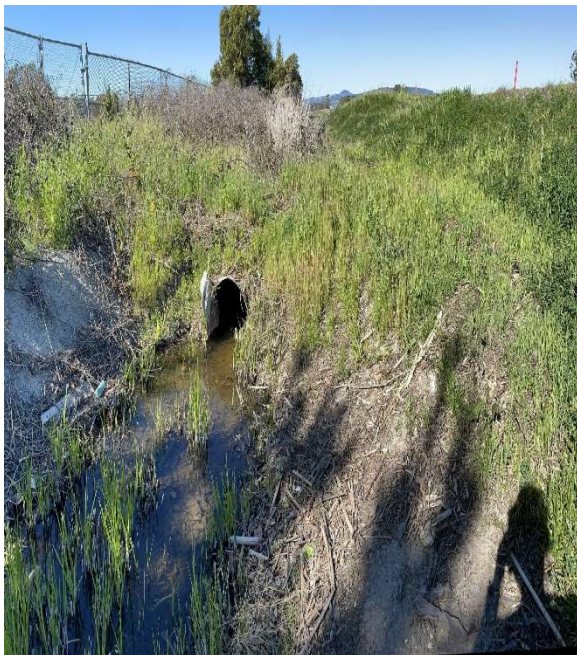
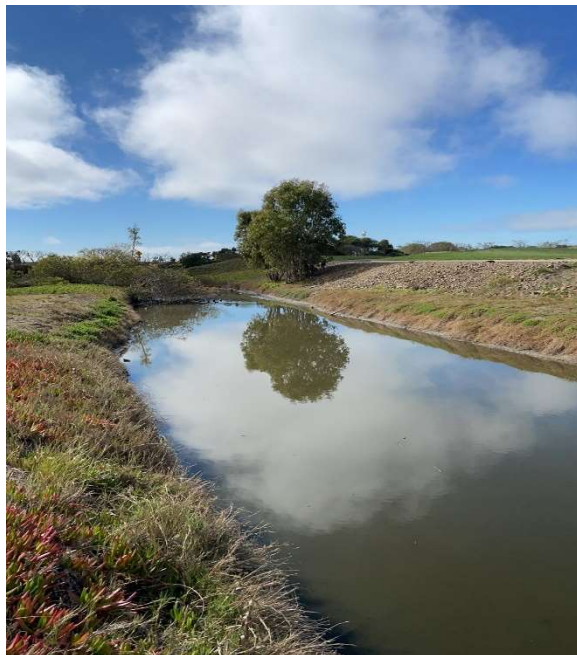
**Figure 4 – Golf Course Drainage System Photos (a) Downstream West Slough (b) Downstream East Slough (c) Upstream West Slough (d) Upstream East Slough**

The sloughs are prone to sediment collecting at the bottom of the channel due to multiple low points in the slough's profile (Appendix A), and standing water caused by backwater from the Golf Course SDPS (Figure 4). Referencing the 1995 slough dredging plan (Section 5.1) and Appendix A, approximately 1.5 ft – 2 ft of sediment has accumulated in the sloughs over the past 27 years.

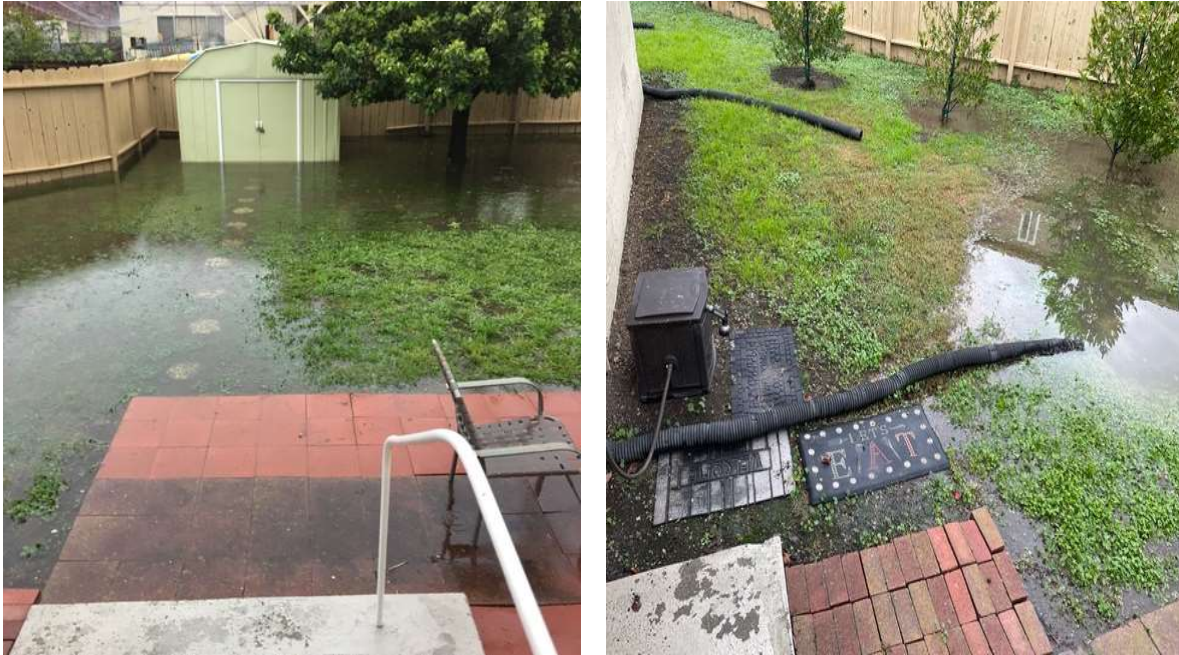
Over the past two years, reports of flooding in residential neighborhoods adjacent to the Golf Course have been brought to the attention of the City of Alameda (City) Public Works Department. Concerned citizens on Maitland Drive and Garden Road have observed a significant increase in the frequency of property flooding during rainfall events (Figure 5), while City crews have also observed frequent flooding on Harbor Bay Parkway (Figure 6), sometimes resulting in the closure of the street.

**Figure 5 – December 2021 Property Flooding at 3 Garden Road**

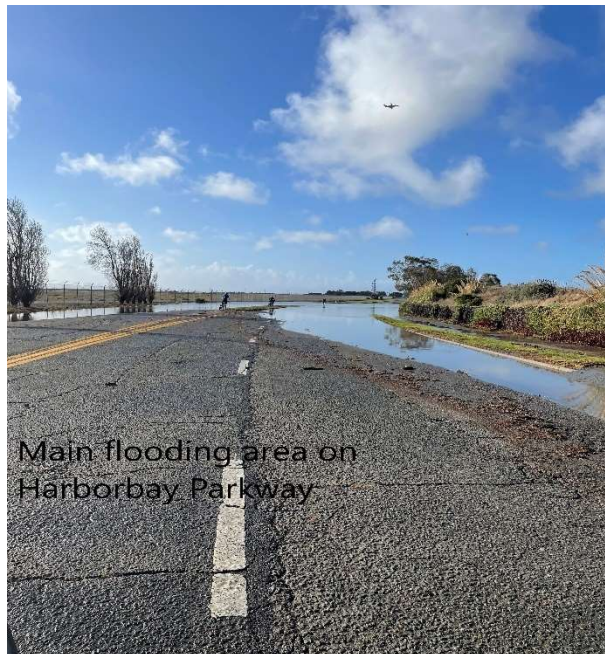
**Figure 6 – December 2021 Flooding of Harbor Bay Parkway 1,500 feet North of Maitland Drive**

6. A picture of the Harbor Bay flooding was provided to WR. It was taken the day after the rainfall event in December 2021. Manny stated it took approximately 3 days to drain.

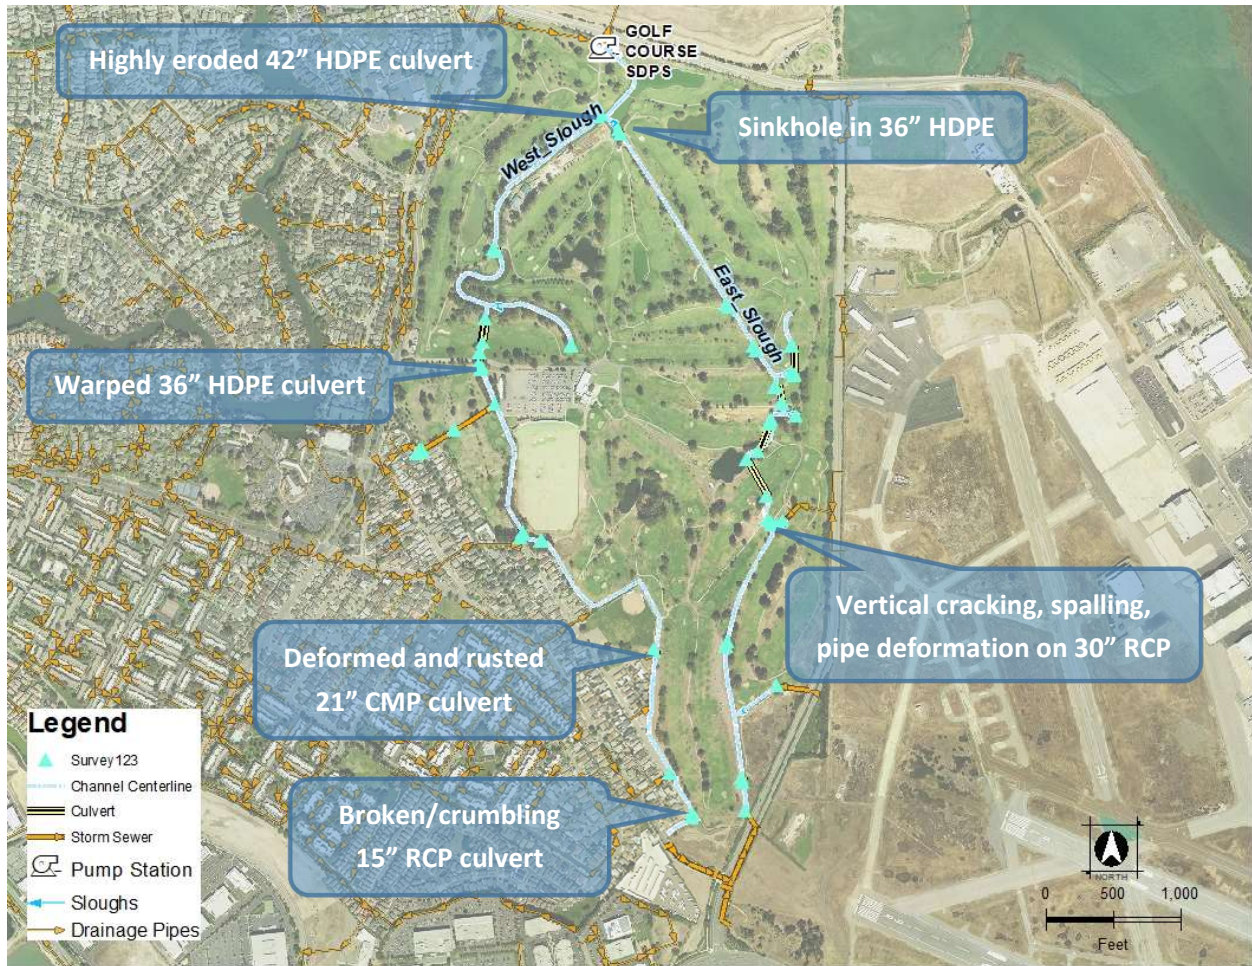
Figure 16 – Survey123 Structural Assessment Locations (Poor Condition Rating Called Out)

Lastly, several slough culverts were observed to have structural deficiencies (Section 7.2). Sinkholes and deformations reduce a culverts hydraulic capacity resulting in increased HGLs upstream. See Figure 22. Spalling concrete and rusting corrugated metal pipes can result in a complete failure of the culvert, resulting in sinkholes and increased upstream HGLs.

4. Repair structurally compromised culverts. Like sediment-filled culverts, structurally compromised culverts have a reduced hydraulic capacity. It is recommended culverts called out in Figure 16 be replaced or repaired.

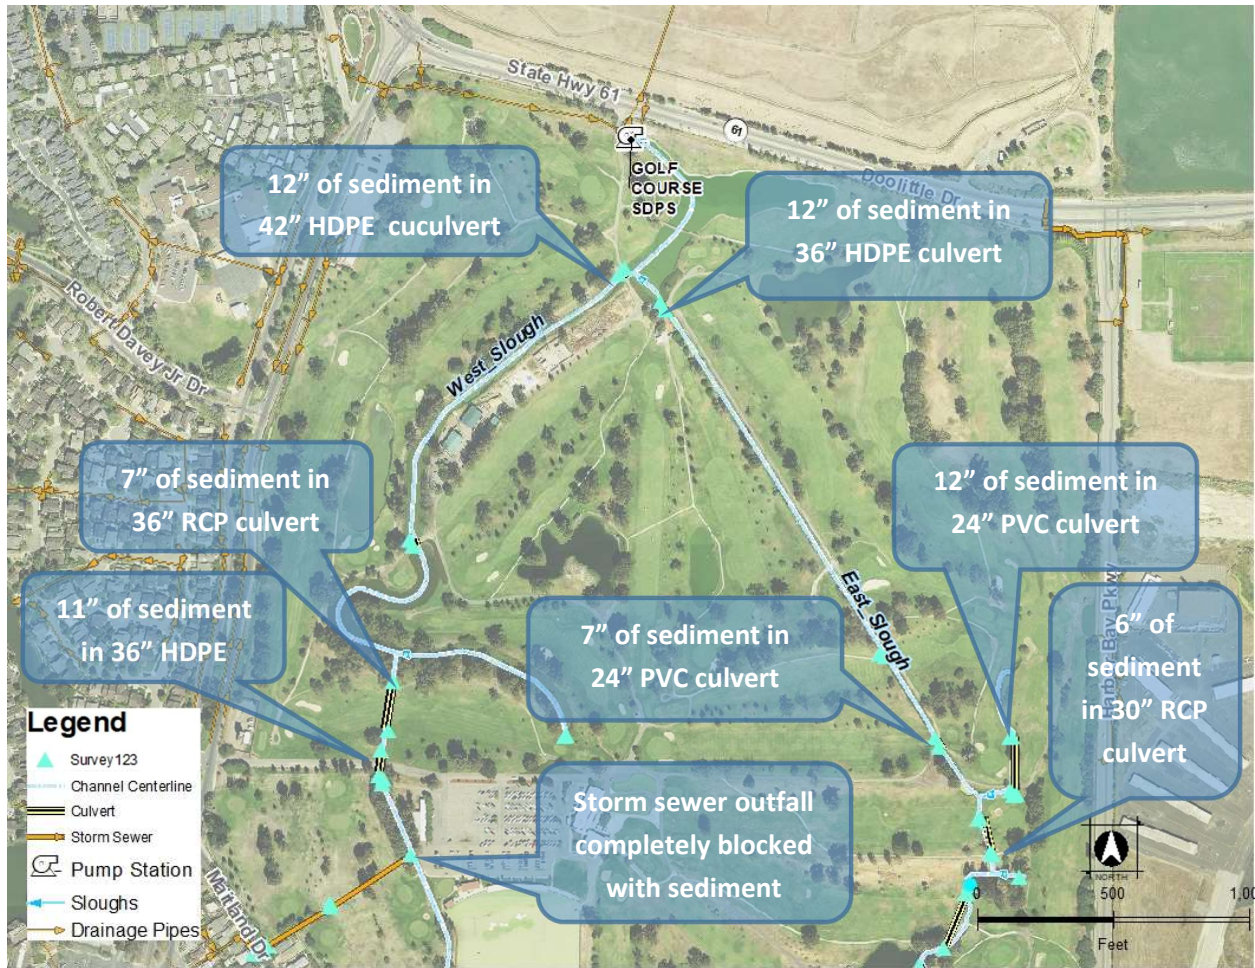
Figure 17 – Survey123 O&M Assessment Locations - North ("Immediate" O&M Condition Rating Called Out)

As shown in Figure 17 and Figure 18, sedimentation accumulated inside the slough's culverts, reducing the hydraulic capacity by 20% to 50%. This has a similar effect as the reduced slough capacity described above. HGLs upstream of the culvert will increase, potentially affecting low-lying areas adjacent to the culvert.

2. Remove sediment from slough culverts. As shown in Figure 17 and Figure 18, several slough culverts have significant sediment accumulation, reducing its conveyance capacity from 20% to 50% less than design capacity. Removing the sediment will allow runoff to drain through the culverts in a more hydraulically efficient manner, thus reducing the HGL upstream.

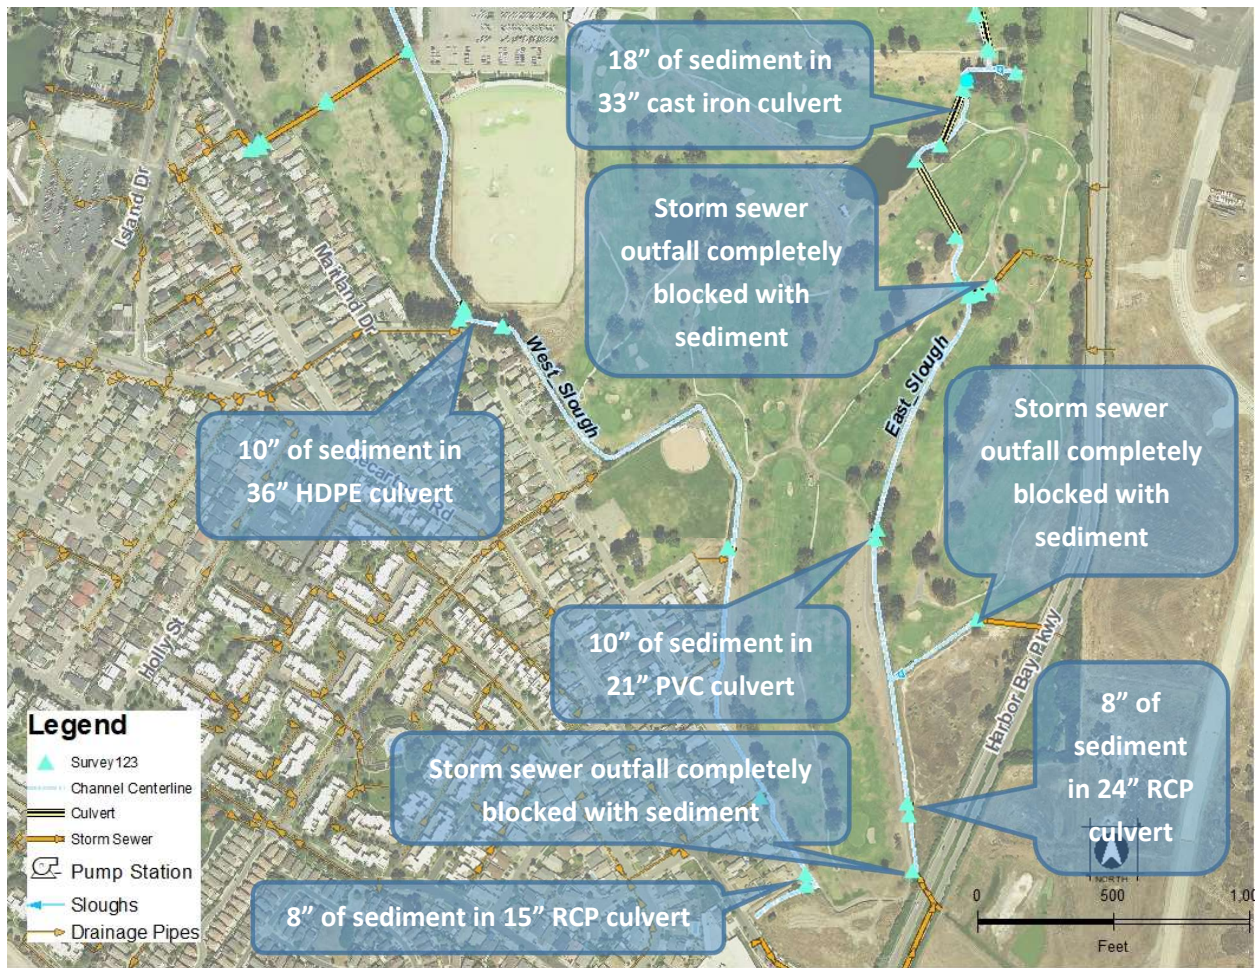
Figure 18 – Survey123 O&M Assessment Locations - South ("Immediate" O&M Condition Rating Called Out)

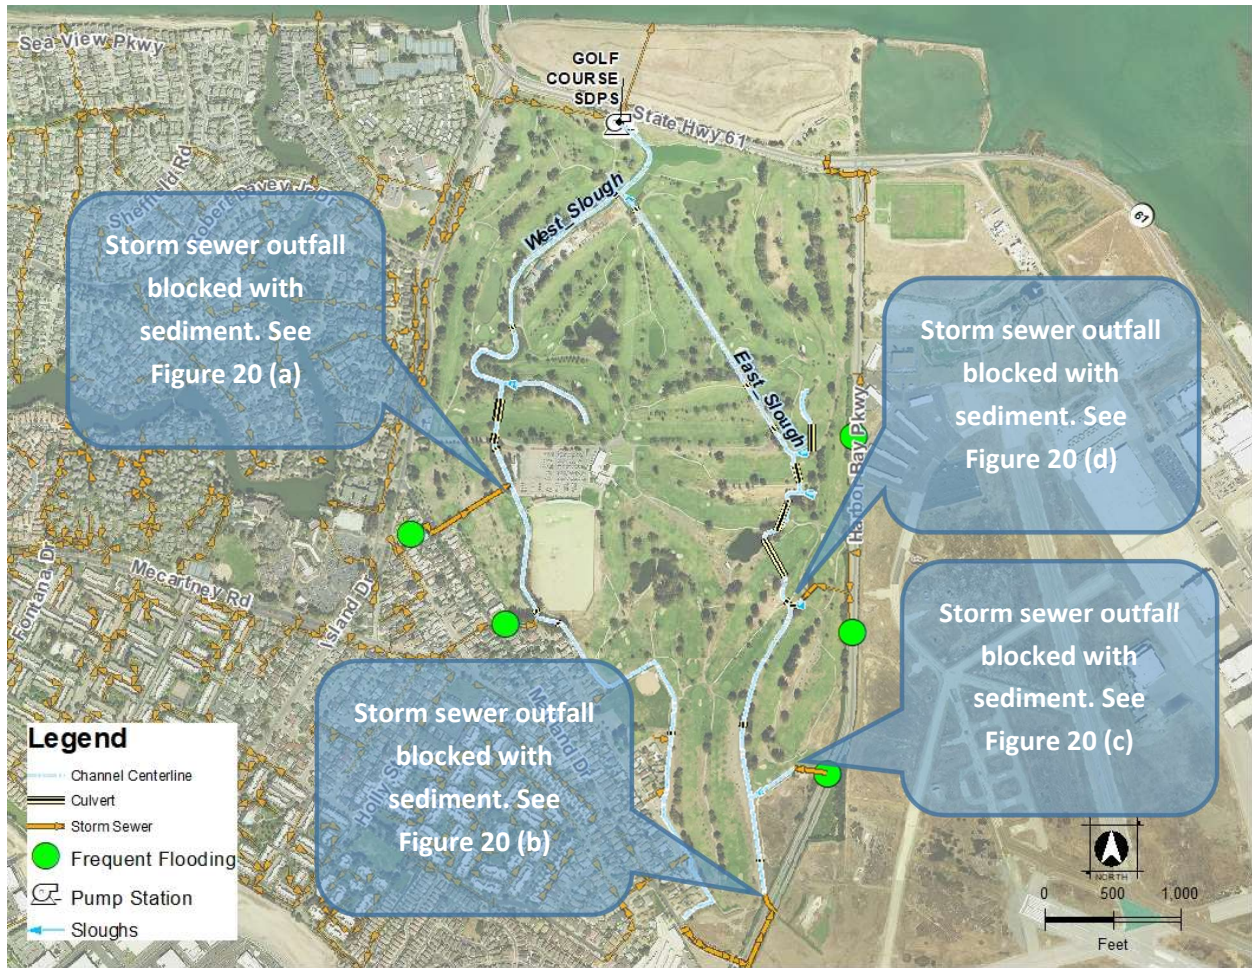
Storm sewers draining residential and street drainage from Maitland Drive and Harbor Bay Parkway were observed to be partially or completely blocked with sediment at their outfall to the Golf Course sloughs. Figure 19 shows the location of the outfalls, while Figure 20 show their images (Images in Figure 20 were taken after exploratory excavation by City staff in early March of 2022. The drawn red line shows the approximate level of sediment prior to excavation). The ability of the outfall to discharge the runoff collected by storm sewers upstream is severely reduced by the sediment. Observations by City staff of the ponding on Harbor Bay Parkway draining in 3+ days is explained by Figure 20 (b), (c), and (d). The runoff cannot get into the sloughs because the sediment blocking the outfall.

Figure 19 – Locations of Storm Sewers Outfalls Blocked with Sediment

1. Remove sediment blocking the outfalls of storm sewers discharging into the sloughs. In March of 2022, City crews have already completed this task, but it is stated in this report to signify its importance.

5. Install duck-billed flap gates at outfalls of storm sewers discharging into the sloughs. The flap gates will prevent sediment from collecting inside City-owned storm sewers, reducing the annual maintenance of the asset.

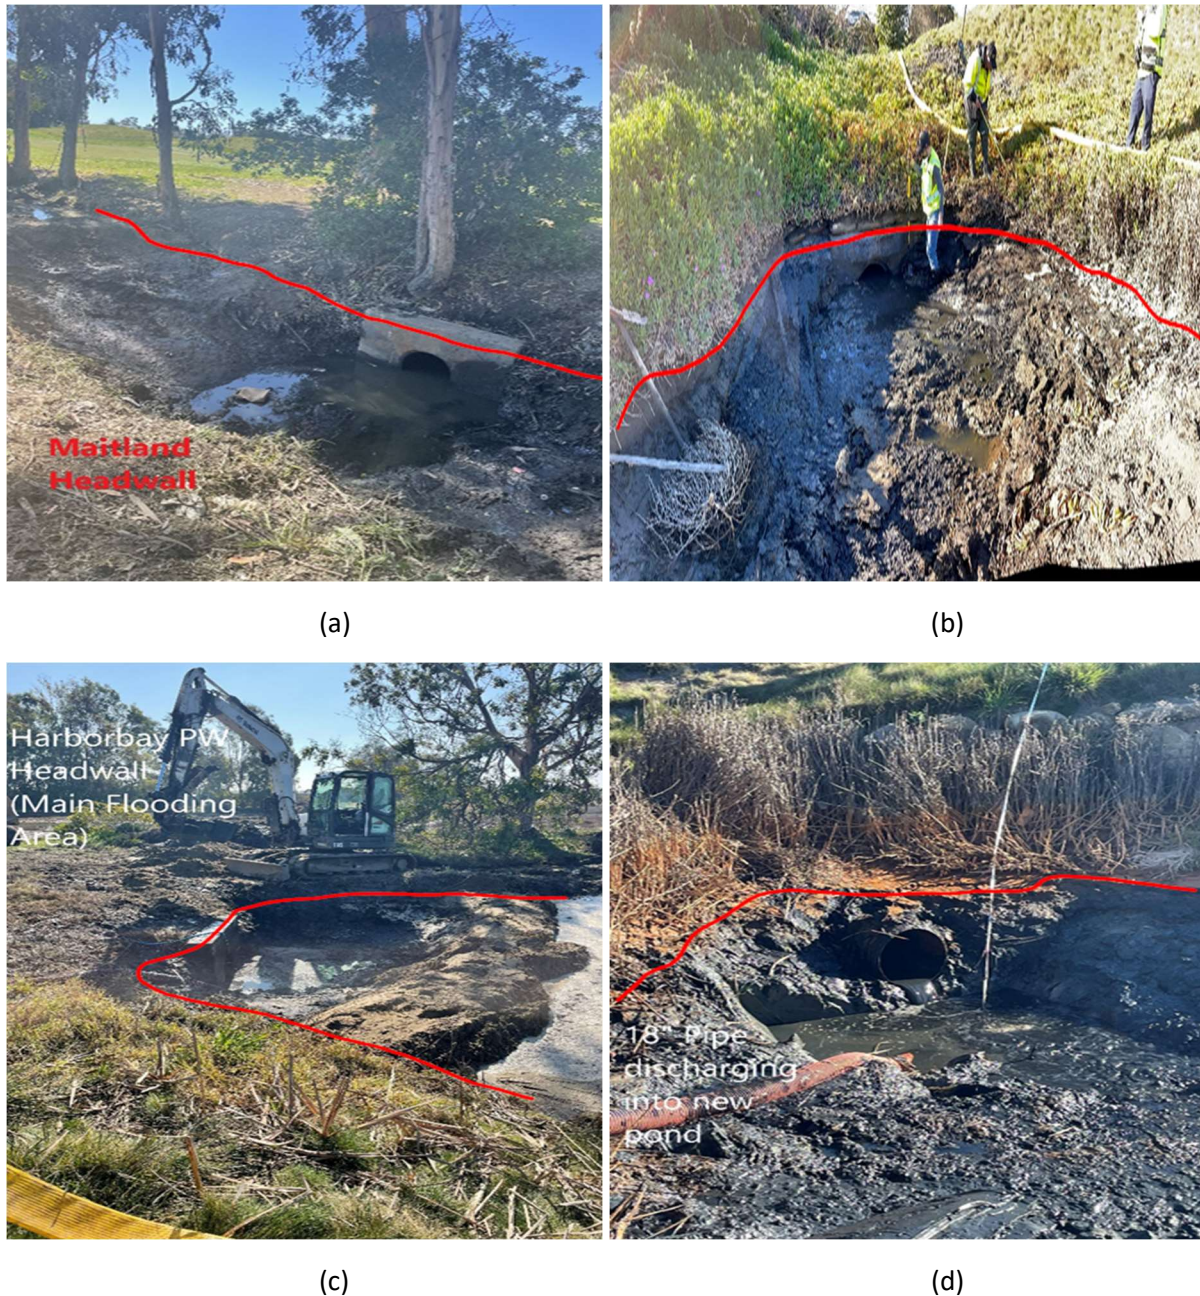
**Figure 20 – Images of Storm Sewer Outfalls Blocked with Sediment (Red Line Shows Approximate Level of Sediment Prior to Excavation)**

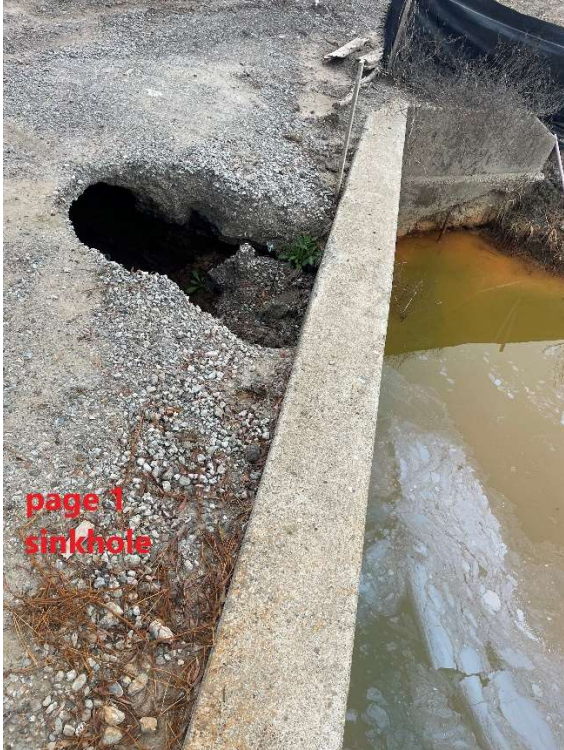
4. Manny's crew observed the Golf Course SDPS turning off during the December 2021 storm when Harbor Bay Parkway was still flooded.
5. Manny's crew observed a chokepoint in the slough system at the culvert draining into the pump station retention pond from the east slough. There is a noticeable sinkhole in the culvert. Crew observed water backing up on the upstream side, but water was barely trickling out of the culvert at the downstream side. Marc Logan, the Golf Course Maintenance Supervisor, has informed the City the sink hole will be fixed in May or June of 2022.

Figure 22 – Sinkhole in 36” PVC Culvert Just Upstream of the Golf Course SDPS Retention Pond on the East Slough
