State of California — The Resources Agency
DEPARTMENT OF PARKS AND RECREATION
PRIMARY RECORD

Page 1 of 16 Resource name(s) or number (assigned by recorder) 802 Buena Vista Avenue

*P2. Location: Not for Publication Unrestricted *a. County Alameda
*b. USGS 7.5' Quad Oakland West, CA Date 2021
*c. Address 802 Buena Vista Avenue City Alameda Zip 94501
*e. Other Locational Data: Assessor's Parcel Number 73-409-32

*P9. Date Recorded:
May 30, 2025

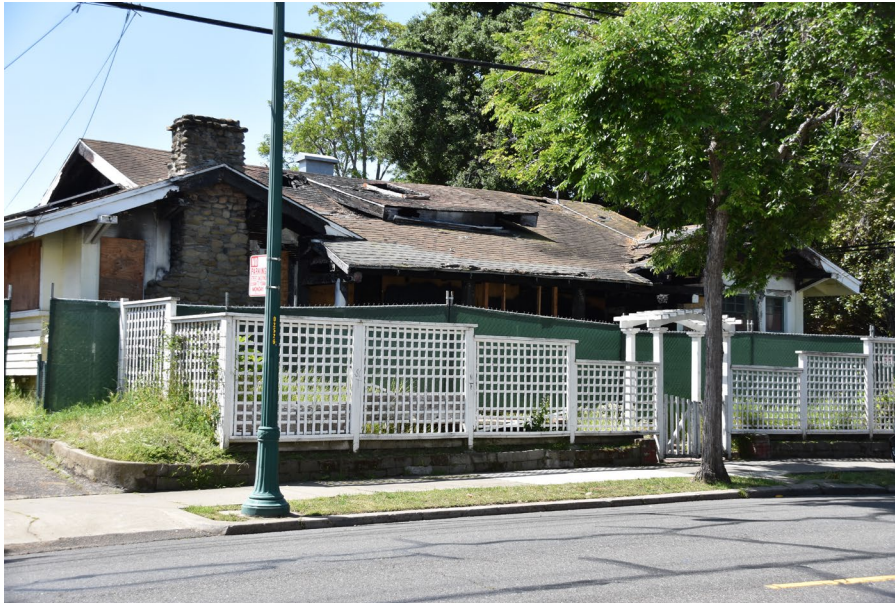
P5a. Photo

P5b. Photo: (view and date)
View of the primary façade, view northwest

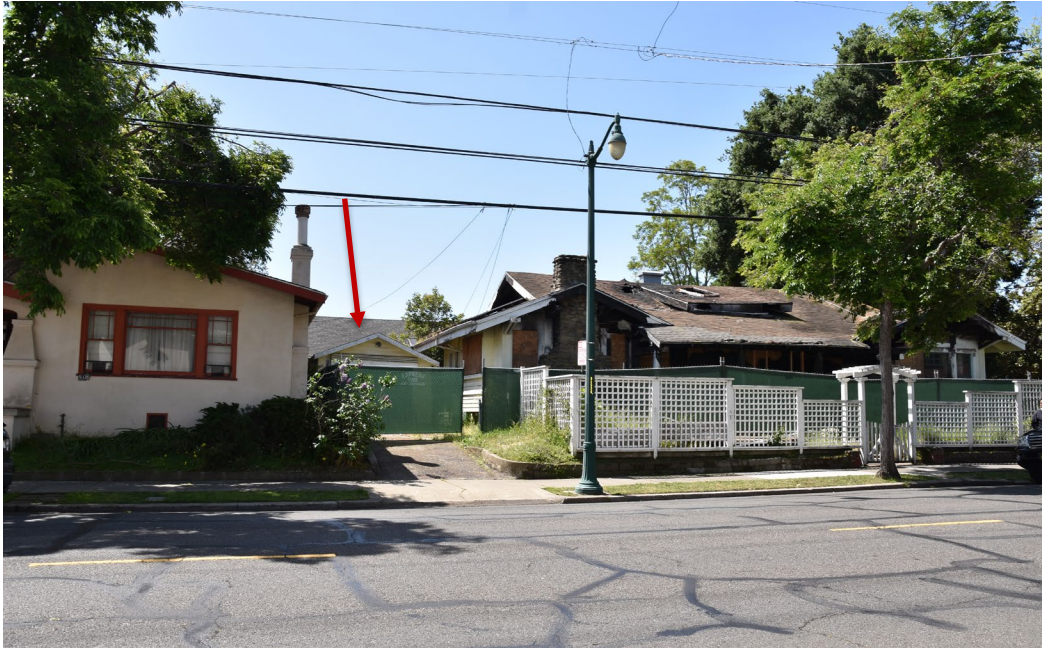
Figure 1. Context view of the subject building at 802 Buena Vista Avenue with garage indicated by red arrow, looking southwest.

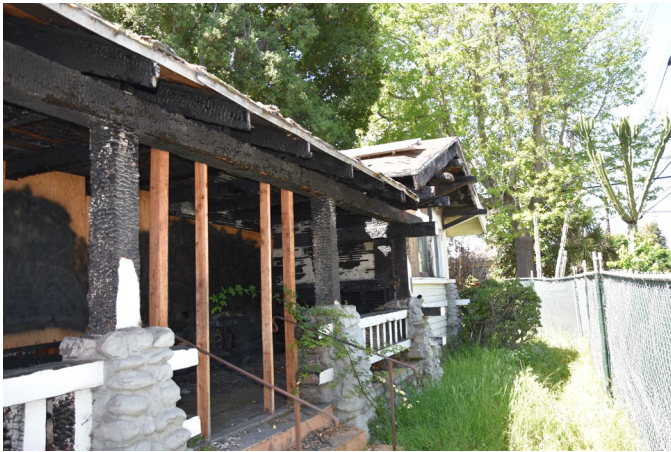
Figure 2. Oblique view of the primary (north) façade, view west.

The western gable end of the primary façade contains a central elongated hung wood window with multiple panes in the upper sash and a single pane in the lower sash; to its west is a similar, narrower hung wood window. The likely similar opening to its east has been concealed by plywood. This gable end has experienced severe fire damage as evidenced by the partially destroyed stucco and exposing wood lath above the window openings. The eastern gable end of the primary façade is pierced in its center by an exterior fieldstone chimney that extends above the roof; the chimney is flanked by small, high window openings, both concealed by plywood.

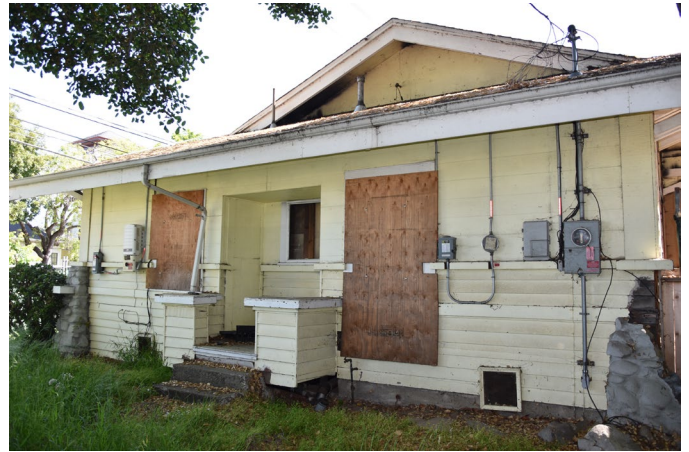
Figure 3. Oblique view of the west façade, view northeast.

The west façade faces a small side yard between Eighth Street to the west. The west façade is clad in horizontal clapboard wood siding in its lower portion and horizontal wood board in the upper portion. It is capped by a cross gable above a narrow, shed roof with overhanging eaves and exposed beams. Towards the north end is a concrete stoop flanked by square piers that are clad in horizontal clapboard siding matching the remainder. The stoop leads to a recessed landing. A square shaped vinyl window is featured at the center of the landing's west façade. No other openings are present. Flanking either side of the stoop is an opening currently concealed by plywood (**Figure 3**).

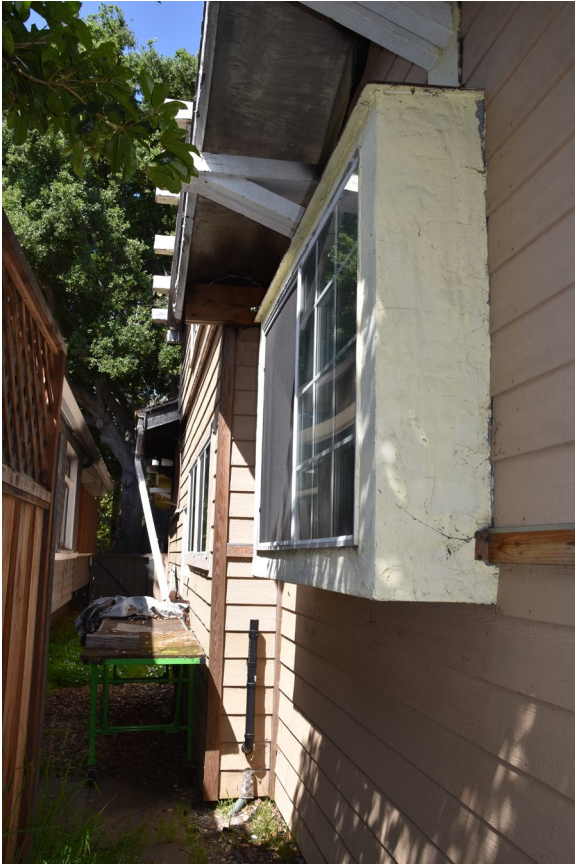
The rear façade faces a narrow yard between the neighboring building at 1720 Eighth Street. It contains a central one-to-one and a-half-story component with shed roofs at multiple planes between recessed gabled ends that feature decorative half-timbering. Triangular knee-brace brackets of wood like those of the north façade support the gables and exposed rafter tails are evident at the shed roofs. The shed roofs have experienced fire damage. The rear façade is clad in horizontal composite board siding. Fenestration consists of a stuccoed bay window opening beneath the eastern gable. The center portion's fenestration is asymmetrical. A contemporary door is located at grade at roughly the center. To its east are paired contemporary sliders at both first story level and the half-story or attic level. To the west of the door is a contemporary multi-light window at grade and a window opening concealed by plywood. Beneath the façade's western gable is a partially concealed wood hung window (**Figure 4, Figure 5**).

Figure 4. Oblique view of the rear south façade, view west.

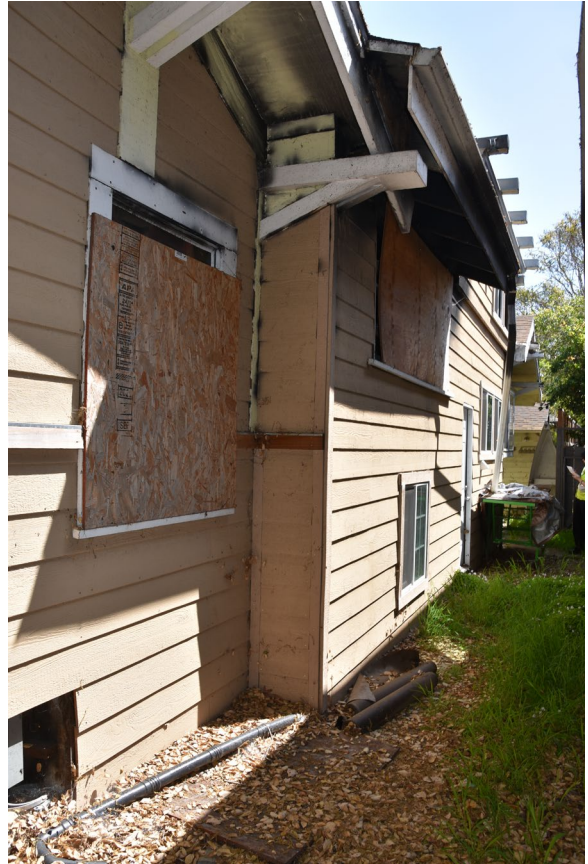
Figure 5. Oblique view of the rear south façade and bay, view east.

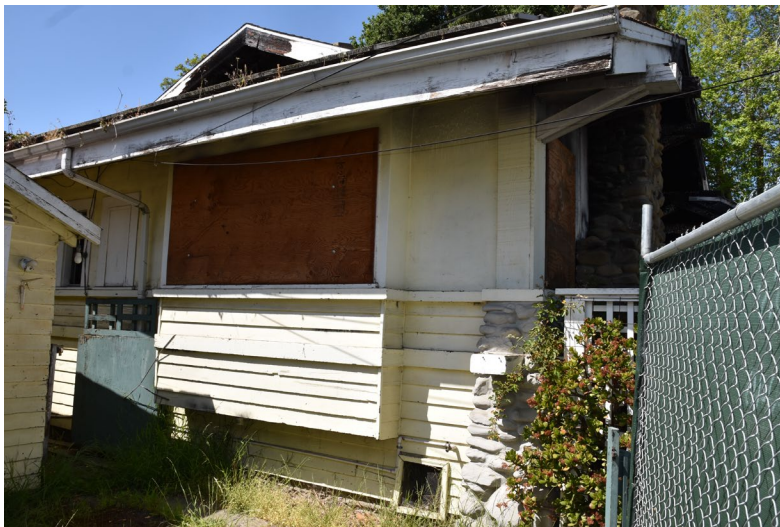
The east façade faces the short paved driveway and the small wood framed garage. The east façade is clad in horizontal wood clapboard siding in its lower portion and painted stucco in the upper portion. Like the west façade, it is capped by a cross gable above a narrow shed roof with overhanging eaves and exposed beams. The fenestration consists of a bay window opening at the northern portion concealed by plywood and three evenly spaced smaller openings in the southern portion, two of which are missing sash and one which is concealed by plywood (**Figure 6, Figure 7**).

Figure 6. Oblique view of the east façade, northern portion, view southwest.

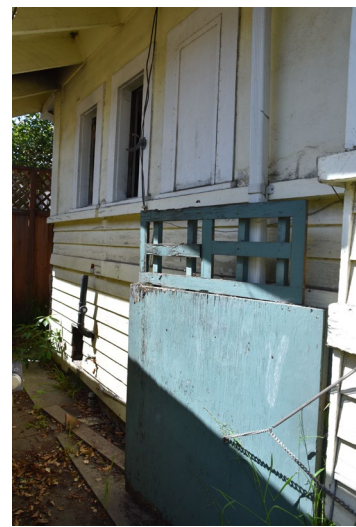
Figure 7. Oblique view of east façade, southern portion view southwest.

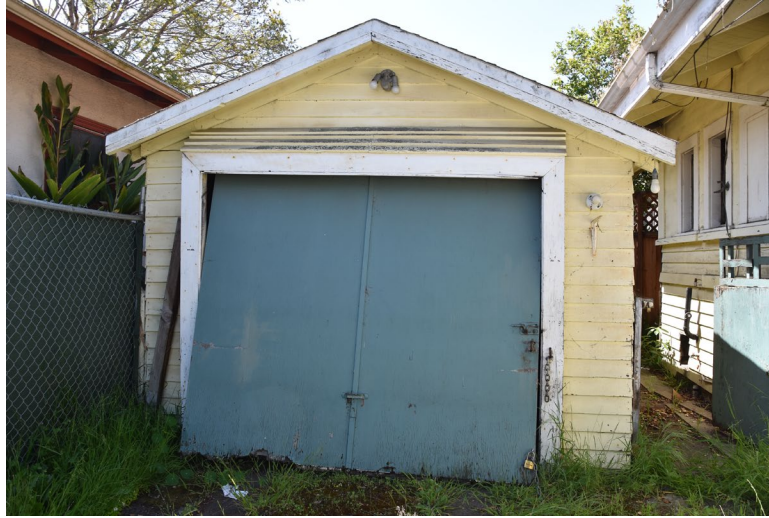
Adjacent and to the east of the east façade is the property's wood frame garage. The garage was likely constructed simultaneously with the residence in ca.1908. It has a low-pitched front gabled roof sheathed in asphalt shingles, featuring overhanging eaves with exposed rafter tails. It is clad in horizontal wood clapboard siding. Its north façade contains a wood garage door and its west façade contains an infilled window opening at its center (**Figure 8**). The south and east facades are visually inaccessible due to proximity to the adjacent unrelated properties at the rear and east side of 802 Buena Vista Avenue.

Figure 8. Garage, north façade, view south.

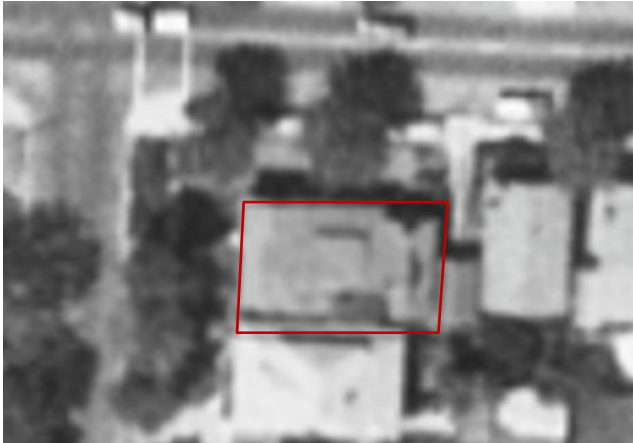
Figure 17. 1965 aerial view of subject property; shed roof dormer and rear shed roof visible. Source: USCB FrameFinder Historic Aerials.

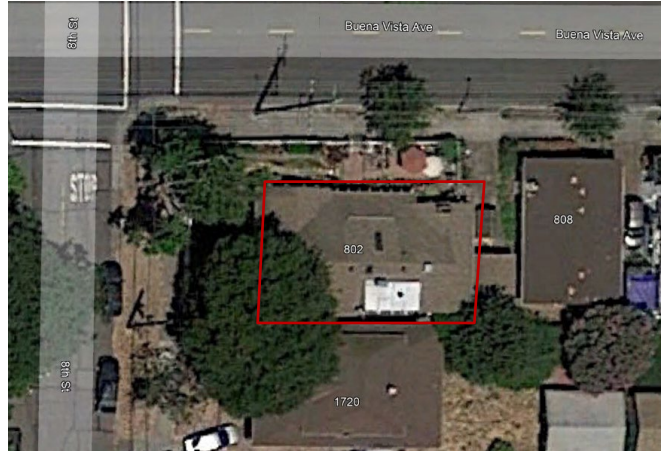
Figure 18. 2020 aerial view of subject property; shed roof dormer and rear shed roof visible. Source Google Earth Historical Aerial Imagery, 2014.

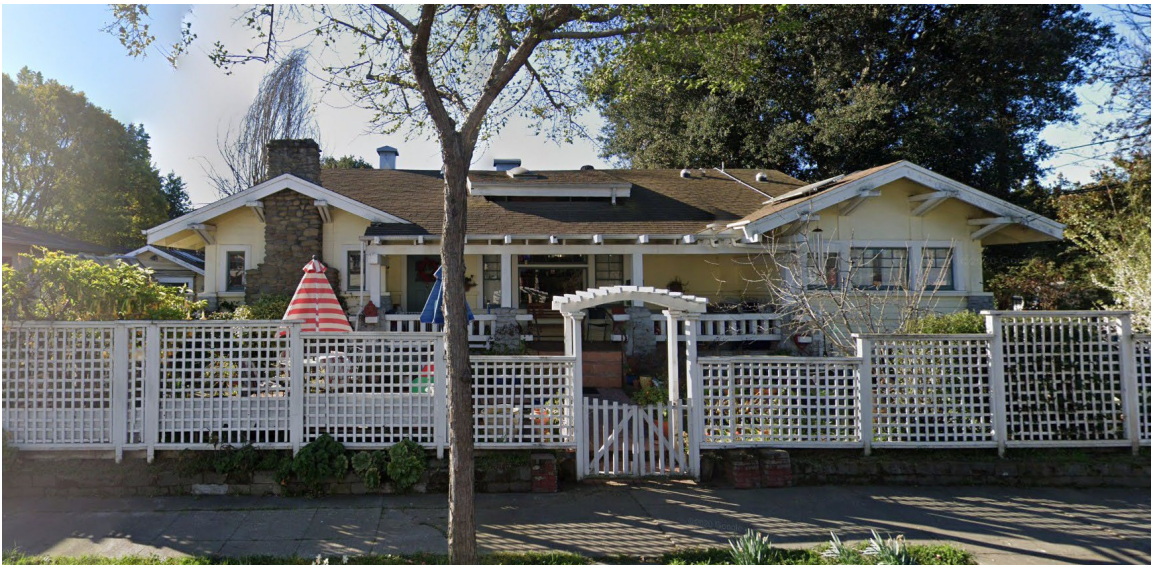
Figure 19. Primary (north) façade of 802 Buena Vista Avenue, view south. Source: Google Streetview, 2020.
