## MEMORANDUM

DATE	May 13, 2025	PROJECT NUMBER	25134
TO	Rajiv N. Jain (Owner)	PROJECT	802 Buena Vista Avenue, Alameda
OF	29523 Holyoke Avenue, Hayward, CA 94544	FROM	Aisha Sawatsky, Preservation Specialist, Page & Turnbull
CC	Christina Dikas Brobst, Principal, Page & Turnbull	VIA	Email

REGARDING Architectural Survey of 802 Buena Vista Avenue, Alameda

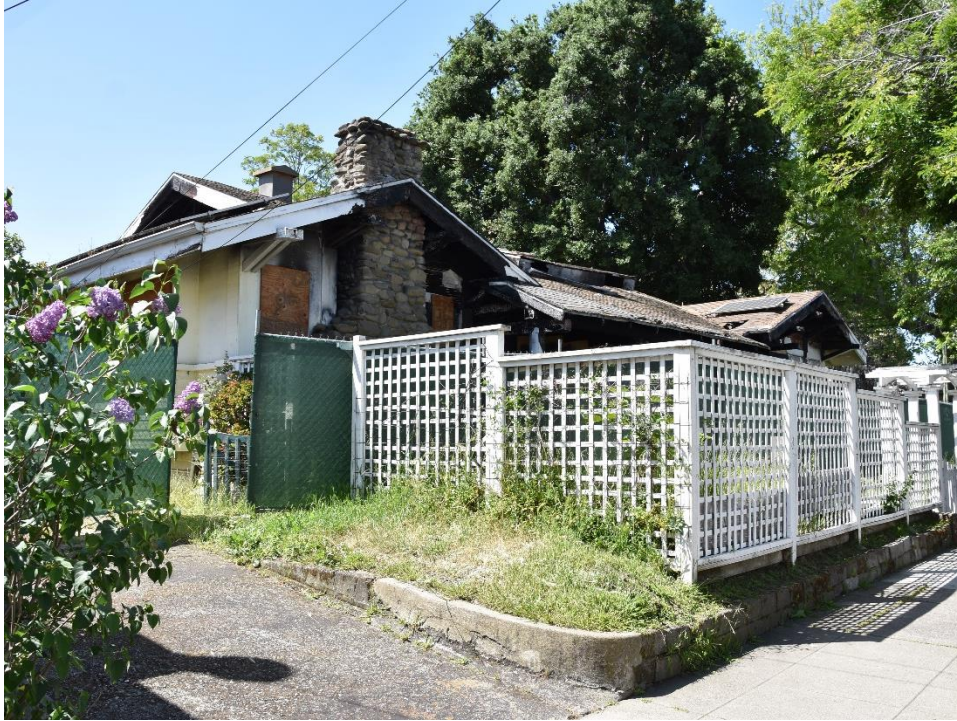
The main entrance to the building is on the north façade that faces Buena Vista Avenue (**Figure 1**). This façade exhibits the most fire damage of all exterior walls. The wood entry porch structure and railings are in poor condition and likely cannot be repaired (**Figure 4**). The shed roof dormer on the gable slope above the porch is in a state of collapse (**Figure 9**). Most of the wood triangular knee braces (angular wood brackets) supporting the roof eaves are in poor condition like the porch. The

Figure 1: Subject building viewed from northeast edge of property on Buena Vista Avenue.

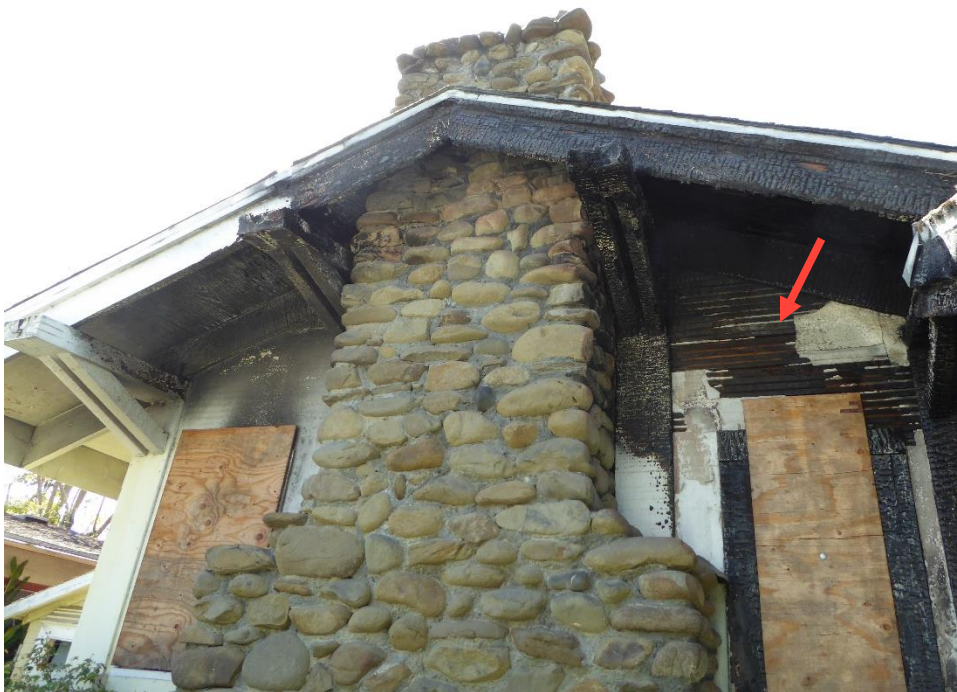
stucco cladding is largely missing (**Figure 2**). The wood clapboard siding within the porch is in poor condition (**Figure 6, Figure 7**). Many of the window and door openings on this façade are covered by plywood and are presumed to be in poor condition based on the condition of the adjacent wall surfaces. Where the adjacent walls are in fair condition, removal of the plywood covers for assessment of the windows is recommended.

Figure 2: Fieldstone chimney, covered windows, burn-damaged wood elements, and missing stucco.

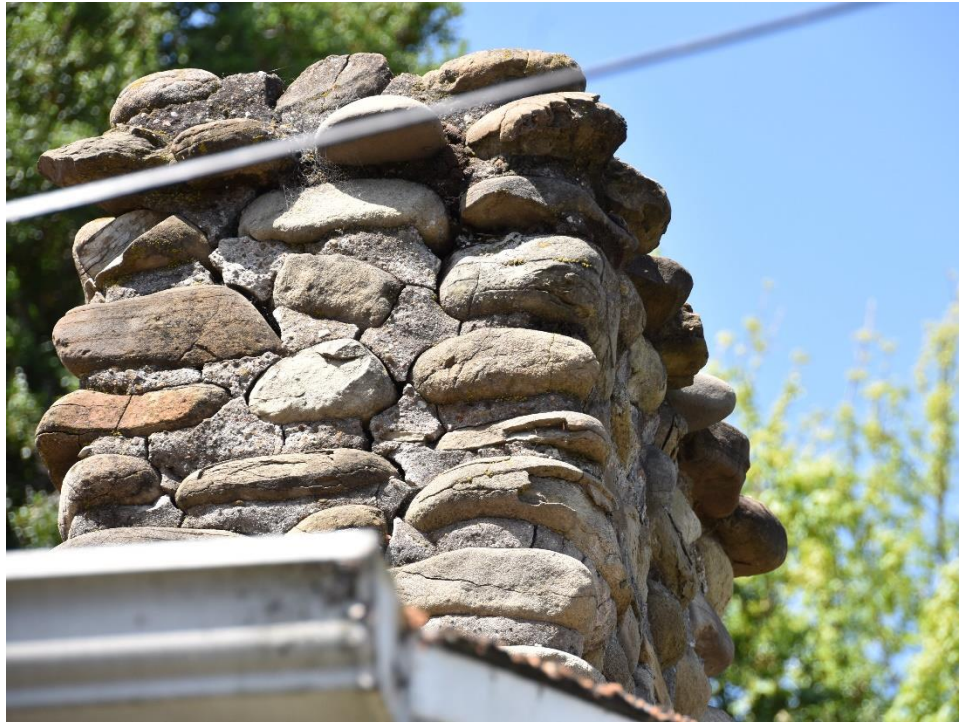
The fieldstone features are generally in good condition, including the chimney, piers, and porch facing. Select stones at the tops of the porch piers are missing (**Figure 5**). The chimney above the roofline is in fair condition and exhibits cracks and loose mortar (**Figure 3**). Paint coatings at the porch piers appear to be trapping moisture and may be deteriorating the stone. The wood clapboard siding on either side of the porch is in good condition with some smoke damage. Two original window sashes are visible at the west end of the north façade; one window appears to be in good condition, while the other appears to be in fair condition and may be repaired by selectively replacing components like the bottom rail (**Figure 8**). As the building was not assessed from the interior, it is unknown whether the windows were burned beyond repair on their interior surfaces.

Figure 3: East side of chimney above roofline with cracks and loose mortar.

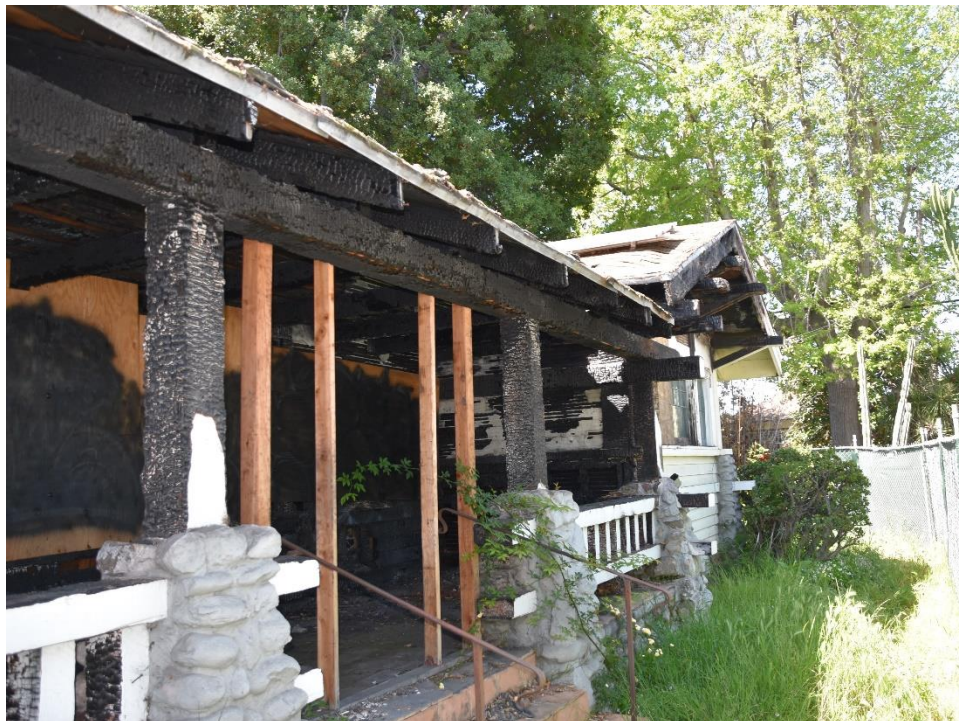
Figure 4: North façade with burn-damaged porch.

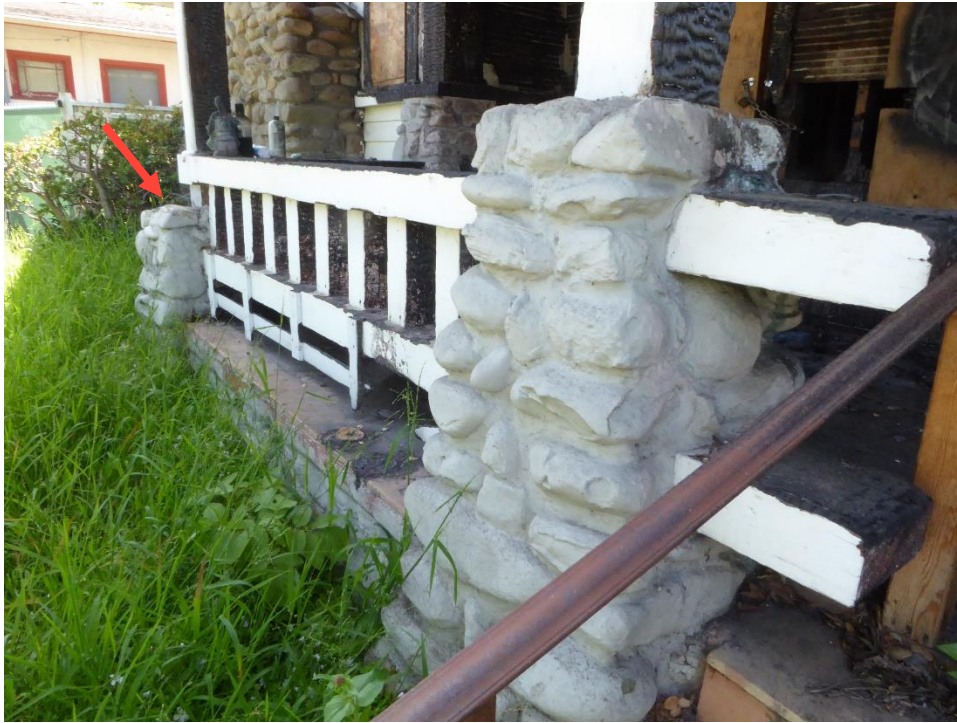
Figure 5: Painted fieldstone porch piers; missing stones at furthest east pier.

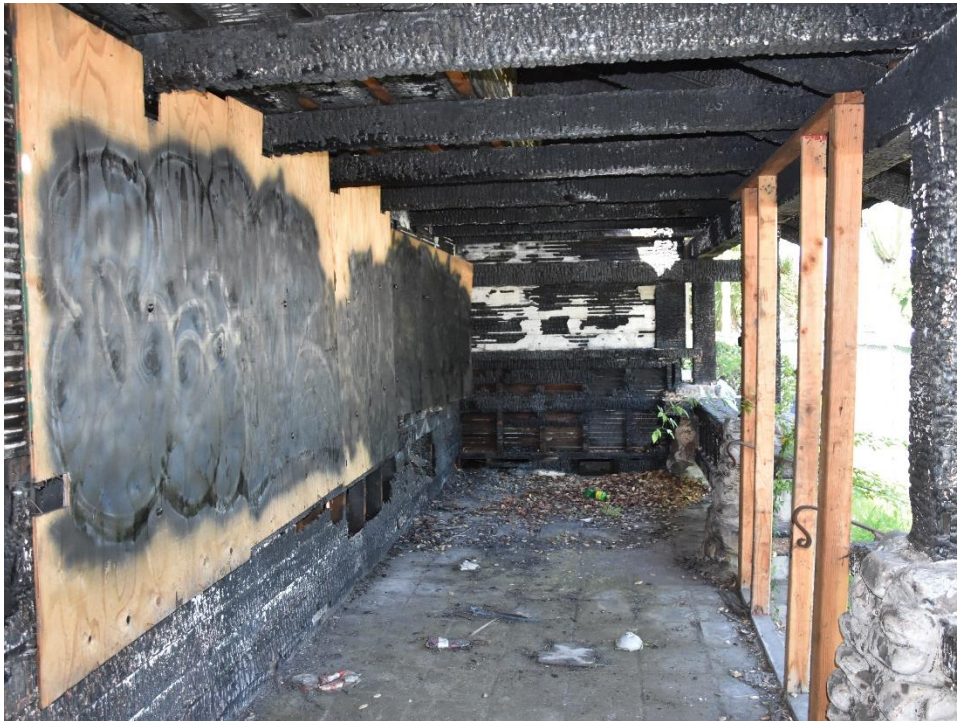
Figure 6: Burn-damaged porch, looking west. Covered window openings at left.

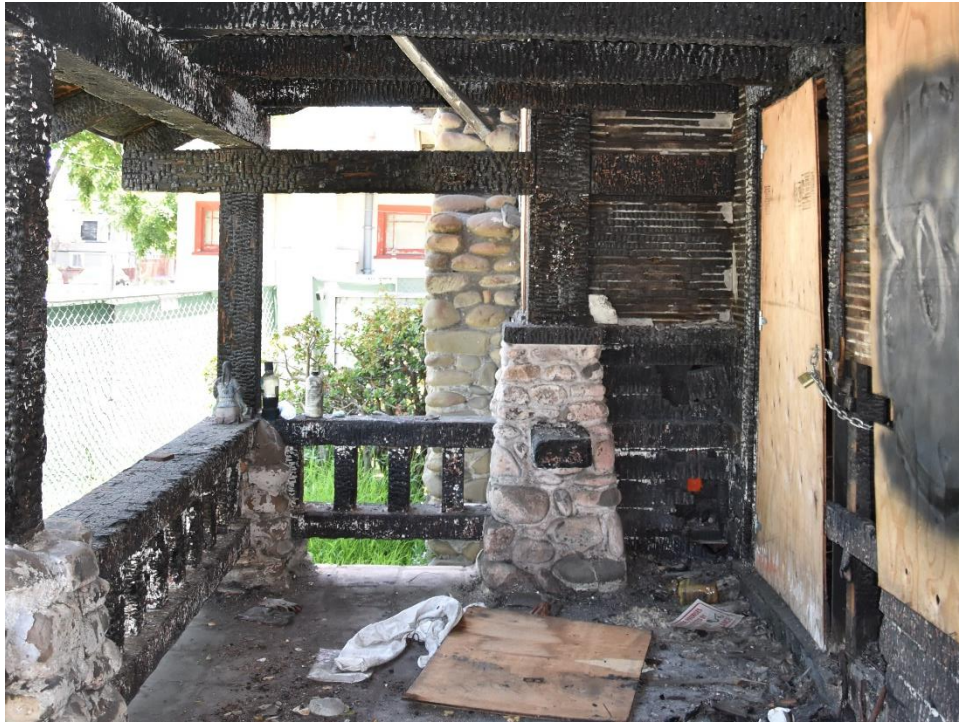
Figure 7: Burn-damaged porch, looking east. Main entry to the house at right.

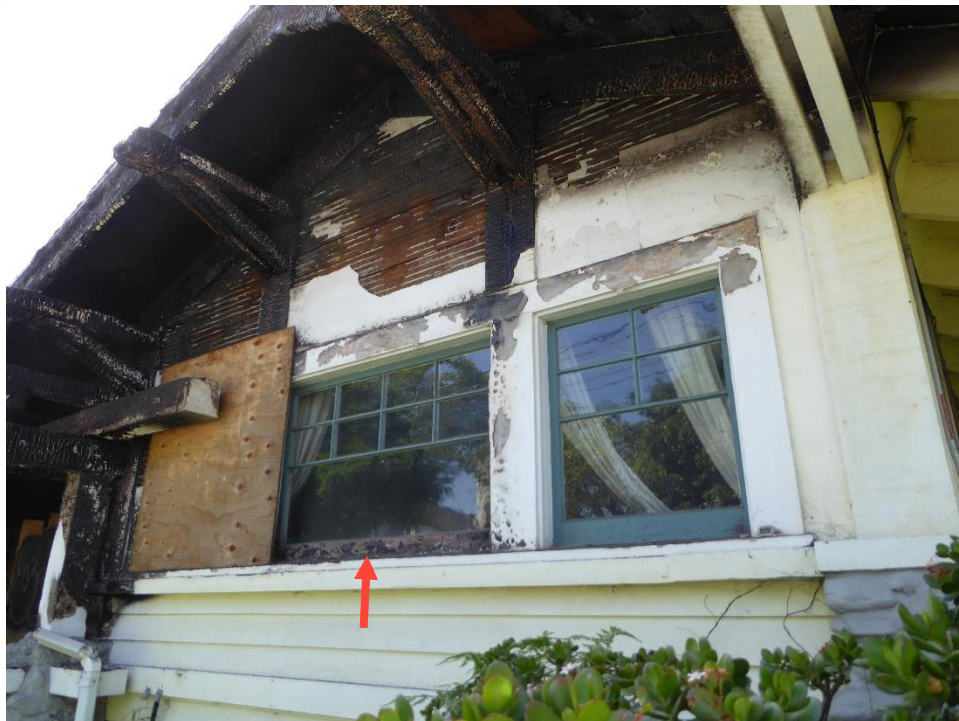
Figure 8: Extant wood windows at west end of north façade. Center window has a burn-damaged bottom rail.

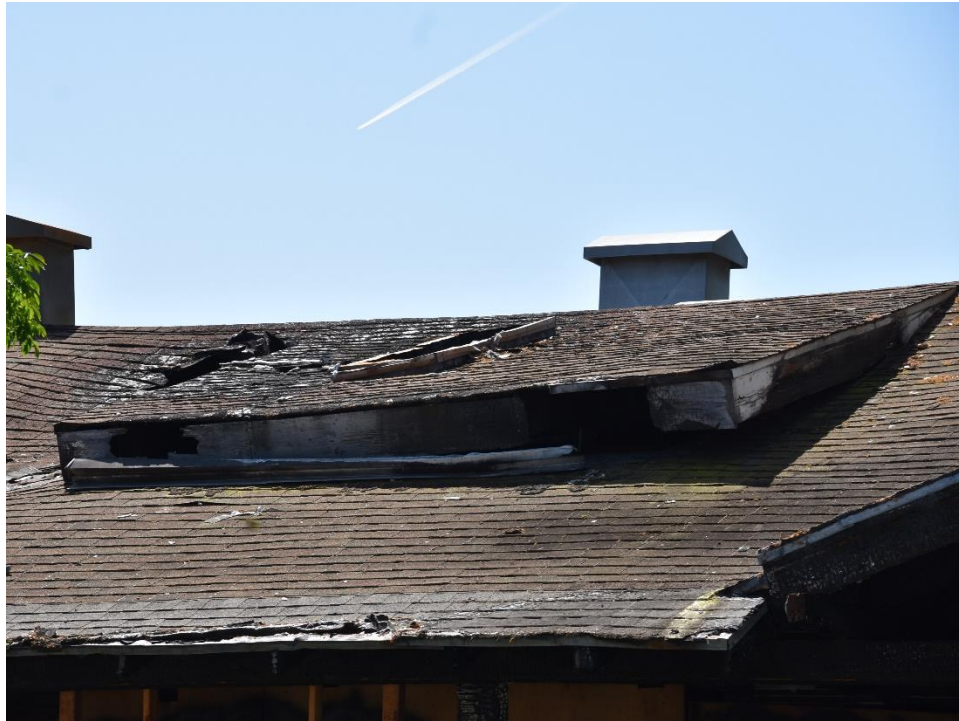
Figure 9: Collapsed shed roof dormer.

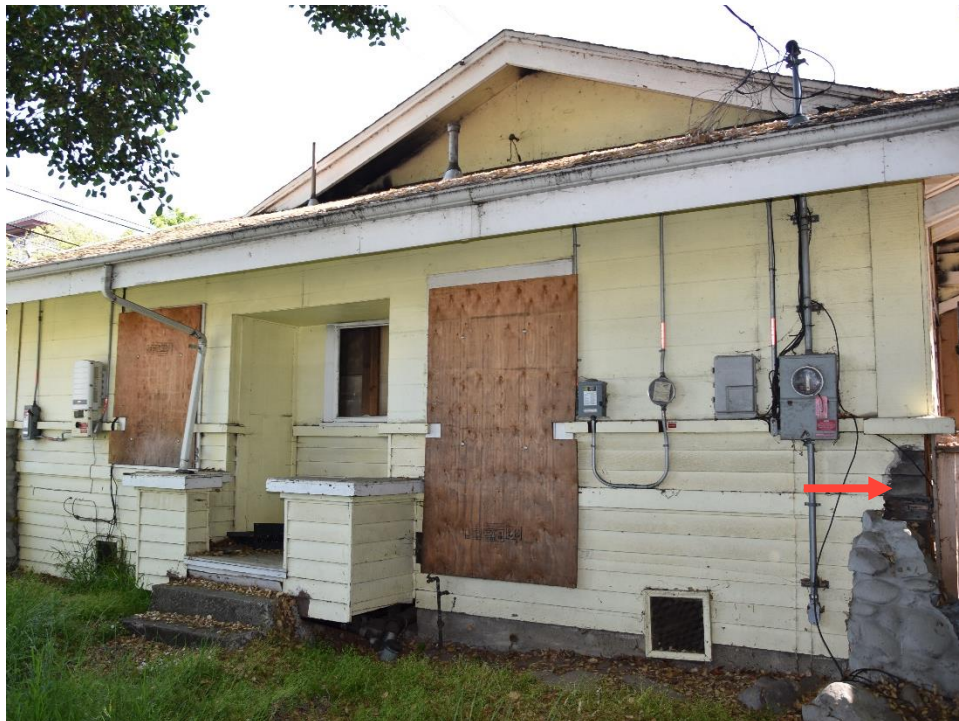
This side façade faces Eighth Street and is generally in good condition (**Figure 10**). A smaller, secondary porch is centered on this façade. The windows on either side of this porch are covered by plywood and are in unknown condition. A small window in the recessed wall behind the porch is missing its sash but retains its trim and screen frame (**Figure 11**). The wood cladding, trim, rafter ends, fascia, and soffits are generally in good condition with some smoke damage at the north end of the façade and at the bottom of the small central window. The recessed cross gable above the eave of this façade is in good condition with some smoke damage.

The fieldstone corner piers are in good to fair condition. The southwest corner pier is missing several of its stones and would need to be partially rebuilt. The stones appear to have been scattered around the pier in the side yard.

Figure 10: West façade facing Eighth Street. Southwest corner pier with missing stones.

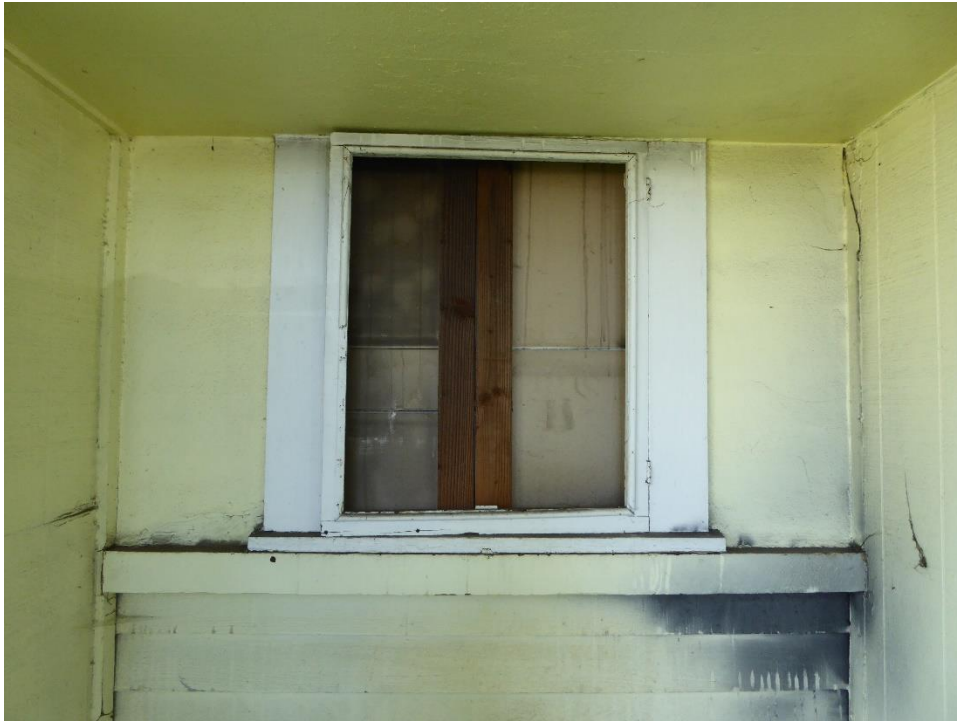
Figure 11: Missing window inside west porch recess.

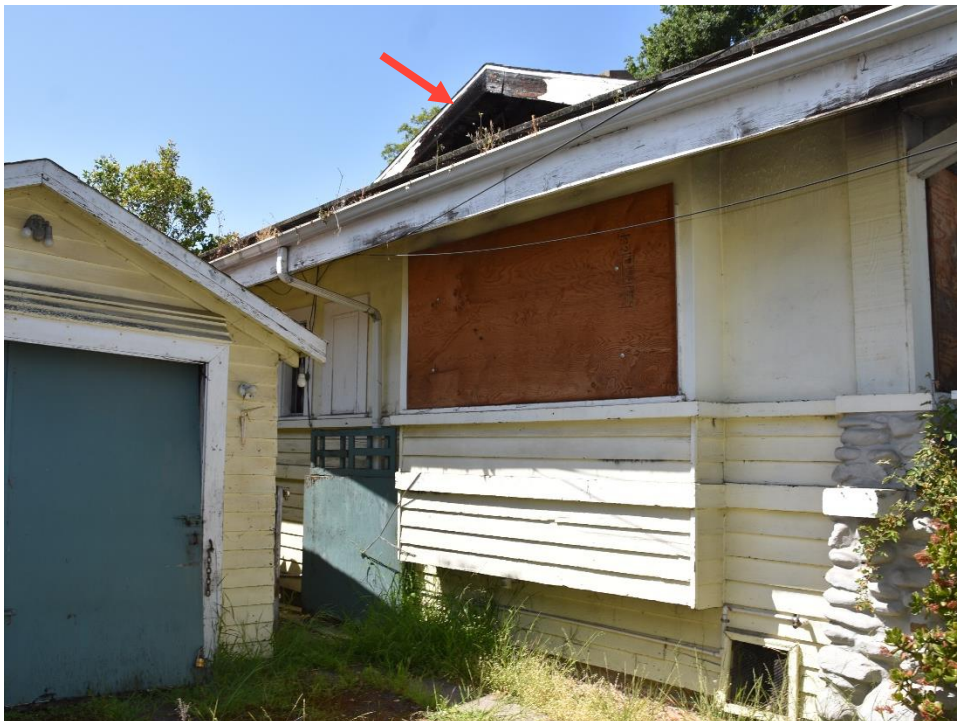
This side façade faces the driveway and is generally in good condition (**Figure 12**). Stucco cladding is extant above the wood clapboard siding; both are in good condition. Limited clapboard pieces are loose and need to be re-secured to the wall. The rafter ends, fascia, and soffits are in fair condition with some smoke damage and weathering.

Figure 12: East façade next to driveway. Burn-damaged cross gable above.

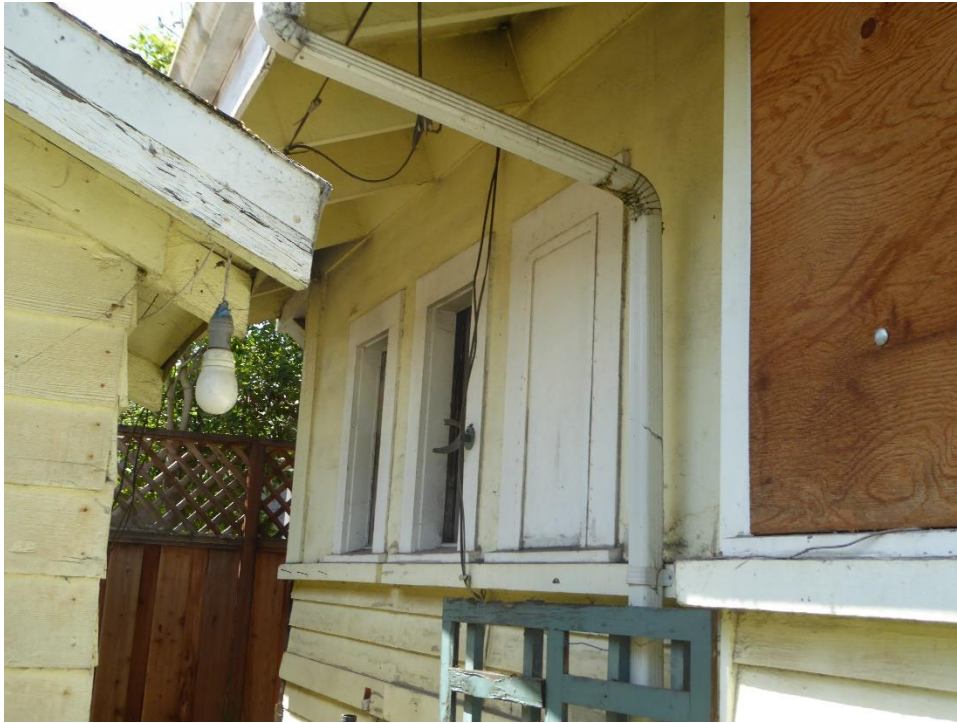
A plywood cover obscures the bay window at the north end of the façade. The south end of the façade has three individual window openings with exterior trim in good condition (**Figure 13**). Two

windows are missing their sashes, and one is blocked with painted plywood that likely predates the fire. Hinges that remain at the two uncovered windows indicate that they were casement windows. The recessed cross gable above the eave of this façade exhibits burn damage and is in poor condition.

Figure 13: Missing casement windows at south end of east façade.

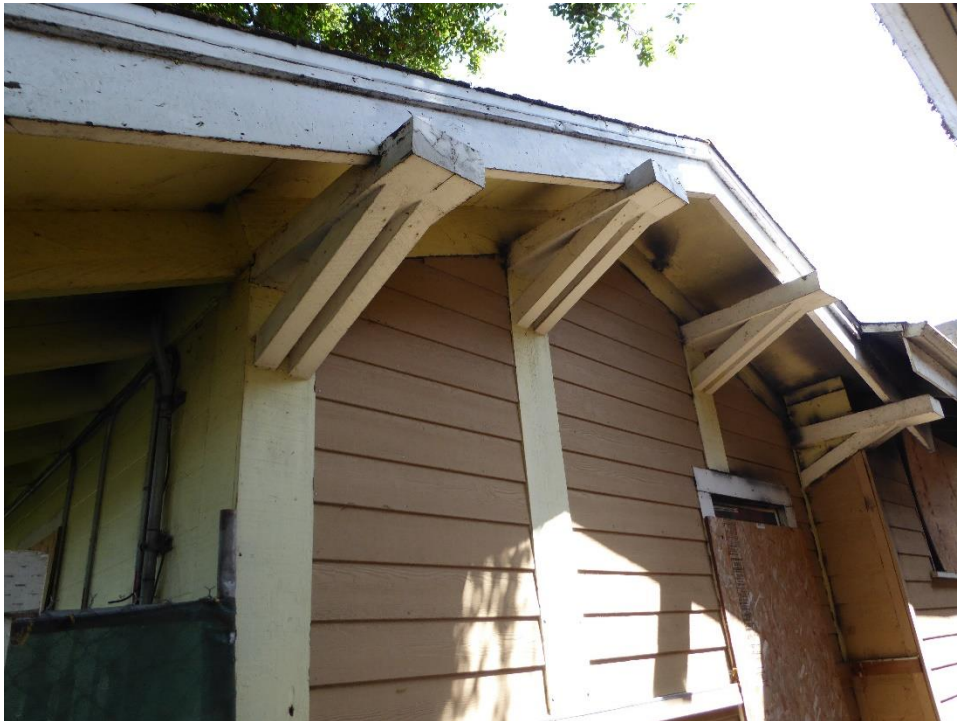
This rear façade retains some original features, such as wood triangular knee braces matching the north façade and a wood double-hung window that is partially obscured by a plywood cover (**Figure 16**). The wood braces are generally in good condition (**Figure 14, Figure 17**); the braces and fascia of the east gable are in fair condition and exhibit weathering (**Figure 18**). The wood soffits are in fair condition with smoke damage, particularly at the center of the façade.

Figure 14: West end of south façade with wood knee braces in good condition.

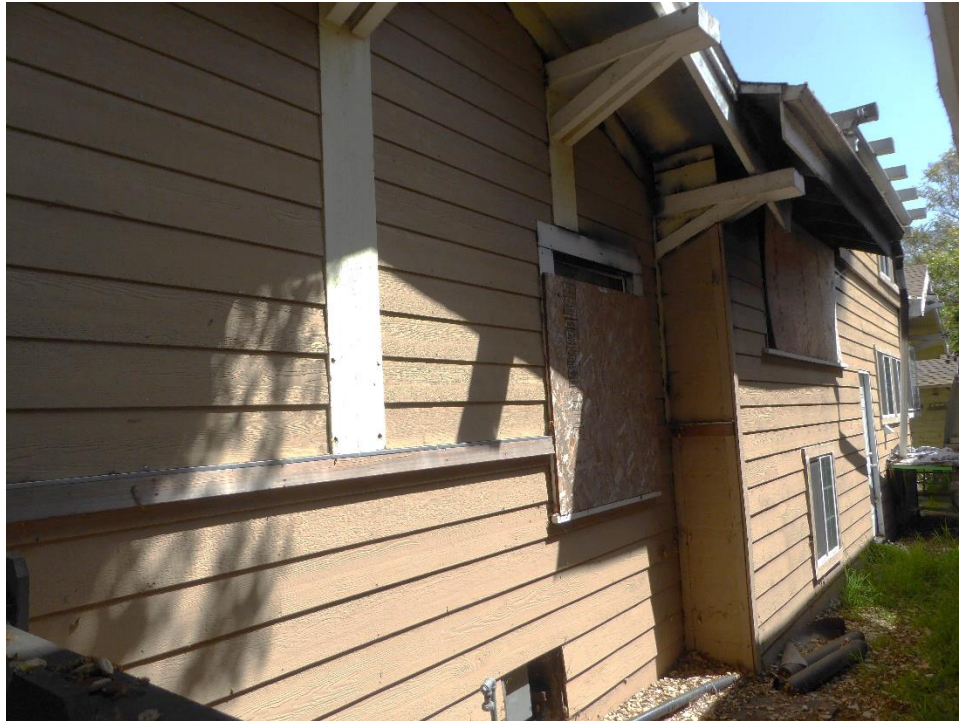
Most windows and all doors on this façade are non-original additions or replacements. The clapboard siding and trim on this façade are mostly unpainted non-original composite material with wood texture (**Figure 15**). A stucco-clad projection with a non-original window is centered under the gable at the east end of the façade. These non-original finishes are generally in good condition.

Figure 15: South façade with composite siding, viewed from southwest corner of the property.

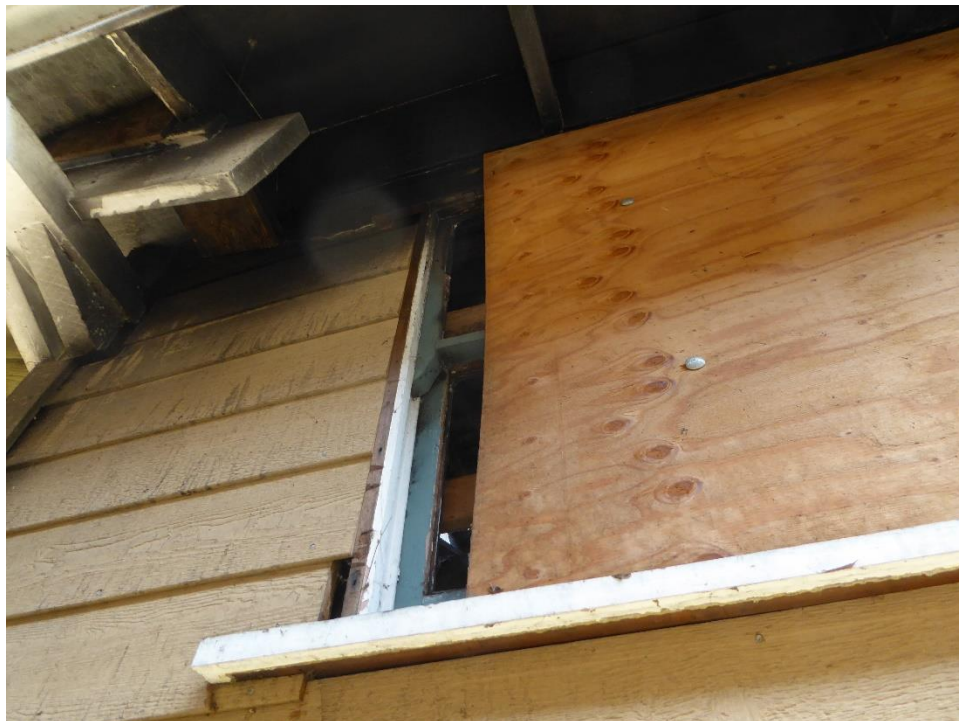
Figure 16: Wood double-hung window behind plywood cover.

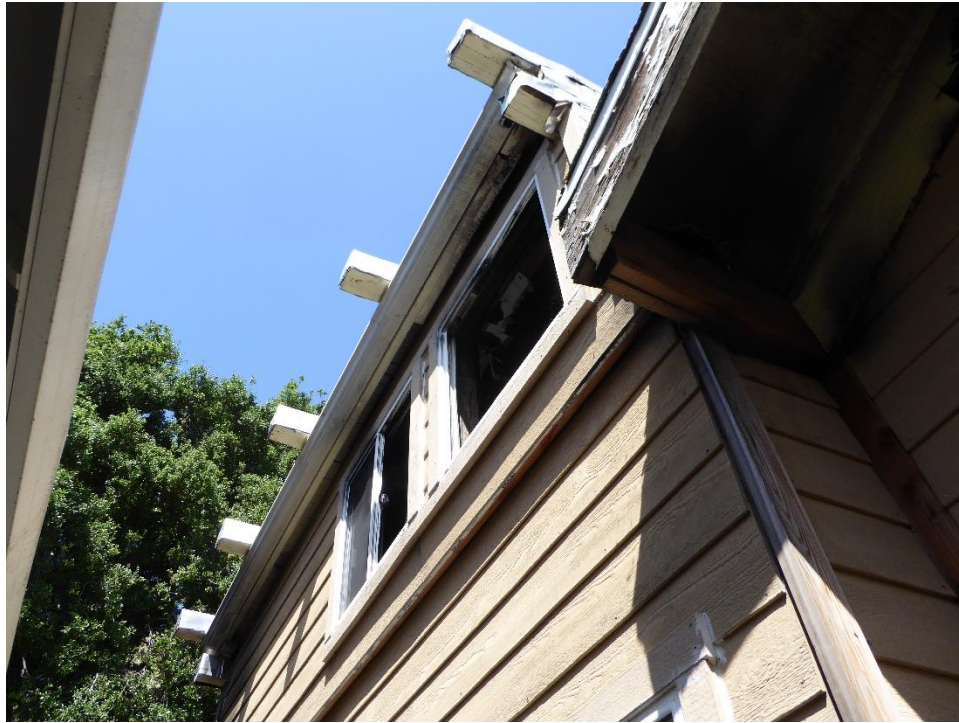
Figure 17: Exposed rafters at upper floor of south façade.

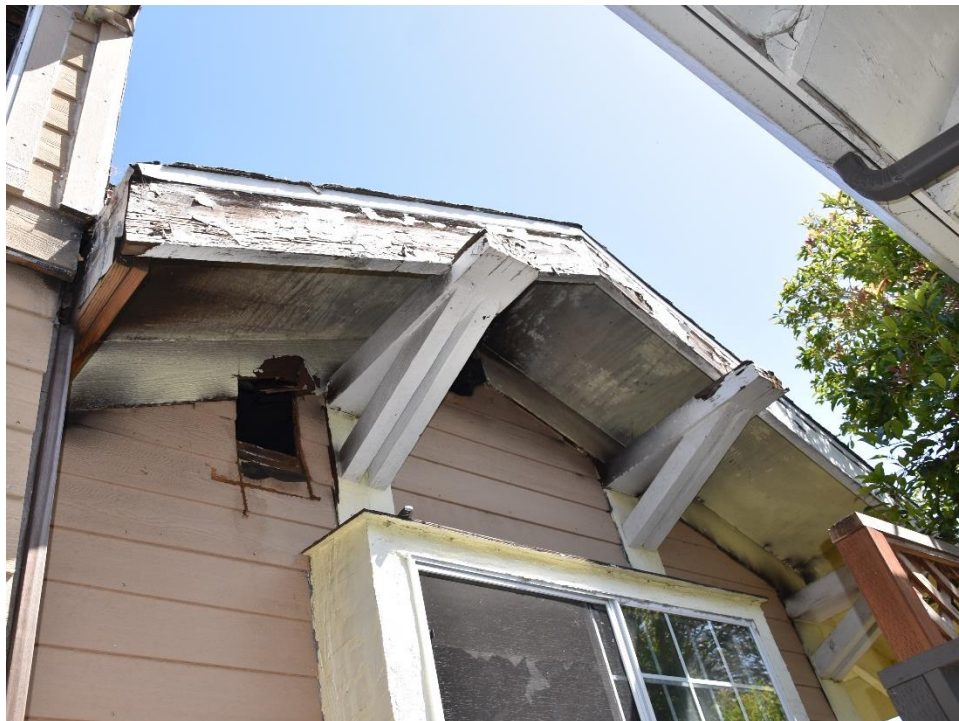
Figure 18: East end of south façade with wood knee braces in fair condition.
