JUDITH L. THOMAS
BAY AREA PLANT CONSULTANTS
Arboricultural Consultant, Horticultural Advisor
83 Mission Hills Street
Oakland CA 94605-4612
1(510) 568-2960 (phone), 1(510) 878-2744 (fax)
<http://bayareaplantconsultants.blogspot.com>

Paula Mathis and Thomas Ellebie Jr.
1208 St. Charles Street
Alameda CA 94501
Cell: 1(949) 466-5162 (Paula), pkmathis@gmail.com
Cell: 1(949) 294-0122 (Tom), t.ellebie@gmail.com

11/27/2016

SUMMARY

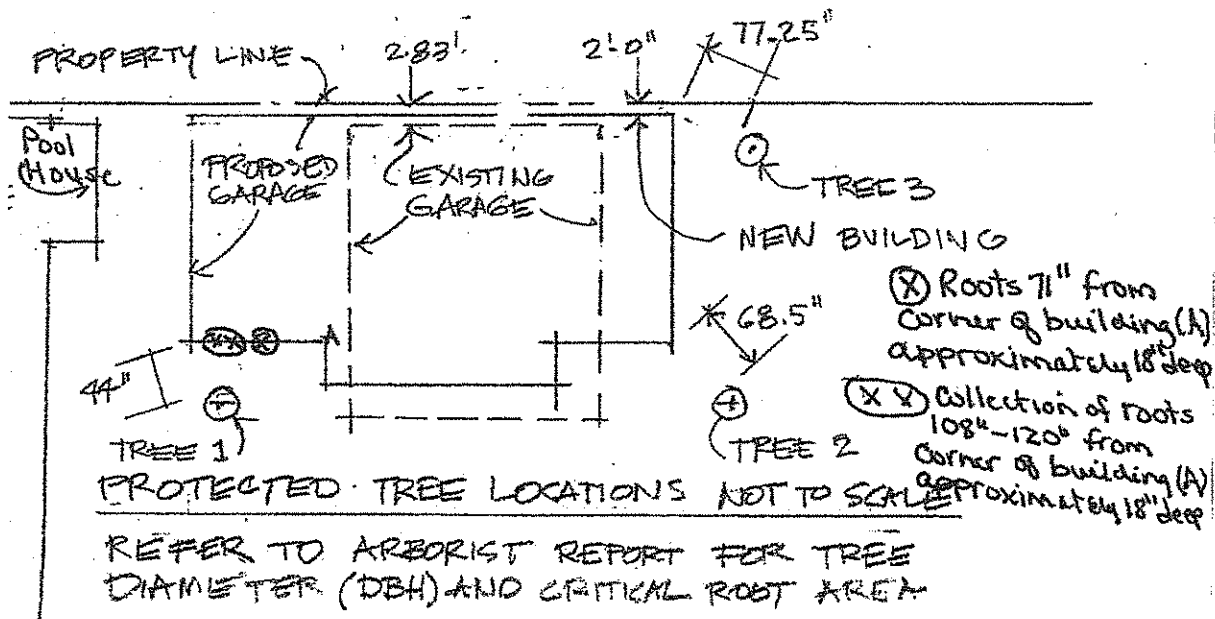
SITE SKETCH

This site sketch pdf file provided by your architect, shows the solid lines of the proposed new garage relative to the three oaks that will require protection. Tree #1 is shown above, near the path to the swimming pool gate. Tree #2 is below on the left, near the paved area. Tree #3 is below on the right near the fence to the property.
