JUDITH L. THOMAS  
BAY AREA PLANT CONSULTANTS  
Arboricultural Consultant, Horticultural Advisor  
83 Mission Hills Street  
Oakland CA 94605-4612  
1(510) 568-2960 (phone), 1(510) 878-2744 (fax)  
<http://bayareaplantconsultants.blogspot.com>

Paula Mathis and Thomas Ellebie Jr.  
1208 St. Charles Street  
Alameda CA 94501  
Cell: 1(949) 466-5162 (Paula), [pkmathis@gmail.com](mailto:pkmathis@gmail.com)  
Cell: 1(949) 294-0122 (Tom), [tellebie@gmail.com](mailto:tellebie@gmail.com)

10/6/16

## BACKGROUND AND ASSIGNMENT

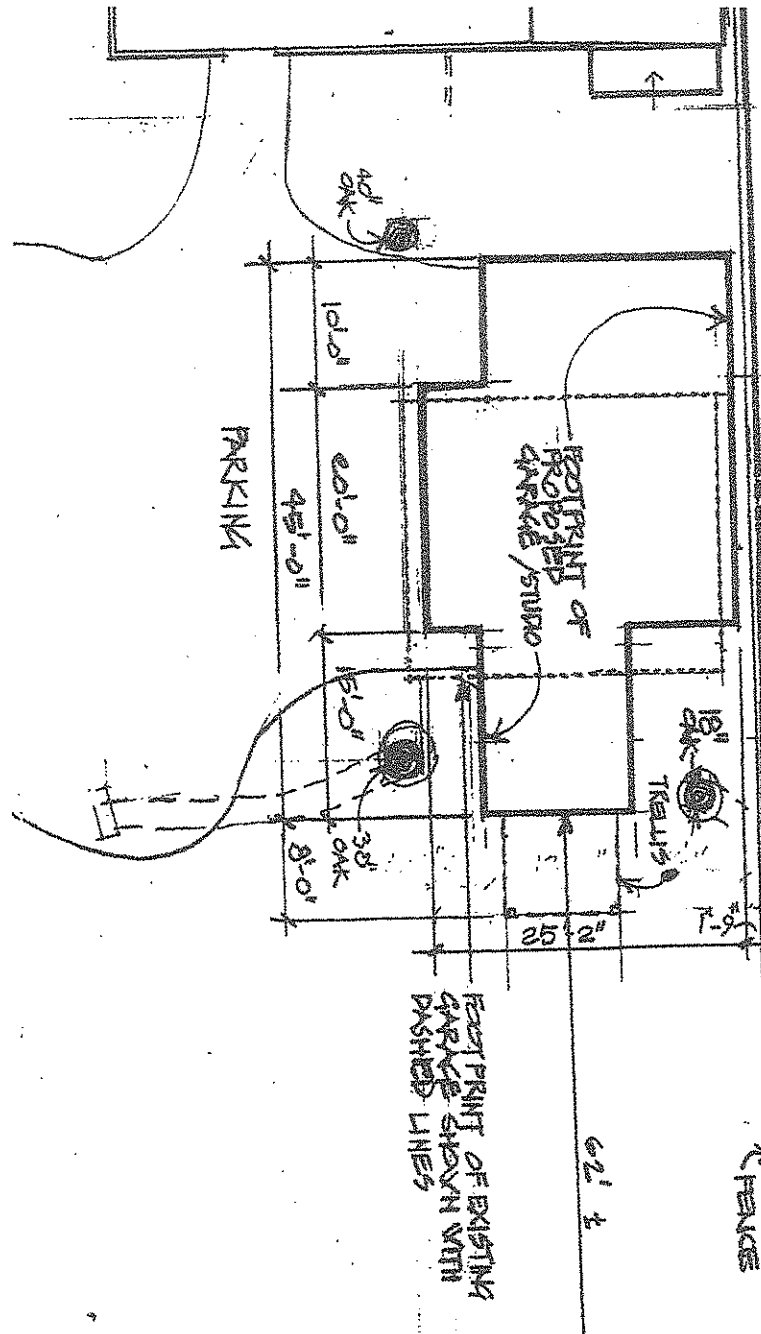
This site sketch pdf file, blown up from the drawing provided by you on 9/15/16, shows the solid lines of the proposed new garage relative to the three oaks that will require protection. Tree #1 is shown above, near the path to the swimming pool gate. Tree #2 is below on the left, near the paved area. The large lower limb on it, extending toward the house, is indicated with dashed lines. Tree #3 is below on the right, near the fence to the property.

For all three trees, protective fencing shall enclose the entire critical root radius areas shown in the chart on page 1 of this letter. Snow fencing and 4-6" of mulch with metal plates on top of the mulch shall be installed within the critical root areas of the trees, shown in the chart on page 1, to protect the soil around the base of the trees from the impacts of the construction work. This fencing should be done prior to any grading or construction. Fences are to remain until all grading and construction is complete, in order to protect the soil and roots beneath the trees from trampling by construction workers. This fencing shall enclose low branches, and shall protect the trunk. No fill soil should be added to this area. Where traffic cannot be diverted in soil areas beneath the trees to be retained, the soil surface shall be protected with thick mulch and steel plates. The steel plates should be anchored into the ground where possible, and placed on top of the mulch.

The Air Spade<sup>R</sup> work for tree #1 will be needed 25" from the corner of the new proposed garage, in both directions along the new foundation.

The Air Spade<sup>R</sup> work for tree #2 will be needed 76" (6.33') from the front corner of the new proposed garage, and 51" (4'3") from the wall of the new proposed studio in the new garage, in both directions along the new foundation.

The Air Spade<sup>R</sup> work for tree #3 will be needed 48" (4') from the wall of the new proposed studio in the new garage, in both directions along the new foundation.
