MEMORANDUM

Subject: Alameda Shipways Project – General Description of Site Conditions
M&N Project No: 9696

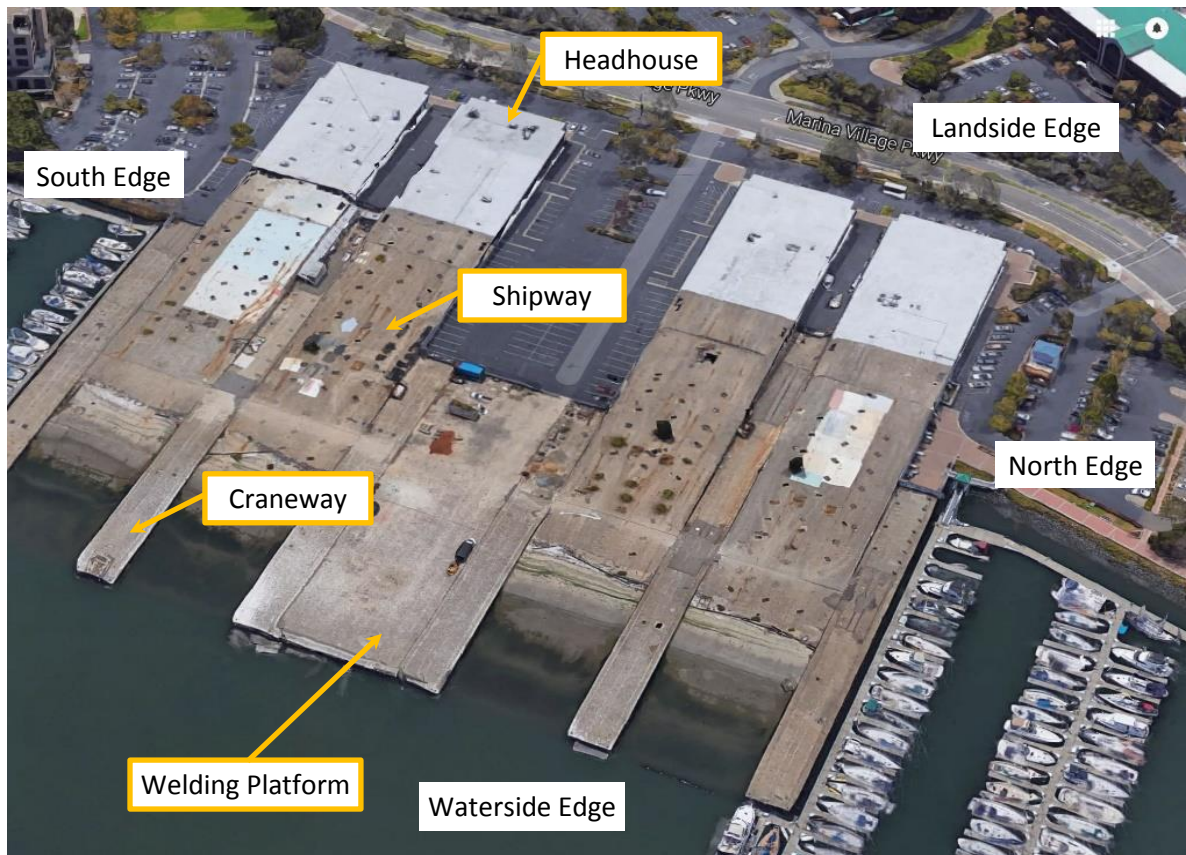
A general description of the site, based on a combination of prior reports and drawings, and visual observations is presented in this memo. The site is a former shipbuilding facility along the waterfront which comprises the following, and as shown in the figure below:

- Four headhouses currently being used as office/warehouse space;
- Four large shipways or ramps that slope from the roofs of the head-houses towards the water;
- Six craneways that are flat and were used to support cranes for building ships;
- A large pile-supported welding slab between the two central craneways.
