Summary Report
On Interim
Inspection,
Testing, and
Preliminary
Analysis of
Alameda Piers 1,
2, and 3

26 May 2017

SGH Project 167543

SIMPSON GUMPERTZ & HEGER

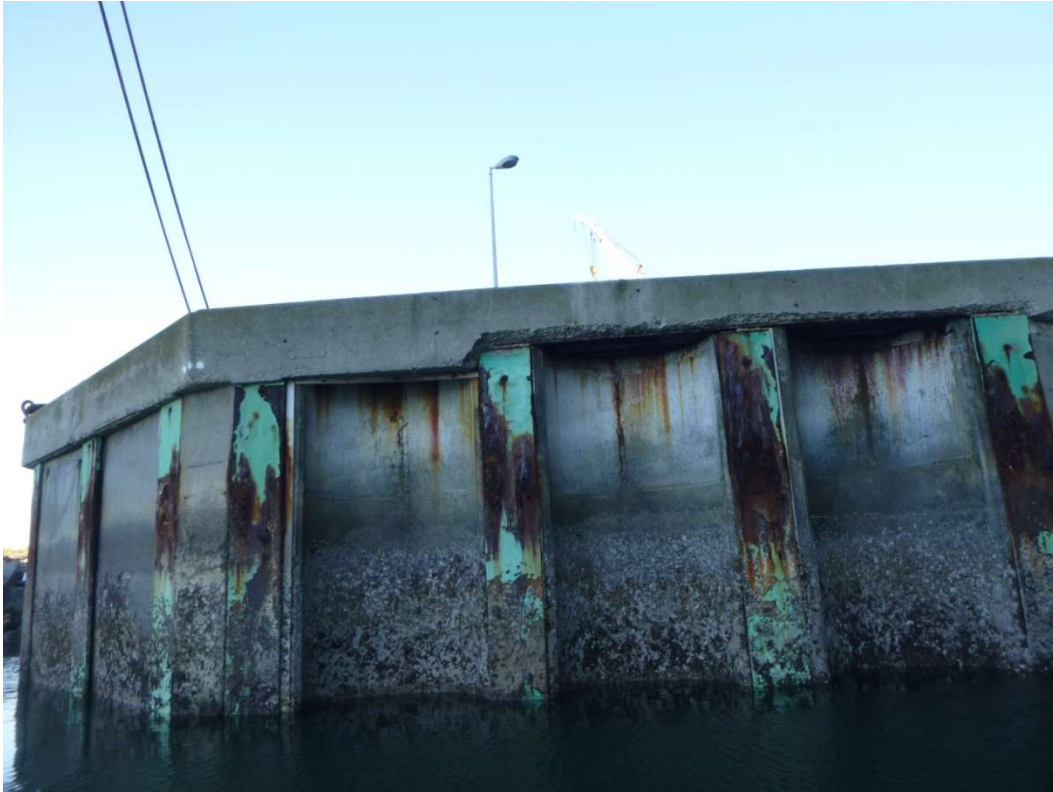
Photo 1 - Typical above water condition of king piles at Pier 1

Pier 1 is in satisfactory condition, but should have maintenance performed to ensure it retains the intended capacity of the structure. The maintenance should include cleaning and recoating of the king piles and repair of the sheet pile bulkhead towards the apron.

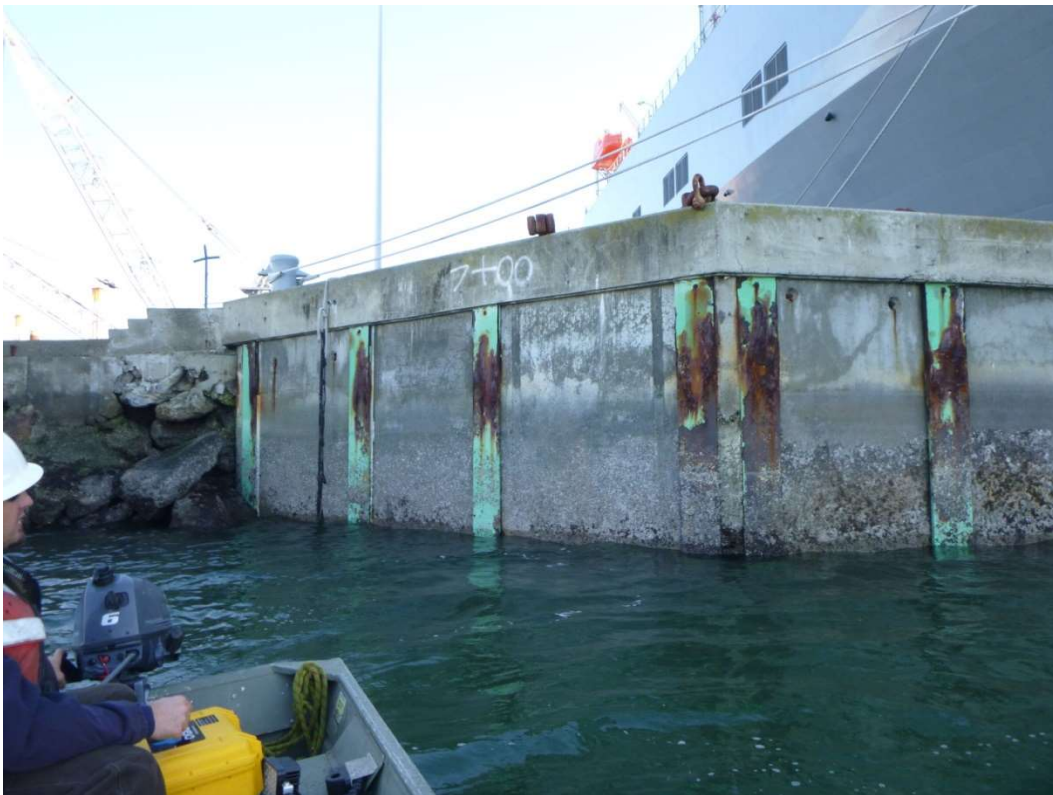
Photo 2 - Typical condition of concrete panels at Pier 1

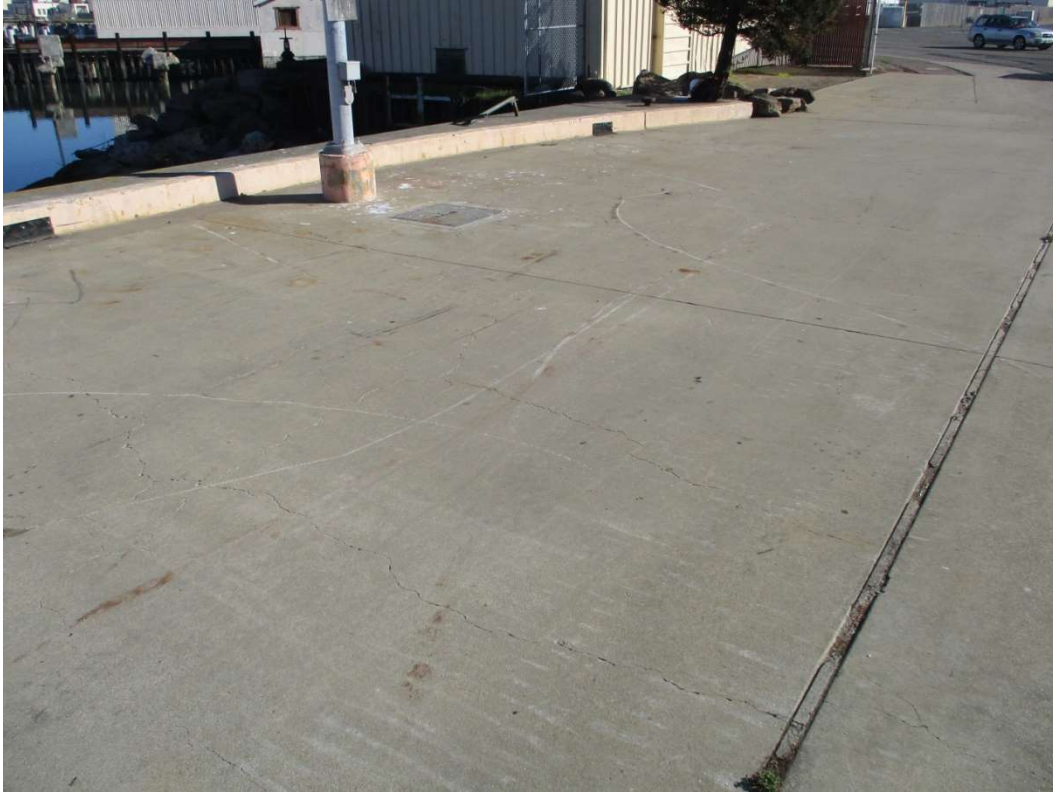
Photo 3 - Typical condition of deck at Pier 1

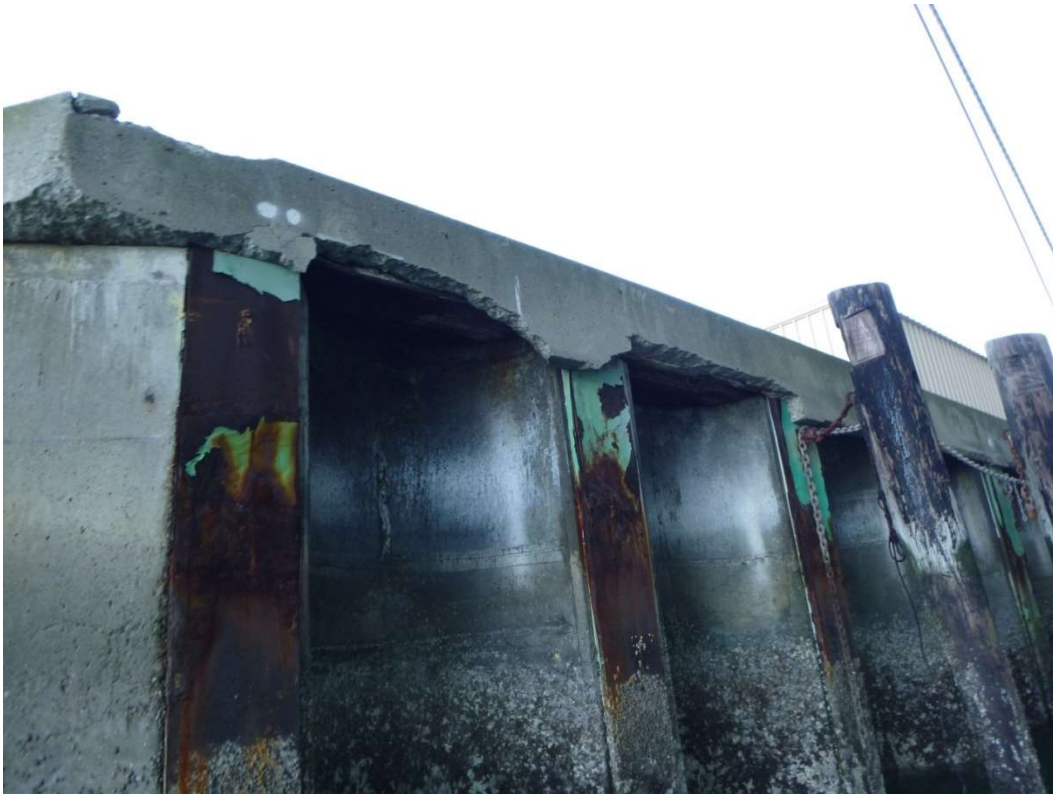
Photo 4 – Spalled lip of pile cap at Pier 1

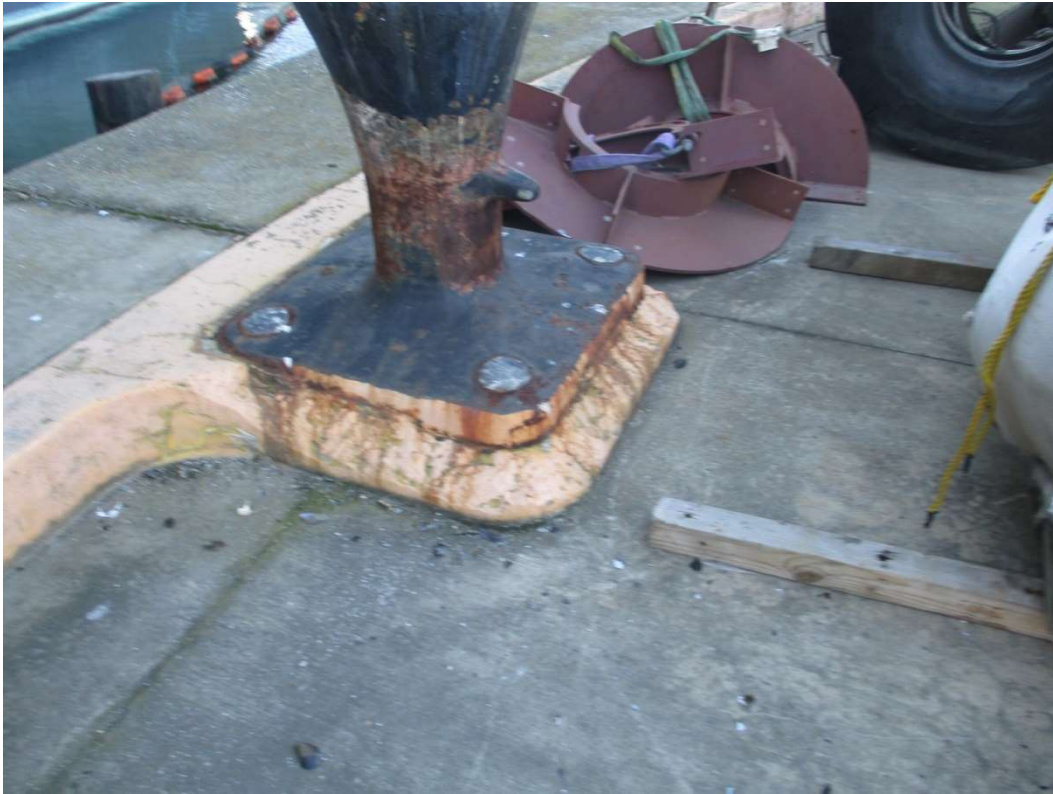
Photo 5 - Typical condition of mooring bollard and base at Pier 1

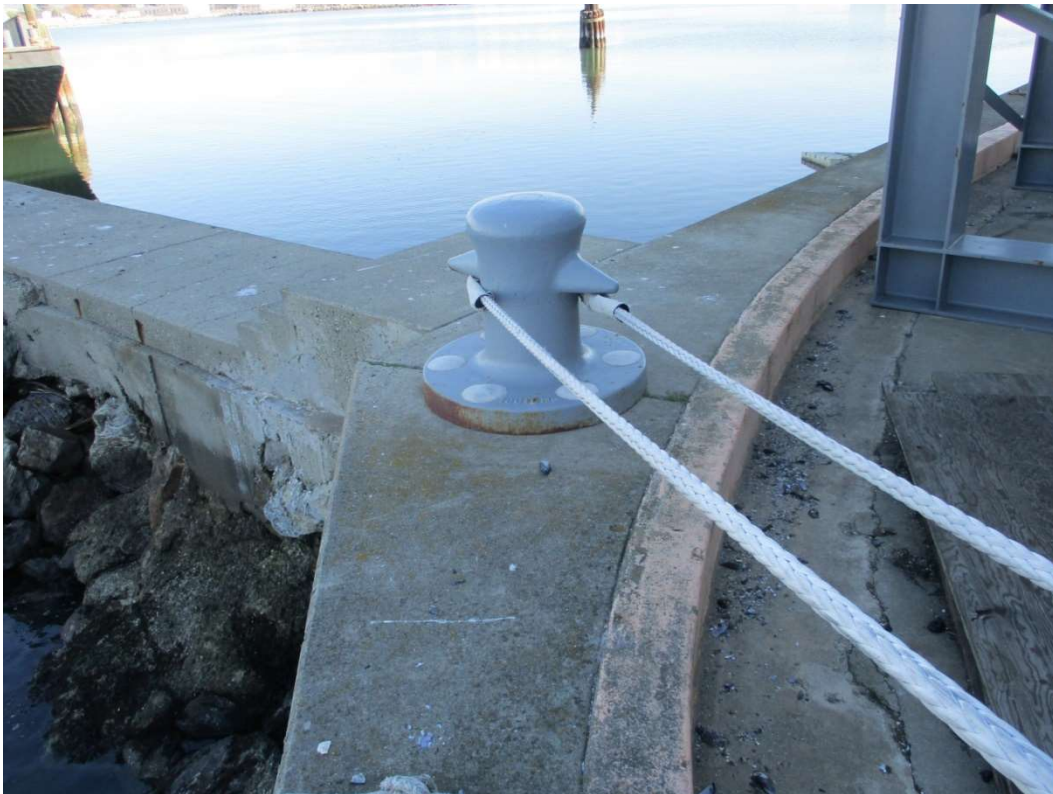
Photo 6 - Typical condition new mooring bollard at Pier 1

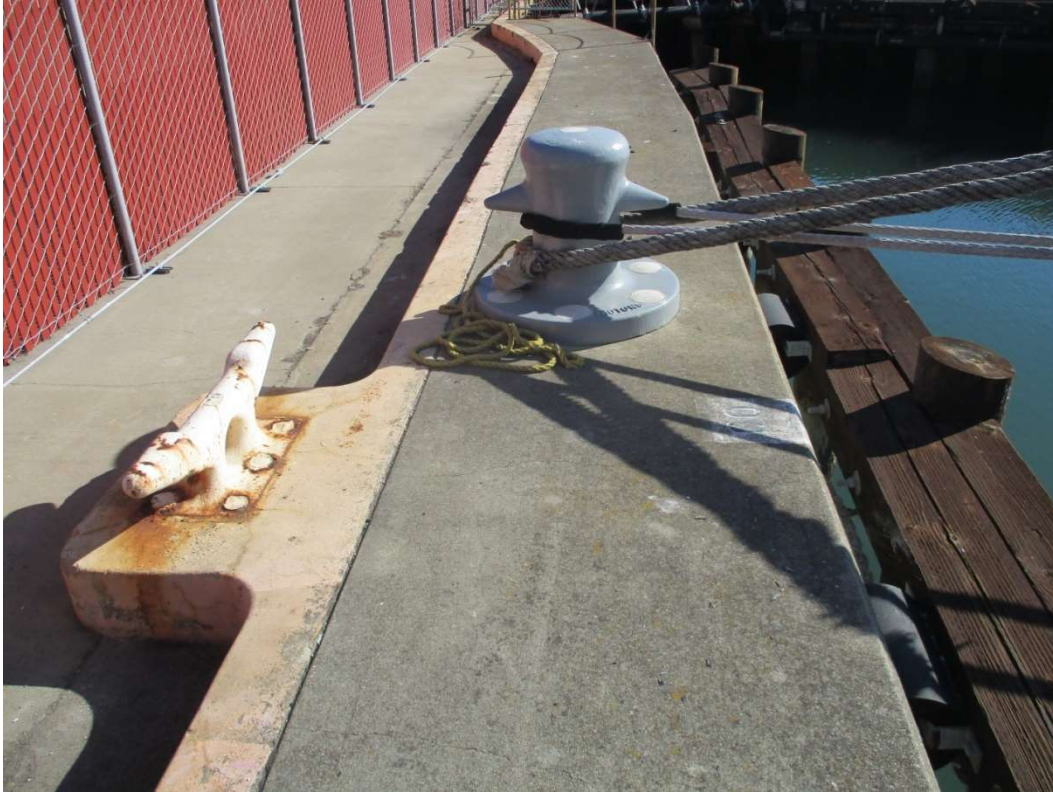
Photo 7 - Typical condition curb and new mooring bollard at Pier 1

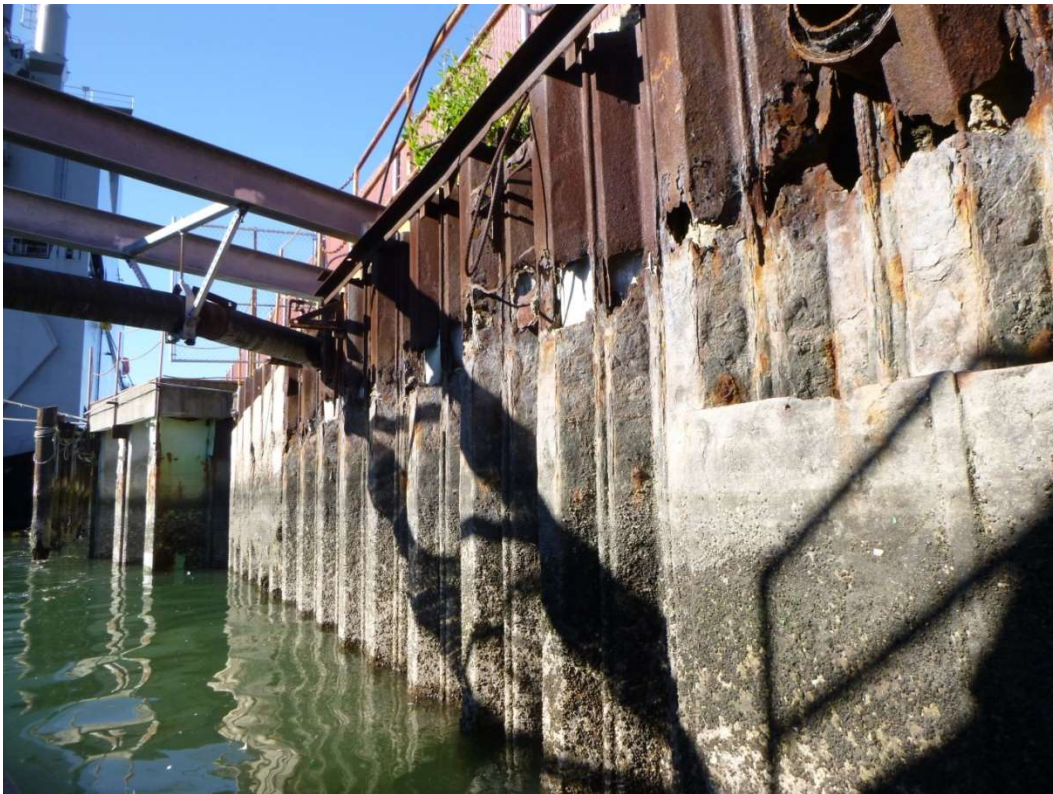
Photo 8 – Deteriorated sheet pile wall at Pier 1

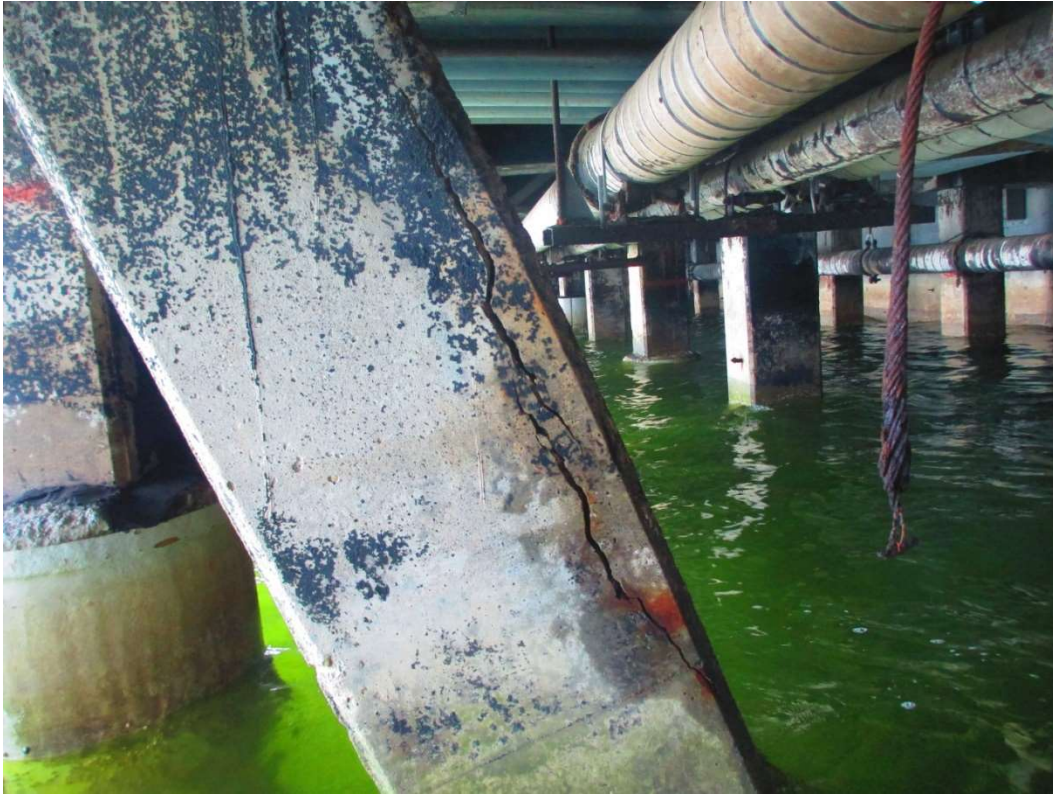
Photo 9 – Pile rated Major due to corrosion spalling at Pier 2

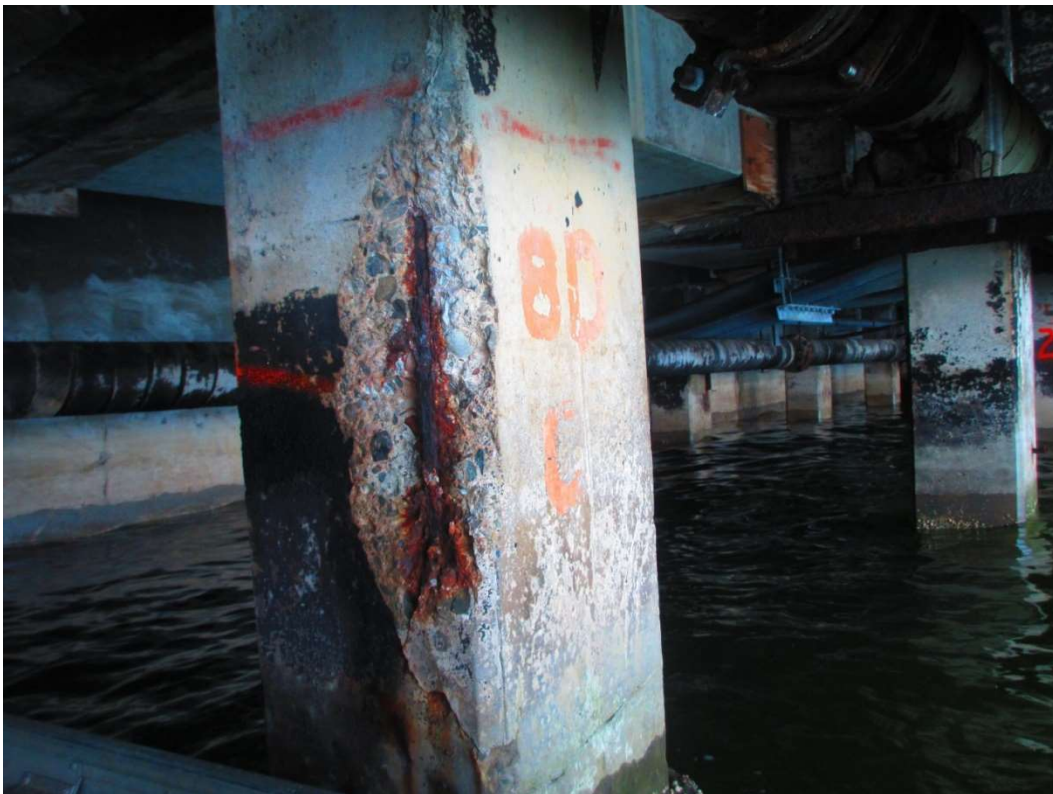
Photo 10 – Pile rated Severe due to corrosion spalling at Pier 2

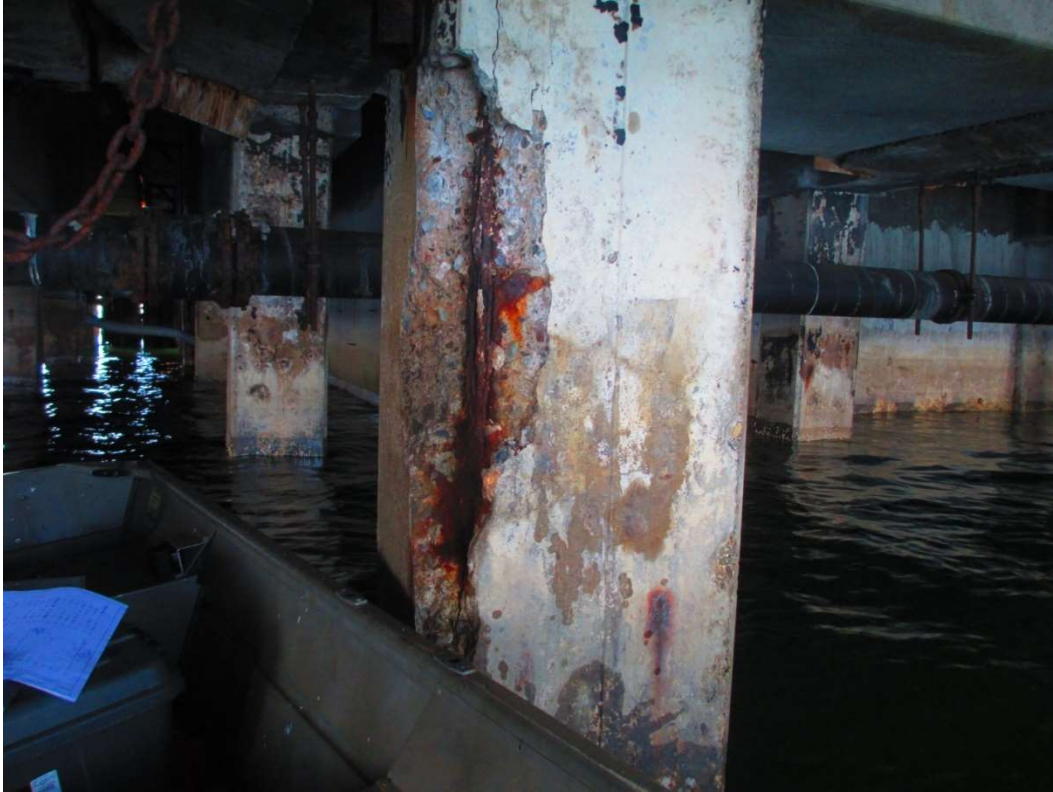
Photo 11 – Pile rated Severe due to corrosion spalling at Pier 2

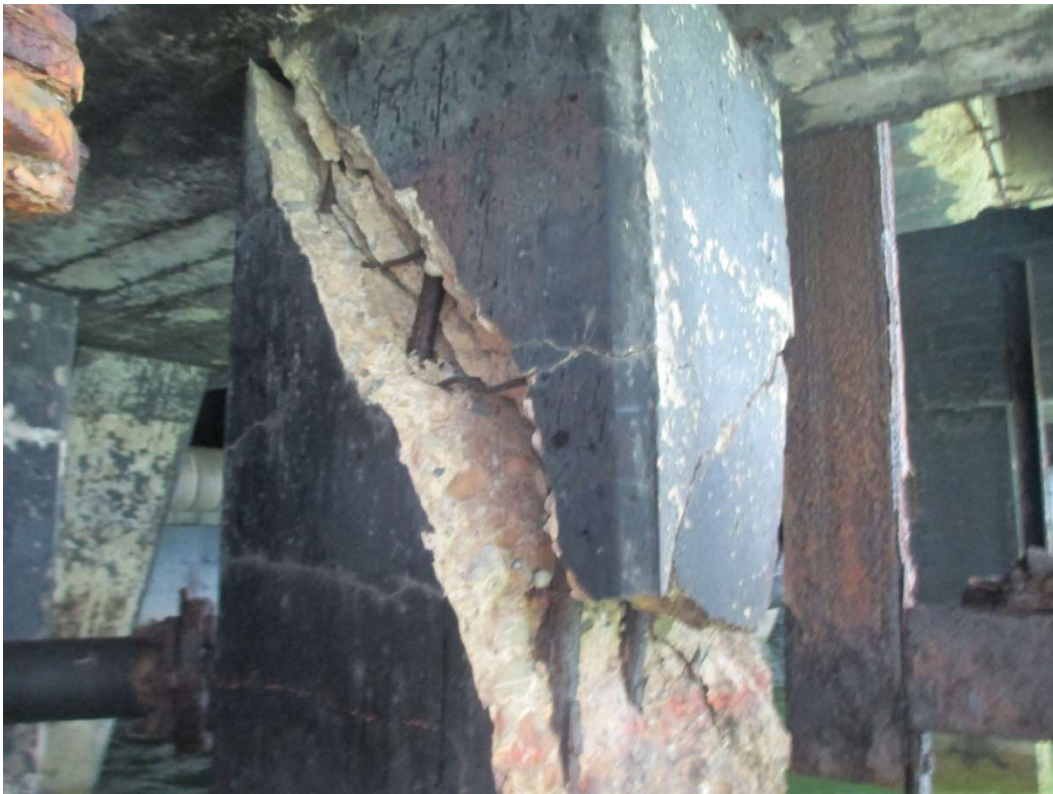
Photo 12 – Pile rated Severe due to impact damage at Pier 2

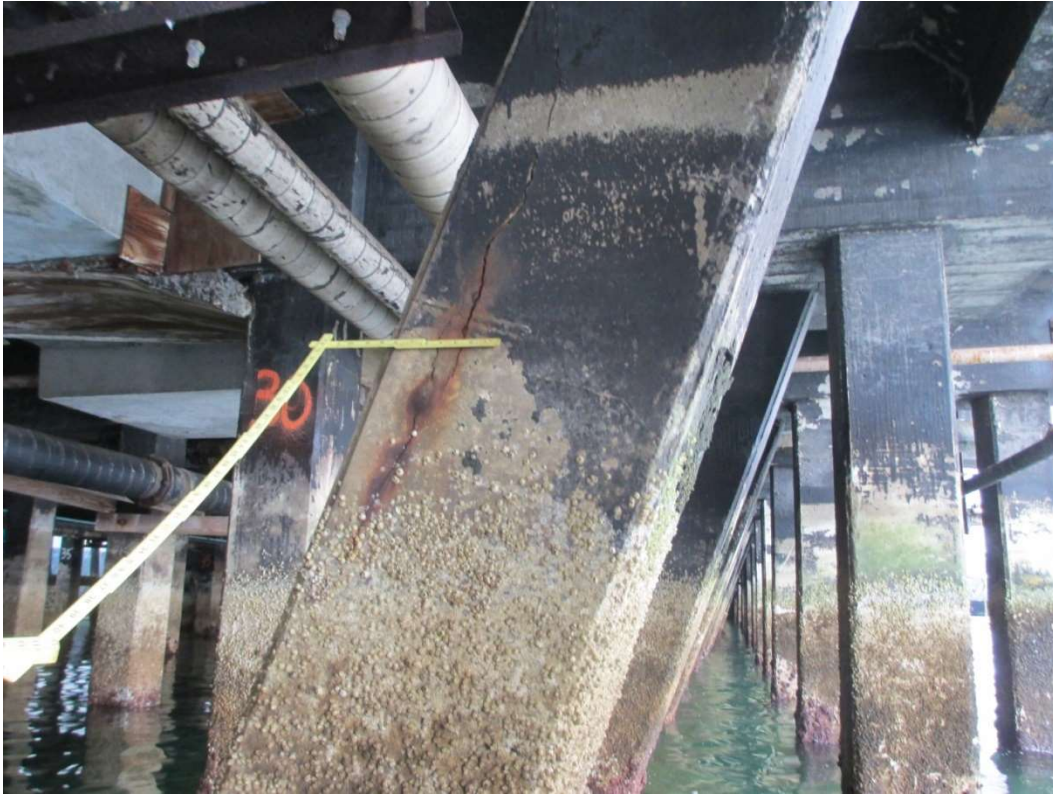
Photo 13 – Pile rated Major due to corrosion spalling at Pier 2

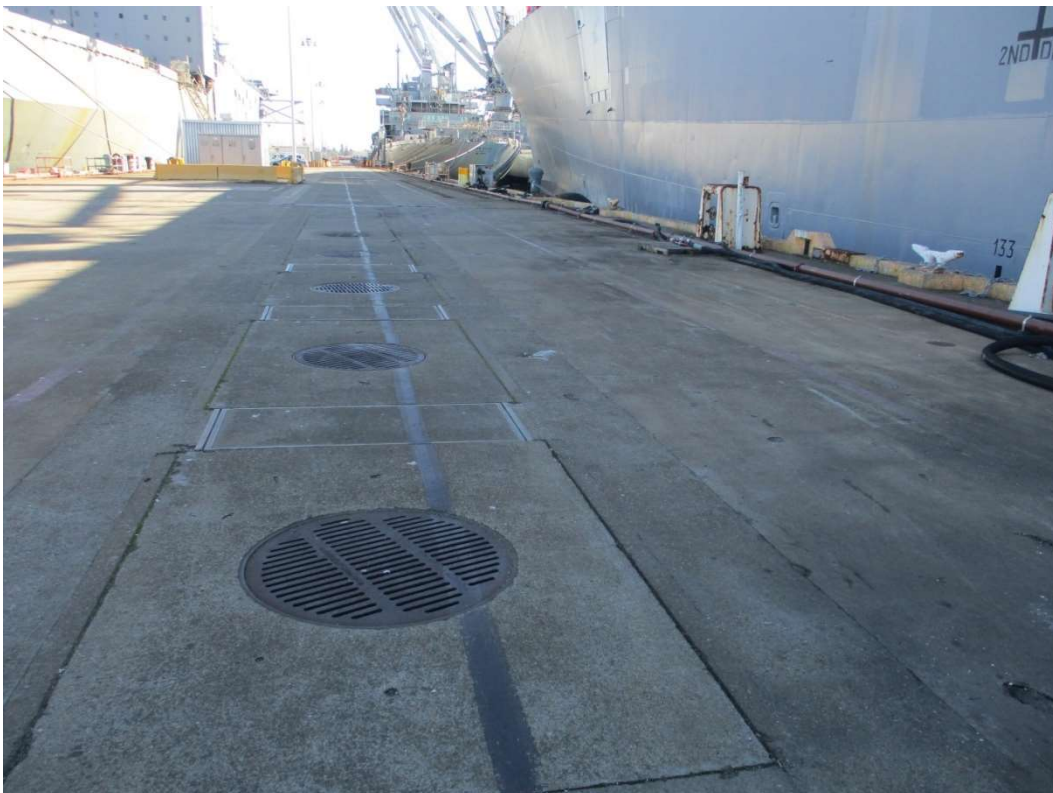
Photo 14 - Typical condition of deck at Pier 2

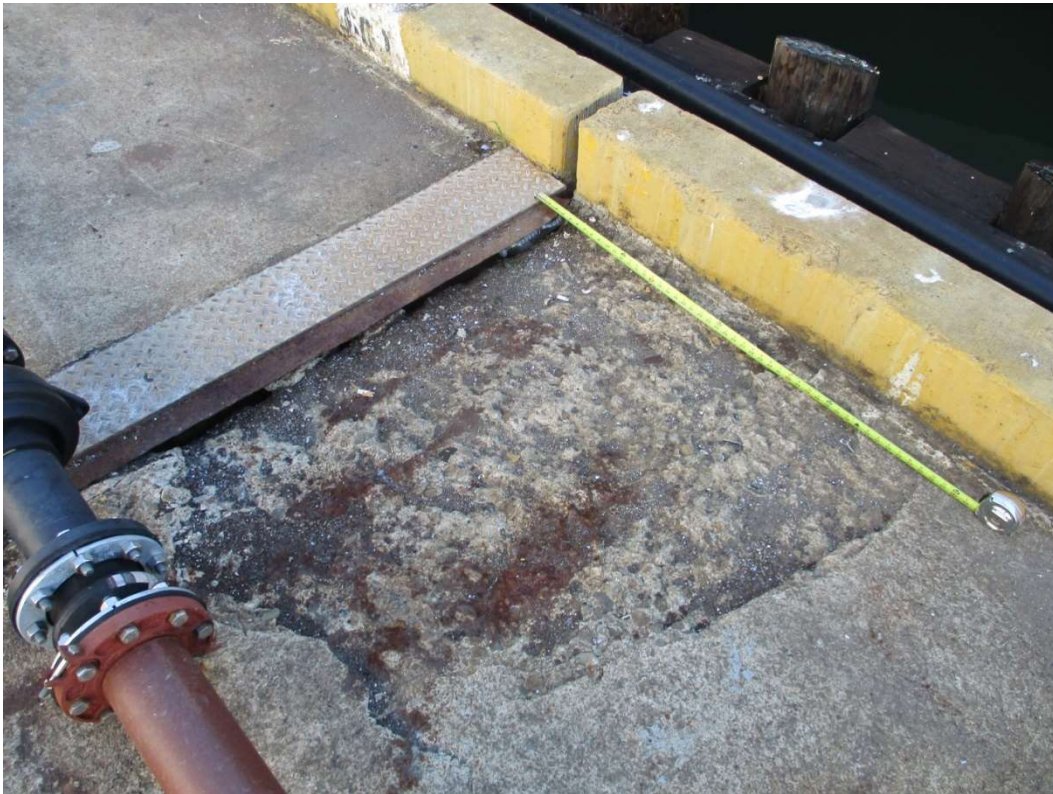
Photo 15 - Spalling of deck at expansion joint at Pier 2

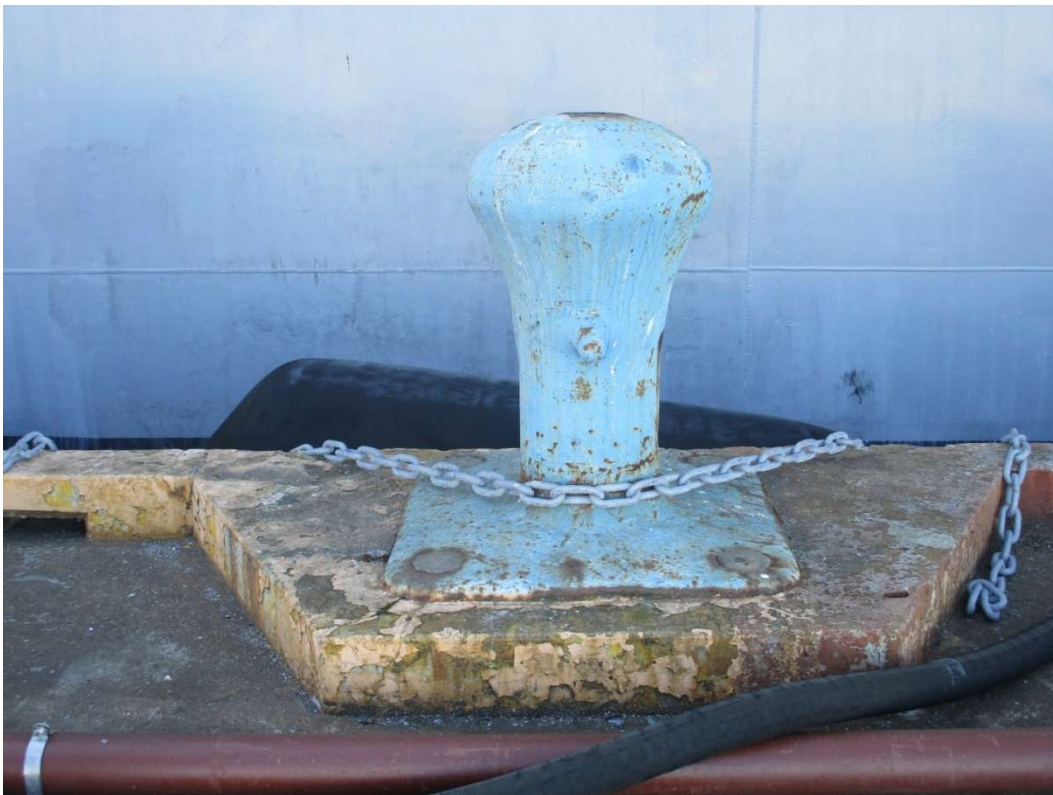
Photo 16 - Typical condition of mooring bollard and base at Pier 2

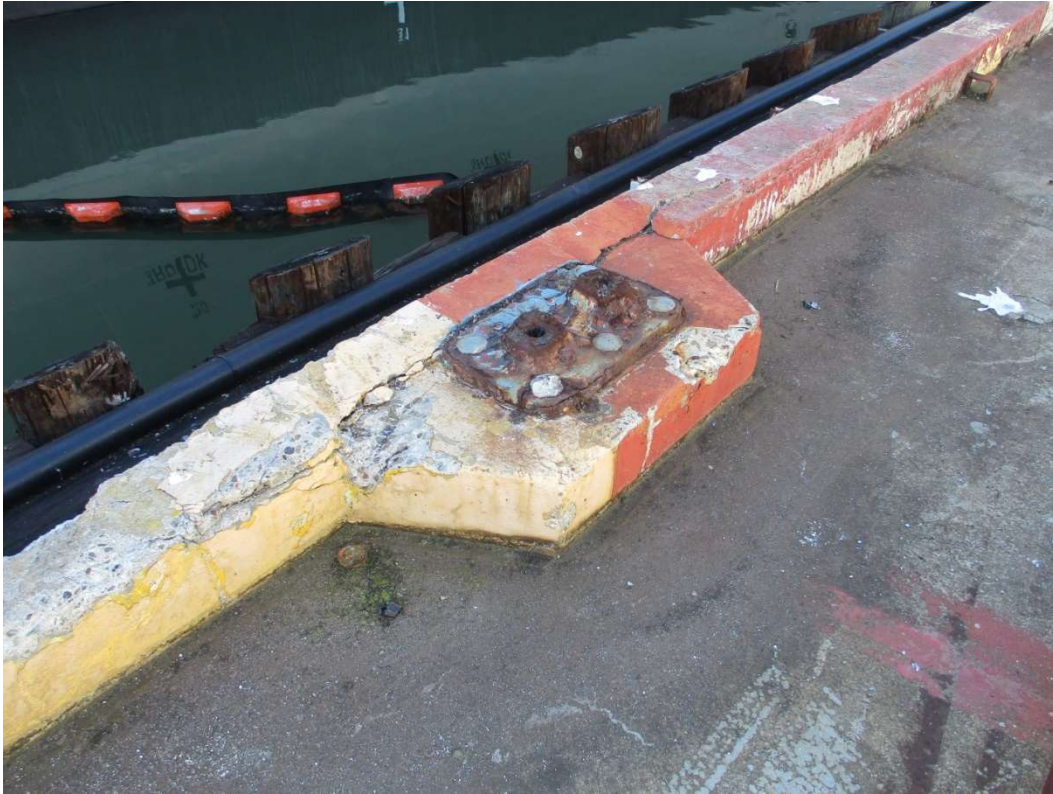
Photo 17 – Broken cleat at Pier 2

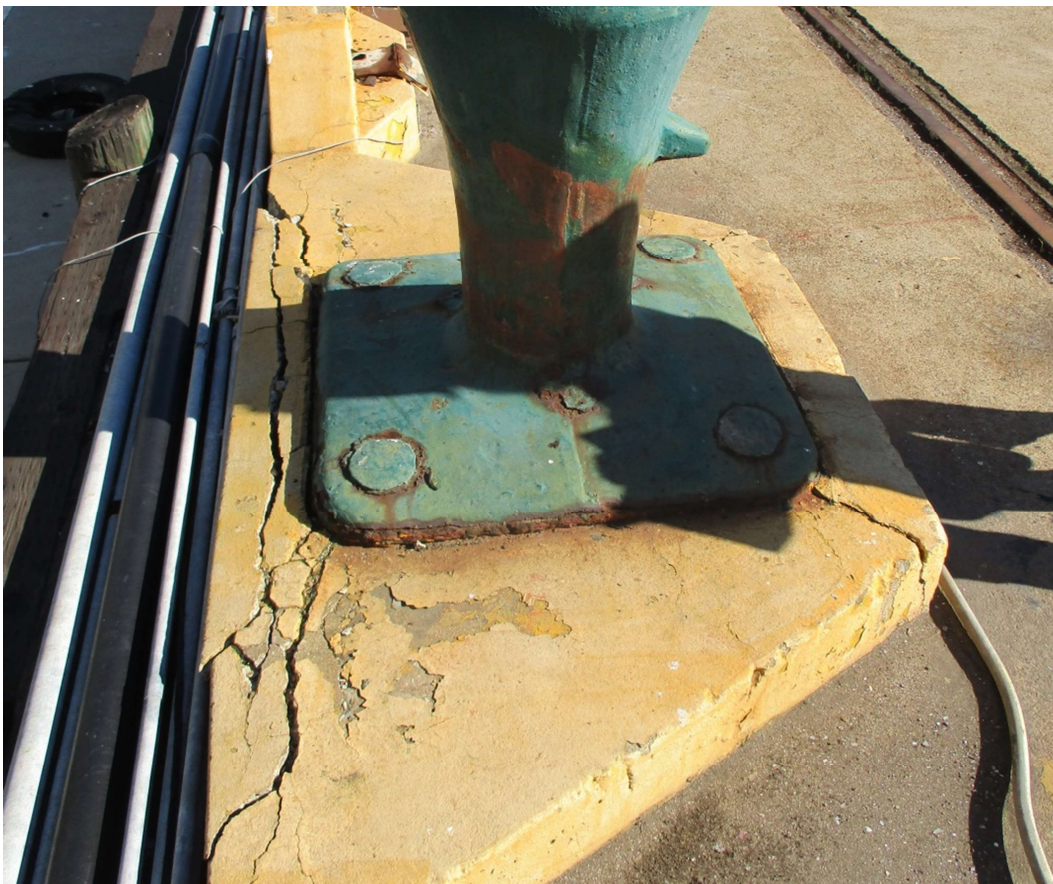
Photo 18 – Spalling in front of mooring bollard base at Pier 2

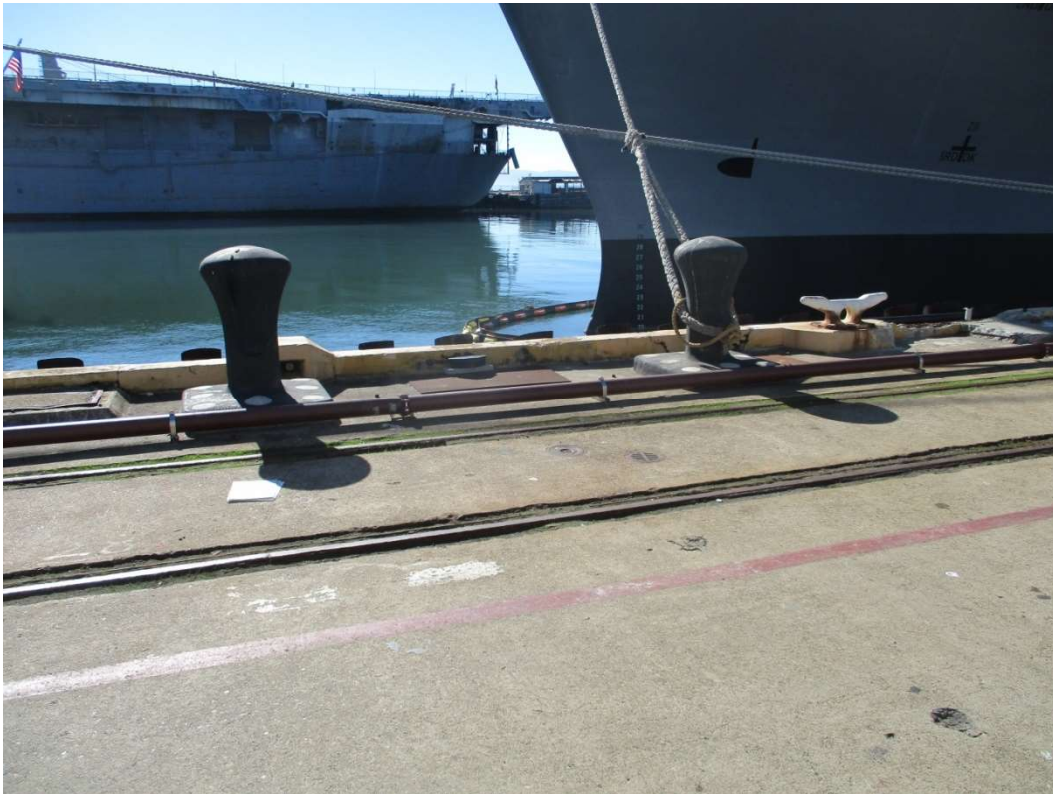
Photo 19 – New bollards at Pier 2

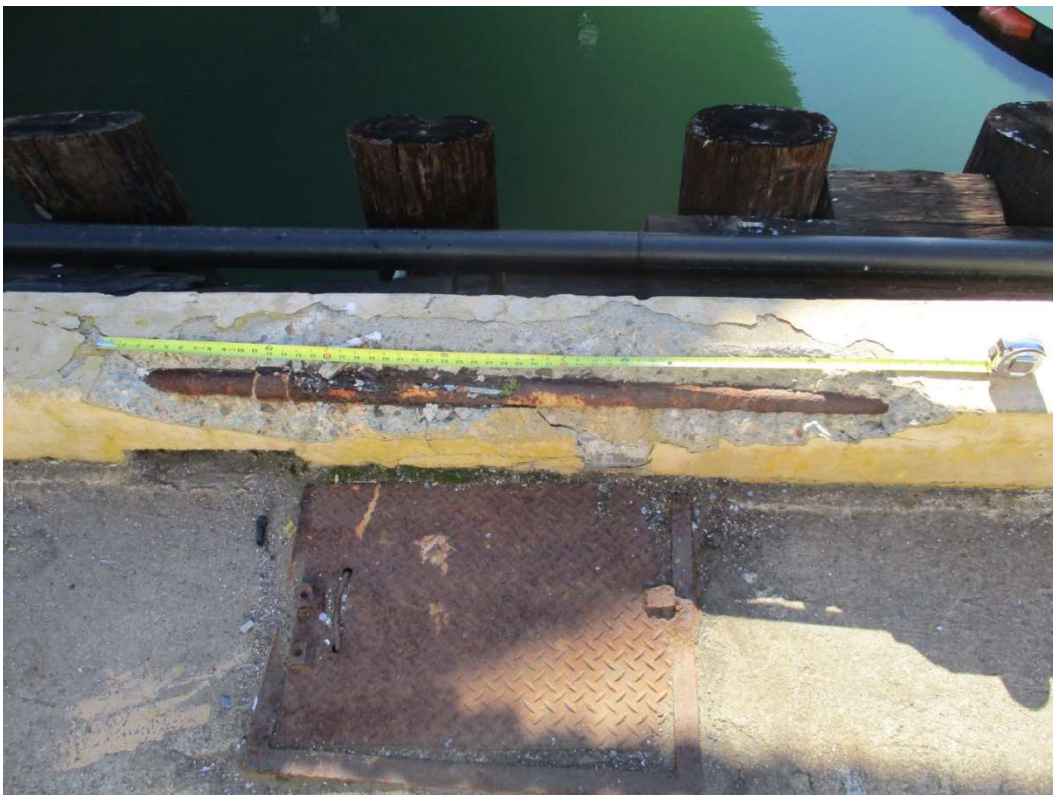
Photo 20 – Spalling of curb at Pier 2

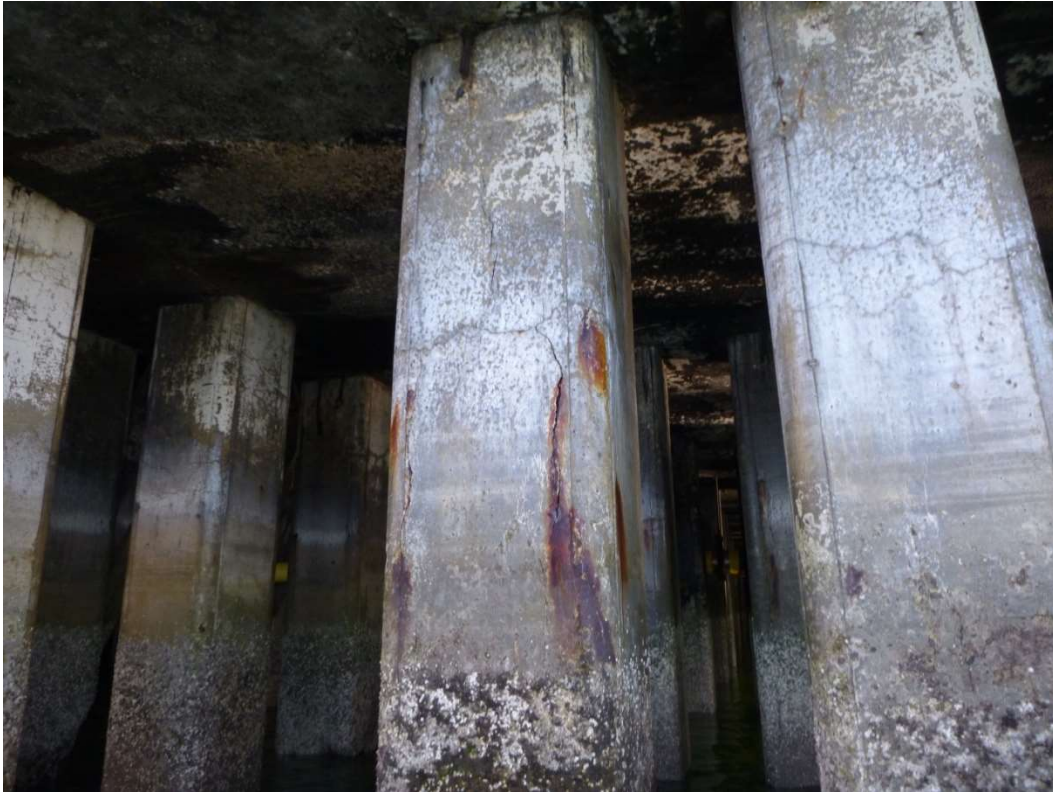
Photo 21 – Corrosion cracking of pile extension at Pier 3

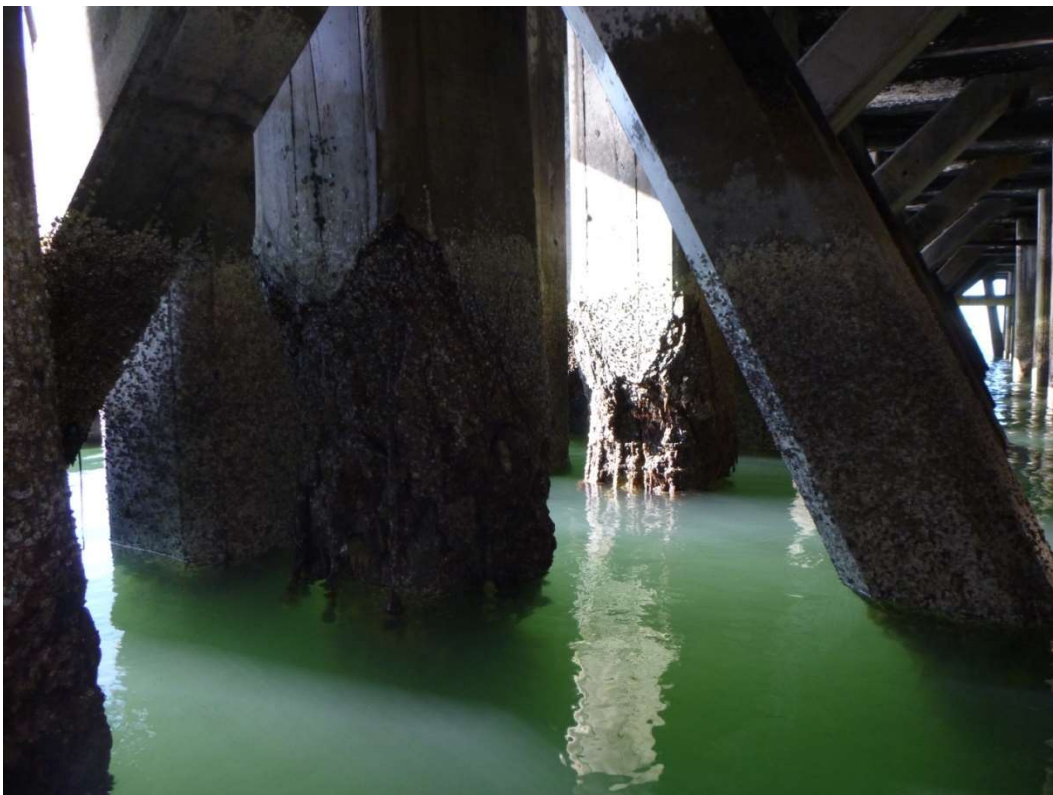
Photo 22 – Deterioration of lower part of pile extension at Pier 3

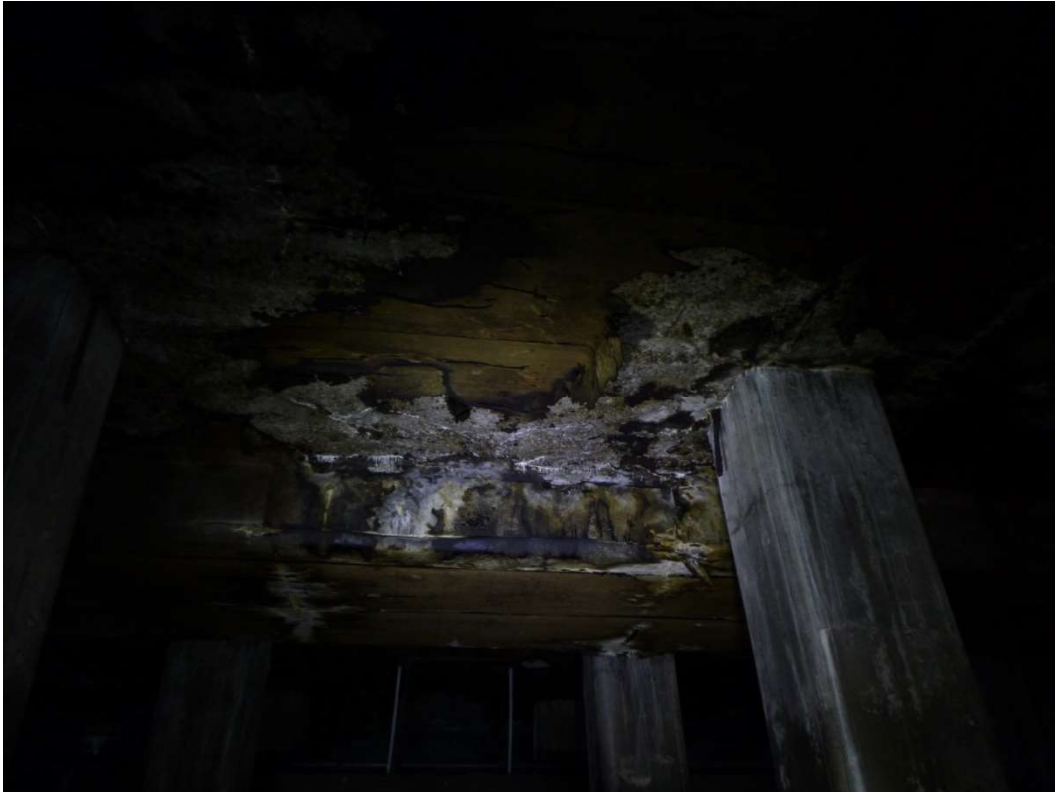
Photo 23 – Efflorescence at soffit of Pier 3

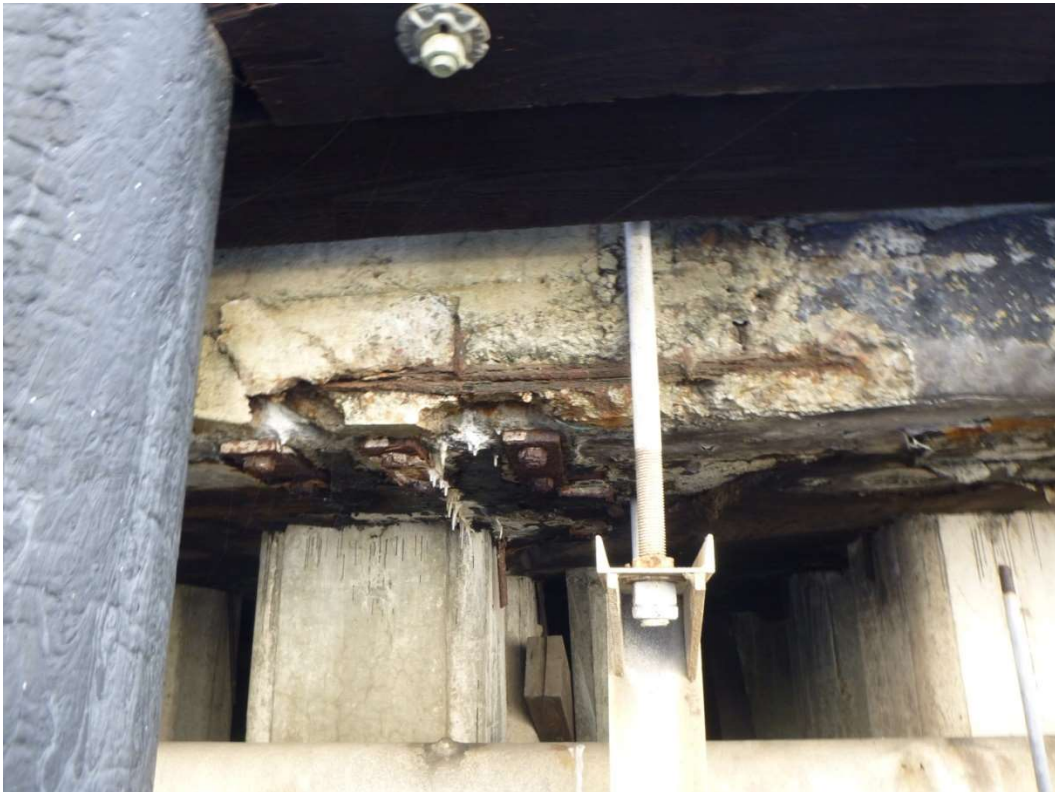
Photo 24 – Corrosion spalling of deck edge at Pier 3

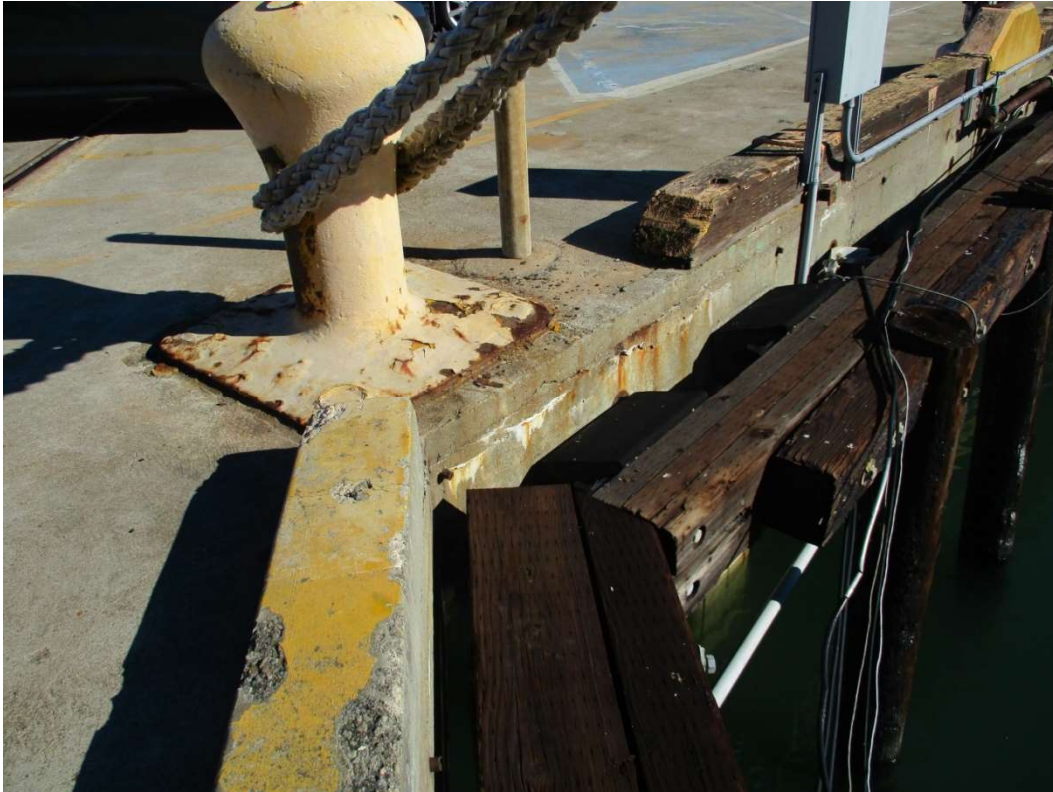
Photo 25 – Typical condition of mooring hardware at Pier 3

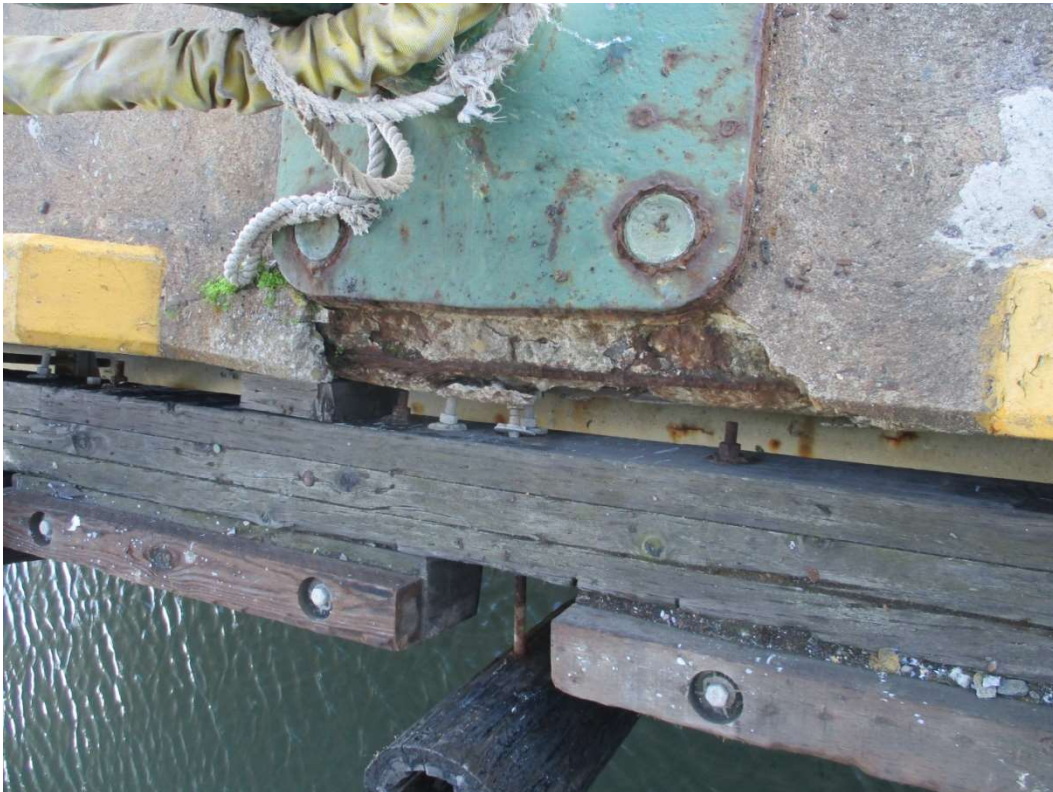
Photo 26 – Corrosion spalling of concrete at mooring hardware at Pier 3

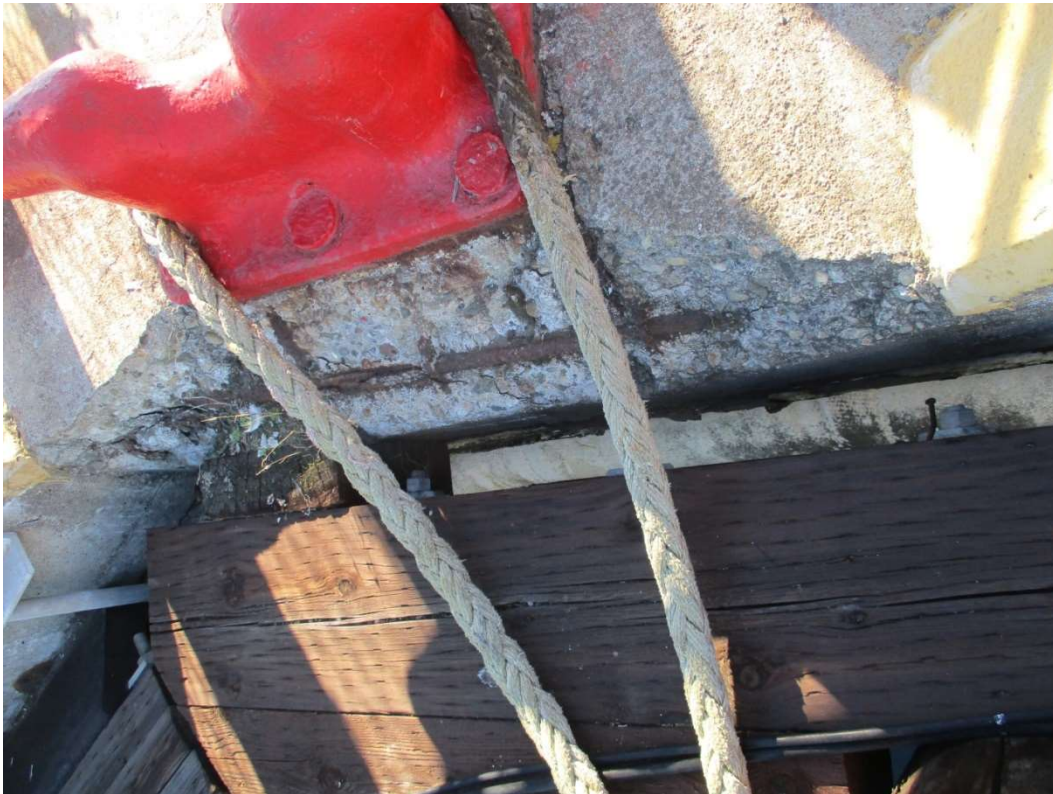
Photo 27 – Corrosion spalling of concrete at mooring hardware at Pier 3
