Summary Report
On Interim
Inspection,
Testing, and
Preliminary
Analysis of
Alameda Piers 1,
2, and 3

26 May 2017

SGH Project 167543

SIMPSON GUMPERTZ & HEGER

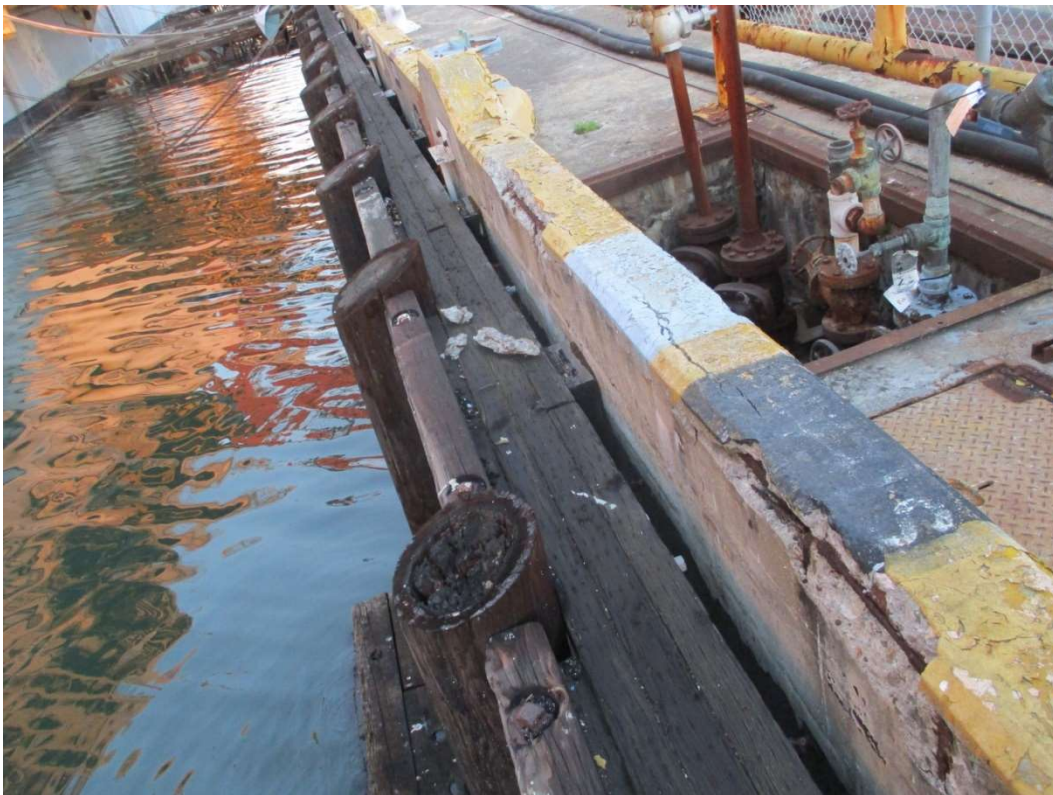
Photo 28 – Corrosion spalling of curb at Pier 3

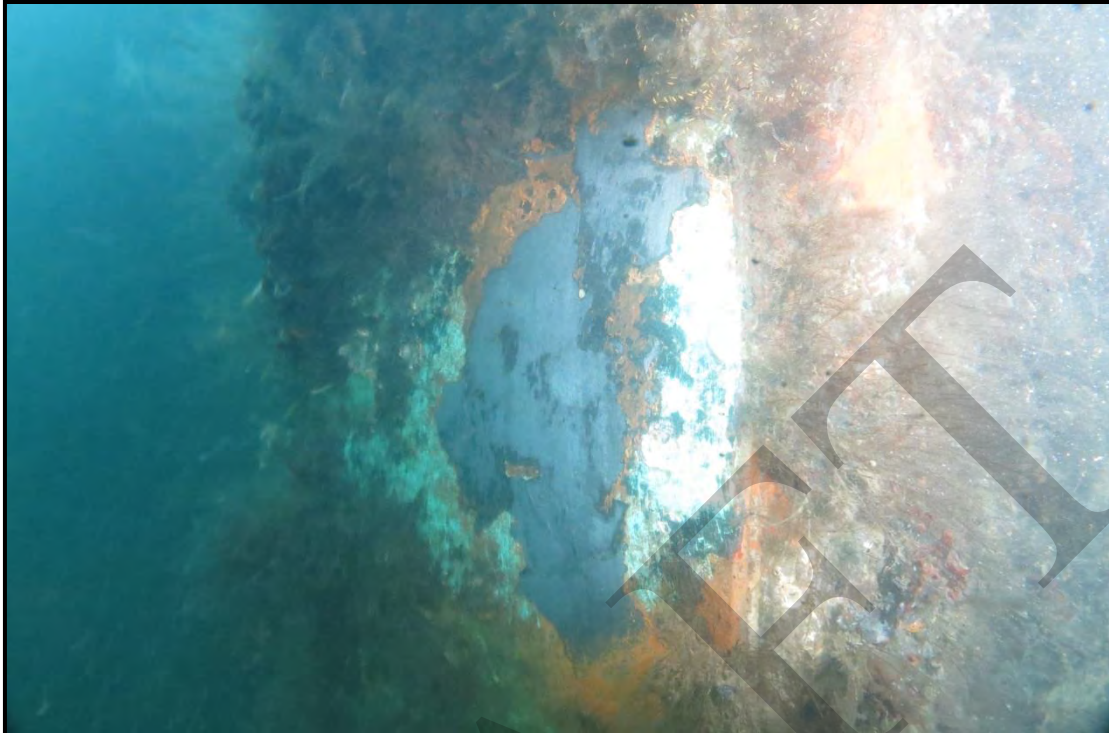
Photo 9: Coating loss and corrosion on steel king pile at Pier 1.

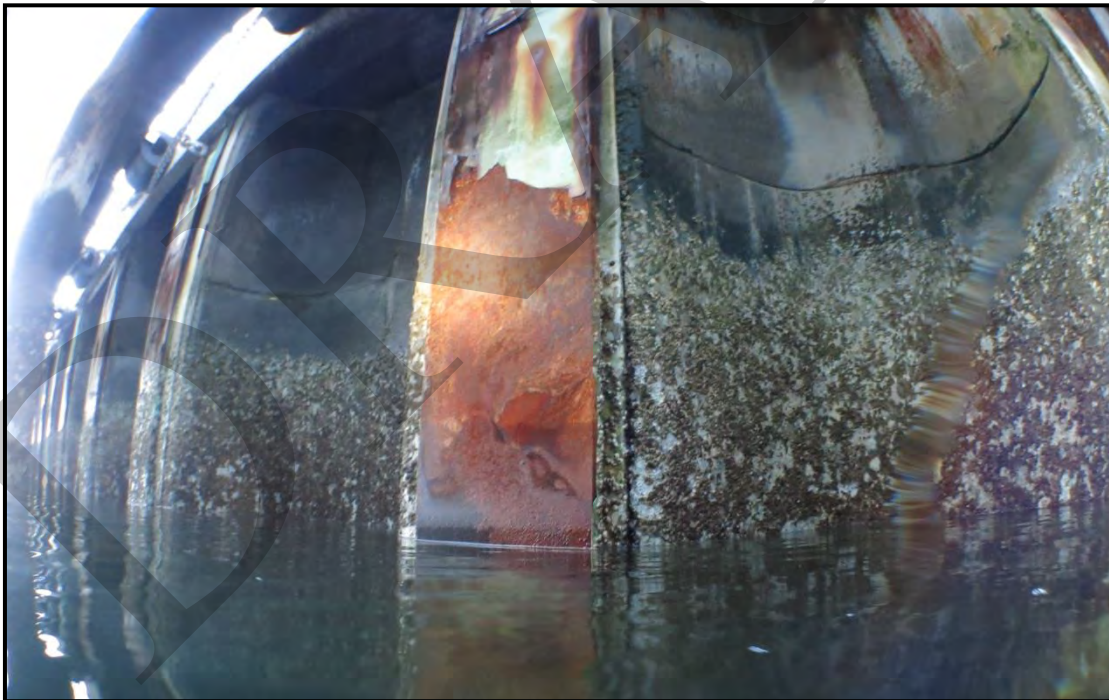
Photo 10: Coating loss and corrosion on steel king pile at Pier 1.

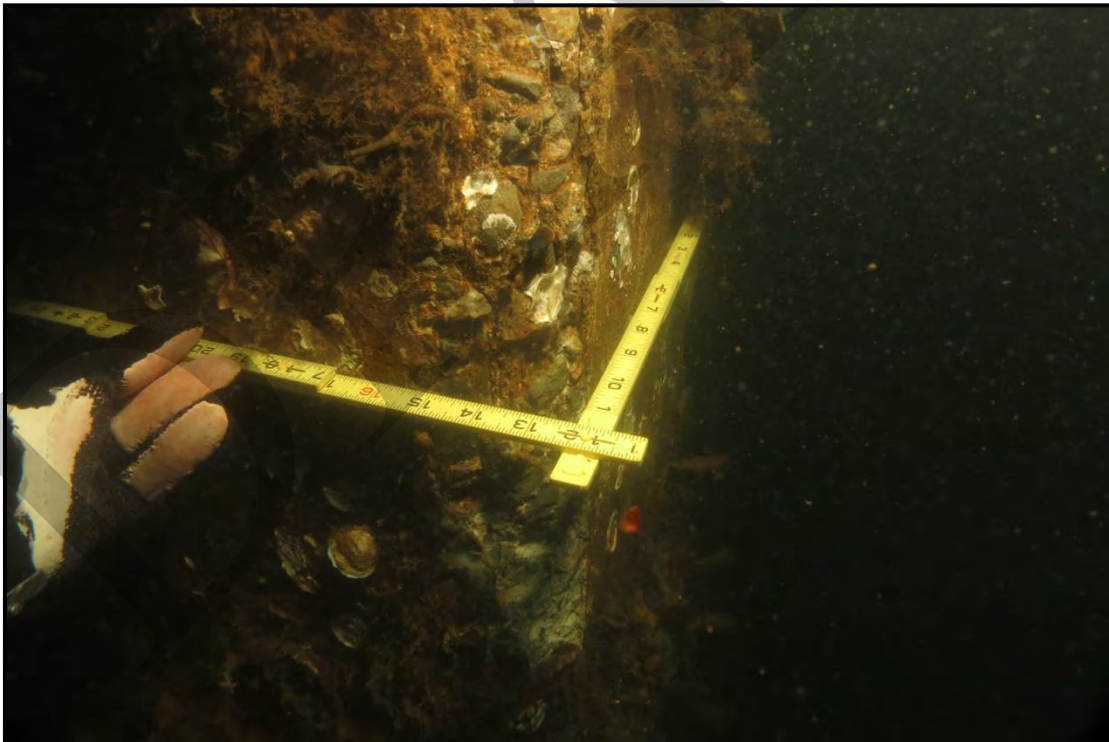
Photo 18: Minor rounding of corner due to chemical deterioration.

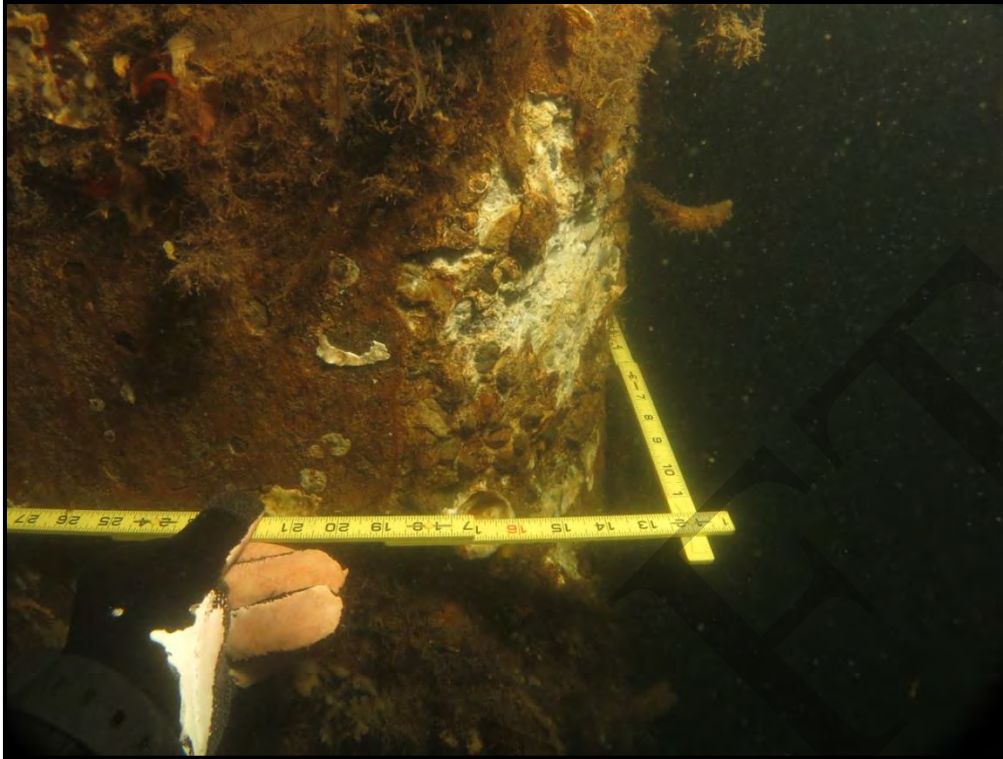
Photo 19: Major rounding of corner due to chemical deterioration.

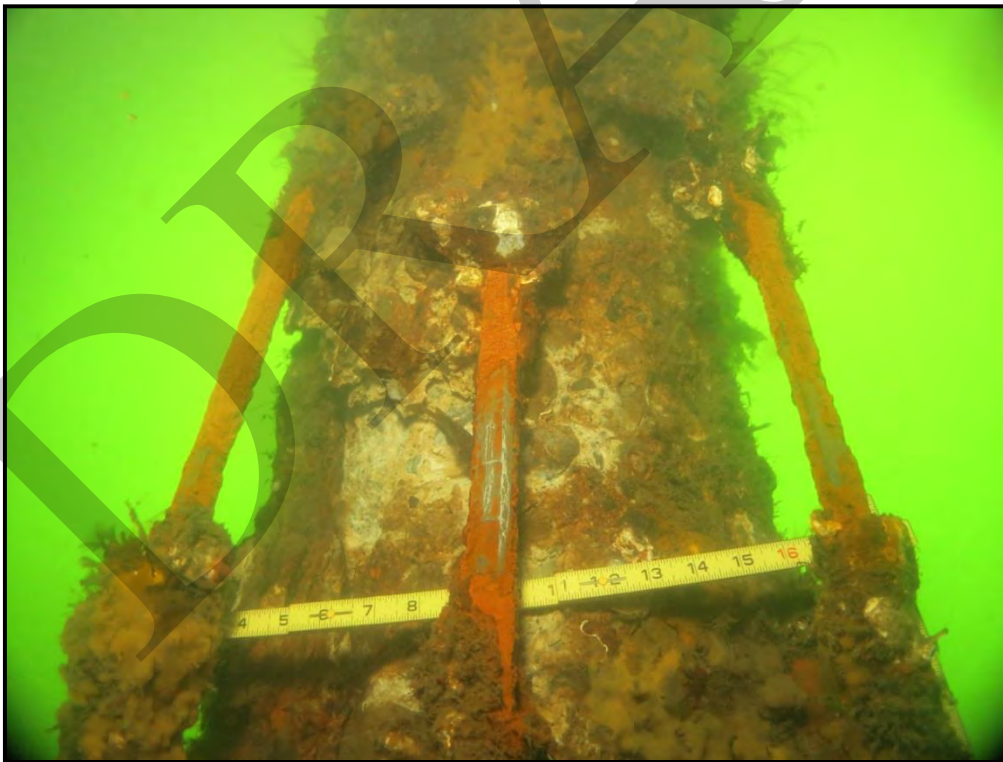
Photo 20: Severe loss of concrete section due to chemical deterioration with exposed reinforcing.

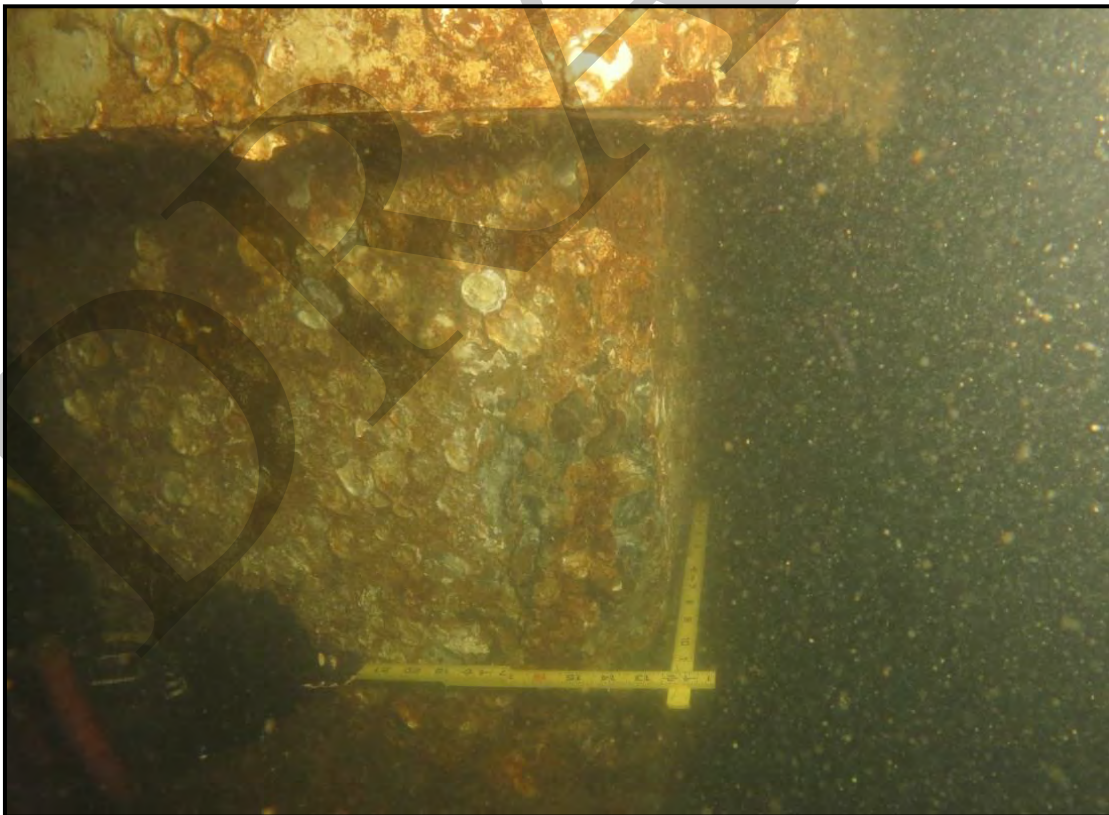
Photo 22: Deterioration of original concrete pile exposed below encasement repair.
