Project Results: Inspection, Testing, Analyses, and Reporting Services, Alameda Point Piers 1, 2, & 3

January - 2018

Overall Summary

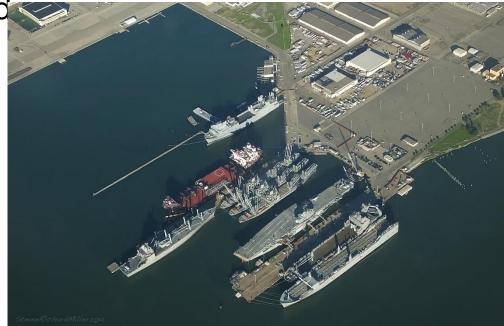
- Piers 1 and 3 Satisfactory are in Satisfactory condition and meet MARAD structural requirements
- Pier 2 Poor
 - Primary Damage Source Identified:
 - Chemical deterioration Widespread deterioration at end of original Pier 2
 - Damage in tidal zone and below

- Repairable

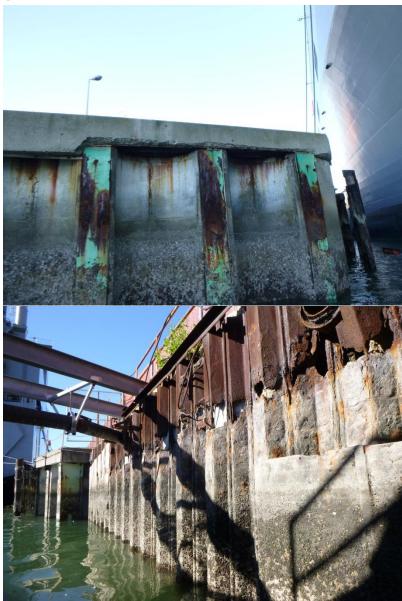
- Pier 1 Overall Satisfactory Condition
 - Moderate corrosion on king piles
 - Concrete panels in Fair condition
 - Sheet pile bulkhead localized area near wharf apron in Poor condition
 - Mooring hardware and curbs in Fair Condition

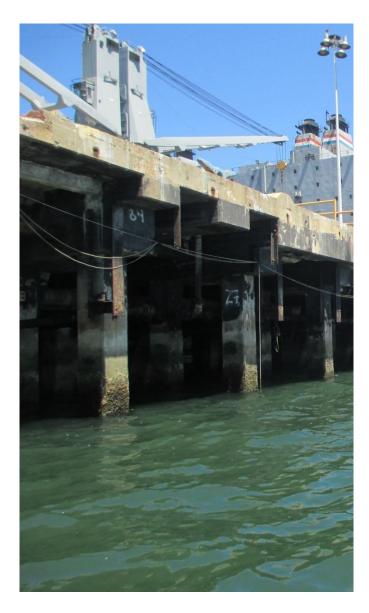
- Pier 2 Overall Poor Condition
- 1136 piles inspected:
 - Minor/No Damage 479
 - Moderate 304
 - Major 90
 - Severe 263
- Widespread pile damage
 - Damaged concentrated at end of original pier
 - Damage in tidal zone and below

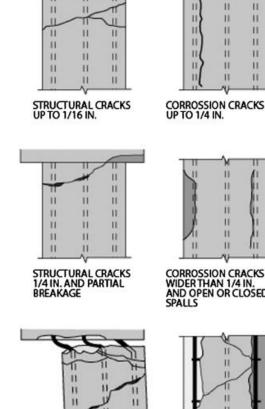
- **Moderate**
 - Rounding of corners
 - Light cracking
- Major

CHEMICAL DETERIORATION CRACKS UP TO 1/16 IN; ROUNDING OF CORNERS

MULTIPLE CRACKS AND DISINTEGRATION DUE TO CHEMICAL DETERIORATION

LOSS OF CONCRETE COVER (EXPOSED STEEL) DUE TO CHEMICAL DETERIORATION

Note: Severe is a very broad category; Exposed rebar to missing pile!

- More advanced damage Spalls/Cracking
- Severe
- Exposed rebar

- SEVERE
- Significant concrete loss

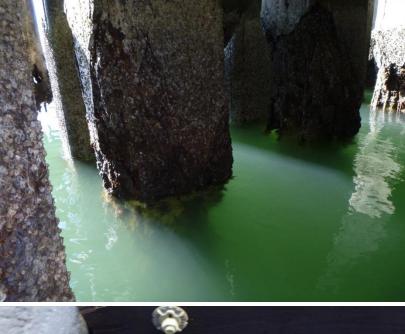
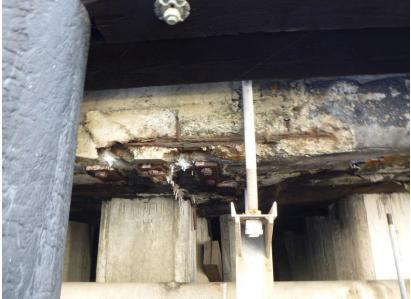
- Pier 3 Overall Satisfactory Condition
 - 500 piles inspected above water (Major/Severe: 29 piles)
 - Deck and soffit in Satisfactory condition
 - Some corrosion spalling at edge of deck
- Deck
 - Satisfactory condition
 - Curbs deteriorated from corrosion and impact (cosmetic)
