# TECHNICAL MEMORANDUM

**Subject:** Alameda Shipways Project

1150 Marina Village Parkway / Alameda CA 94501

Shoreline Engineering

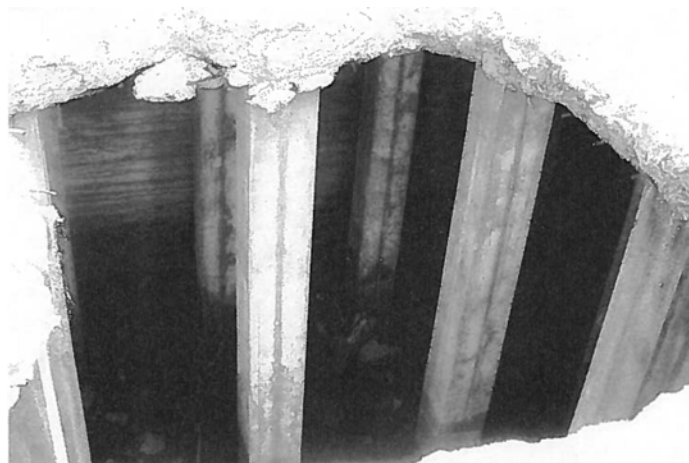
Figure 4 – View of Existing Support Structure under Shipway Slab

Below the headhouses and the upper portion of the shipways, the timber piles extended some distance above the original marsh deposits and terminated in 16- to 24-inch thick concrete grade beams. Above the grade beams are concrete columns that vary in length that support the sloping 12-inch thick concrete deck slab, with a thickened slab below the center of the shipway where the ship weight was concentrated (see Figure 4).

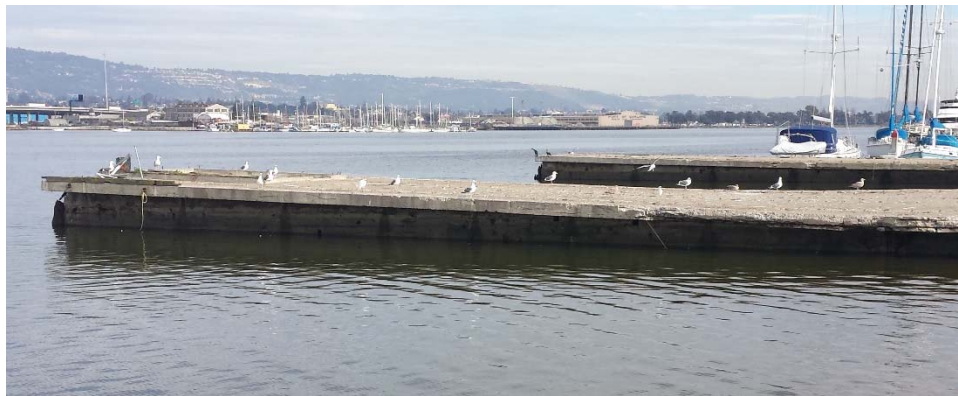
Based on visual inspection of the readily accessible portions of the structures, the structures are generally in poor condition and are not expected to meet current static or seismic loading criteria. The concrete structures show extensive cracking and spalling of the deck, perimeter walls, and support columns. The craneways show signs of moderate to severe amounts of distress and the decks have sagged in several areas. The shipways show widespread deck damage and significant cracking of the exterior walls and columns. The lower (waterside) portions are cracked and some areas show the ravages of differential settlement. A 2001 investigation of the exposed portions of the piles in the crawl space reported serious deterioration in many piles (loss of section and contact with the concrete pile caps) due to borer damage, bacteria, and fungi<sup>2</sup>. Piles were also found to have lost support due to settlement of the pile itself.

Figure 5 – Craneway 5 (foreground) and Craneway 6 (background).  
Note: Both craneways show severe deterioration due to foundation settlement

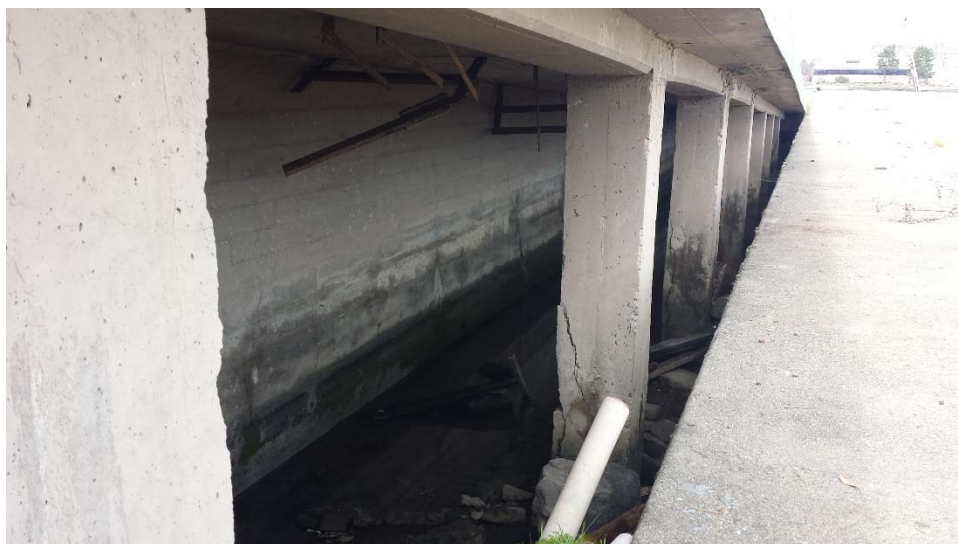
Figure 6 – Shipway (left) and Craneway (right).  
Note: Shipway columns show severe cracking.

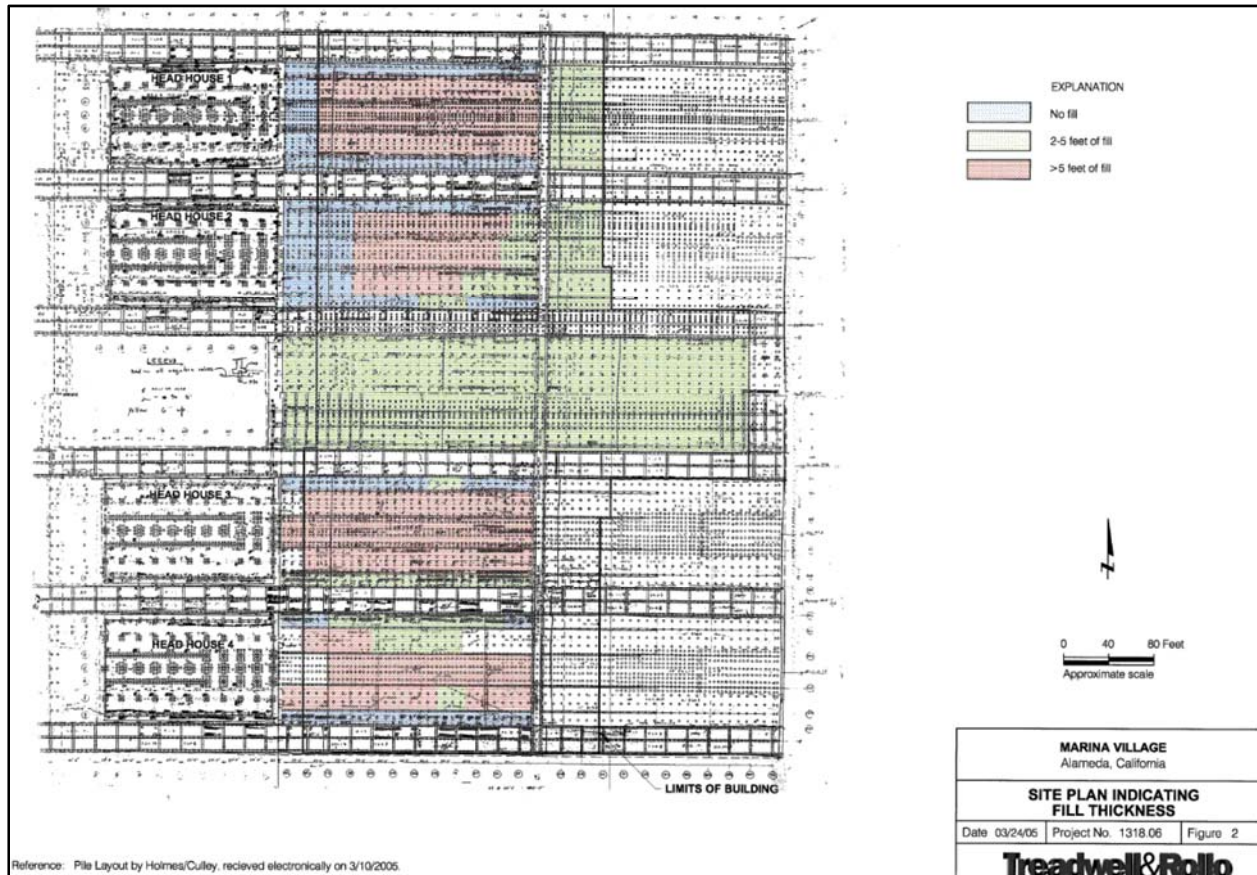
Figure 7 – Pile Layout and Fill Thickness Plan<sup>3</sup>

In the mid 1980's, numerous holes were cut through the deck of each shipway ramp and portions of the welding slab and craneways, and about 15,000 cubic yards of dredged material from nearby marinas was pumped to partially fill the crawl space between the slabs and the ground surface (see Figure 7).

A subsequent geotechnical report notes that on-going bay mud consolidation and settlement appears to have been exacerbated by the dredge material fill due to the increased weight of the dredged material on the compressible Bay Mud. A geotechnical report in 2001 indicated that ongoing consolidation will result in future settlement of 8 to 16 inches over 50 years for the existing structures<sup>4</sup>.
