“Birth” Sculpture

Conservation Assessment and Recommendations

Prepared for
Amanda Gehrke
Economic Development
City of Alameda
Community Development Department

July 30, 2020

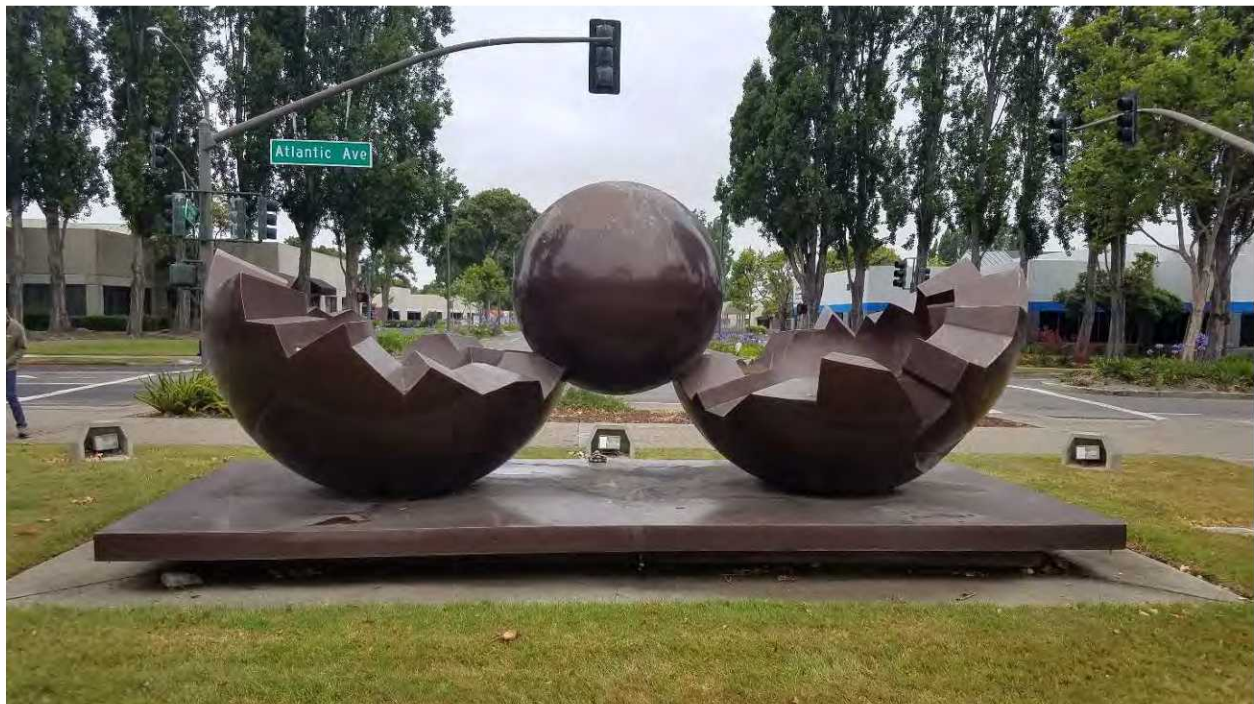
"Birth" Sculpture Southeast Elevation

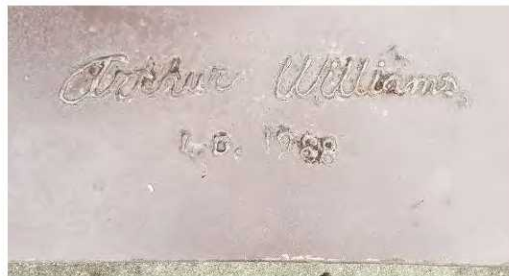
Inscriptions: On east corner, "Arthur Williams L.D. [?] 1988" written in cursive in welding rod.

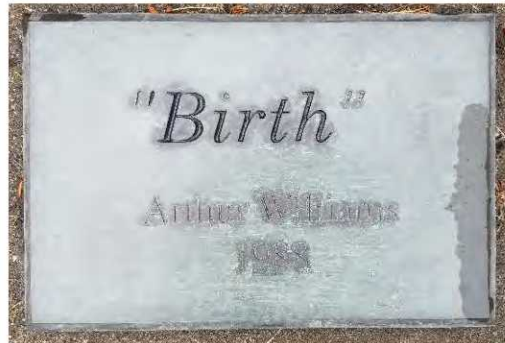
Plaque: Set on the concrete slab centered in front of the northwest elevation, "Birth" Arthur Williams 1988"
