# APPENDIX

# APPENDIX A

## A - FACILITY ASSESSMENT CONDITION FORMS

The City of Alameda has requested a structural assessment of Alameda Fire Station No. 1. This report represents the results of an ASCE 41 seismic assessment and general structural condition review of the building. Alameda Fire Station No. 1 is located at 2401 Encinal Avenue, Alameda, California. The fire station consists of a single-story apparatus bay and an office and dormitory wing with both one-story and two-story portions initially constructed in 1968. The team was not provided with any data or information regarding pending or past modernizations or retrofits for this building.

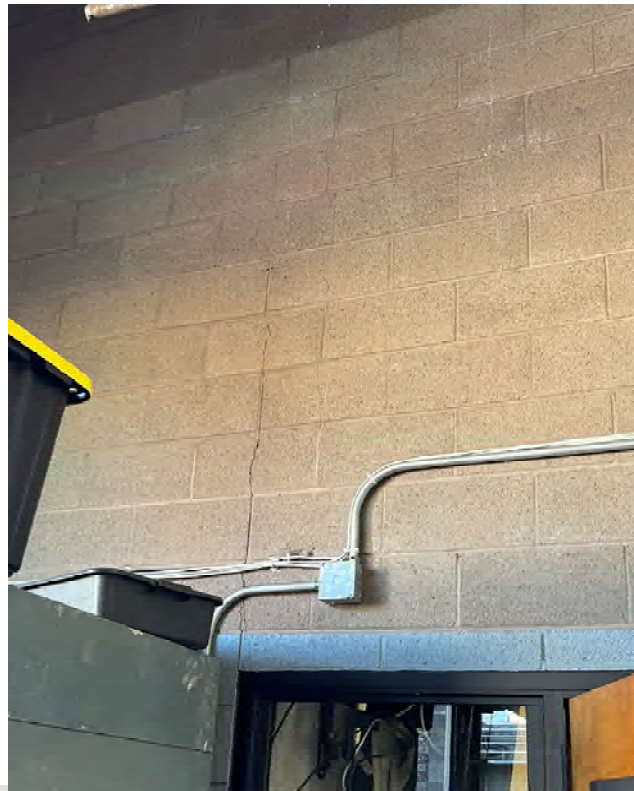
**Photo 7: Interior of Apparatus Bay – Cracks in CMU Wall Openings**

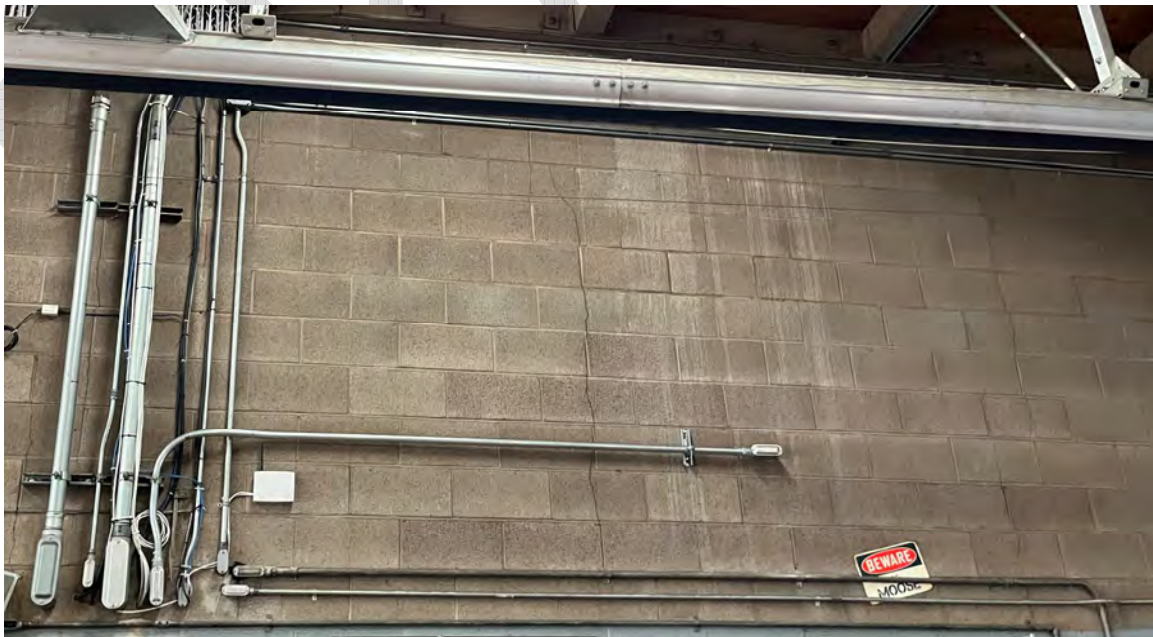
**Photo 8: Interior of Apparatus Bay – Cracks in CMU Wall**

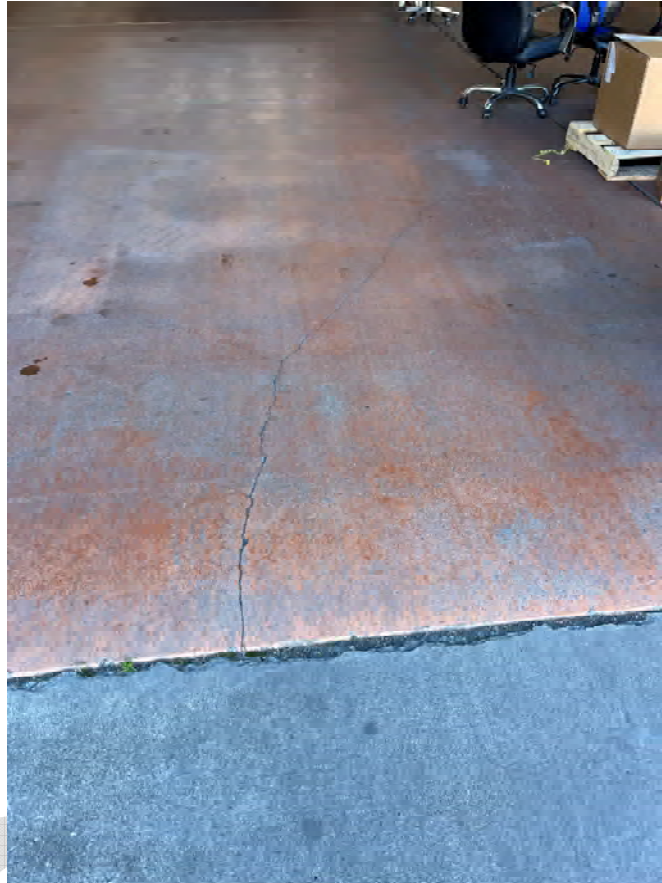
**Photo 9: Cracking in Main Apparatus Bay Slab**

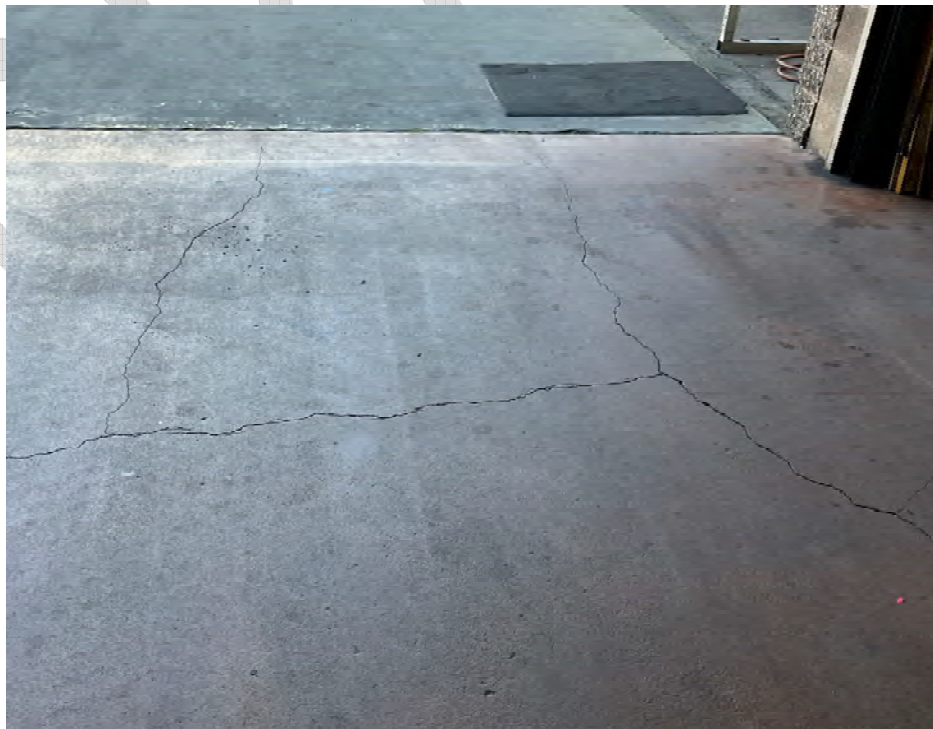
**Photo 10: Cracking in Main Apparatus Bay Slab**

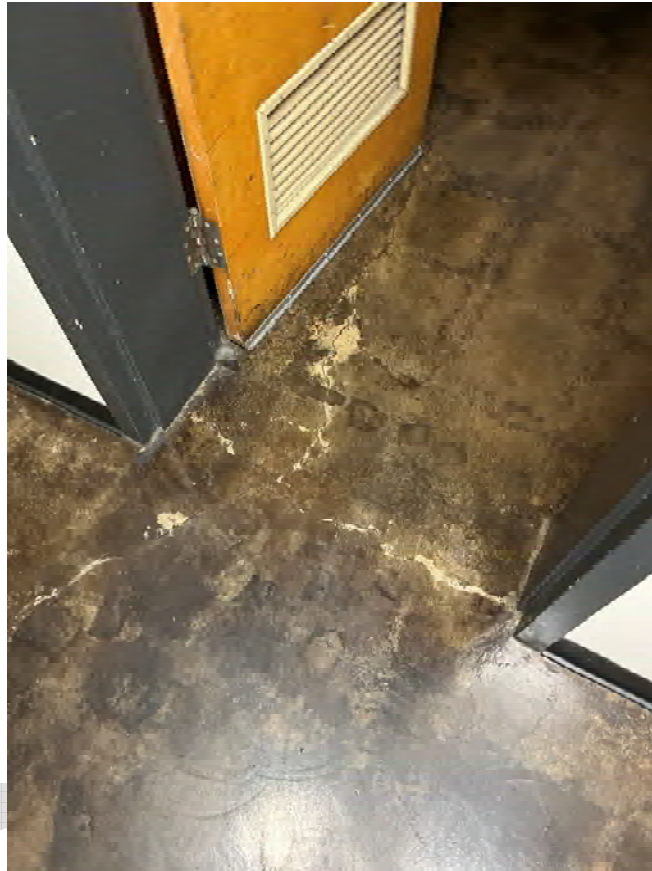
**Photo 11: Cracking in Main Apparatus Bay Slab**

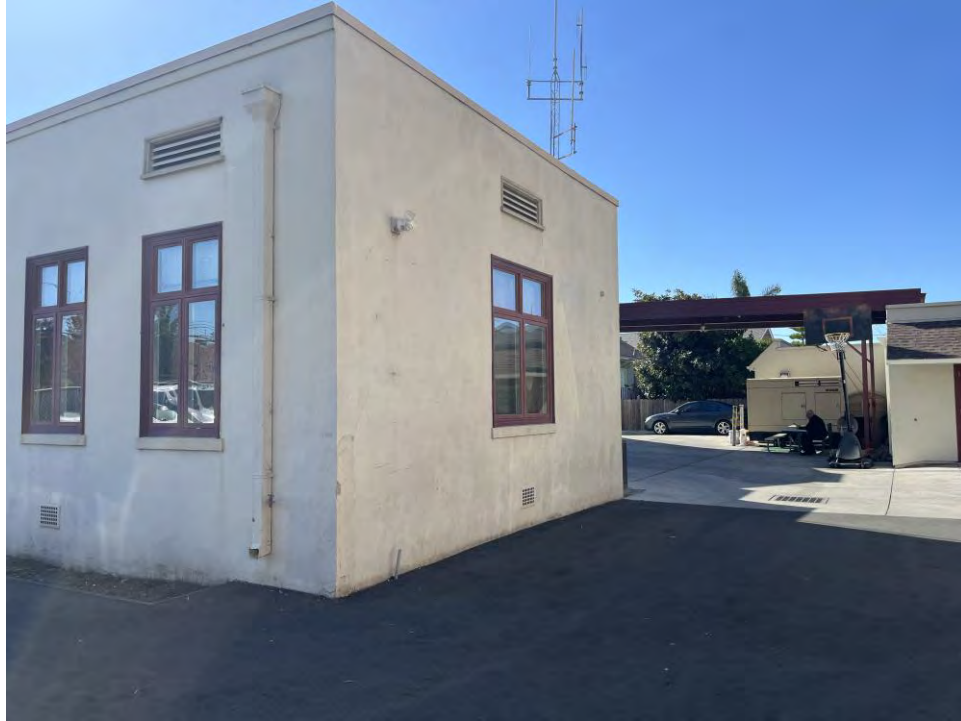
**Photo 11: Minor Chipping at Exterior Stucco**

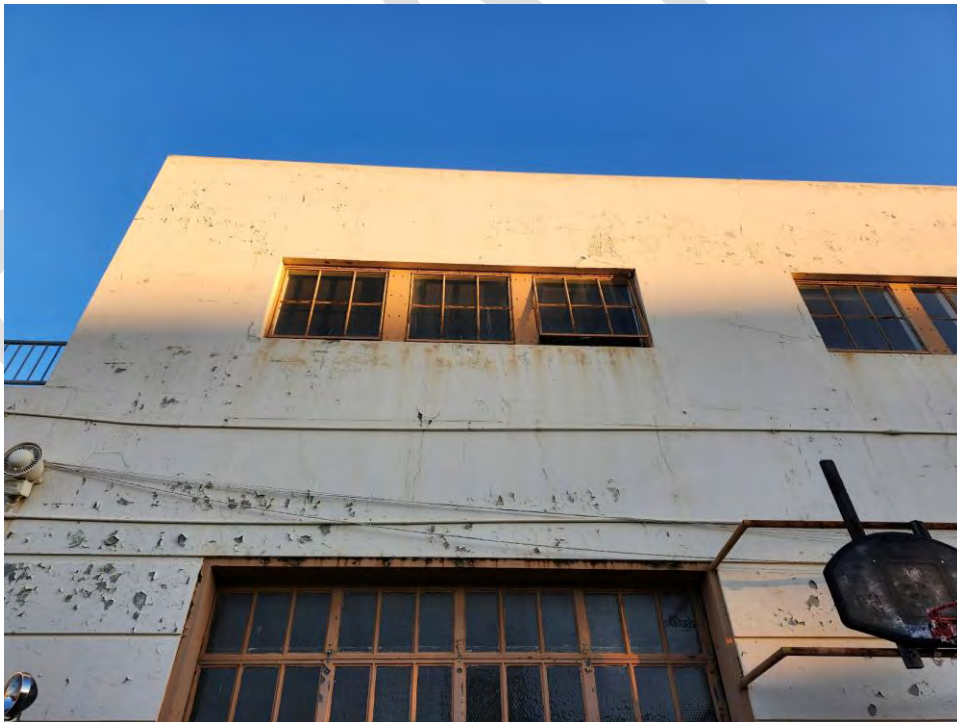
**Photo 8: Exterior Cracks at Southern Face Two Story**

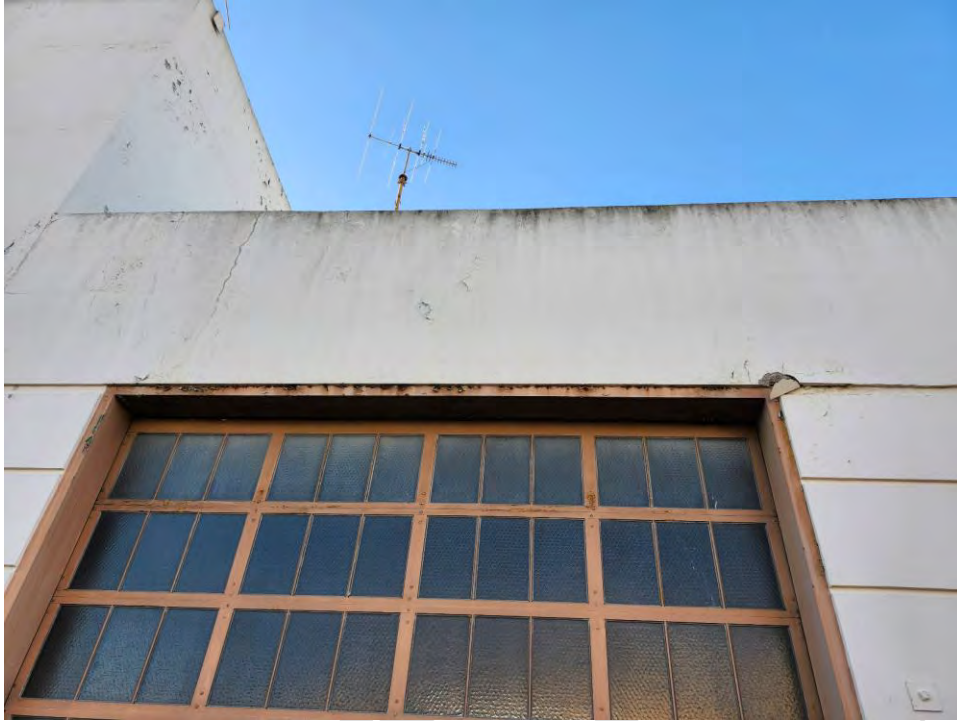
**Photo 9: Exterior Cracks at Northern Face**

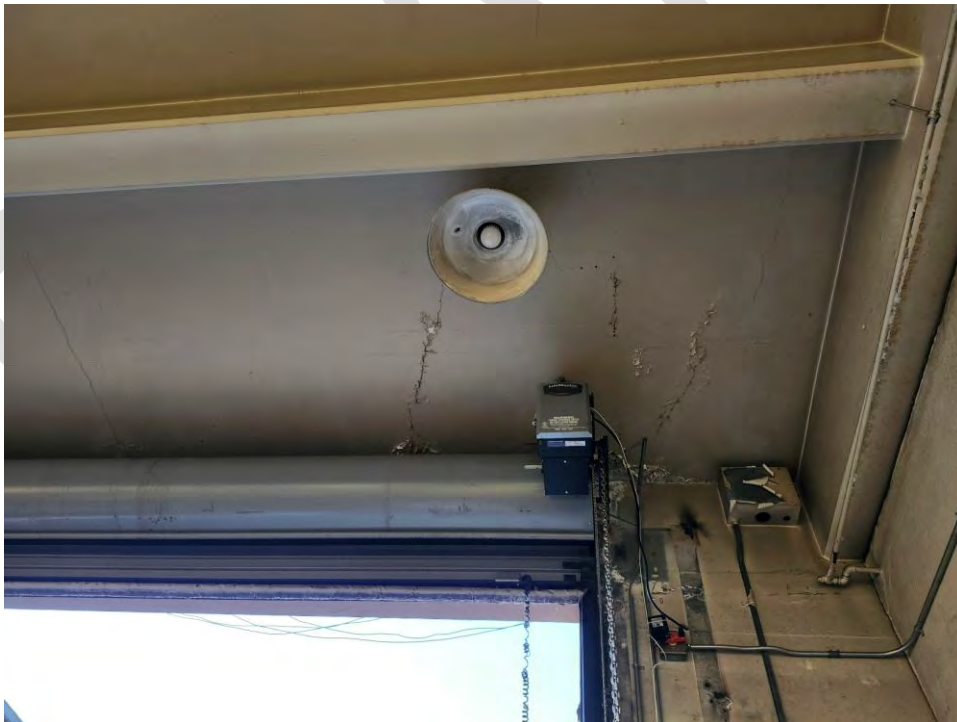
**Photo 10: Roof Slab Cracks at Apparatus Door**

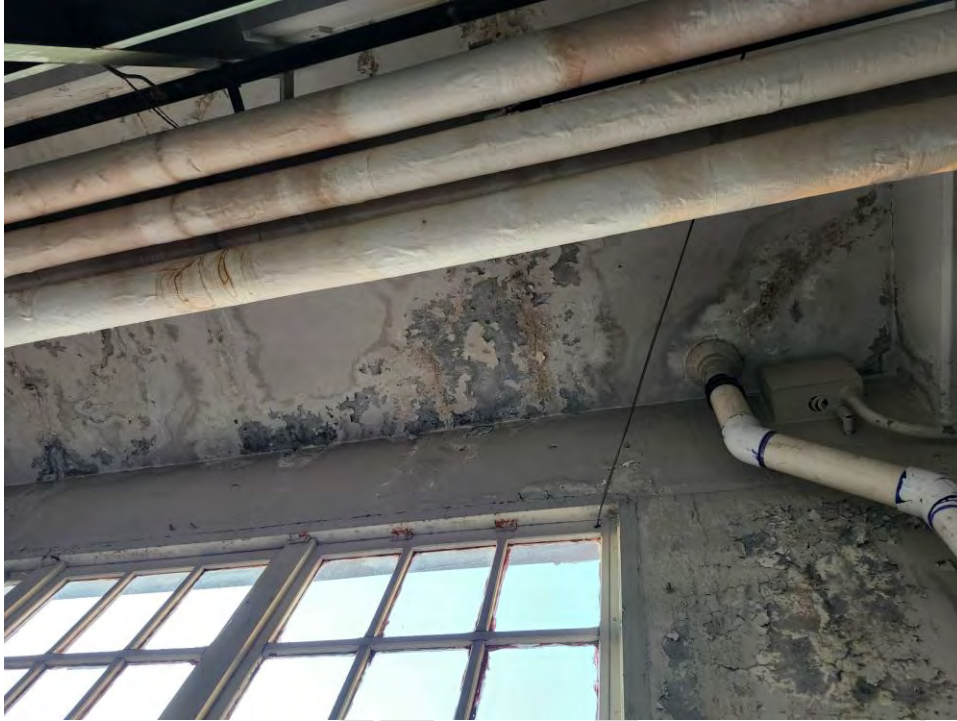
**Photo 11: Water Damage at Concrete Roof Slab**

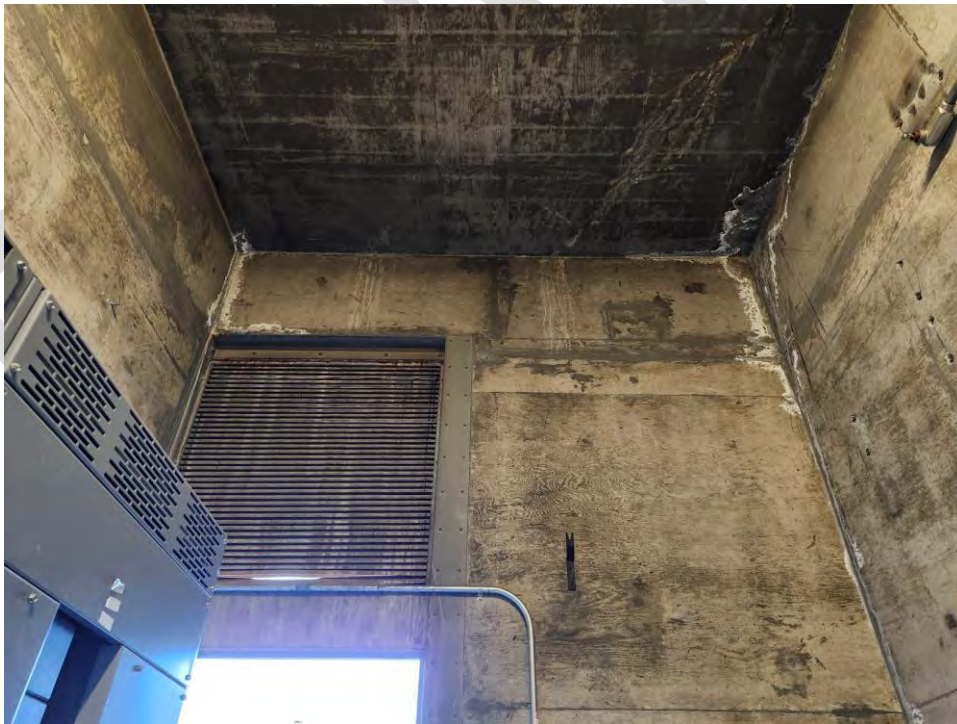
**Photo 12: Water Intrusion at Mechanical Room Concrete Roof Slab and Wall**

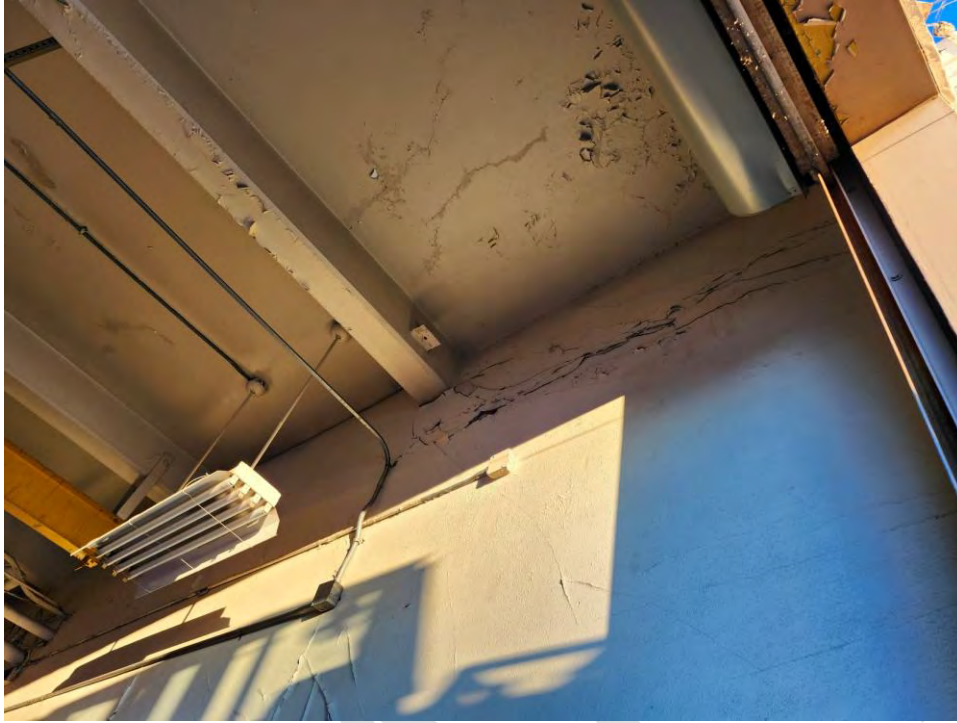
**Photo 13: Cracks at Apparatus Bay Wall and Ceiling**

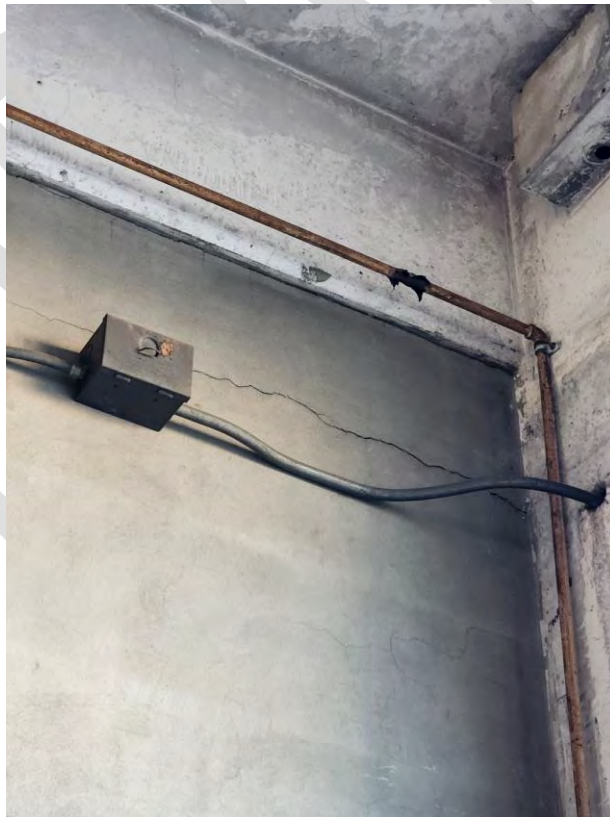
**Photo 14: Crack at Interior Infill Wall**

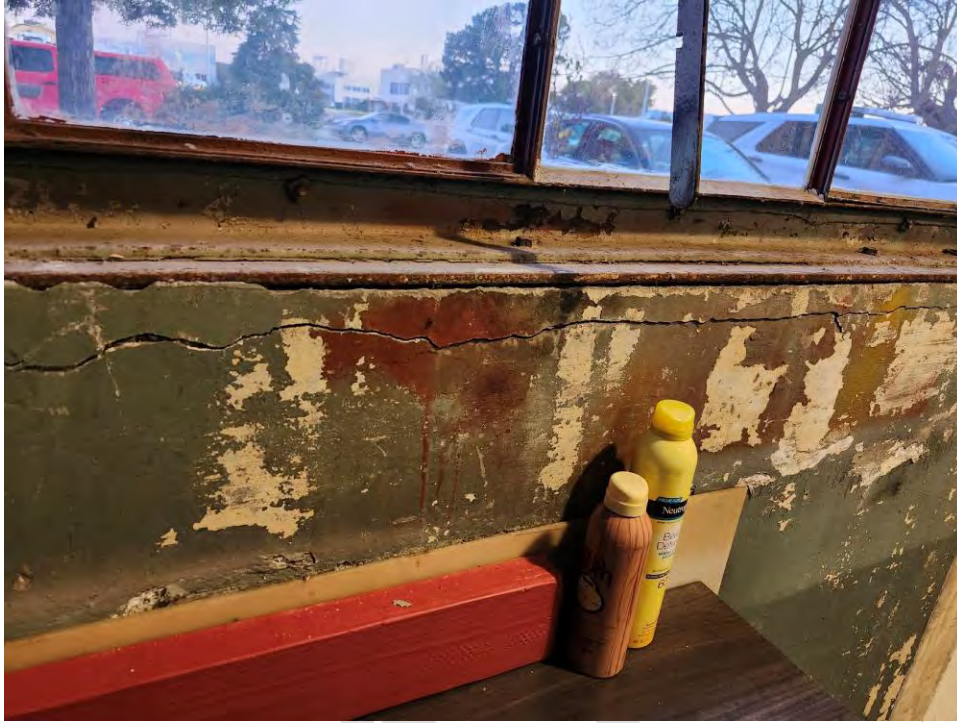
**Photo 15: Crack at Classroom Window Concrete Wall**

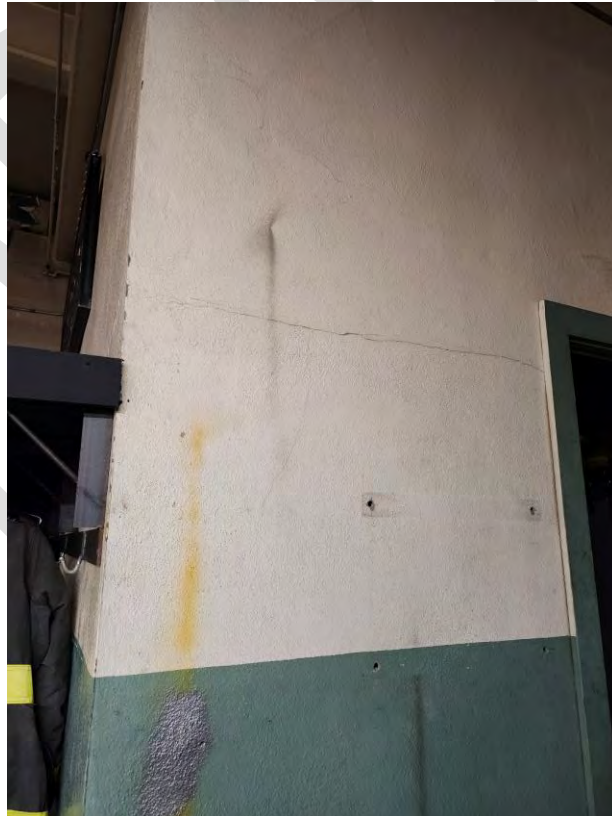
**Photo 16: Crack at Locker-room Concrete Wall**

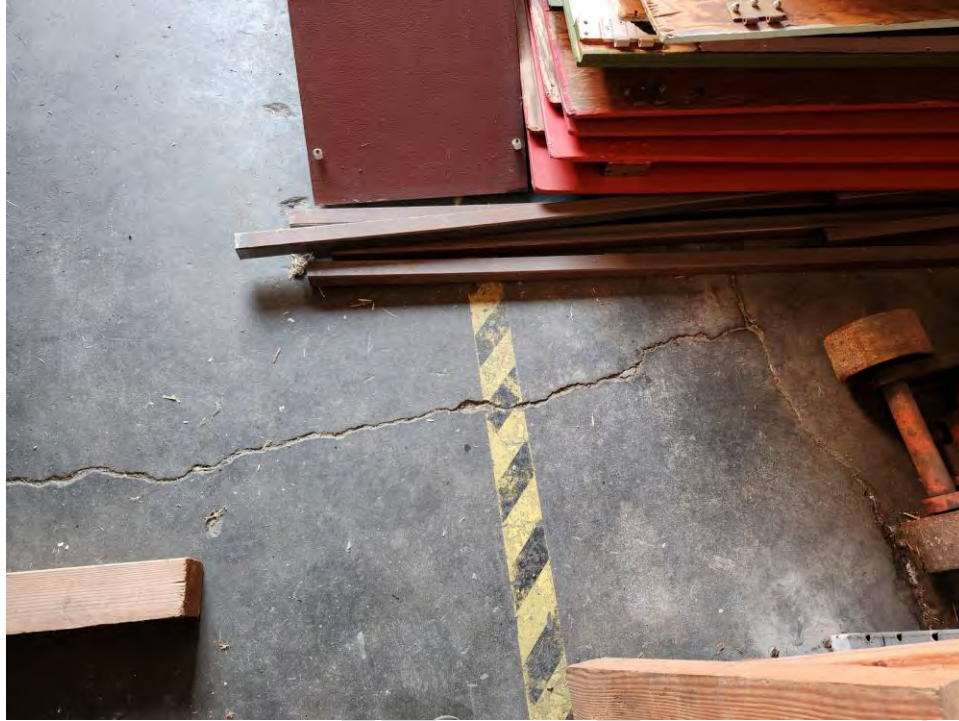
**Photo 17: Crack at Second ??? Floor Slab**

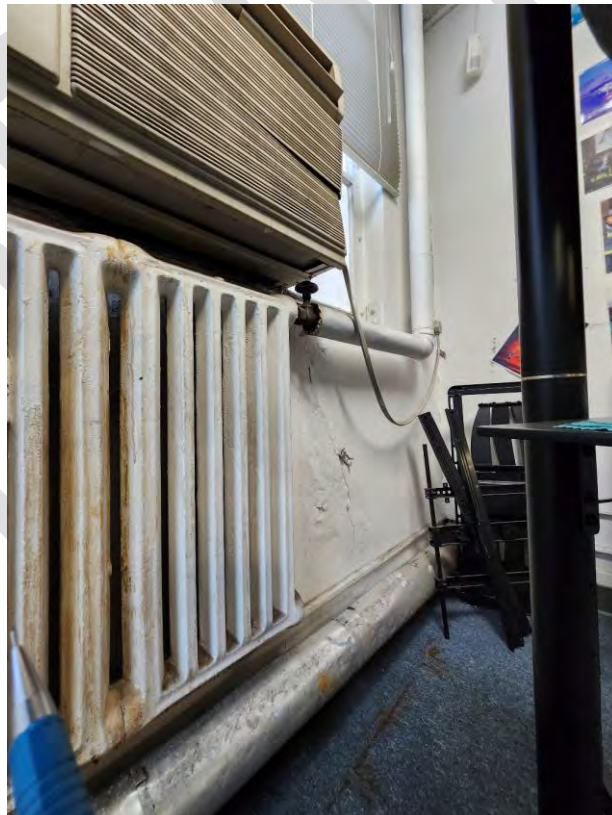
**Photo 18: Interior Water Damage at Conference Room**

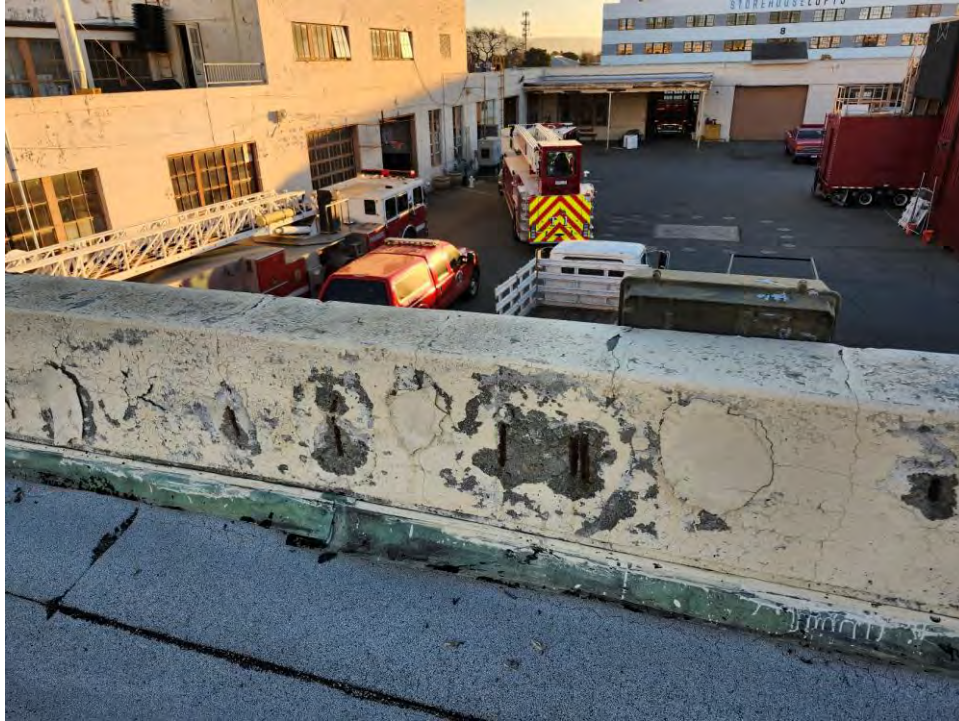
**Photo 21: Exterior Damage – Exposed Reinforcement at Roof Parapet Concrete**

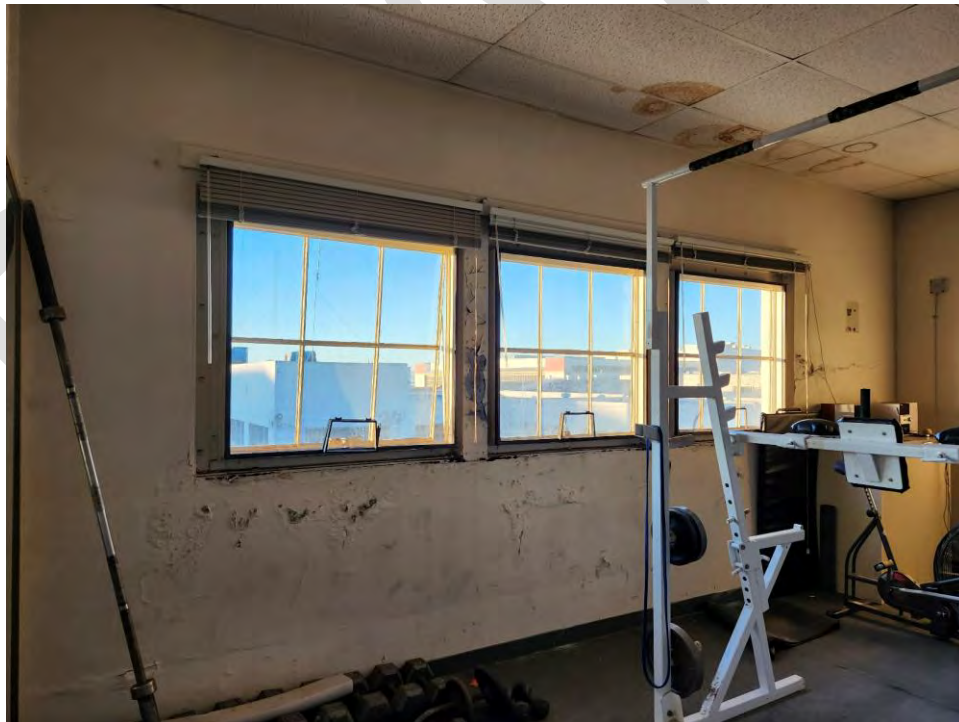
**Photo 22: Cracks at Exterior Wall of Penthouse Gym**

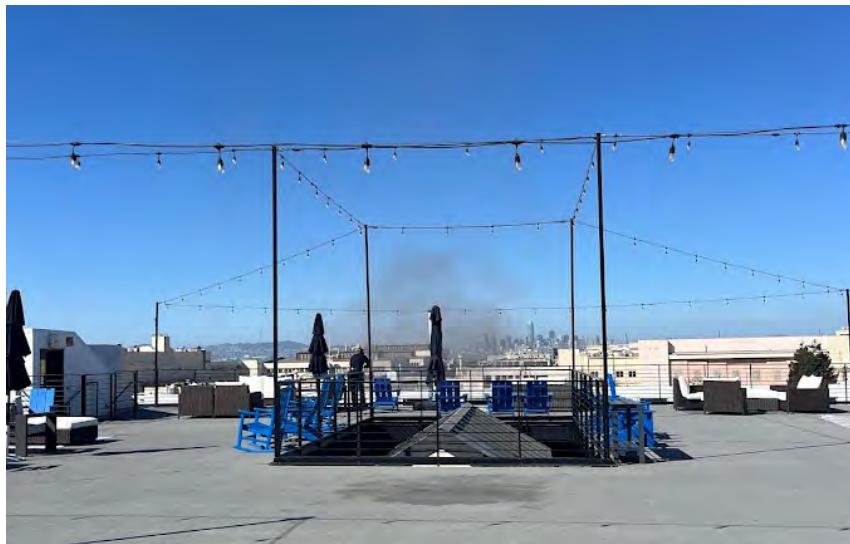
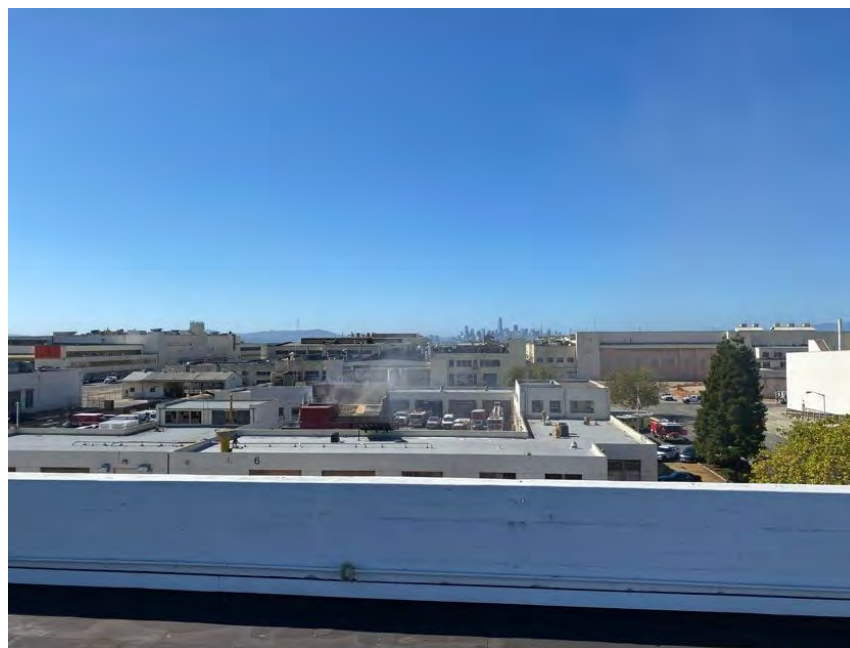
Figure 1. (Top) Exhaust observed from far end of rooftop of neighboring apartments when tar paper was burnt. (Bottom) Exhaust observed from edge of rooftop closest to the Training Facility when no tar paper was involved. Odor and smoke opacity noticeably increased when tar paper was used.
