Architectural Survey Memorandum [25134 – 802 Buena Vista Avenue, Alameda] Page 10 of 17

Page & Turnbull has been engaged to conduct an architectural survey of the residential building at 802 Buena Vista Avenue in Alameda, CA. The building suffered from fire damage in 2022 and has been vacant since. The purpose of this memorandum is to identify which architectural characterdefining features can be salvaged and which could be successfully replaced in-kind. Updated State of California Department of Parks and Recreation (DPR) Primary Record (523A) and Building, Structure, and Object Record (523B) forms have been prepared to accompany this memorandum. The character-defining features of 802 Buena Vista Avenue are listed in the updated DPR forms.

Aisha Sawatsky and Jennifer Hembree visited the site on April 21, 2025, to survey the exterior facades. The interior of the building was not examined. Existing conditions and character-defining features were documented using digital photographs and field notes.

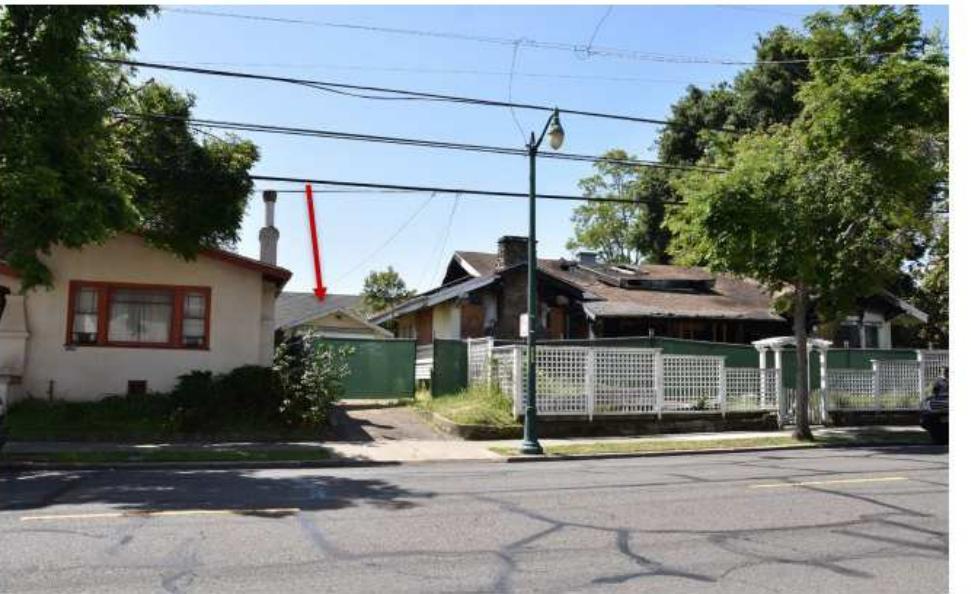
Figure 1. Context view of the subject building at 802 Buena Vista Avenue with garage indicated by red arrow, looking

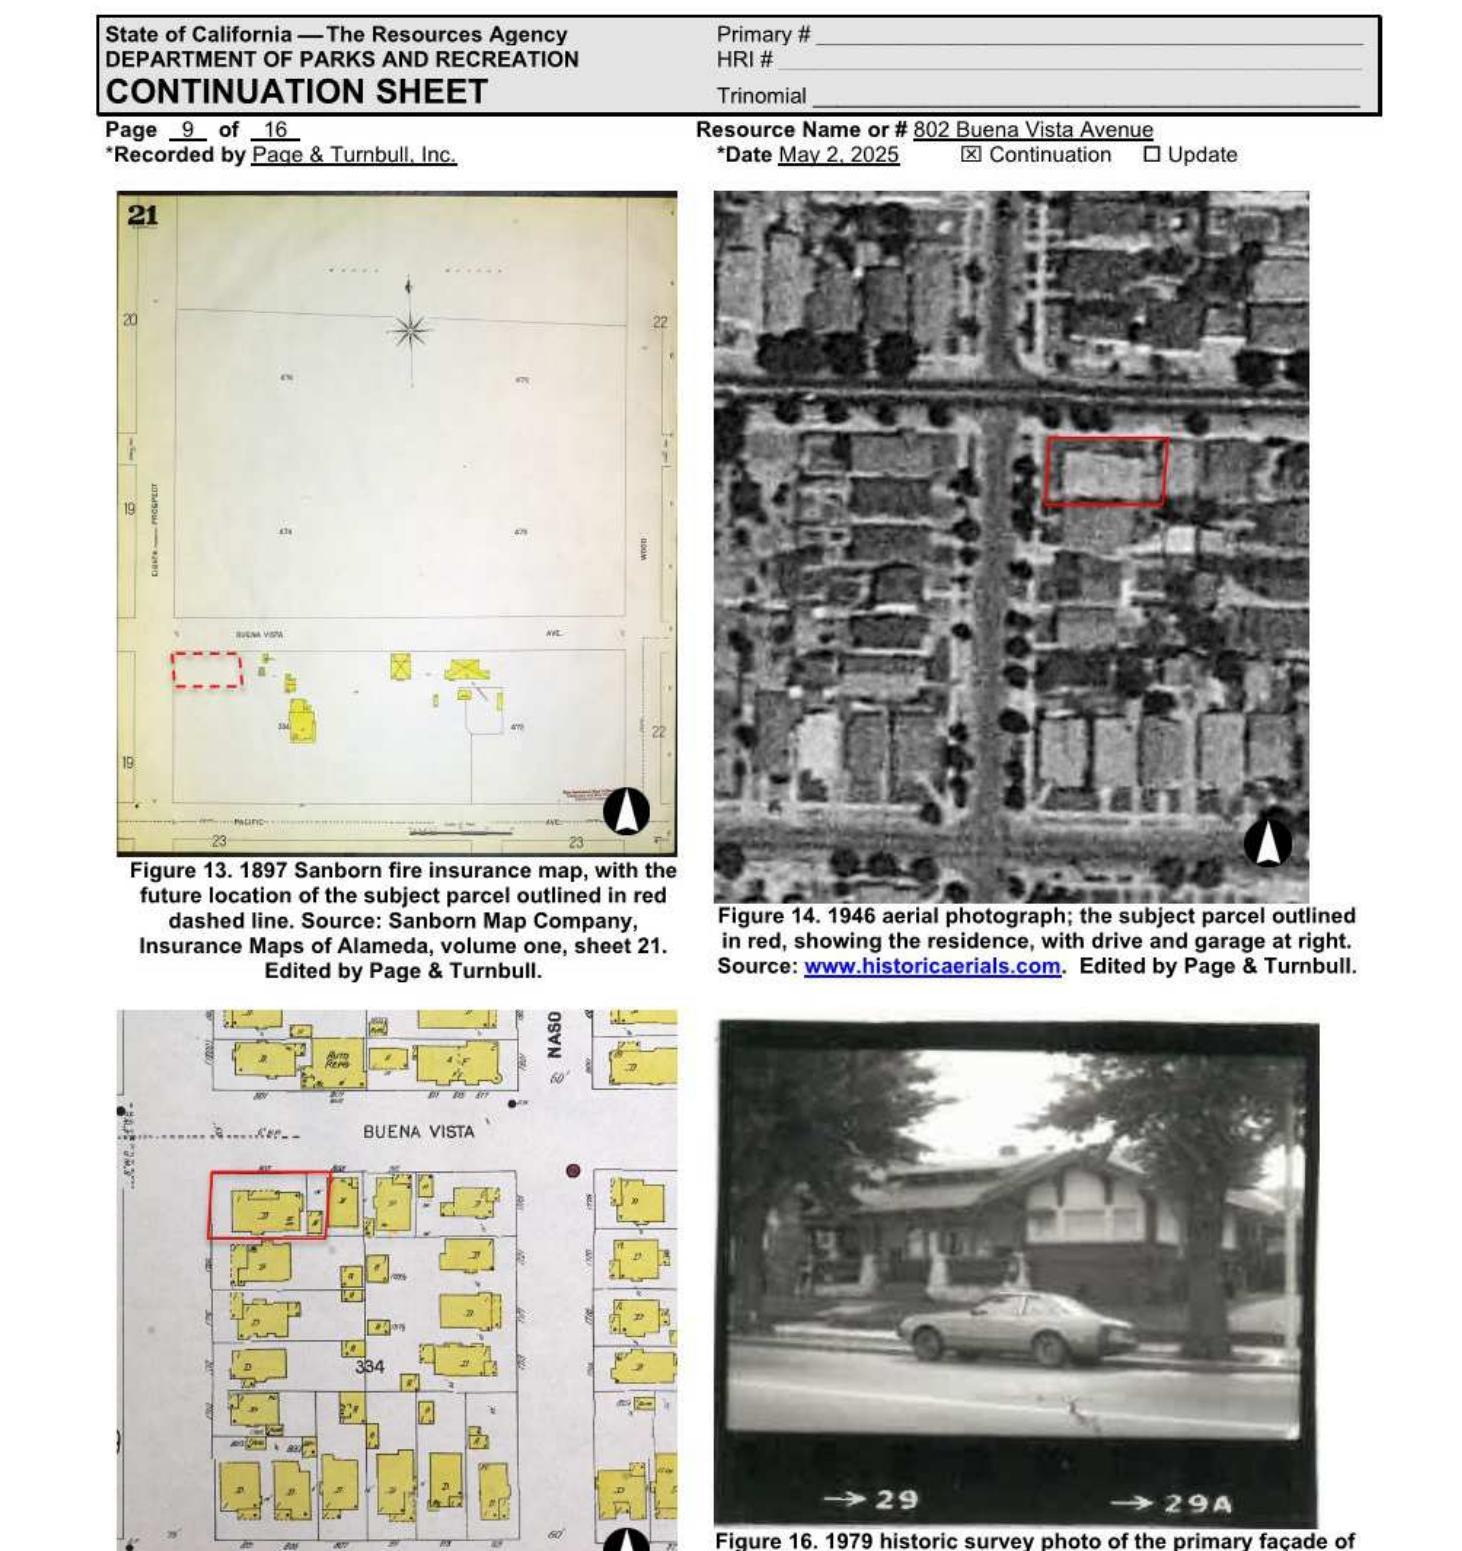
Figure 15. 1948 Sanborn fire insurance map, subject parcel outlined in red dashed line. Source: Sanborn Map Company, Insurance Maps of Alameda, volume one, sheet 21. Edited by Page & Turnbull.

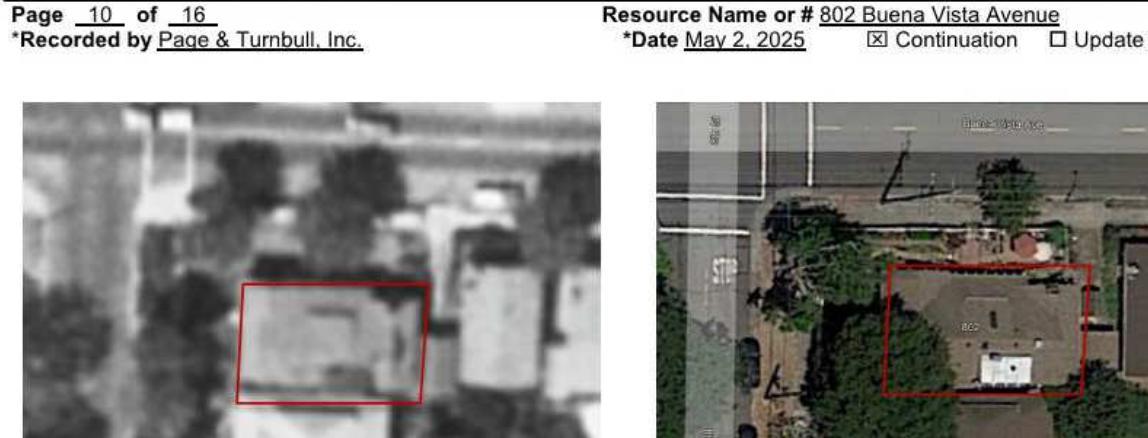
iqure 17. 1965 aerial view of subject property; shed roof dormer and rear shed roof visible. Source: USCB FrameFinder Historic Aerials.

Figure 18. 2020 aerial view of subject property; shed roof dormer and rear shed roof visible. Source Google Earth Historical Aerial Imagery, 2014.

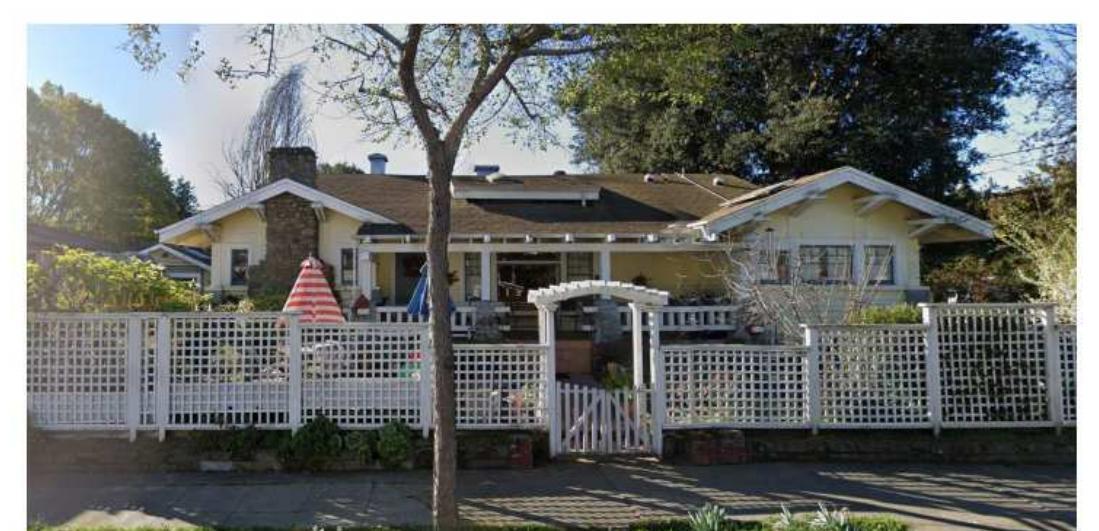
Figure 19. Primary (north) façade of 802 Buena Vista Avenue, view south. Source: Google Streetview, 2020.
