5. SHOPS AREA

5.1. Architectural Vocabulary of the Shops Area

Cultural Landscape Report

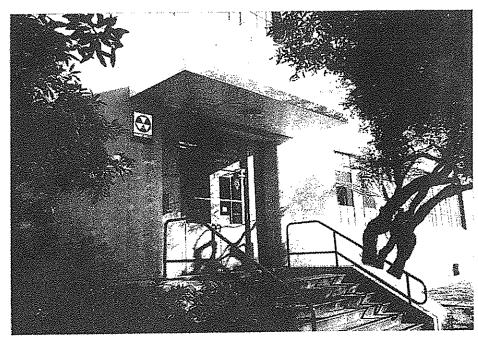
Building 8 includes steel industrial sash throughout. It also includes numerous original steel personnel doors, one of which is shown in **Photograph 54.** As a warehouse, the bulk of the doors in this building are wide industrial openings. Most of the industrial doors appear to have been replaced.

Photograph 54. Original steel personnel door, Building 8.

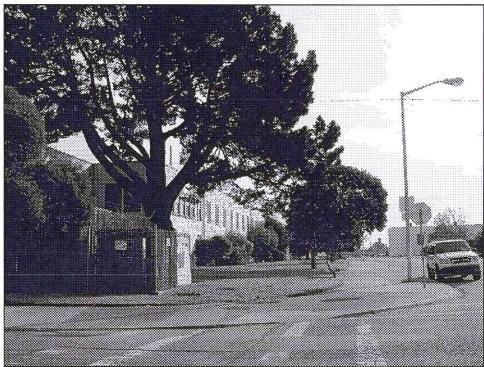
Photograph 103: Vegetation on west side of Building 114, facing south down Lexington

Lawn is planted in deep setbacks at Buildings 6, 8, 62, and 114, similar to the way lawn is used in much of the Administrative Core, and each of these buildings also has foundation shrubbery (**Photograph 100, Photograph 101, Photograph 102, Photograph 103**). Elsewhere there are some areas where weedy grasses are being mown. Planting strips between the curb and sidewalk on West Midway Avenue have been filled in with asphalt paving. Elsewhere there are no sidewalks and no evidence of planting strips having existed.

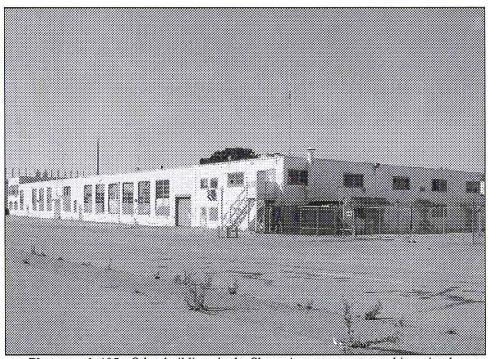
Photograph 105: Other buildings in the Shops Area are constructed in a simple, functional style; Building 114, facing northwest.
