RE: Permit for Solar Array at Assessors Parcel 174-1040-001-00

# Avian Mortality at Solar Energy Facilities in Southern California: A Preliminary Analysis

Rebecca A. Kagan, Tabitha C. Viner, Pepper W. Trail, and Edgard O. Espinoza  
National Fish and Wildlife Forensics Laboratory

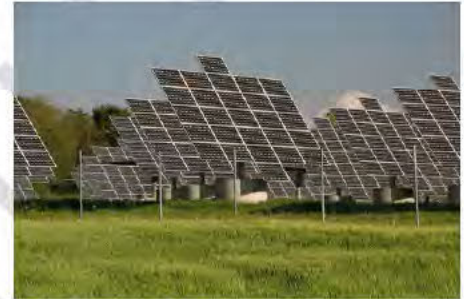
1) **Photovoltaic systems** directly convert the sun's light into electricity. The perceived threat to birds is associated with the presence of water ponds which attract birds and from traumatic impact with the photovoltaic cells. An example of this type of solar power plant is Desert Sunlight Solar Farm (AKA First Solar).

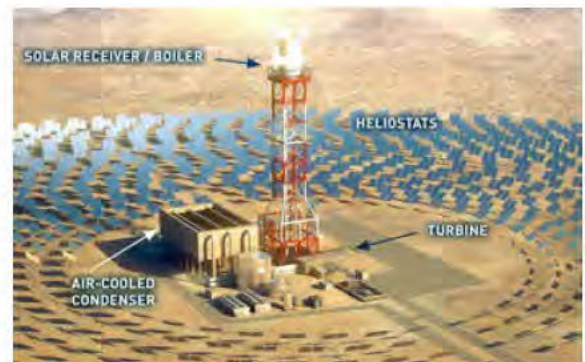
3) **Solar power towers** use thousands of mirrors to reflect the solar energy to a tower, where water in a boiler is converted to steam, generating the electricity. The perceived threat to birds is associated traumatic impact with the mirrors and the danger associated with the heat produced by the mirrors. An example of this type of solar power plant is Ivanpah Solar Electric Generating System.

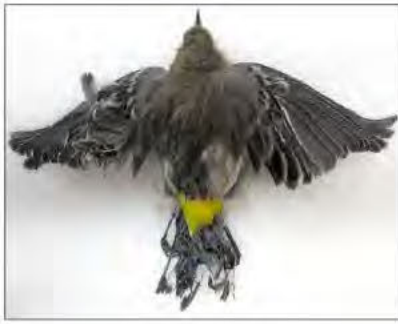
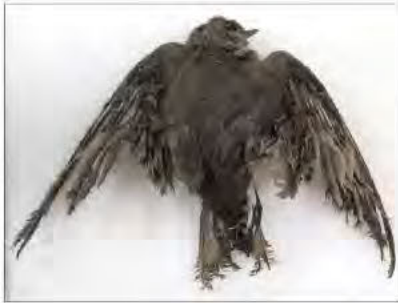
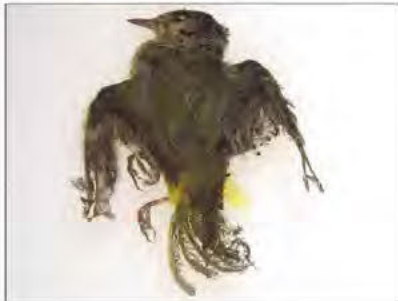
**Figure 1: Three grades of flux injury based on extent and severity of burning. Grade 1 (top); Yellow-rumped Warbler with less than 50% of the flight feathers affected (note sparing of the yellow rump feathers). Grade 2 (middle); Northern Rough-winged Swallow initially found alive but unable to fly, with greater than 50% of the flight feathers affected. Grade 3 (bottom); MacGillivray's Warbler with charring of feathers around the head, neck, wings and tail.**

Birds with feather burns were graded based on the extent of the lesions. Grade 1 birds had curling of less than 50% of the flight feathers. Grade 2 birds had curling of 50% or more of the flight feathers. Grade 3 birds had curling and visible charring of contour feathers (Figure 1).

The yellow and red rumps of Yellow-rumped Warblers and House Finches respectively remained strikingly unaffected (See Figure 1). Charring of head feathers, in contrast, was generally diffuse across all color patterns. A pattern of spiraling bands of curled feathers across or around the body and wings was often apparent.

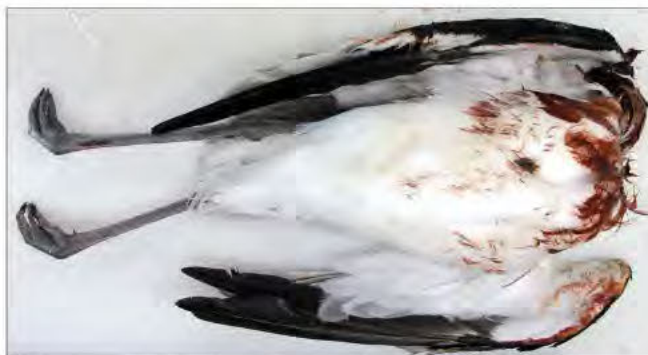
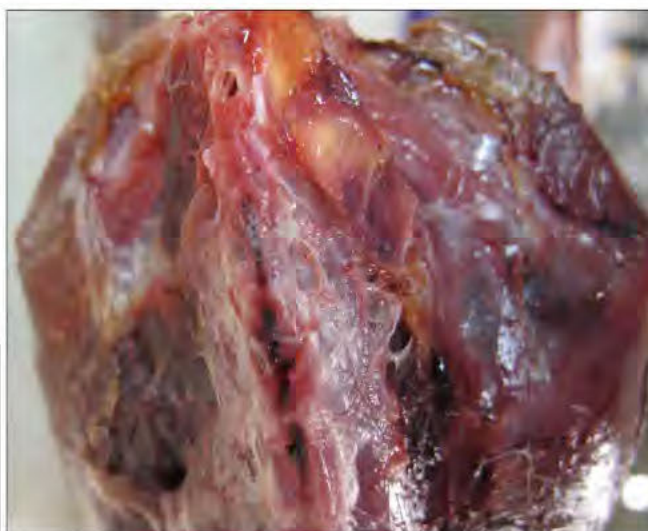
Figure 2: Predation trauma (top) resulting in traumatic amputation of the head and neck (American Avocet) and impact trauma (bottom) causing bruising of the keel ridge of the sternum (Brown Pelican).

Blunt force impact trauma was determined to have been the cause of death for 19 Desert Sunlight birds including two Western Grebes (*Aechmophorus occidentalis*) and one each of 16 other species. Impact (blunt force) trauma is diagnosed by the presence of fractures and internal and/or external contusions. In particular, bruising around the legs, wings and chest are consistent with crash-landings while fractures of the head and/or neck are consistent with high-velocity, frontal impact (such as may result from impacting a mirror).

Predation was the immediate cause of death for 15 birds. Lesions supporting the finding of predation included decapitation or missing parts of the body with associated hemorrhage (9/15), and lacerations of the skin and pectoral muscles. Eight of the predated birds from Desert Sunlight were

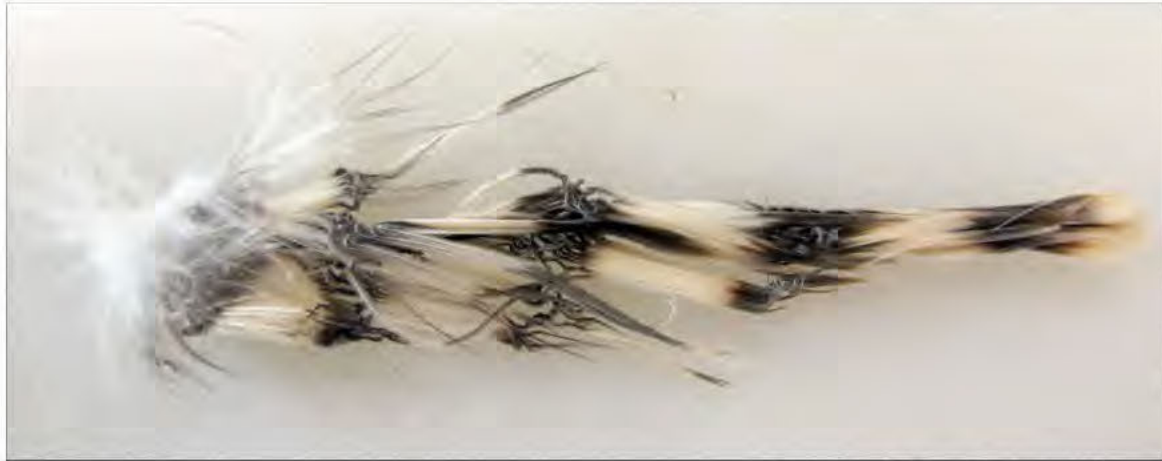
Figure 4: Feather from a Peregrine Falcon with Grade 2 solar flux injury. Note burning of dark feather bands with relative sparing of light bands.

Solar flux injury was identified as the cause of death in 47/141 birds. Solar flux burns manifested as feather curling, charring, melting and/or breakage and loss. Flight feathers of the tail and/or wings were invariably affected. Burns also tended to occur in one or more of the following areas; the sides of the body (axillae to pelvis), the dorsal coverts, the tops and/sides of the head and neck and the dorsal body wall (the back). Overlapping portions of feathers and light-colored feathers were often spared (Figures 3 and 4).

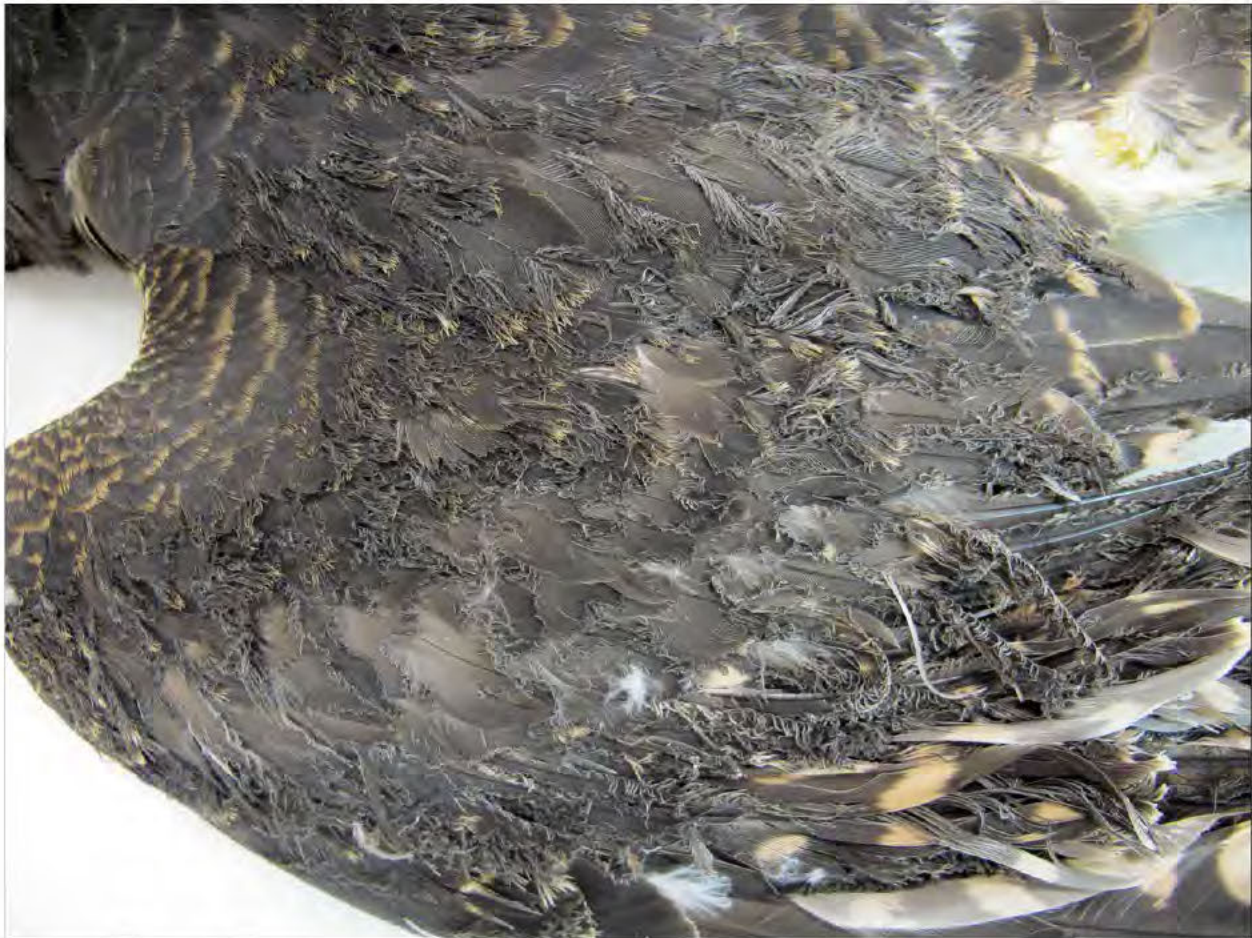
Figure 5: The dorsal aspect of the wing from a Peregrine Falcon (the same bird as shown in Figure 4) with Grade 2 lesions. Note extensive curling of feathers without visible charring. This bird was found alive, unable to fly, emaciated and died shortly thereafter. These findings demonstrate fatal loss of function due to solar flux exposure in the absence of skin or other soft tissue burns.

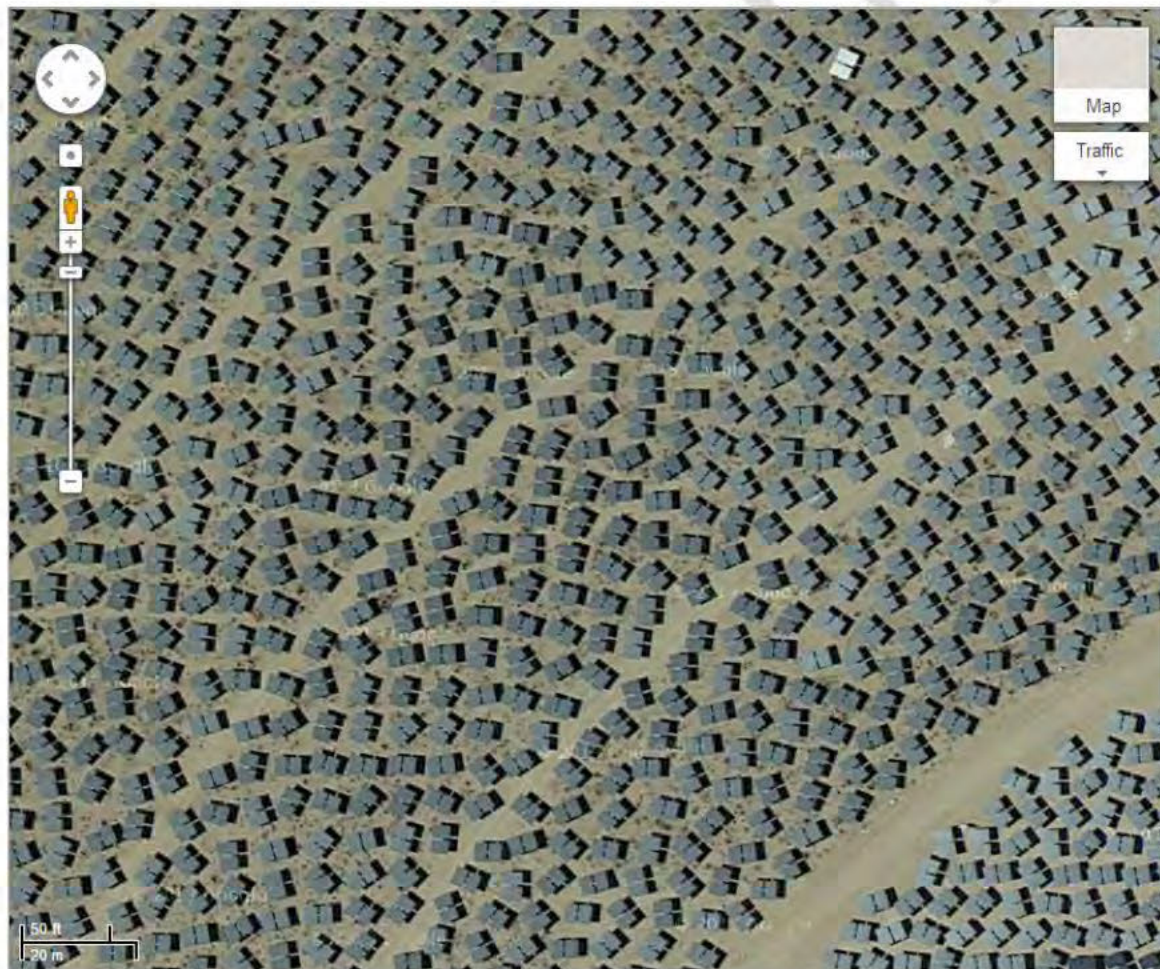
Figure 6: The Ivanpah Solar Electric Generating System as seen via satellite. The mirrored panels are 5 x 8 feet.

A desert environment punctuated by a large expanse of reflective, blue panels may be reminiscent of a large body of water. Birds for which the primary habitat is water, including coots, grebes, and cormorants, were over-represented in mortalities at the Desert Sunlight facility (44%) compared to Genesis (19%) and Ivanpah (10%). Several factors may inform these observations. First, the size and continuity of the panels differs between facilities. Mirrors at Ivanpah are individual, 4 x 8' panels that appear from above as stippling in a desert background (Figure 6). Photovoltaic panels at Desert Sunlight are long banks of adjacent 27.72 x 47.25" panels (70 x 120 cm), providing a more continuous, sky/water appearance. Similarly, troughs at Genesis are banks of 5 x 5.5' panels that are up to 49-65 meters long.

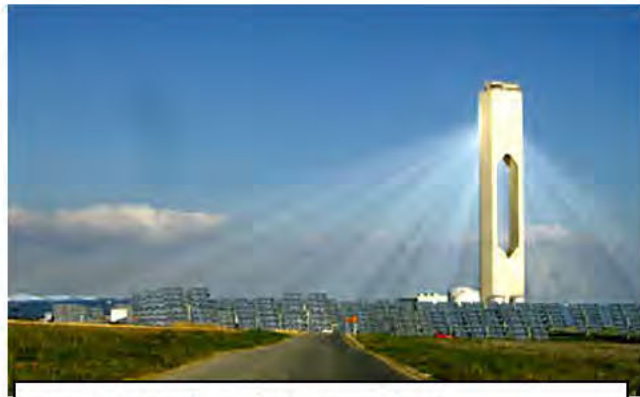
Figure 8: Seville solar power facility  
(<http://inhabitat.com/sevilles-solar-power-tower>)

If all the solar heliostats are focused on the solar tower the beams multiply the strength of sunlight by 5000 times, and this generates temperatures at the solar tower in excess of 3600° Fahrenheit ( $> 1982^{\circ}$  Celsius). Since steel melts at 2750° Fahrenheit ( $1510^{\circ}$  Celsius), only a percentage of heliostats are focused on the solar receiver so that the optimal temperature at the tower is approximately 900° Fahrenheit ( $\sim 482^{\circ}$  Celsius) (“How do they do it” Wag TV for Discovery Channel, Season 3, Episode 15, “Design Airplane Parachutes, Create Solar Power, Make Sunglasses” Aired August 25, 2009).

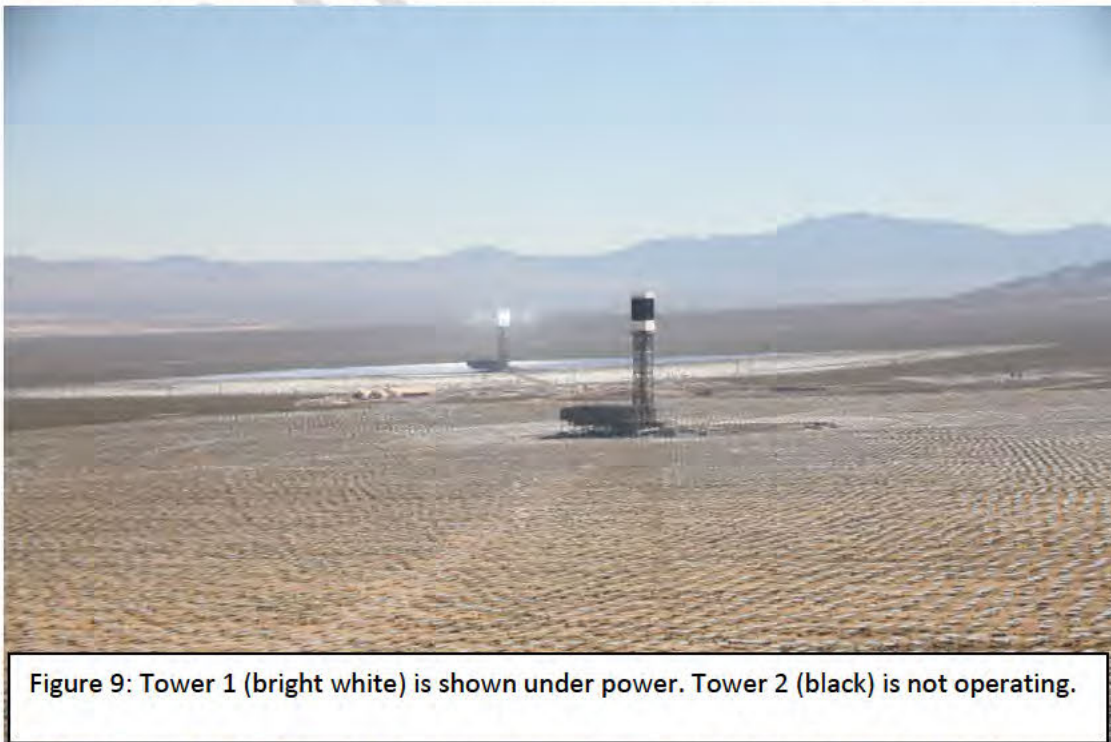
Figure 9: Tower 1 (bright white) is shown under power. Tower 2 (black) is not operating.

There is a phenomenon that occurs when the heliostats are focused on the tower and electricity is being generated. The phenomenon can be described as either a circle of clouds around the tower or, at times, a cloud formed on the side that is receiving the solar reflection. It appears as though the tower is creating clouds. Currently we propose two hypotheses of why this “cloud” is formed. The first hypothesis is simply the presumption that the high heat associated with towers is condensing the air, and forming the

clouds. The second hypothesis is that this phenomenon does not represent clouds at all rather it is a place in space where the heliostats that are not being used to generate heat are focused. Under this scenario, it is a place where the mirrors focus the excess energy not being used to generate electricity.

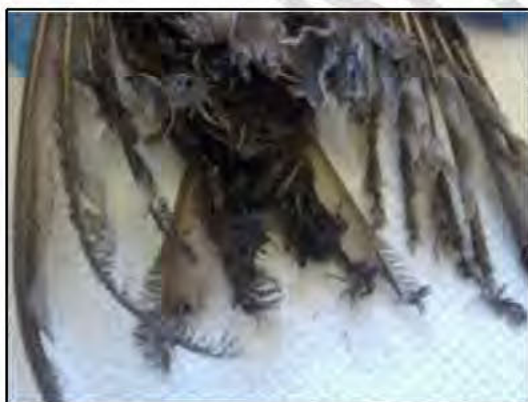
Figure 10: Singed feathers from a Northern Rough-winged Swallow

Many of the carcasses recovered from the Ivanpah Solar plant after the plant became operational showed singeing of feathers as shown in Figure 10.

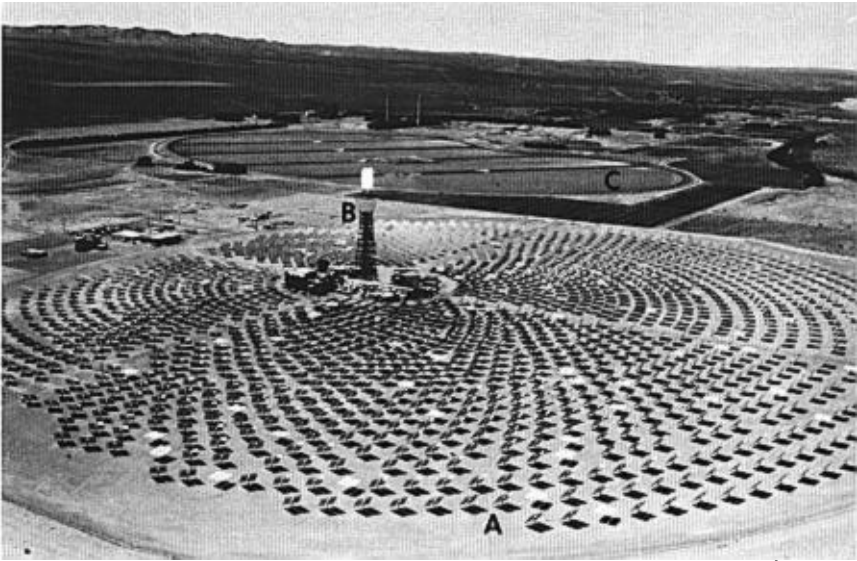
FIGURE 1. Aerial view of Solar One: (A) heliostat field, (B) central receiver tower, (C) evaporation ponds. Tower height = 86 m, diameter of field = 765 m.

Solar One is located in the Mojave Desert, 4 km east of Daggett, San Bernardino County, California (34°52'N, 116°51'W). The dominant desert plant community in this area is creosote bush (*Larrea divaricata*) scrub, although abandoned and active agricultural fields (alfalfa) and extensive (53 ha) evaporation ponds (Fig. 1) are adjacent to Solar One.
