# ADA Transition Plan: Mastick Senior Center

95% CD DRAWINGS – 05/06/2026 – READY FOR PERMIT

INTERACTIVE RESOURCES – ARCHITECT

- CSW | ST2 ENGINEERING – CIVIL
- EDESIGNC – MEP

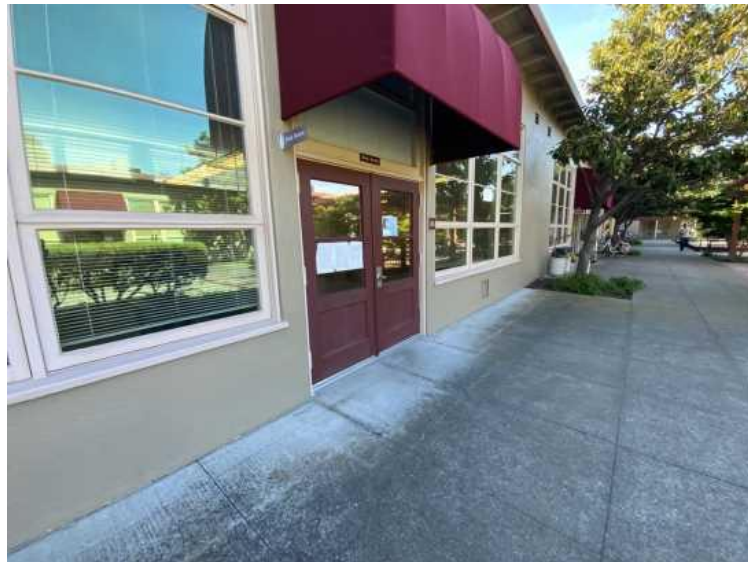
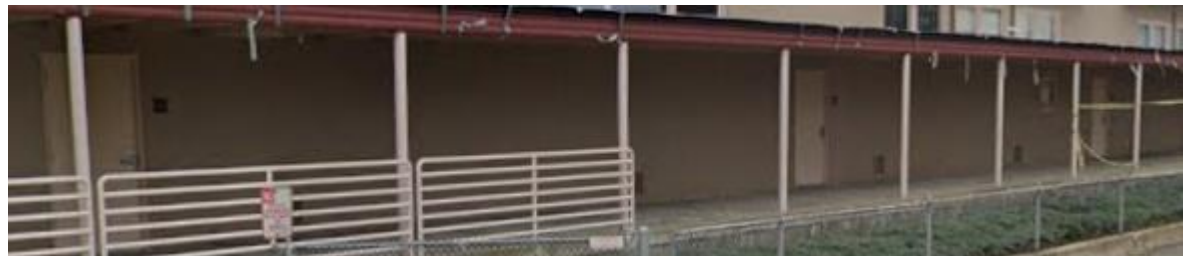
Characteristic of Building, Incidental Impacts Exceed Budgetary Constraints:

- Transom Windows
- Overhangs

Reality of the potential fix would require total demo of courtyard adjacent walls, resulting in much longer downtime for whole buildings that is not necessary. Instead, each room has an exterior facing door closer to the ADA ramps.

Alternative: POT includes the doors on exterior walkways which do not have transom windows and walkways that are already much closer to grading requirements per ADA Codes. These doors are the shorter path from parking, ramps to classrooms

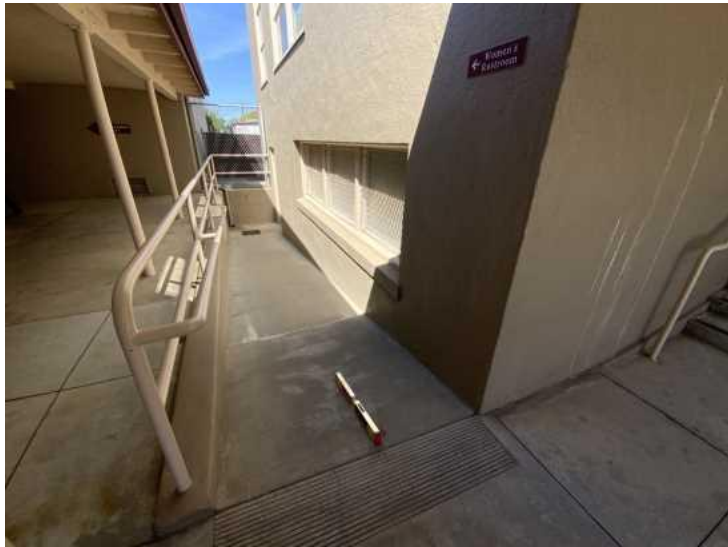
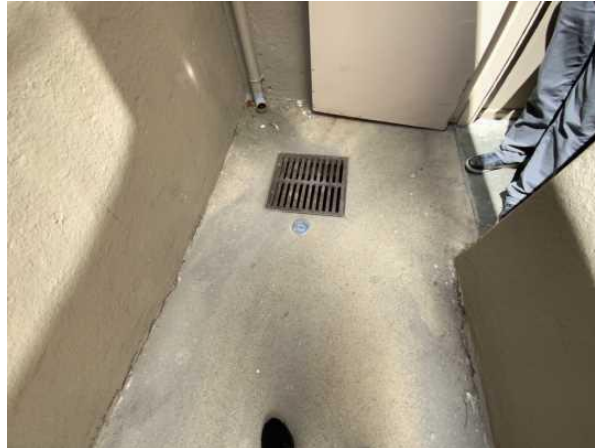
Landing Dimensions and Slope corrections would require more than 5 foot extension into the existing walkway, which is a landing area for adjacent stairs and separate ramp – Structural Infeasibility.

Leveling the landing is not feasible with existing door threshold and interior finished floor

Upgrades will still be made – Grate pictured to be replaced, Signage directing to ADA restrooms at Social Hall
