MEMORANDUM

Project: 2025051 - 1711 Arbor Street, Alameda

Re: 1711 Arbor Street, Alameda – Historic Resource Evaluation and Condition Assessment Memorandum

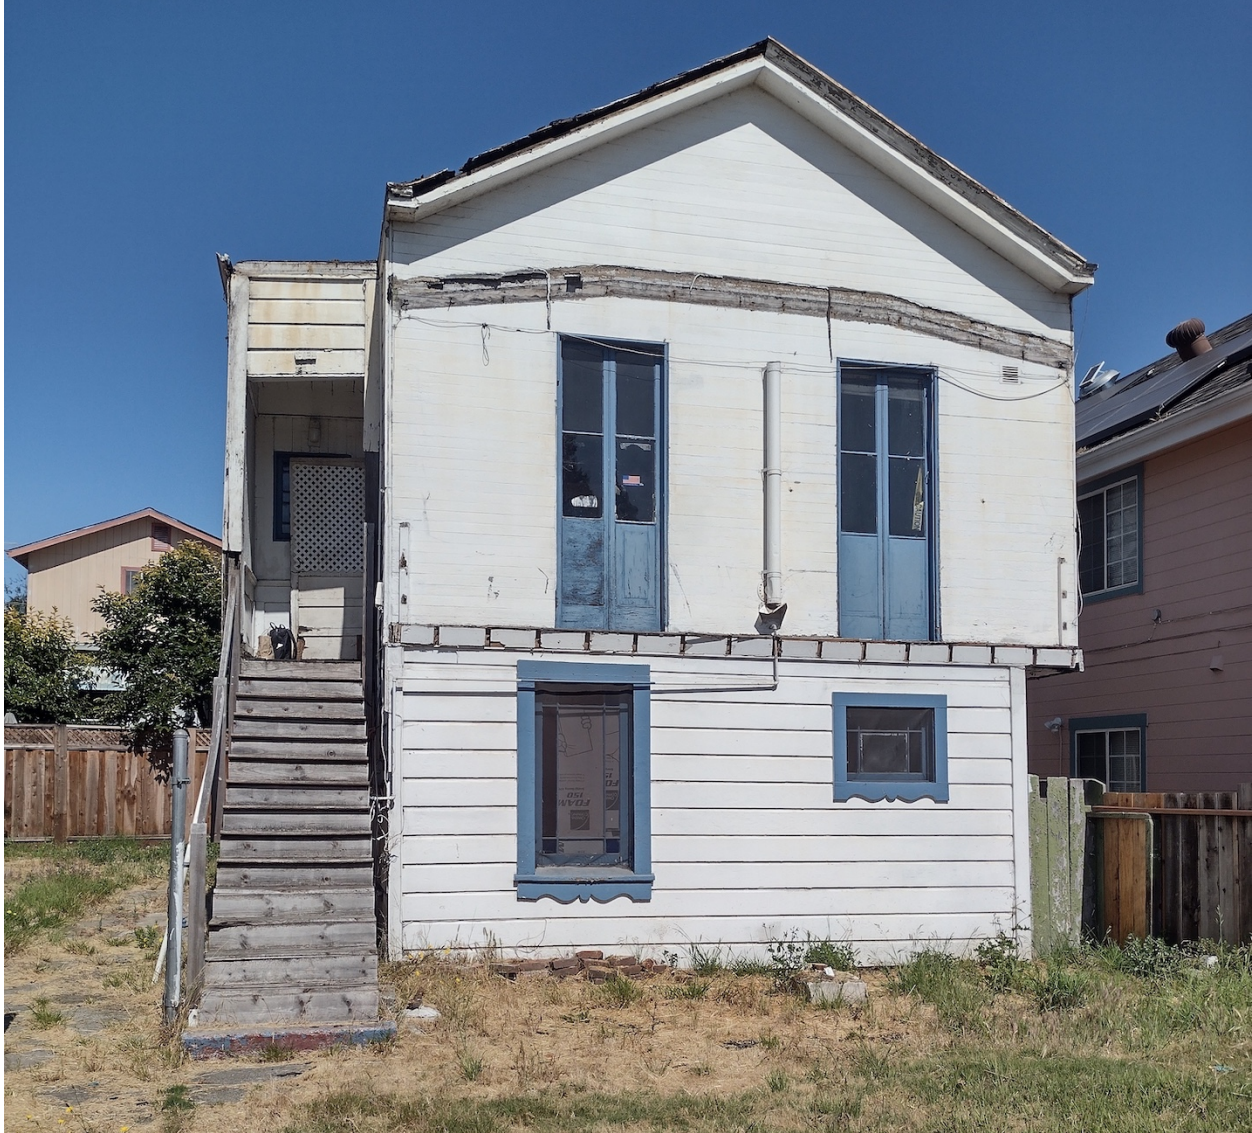
The front 2nd floor's lack of detailing at the exterior, the presence of several later additions, the replacement of the stairs (c. 1970), the removal of the 2nd-story porch and associated hipped porch roof from the front facade (c. 2024), and a mix of channel rustic and tongue-and-groove siding throughout the building communicate an overall lack of architectural cohesion.

Figure 5. View of the front (East) facade of 1711 Arbor Street from Arbor Street (GA, June 2025)
