## **MEMORANDUM**

**Project:** 2025051 - 1711 Arbor Street, Alameda

**Re:** 1711 Arbor Street, Alameda – Historic Resource Evaluation and Condition Assessment Memorandum

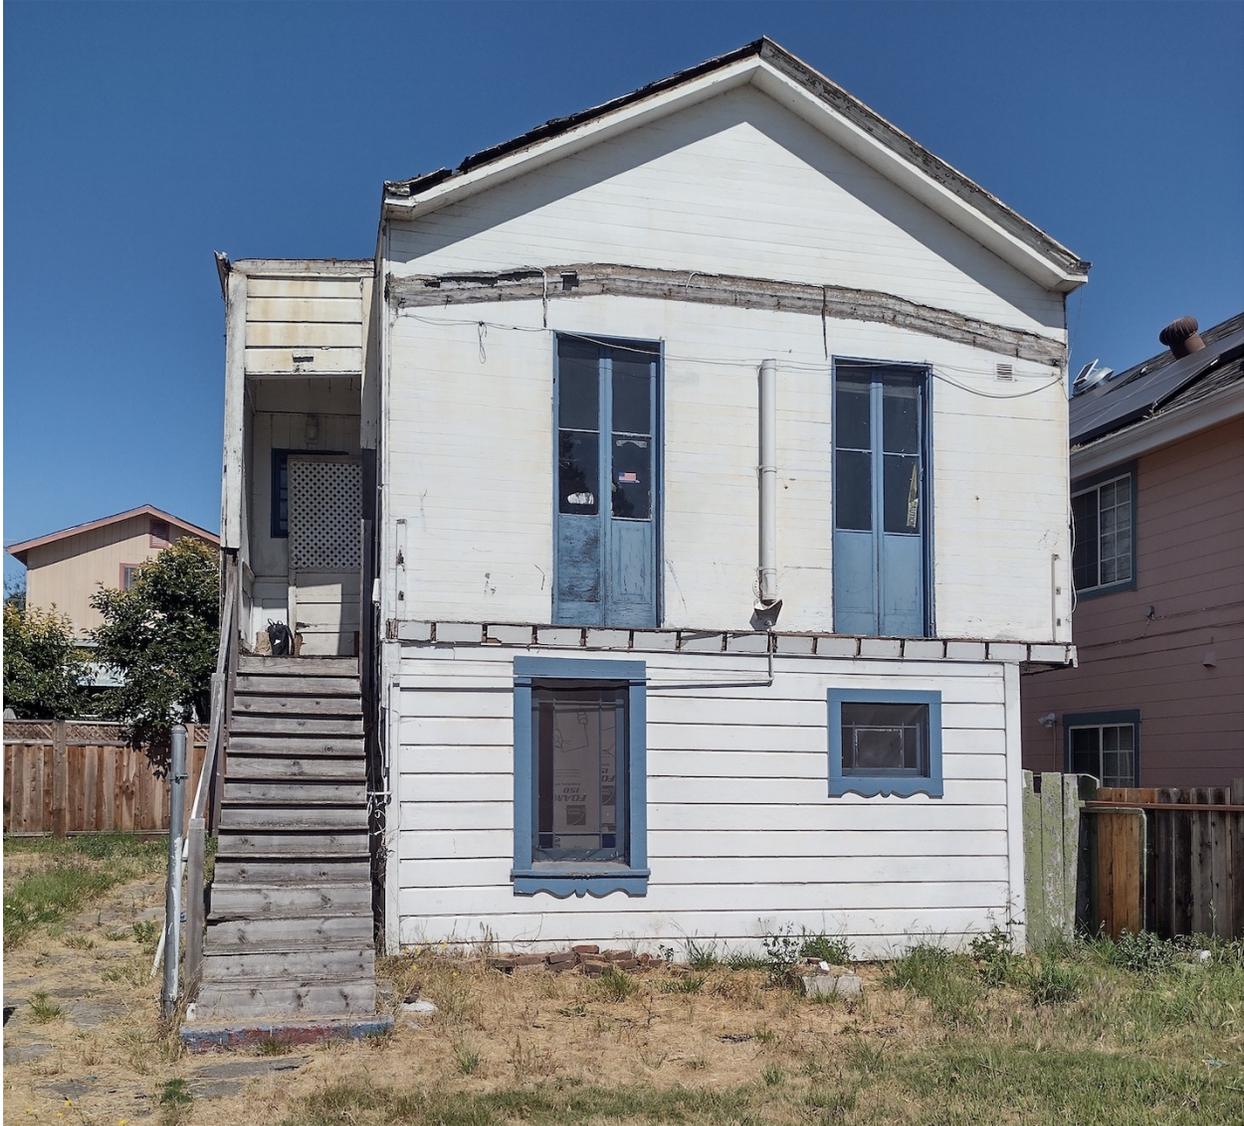
The front 2nd floor's lack of detailing at the exterior, the presence of several later additions, the replacement of the stairs (c. 1970), the removal of the 2nd-story porch and associated hipped porch roof from the front facade (c. 2024), and a mix of channel rustic and tongue-and-groove siding throughout the building communicate an overall lack of architectural cohesion.

Figure 5. View of the front (East) facade of 1711 Arbor Street from Arbor Street (GA, June 2025)
