**Date:** December 5, 2022

**Project Name:** Chuck Corica Golf Course Drainage

**Subject:** Project Technical Memorandum

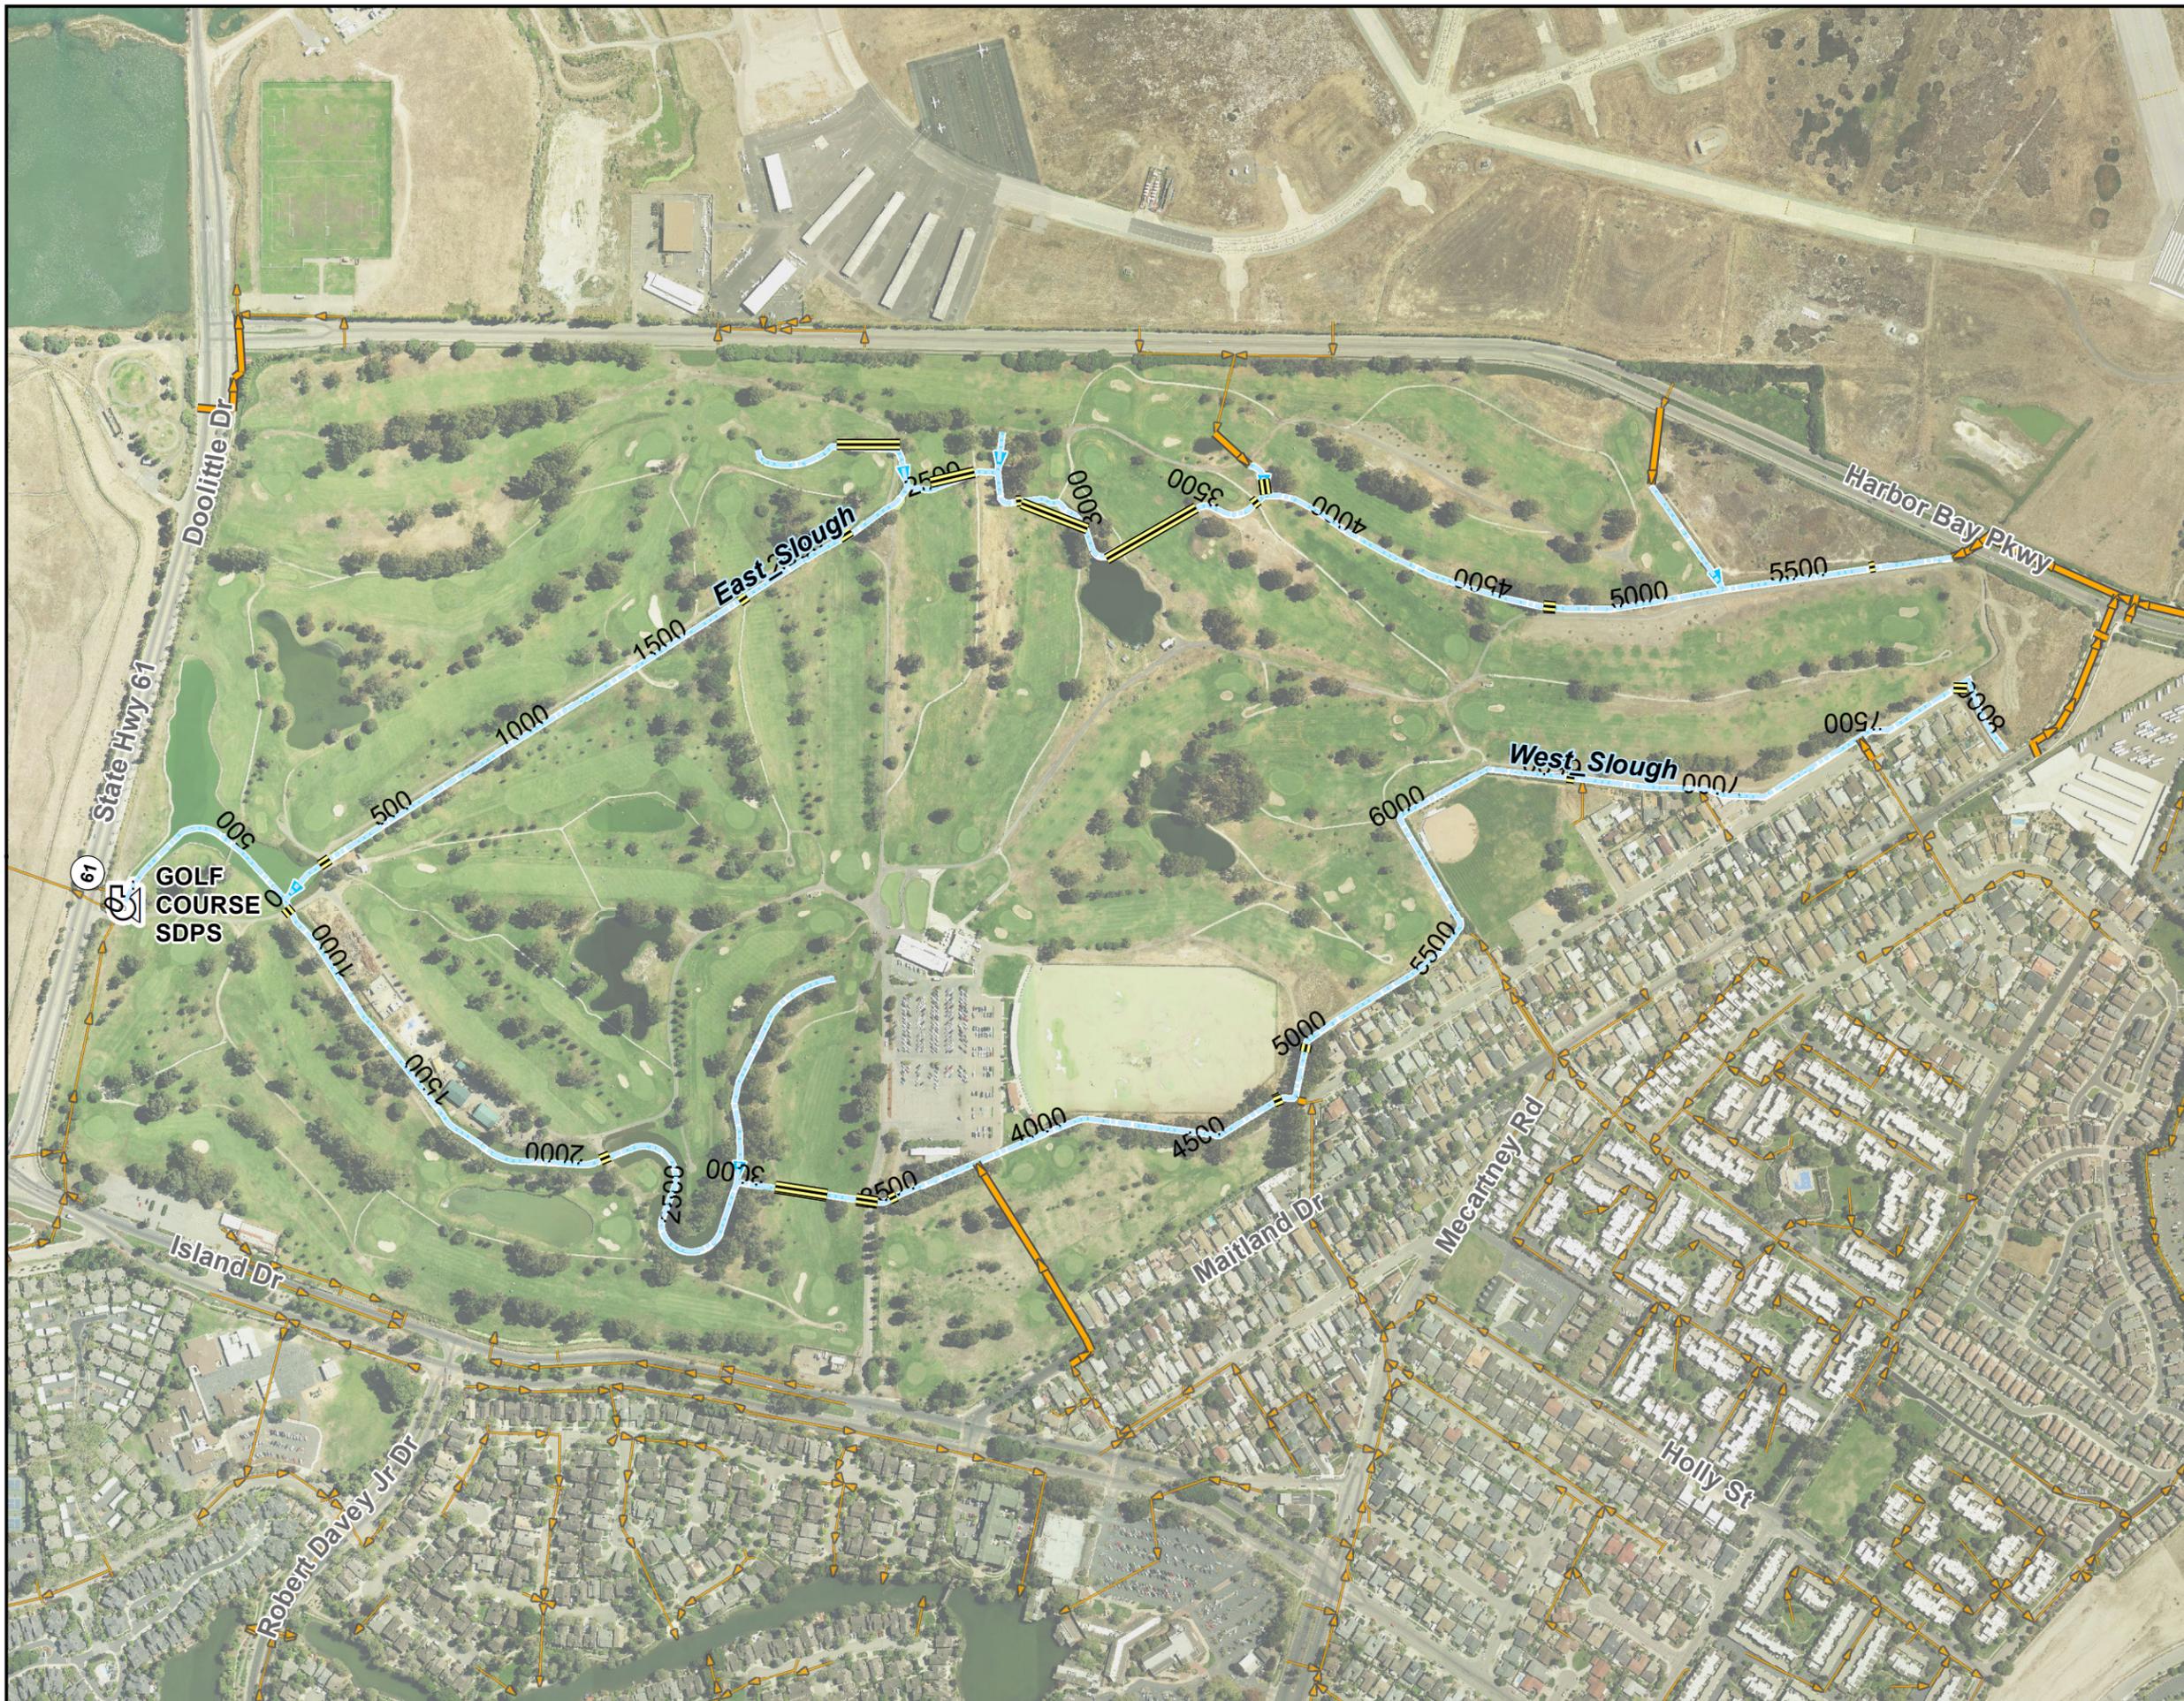
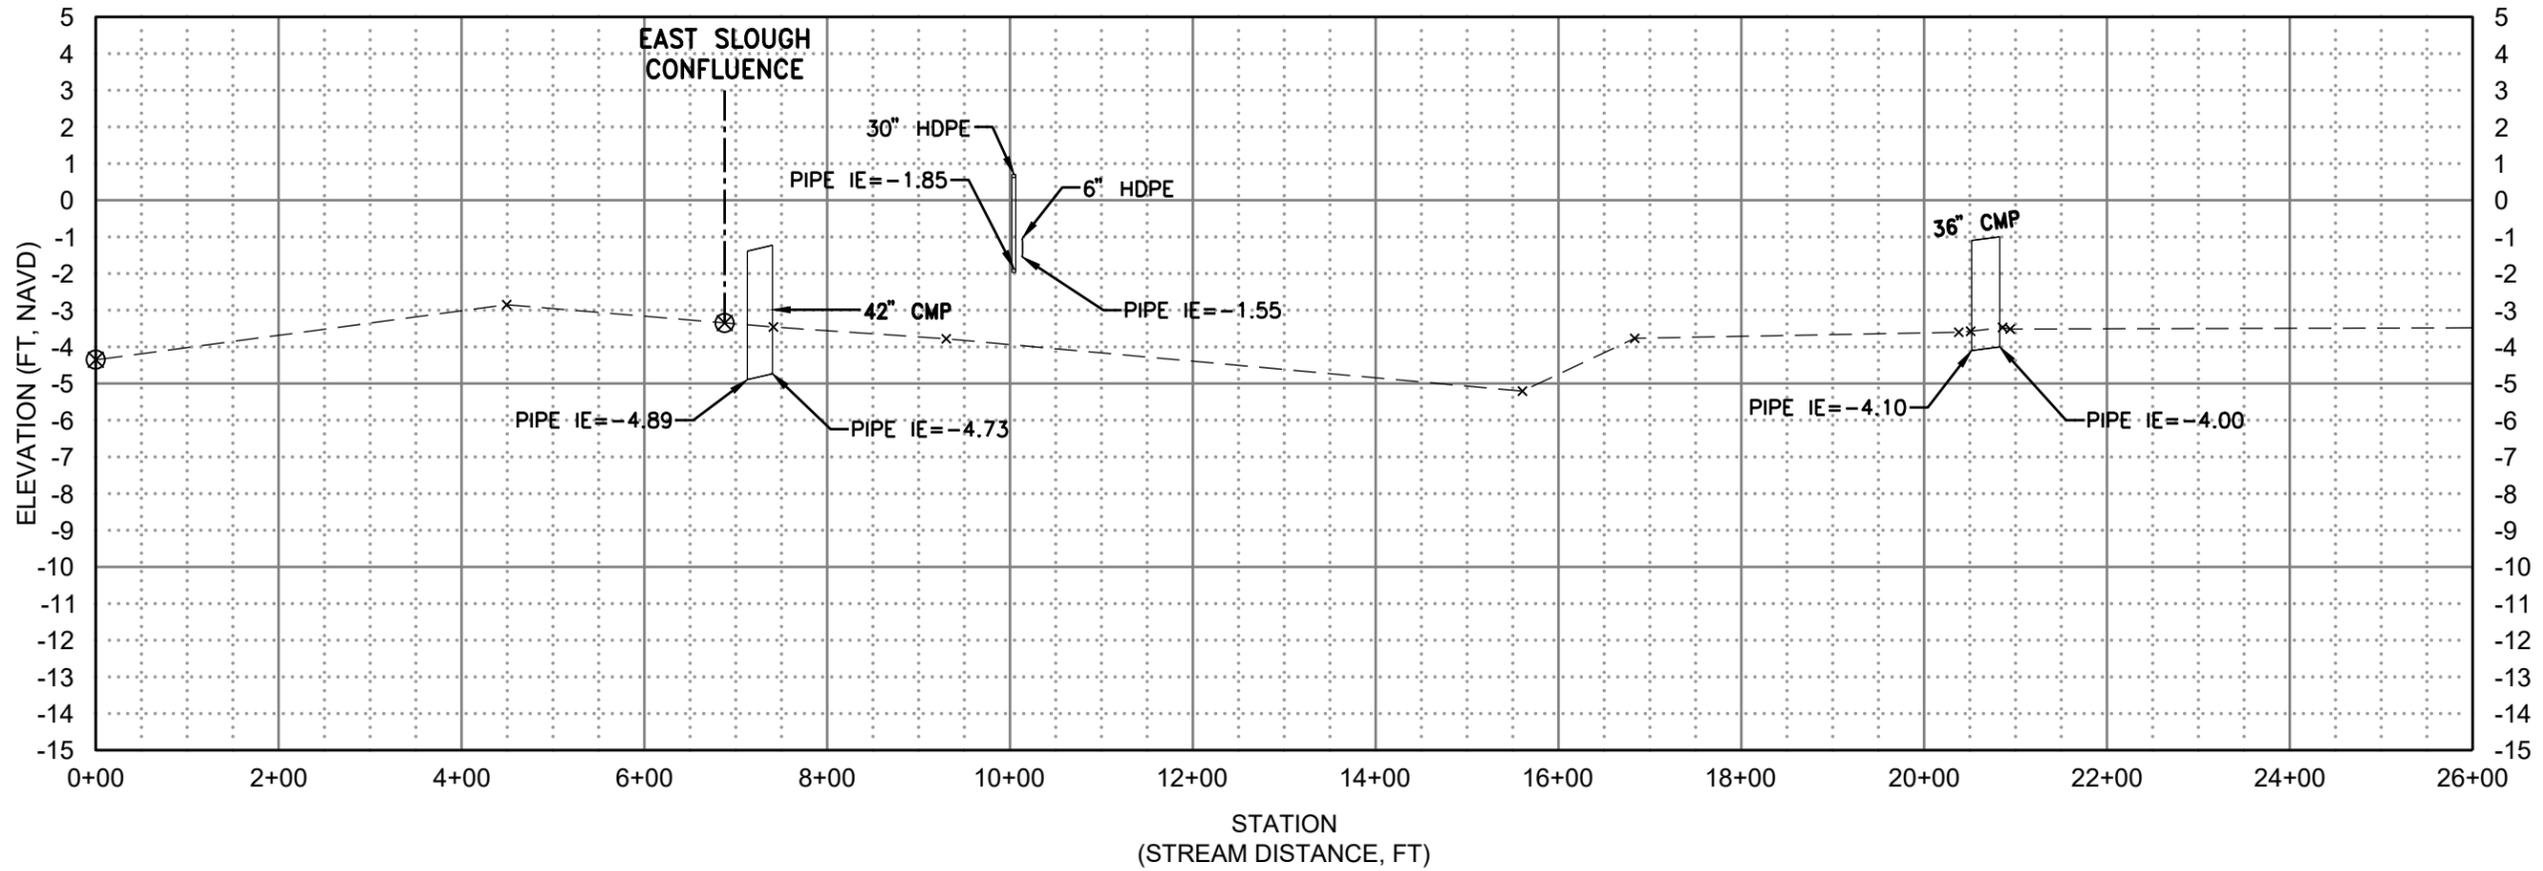
WEST SLOUGH STA 0+00 TO STA 26+00

The sloughs are prone to sediment collecting at the bottom of the channel due to multiple low points in the slough's profile (Appendix A), and standing water caused by backwater from the Golf Course SDPS (Figure 4). Referencing the 1995 slough dredging plan (Section 5.1) and Appendix A, approximately 1.5 ft – 2 ft of sediment has accumulated in the sloughs over the past 27 years.
