**Date:** December 5, 2022

**Project Name:** Chuck Corica Golf Course Drainage

**Subject:** Project Technical Memorandum

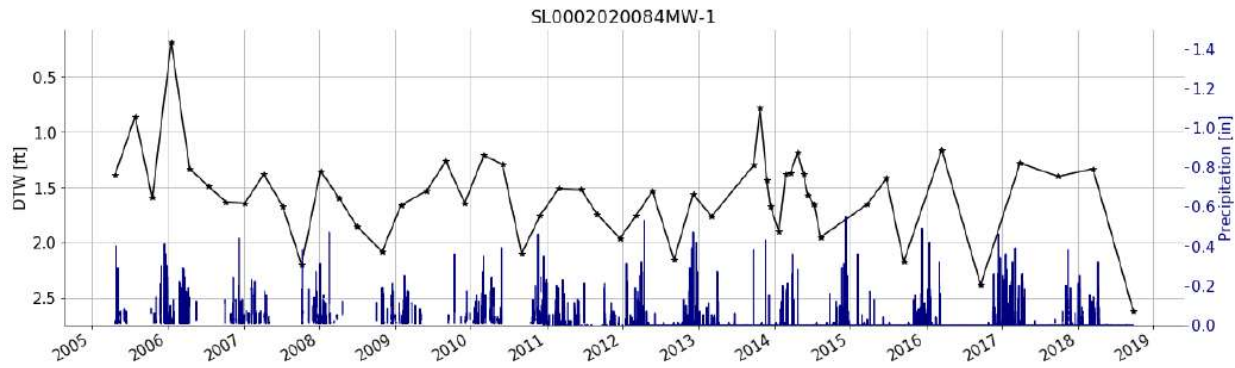
To a lesser extent, other factors such as groundwater and structurally compromised assets contribute to the Golf Course storm system’s flooding. The 2020 groundwater report published by Silvestrum Climate Associates (Section 5.2) concluded the City is highly susceptible to shallow groundwater. Figure 21, taken from their report, shows the depth to shallow groundwater adjacent to Doolittle Drive on Bay Farm Island can range between 0.5 feet and 2.5 feet, depending on the time of year. Any location in the slough with a depth larger than 2.5 feet below its bank will most likely experience groundwater intrusion throughout

the calendar year. In fact, water surface elevations measured in the field were shown to be within the depth tolerance of Figure 21, concluding the standing water observed in the northern portion of the sloughs is most likely from shallow groundwater intrusion. The consequence of groundwater draining into the sloughs is that the capacity is further reduced. Groundwater is occupying hydraulic capacity and storage which, if not present, could be used to convey and store storm runoff.

**Figure 21 – Depth to Groundwater (DTW) at Doolittle Drive on Bay Farm Island<sup>1</sup>**

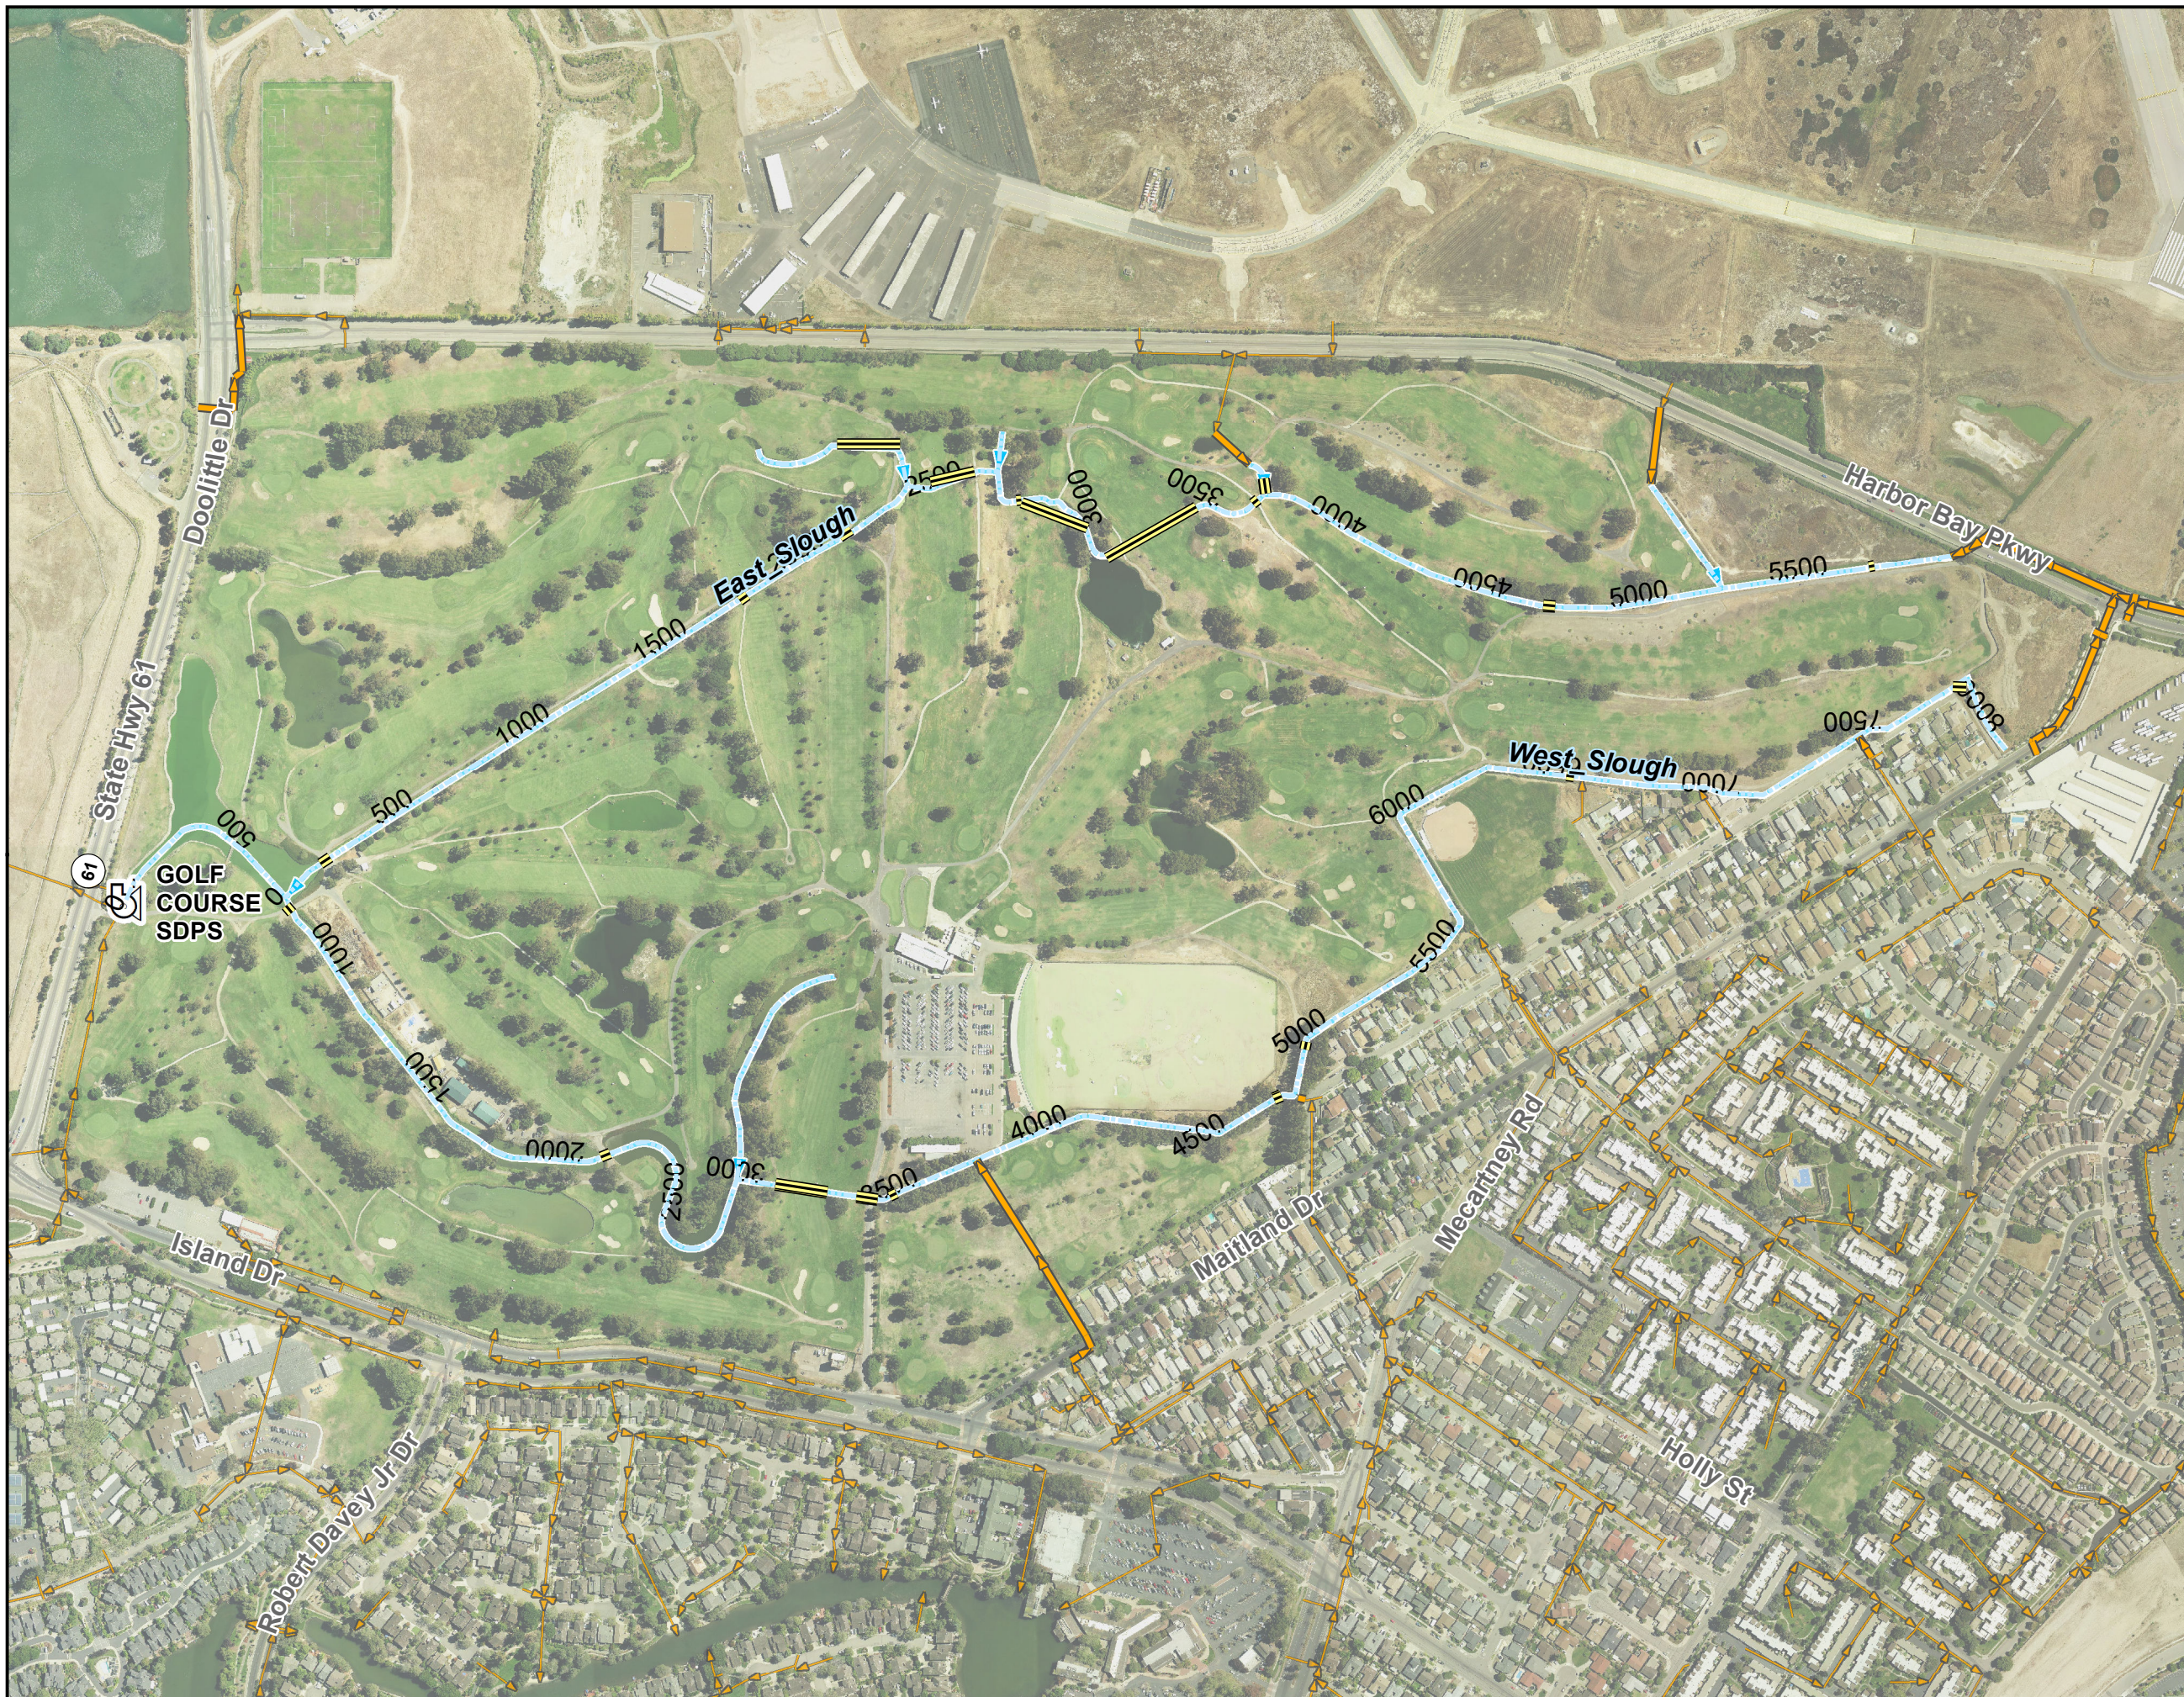
WEST SLOUGH STA 0+00 TO STA 26+00

The sloughs are prone to sediment collecting at the bottom of the channel due to multiple low points in the slough's profile (Appendix A), and standing water caused by backwater from the Golf Course SDPS (Figure 4). Referencing the 1995 slough dredging plan (Section 5.1) and Appendix A, approximately 1.5 ft – 2 ft of sediment has accumulated in the sloughs over the past 27 years.
