Summary Report
On Interim
Inspection,
Testing, and
Preliminary
Analysis of
Alameda Piers 1,
2, and 3

26 May 2017

SGH Project 167543

SIMPSON GUMPERTZ & HEGER

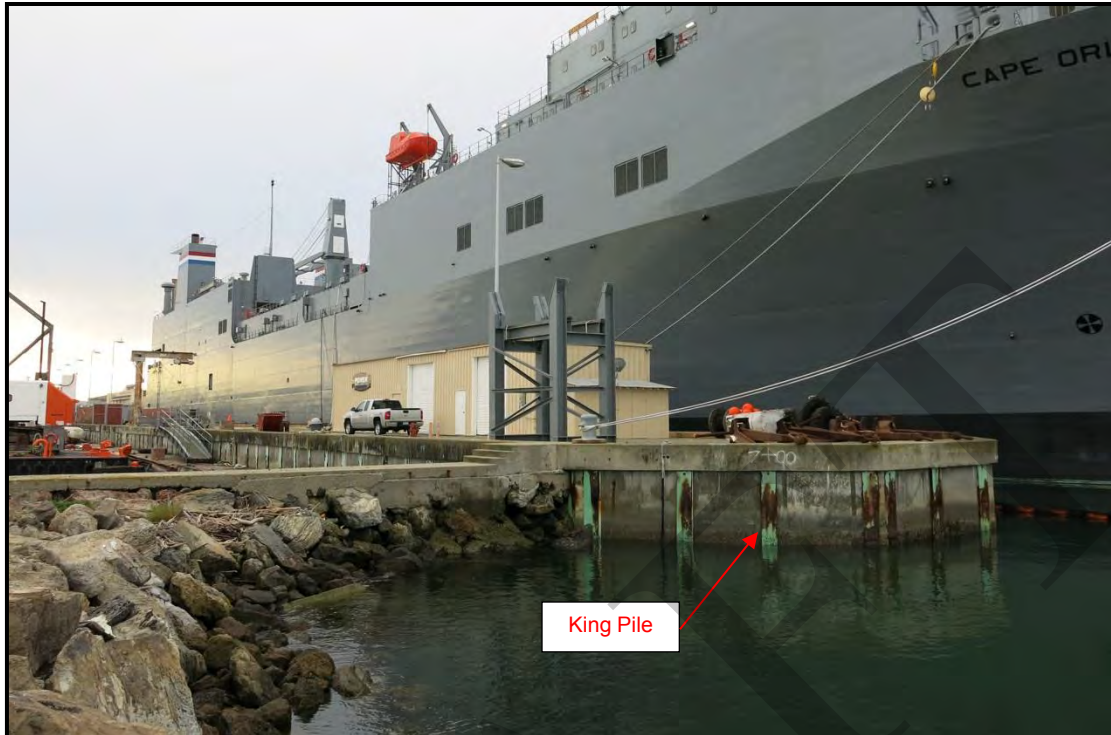
Photo 1: West end of Pier 1 looking east.

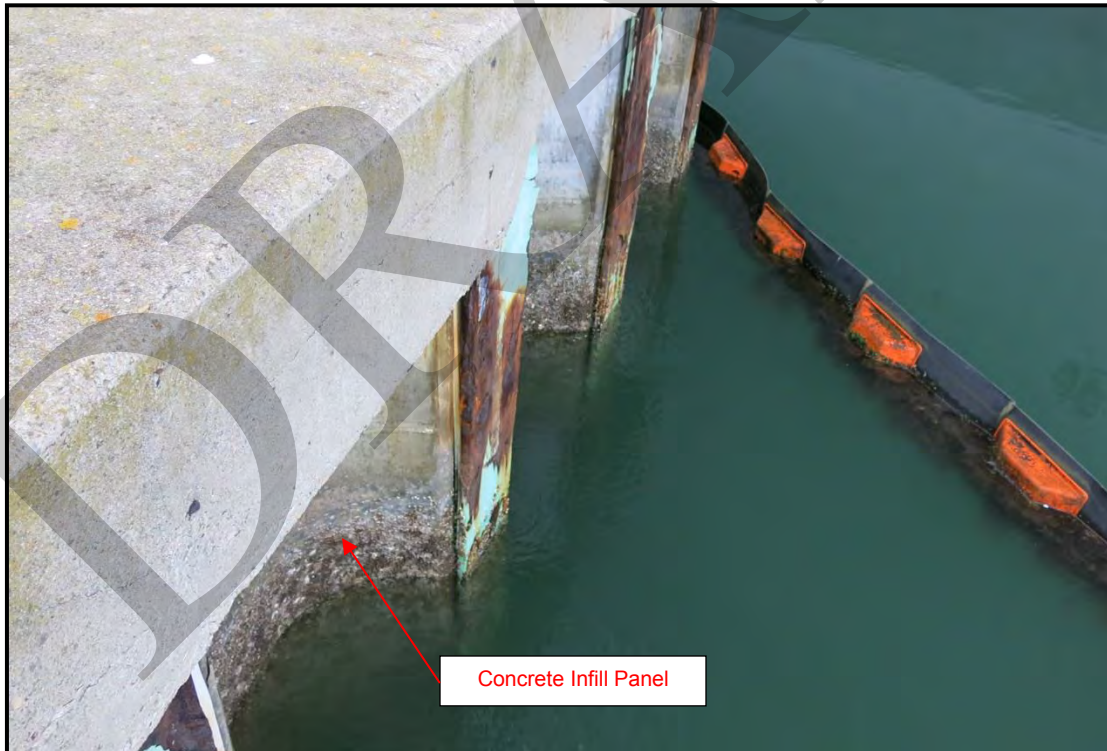
Photo 2: Scalloped concrete infill panels at south side of Pier 1.

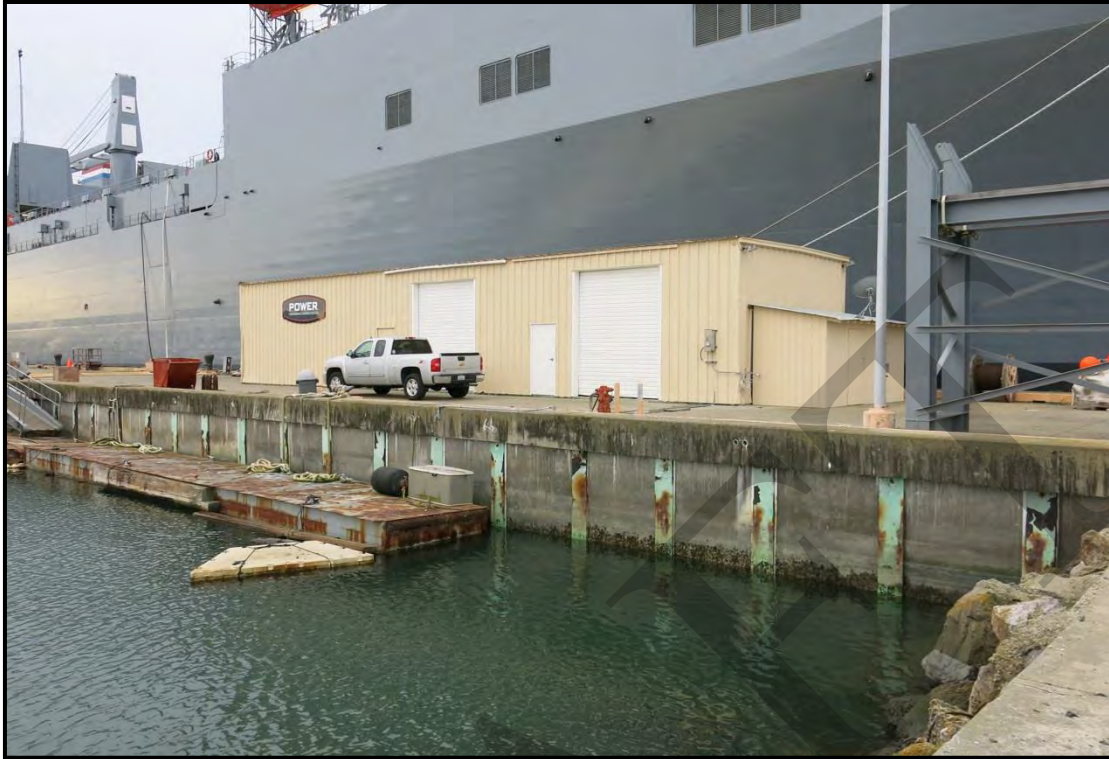
Photo 3: Flat concrete infill panels at north side of Pier 1.

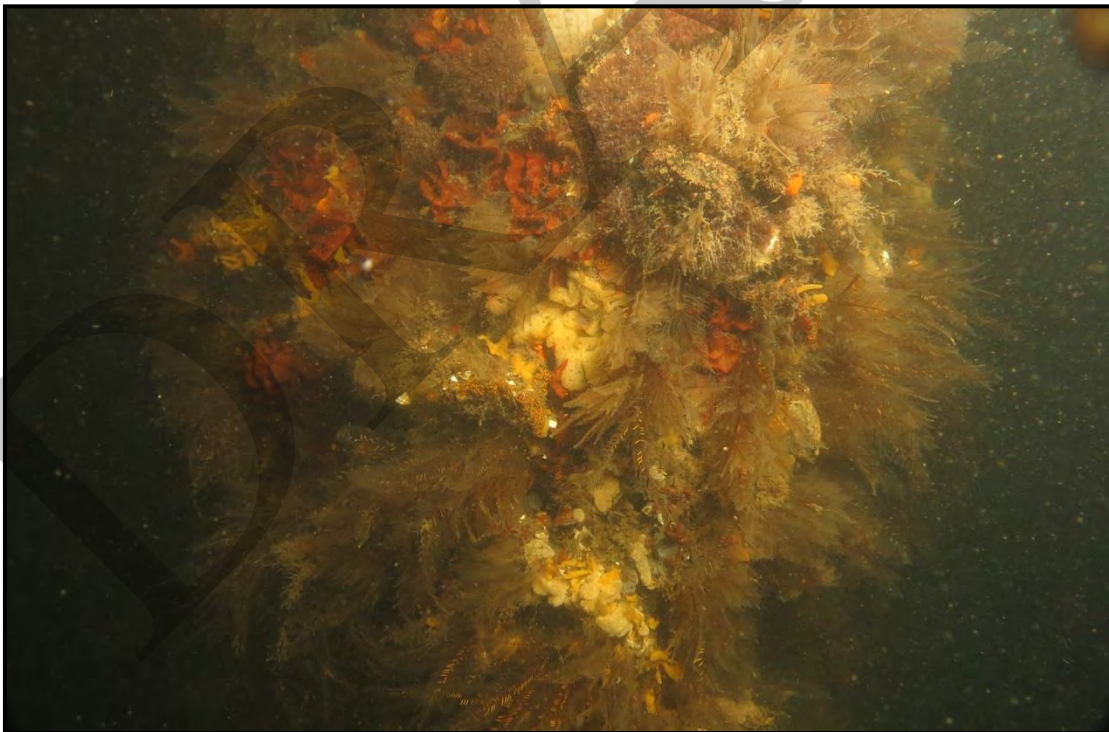
The underwater visibility during the inspection was typically less than five feet with no current. Hard and soft marine growth up to six inches thick was typically found below water (Photo 4). A commercial pressure washer was employed to remove the growth at Level II inspection locations (Photo 5).

Photo 4: Typical marine growth on structural piles.

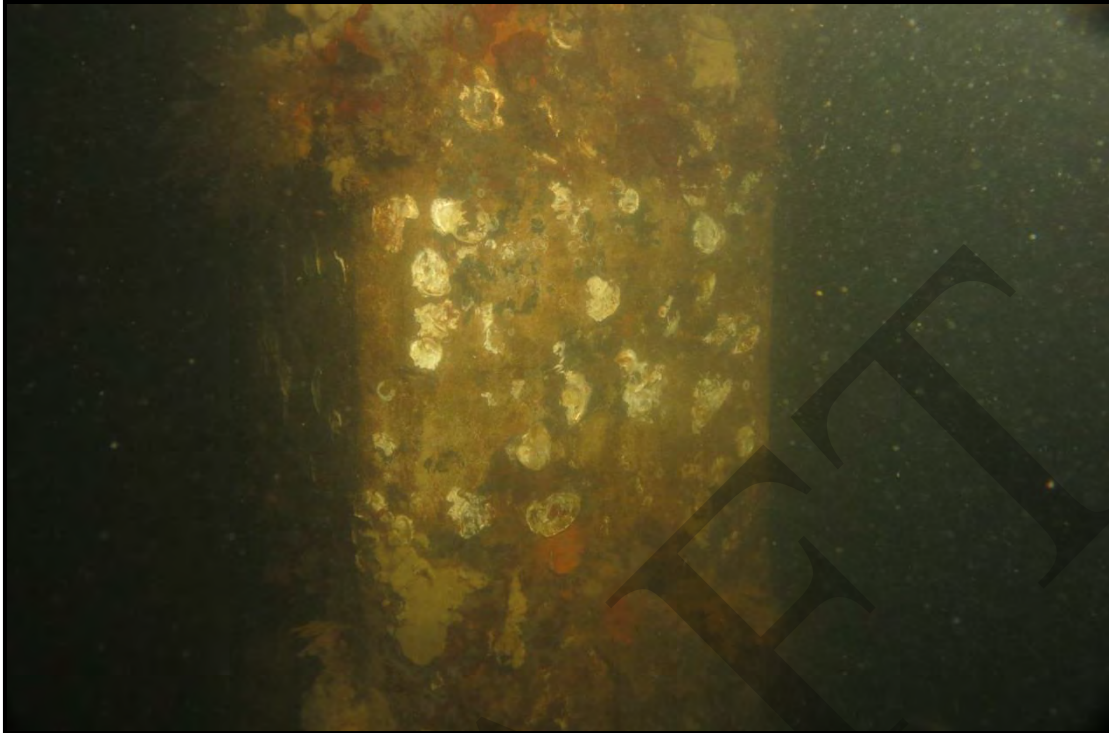
Photo 5: Typical Level II location with marine growth removed.

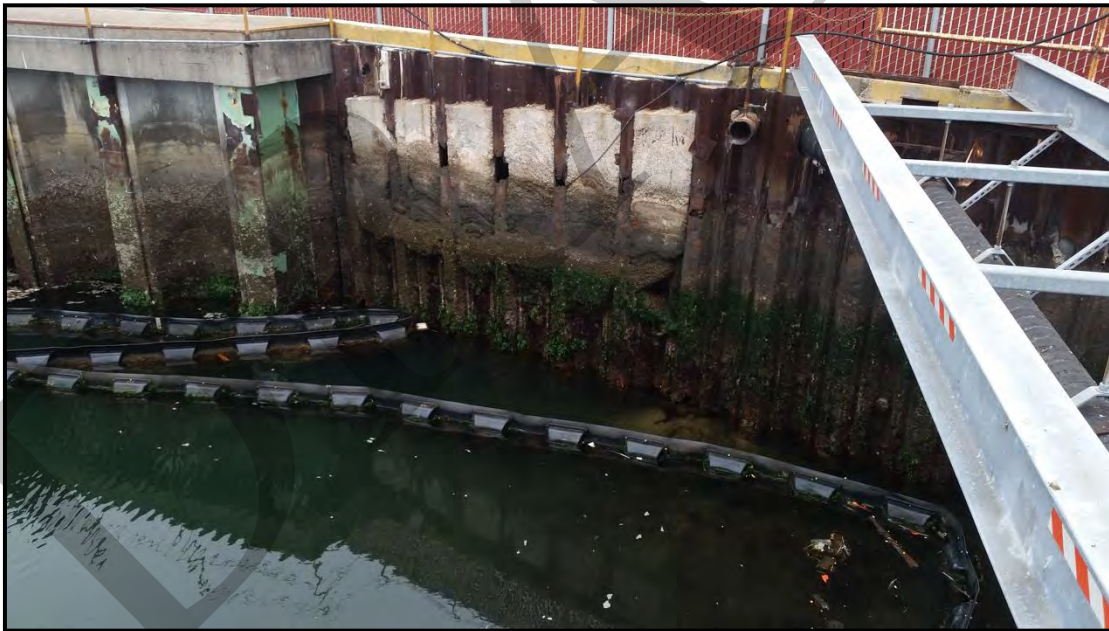
The steel sheet pile wall on the south side of the pier between the marginal wharf and the pier is in poor condition with severely corroded steel, holes in the sheet piles, and loss of fill (Photos 6 and 7).

Photo 6: Original steel sheet pile wall at south side of Pier 1.

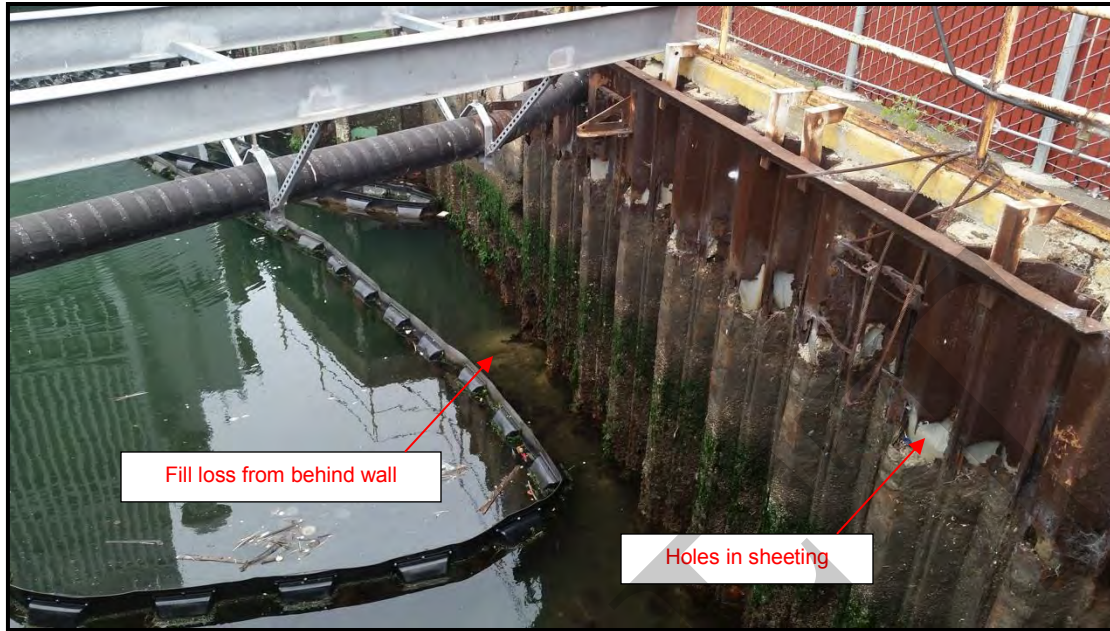
Photo 7: Original steel sheet pile wall at south side of Pier 1.

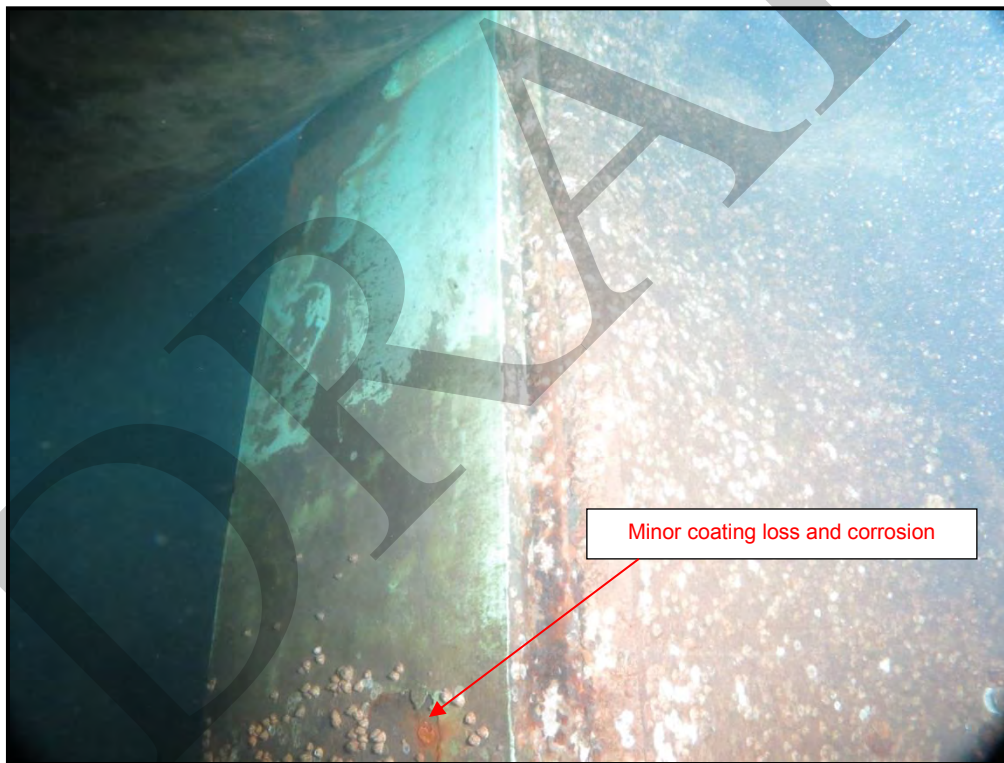
The steel king piles are typically in good condition below water. Pile coatings are generally intact but several isolated areas of coating loss and corrosion were noted (Photos 8 and 9). In the tidal zone and atmospheric zone there is significant coating loss and minor to moderate corrosion (Photo 10). Ultrasonic thickness (UT) measurements and electrical potential readings were recorded at all Level III locations (Photos 11 and 12). Refer to Appendix C for Level III inspection data. UT readings generally indicate little to no loss of cross section at the areas measured. There is no cathodic protection (CP) system in place at Pier 1 and the electrical potential readings confirm that the steel is unprotected.

Photo 8: Steel king pile with substantially intact coating below water.

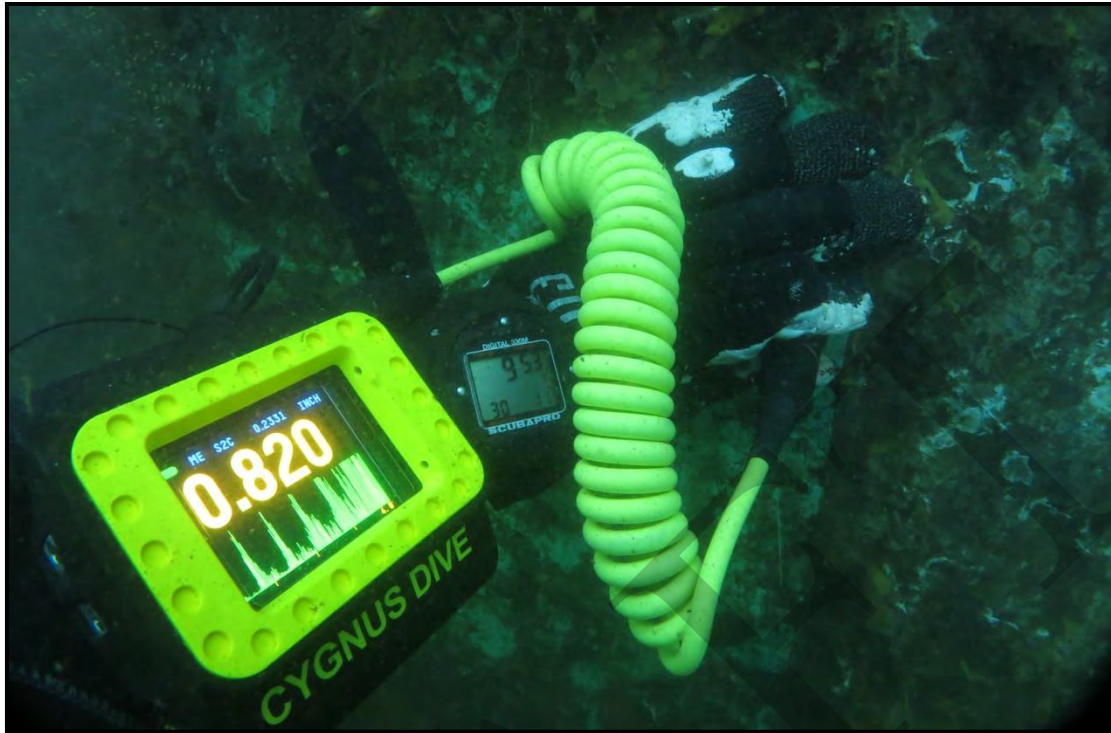
Photo 11: Ultrasonic thickness measurement at steel king pile on Pier 1.

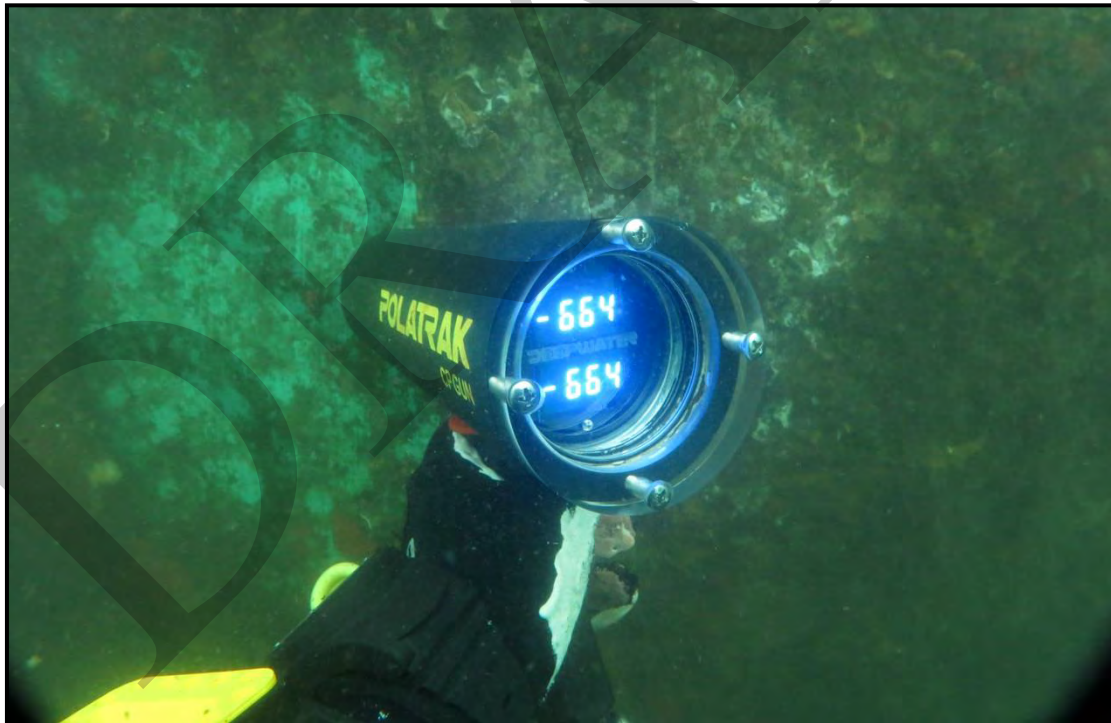
Photo 12: Electrical potential measurement at steel king pile at Pier 1.

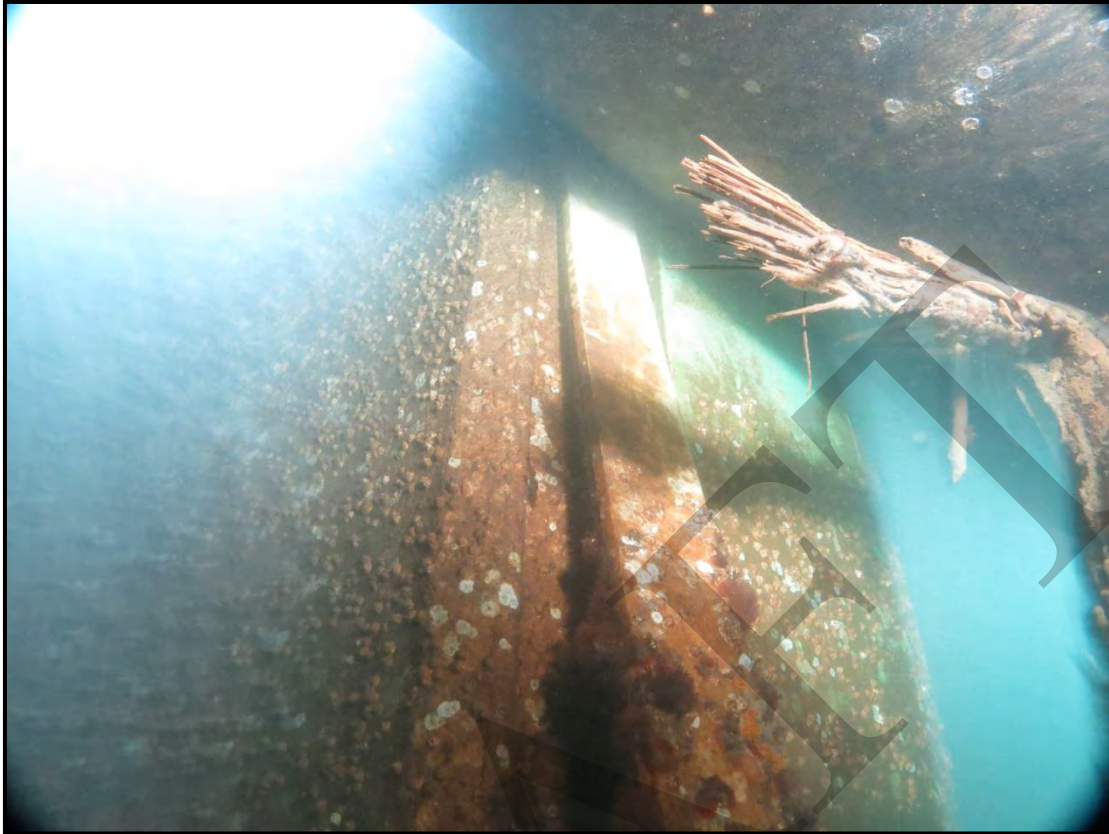
The concrete infill panels are generally in good condition with only minor cracking observed in a few locations. The plastic guides installed between the king piles and the infill panels are generally in place; however, in several locations they are displaced (Photo 13).

Photo 13: Displaced plastic guide between king pile and concrete infill panel.

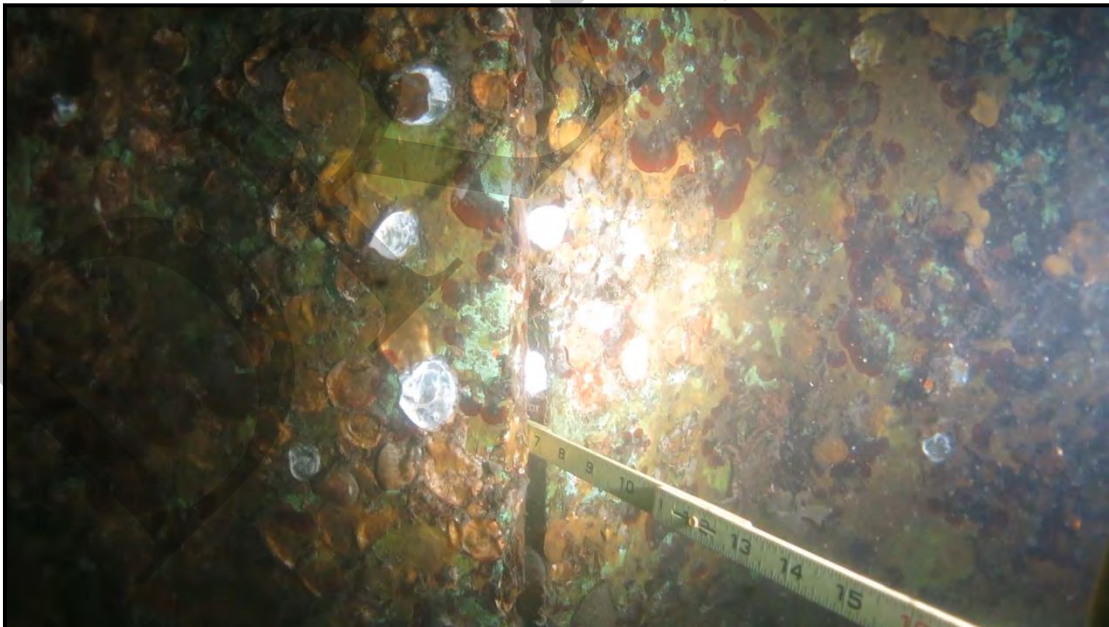
At the offshore end of the pier at corners 6+52, 6+75, and 6+92 concrete fills the void between the two king piles at each corner. This concrete extends from the deck to the lower tidal zone. Below water, the inner two flanges of the king piles are visible. At corner 6+75 there is a gap between these two flanges with minor fill loss (Photo 14).

Photo 14: Gap between inner flanges of steel king piles at Corner 6+75 at the west end of Pier 1.

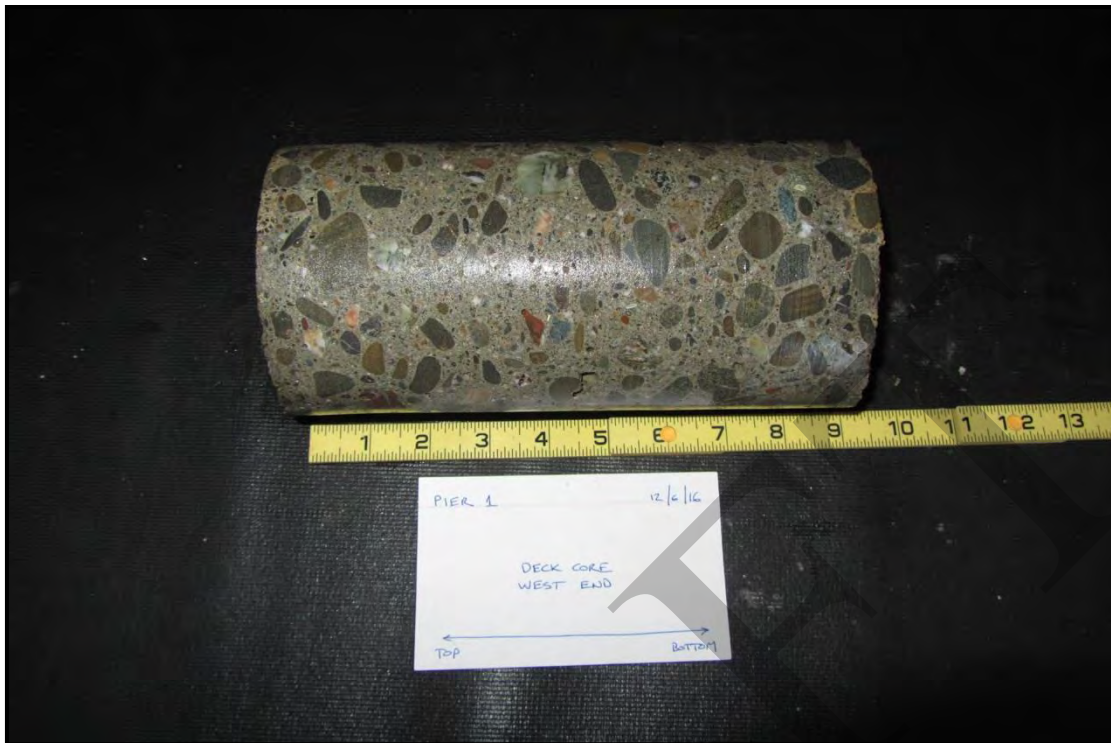
Core samples were extracted from two locations on the deck. One on the north side near the gangway to the floating docks and one near the offshore end of the pier. Both core samples were approximately 8 in. long and came out as one piece (Photo 15). Soil was encountered immediately below the deck with no voids noted between the fill and bottom surface of the deck.

Photo 15: Concrete core sample taken from Pier 1 deck.

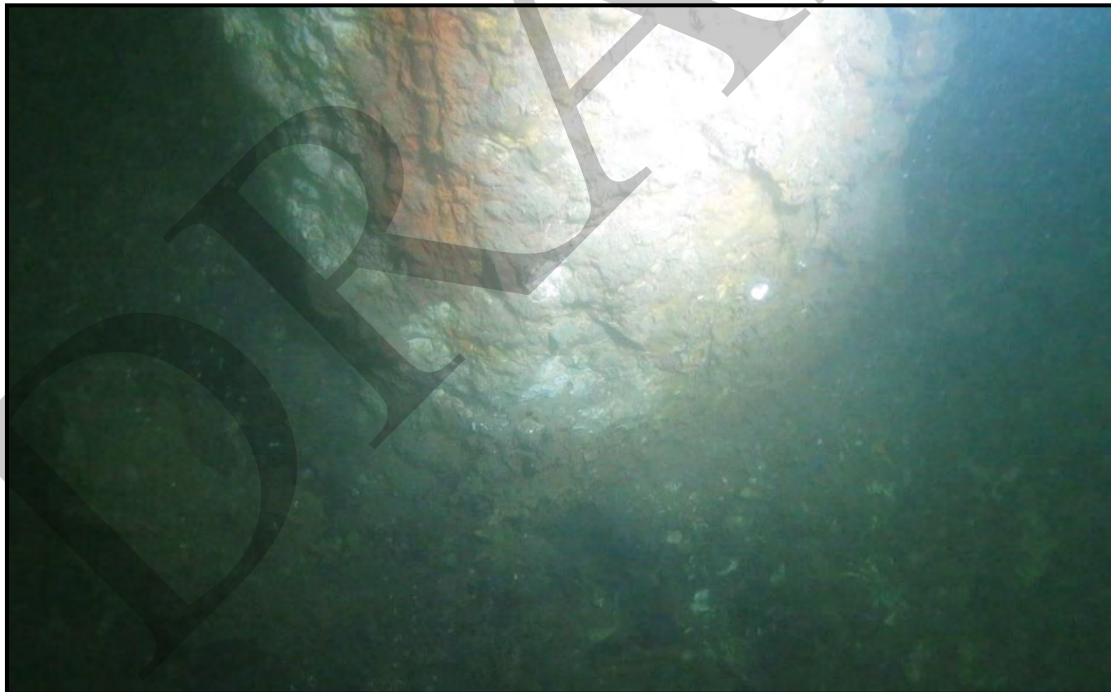
typically appeared to be in better condition near the mudline but some piles have exposed rebar that extends below the mudline (Photo 16).

Photo 16: Pier 2, Pile 43-H - Exposed reinforcing near the mudline.

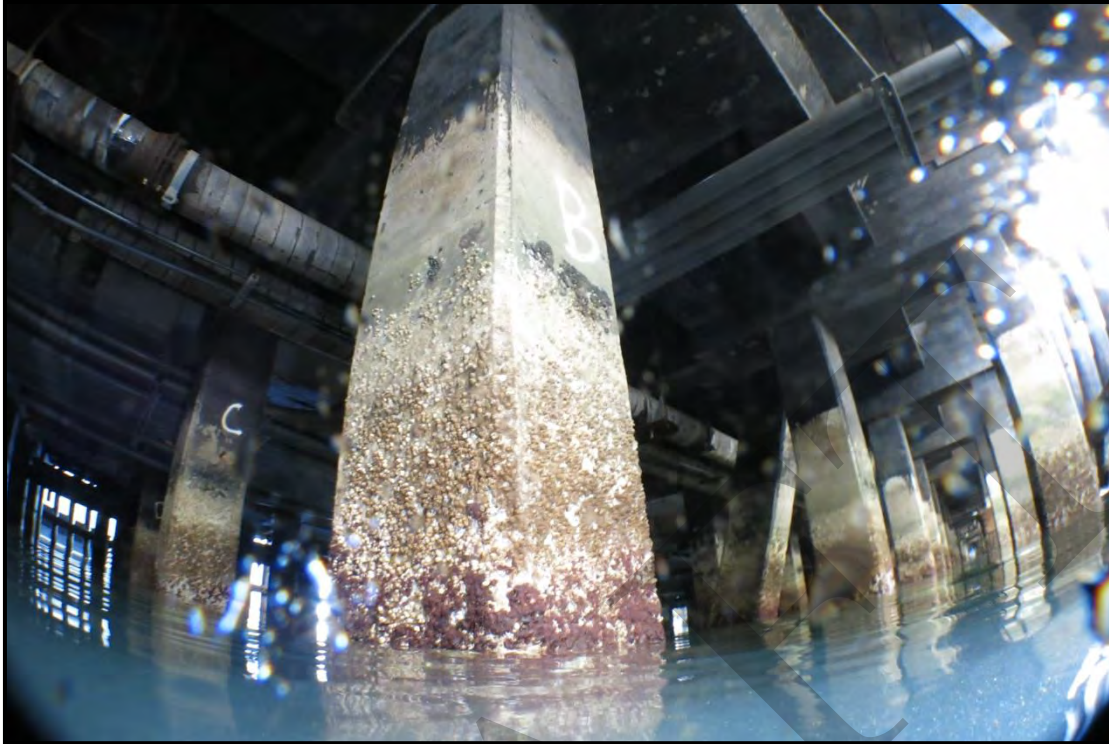
As the concrete becomes soft the corners tend to round off and no longer maintain the chamfered edge seen on intact piles (Photo 17). Based on the rating criteria, rounding up to one inch deep indicates a "Moderate" pile (Photo 18). Rounding greater than one inch deep with no exposed rebar indicates a "Major" pile (Photo 19). Once rebar becomes exposed the pile is considered to be "Severe" (Photo 20).

Photo 17: Typical square pile with chamfered corners.

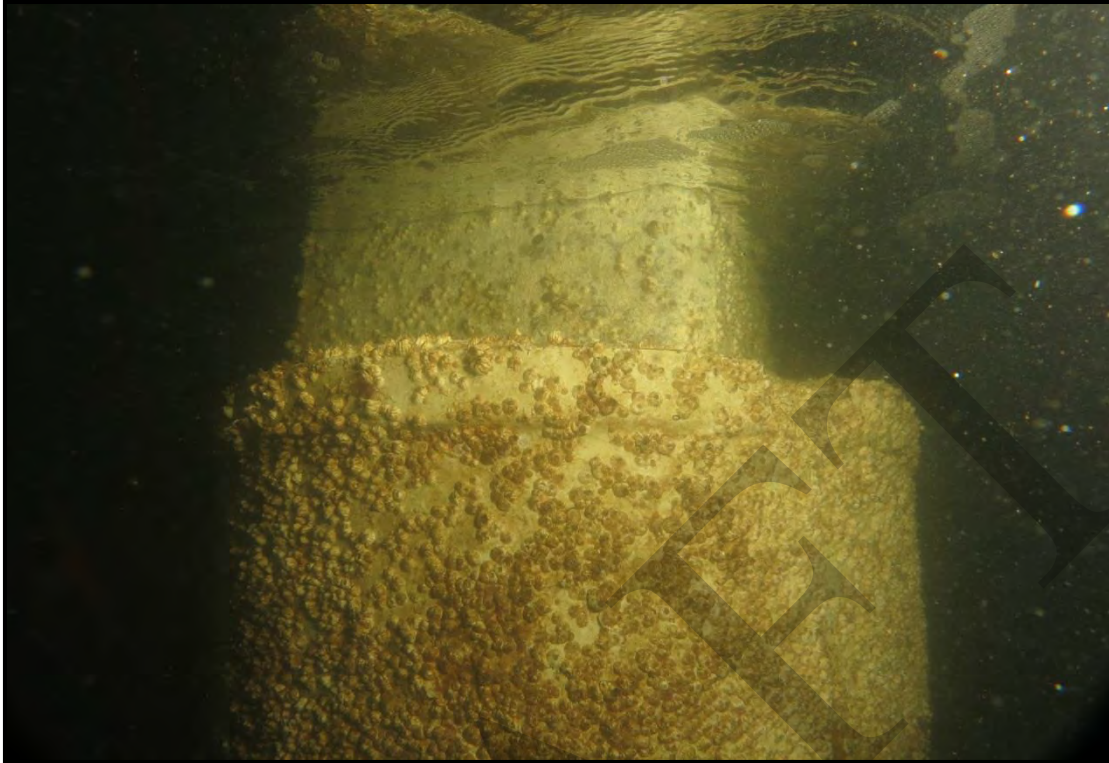
Concrete encasement repairs are present on a number of piles (Photo 21). In some cases, the encasements do not extend below the mudline and the original pile is visible below the encasement. Several of these previously repaired piles are rated major or severe due to deficiencies below the encasements (Photo 22).

Photo 21: Typical concrete encasement installed on concrete pile at Pier 2.

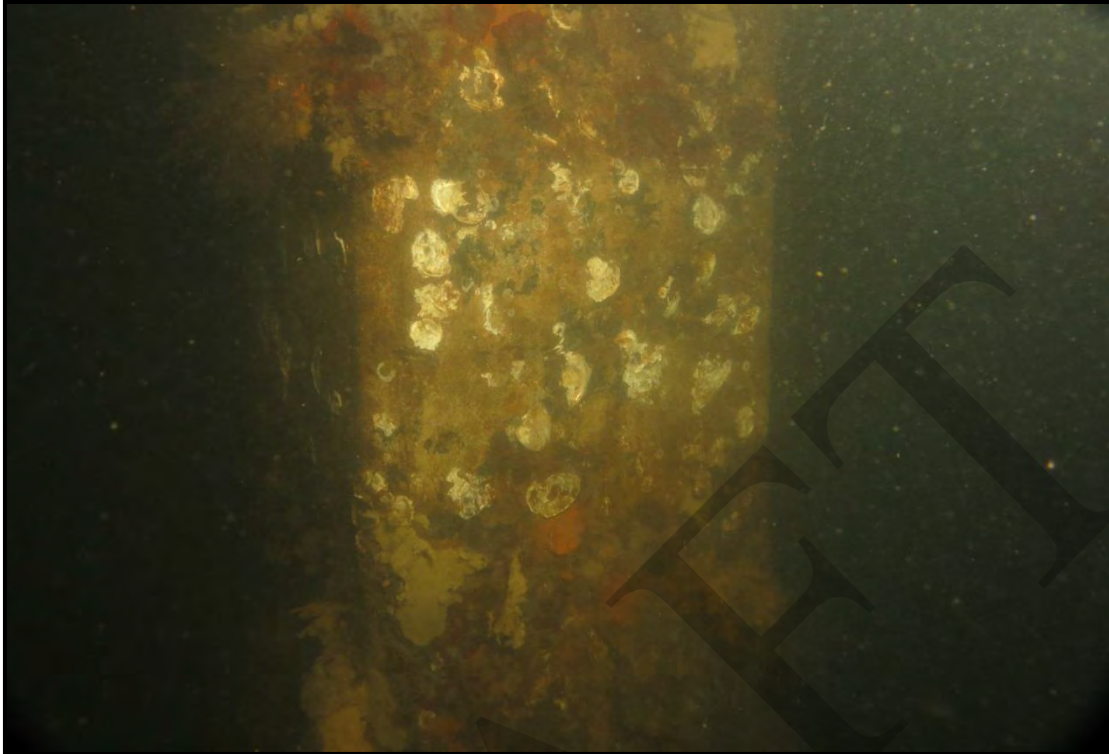
The prestressed piles supporting the extension to Pier 2 (Bents 1-18) and the Mooring Dolphin are generally in good condition with only minor defects noted below water (Photo 23).

Photo 23: Typical Level II inspection location on a prestressed pile.

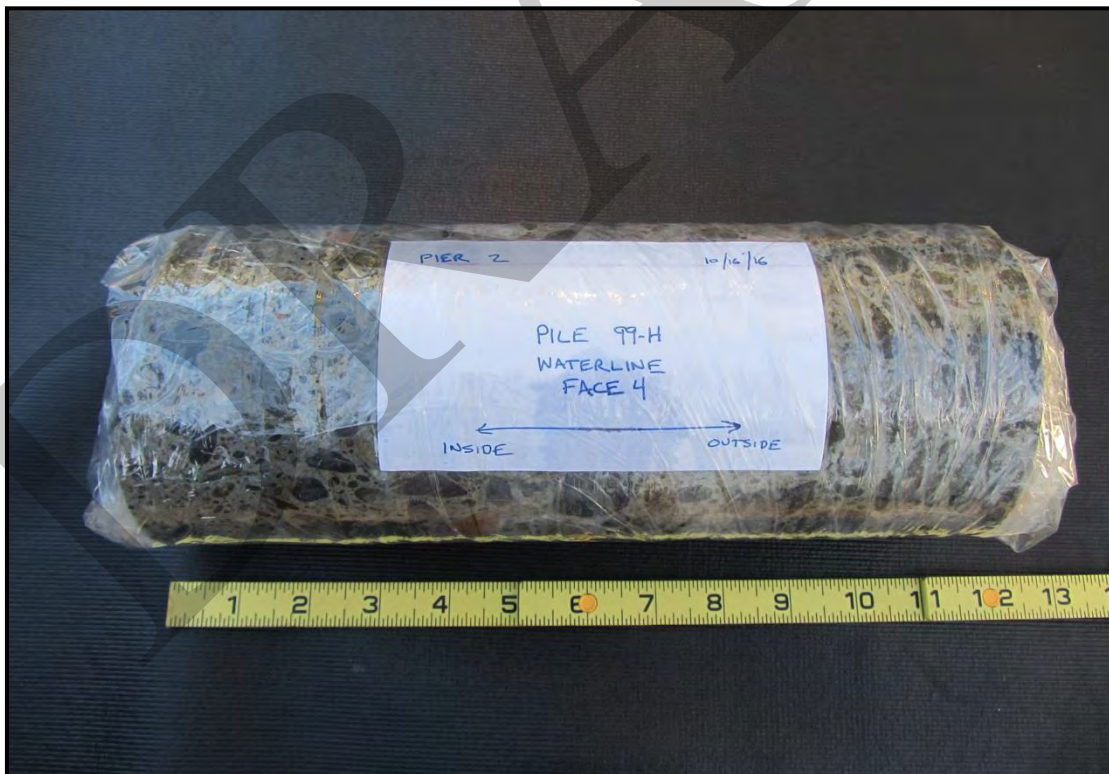
Core samples were removed from 11 piles at Pier 2 (33 core samples)(Photo 24). Refer SGH's report for a discussion of the findings from the chloride intrusion analysis, petrographic analysis, and compressive strength testing.

Photo 24: Typical concrete core sample extracted from Pier 2 (wrapped in plastic prior to packaging for delivery to the testing lab).

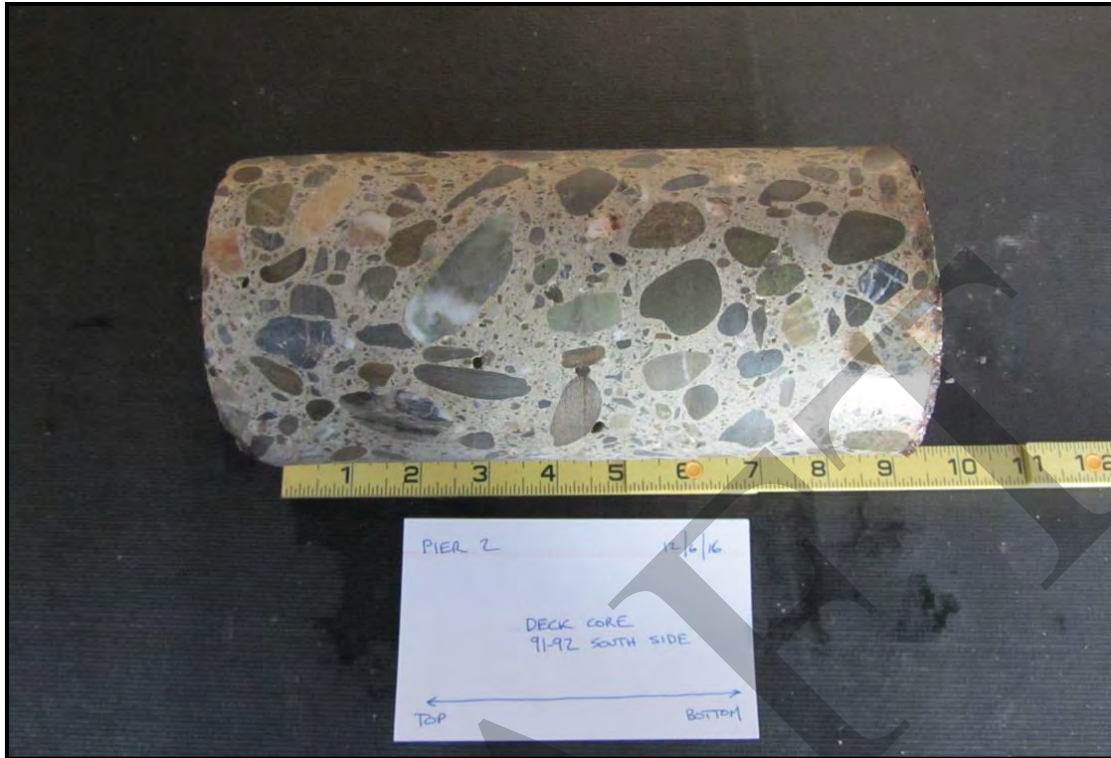
Core samples were extracted from two locations on the deck. One was taken from the north side of the pier close to the concrete curb between Bents 37 & 38 and the other from the south side between Bents 91 & 92. The core samples were approximately 8 in. long and came out as one piece (Photo 25). Both core samples went through the full section of the deck.

Photo 25: Core sample removed from the deck of Pier 2.

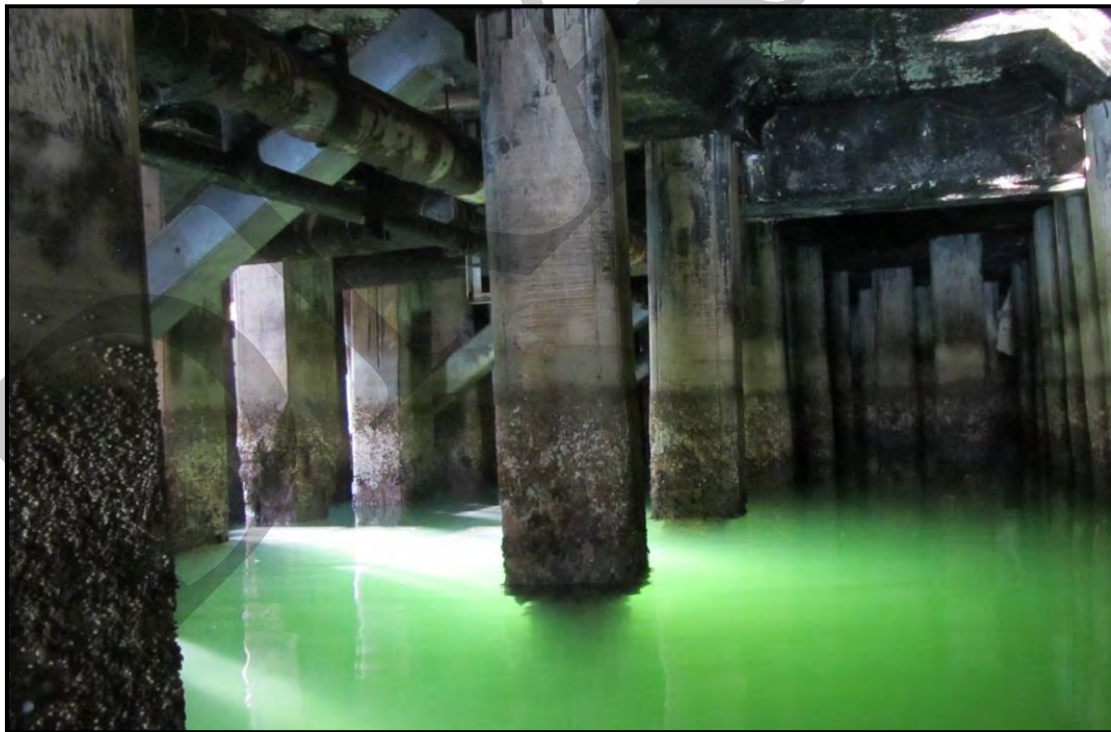
The concrete piles at Pier 3 were not included in the scope of the underwater inspection. SGH performed an inspection of the piles located around the perimeter of the pier that were visible by boat. The piles at Pier 3 have a larger concrete extension cast on top of the original piles (Photo 26). The extensions typically extend below the waterline making visual inspection of the original piles difficult at all but the very lowest tides. During the course of the inspection several piles were noted to be in severe condition due to chemical attack. Refer to SGH's above water inspection report for additional information.

Photo 26: Pier 3 pile with larger extension cast on top of original pile (original pile visible below water).

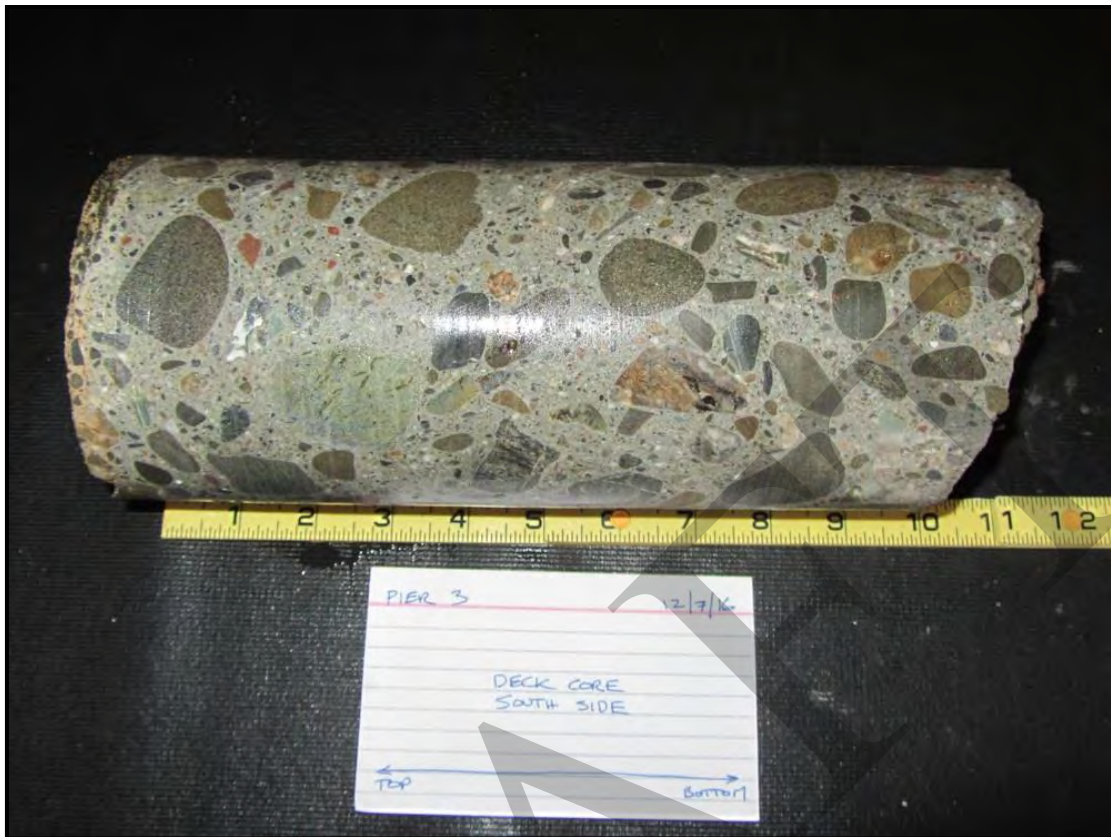
Core samples were extracted from two locations on the deck. Both cores were taken near the offshore end of the pier, one on the north side and one on the south side. The core samples were approximately 10 in. long and each came out as one piece (Photo 27). Due to the increased thickness of the deck at the coring locations, both core samples did not penetrate through the full section of the deck.

Photo 27: Core sample from deck of Pier 3.

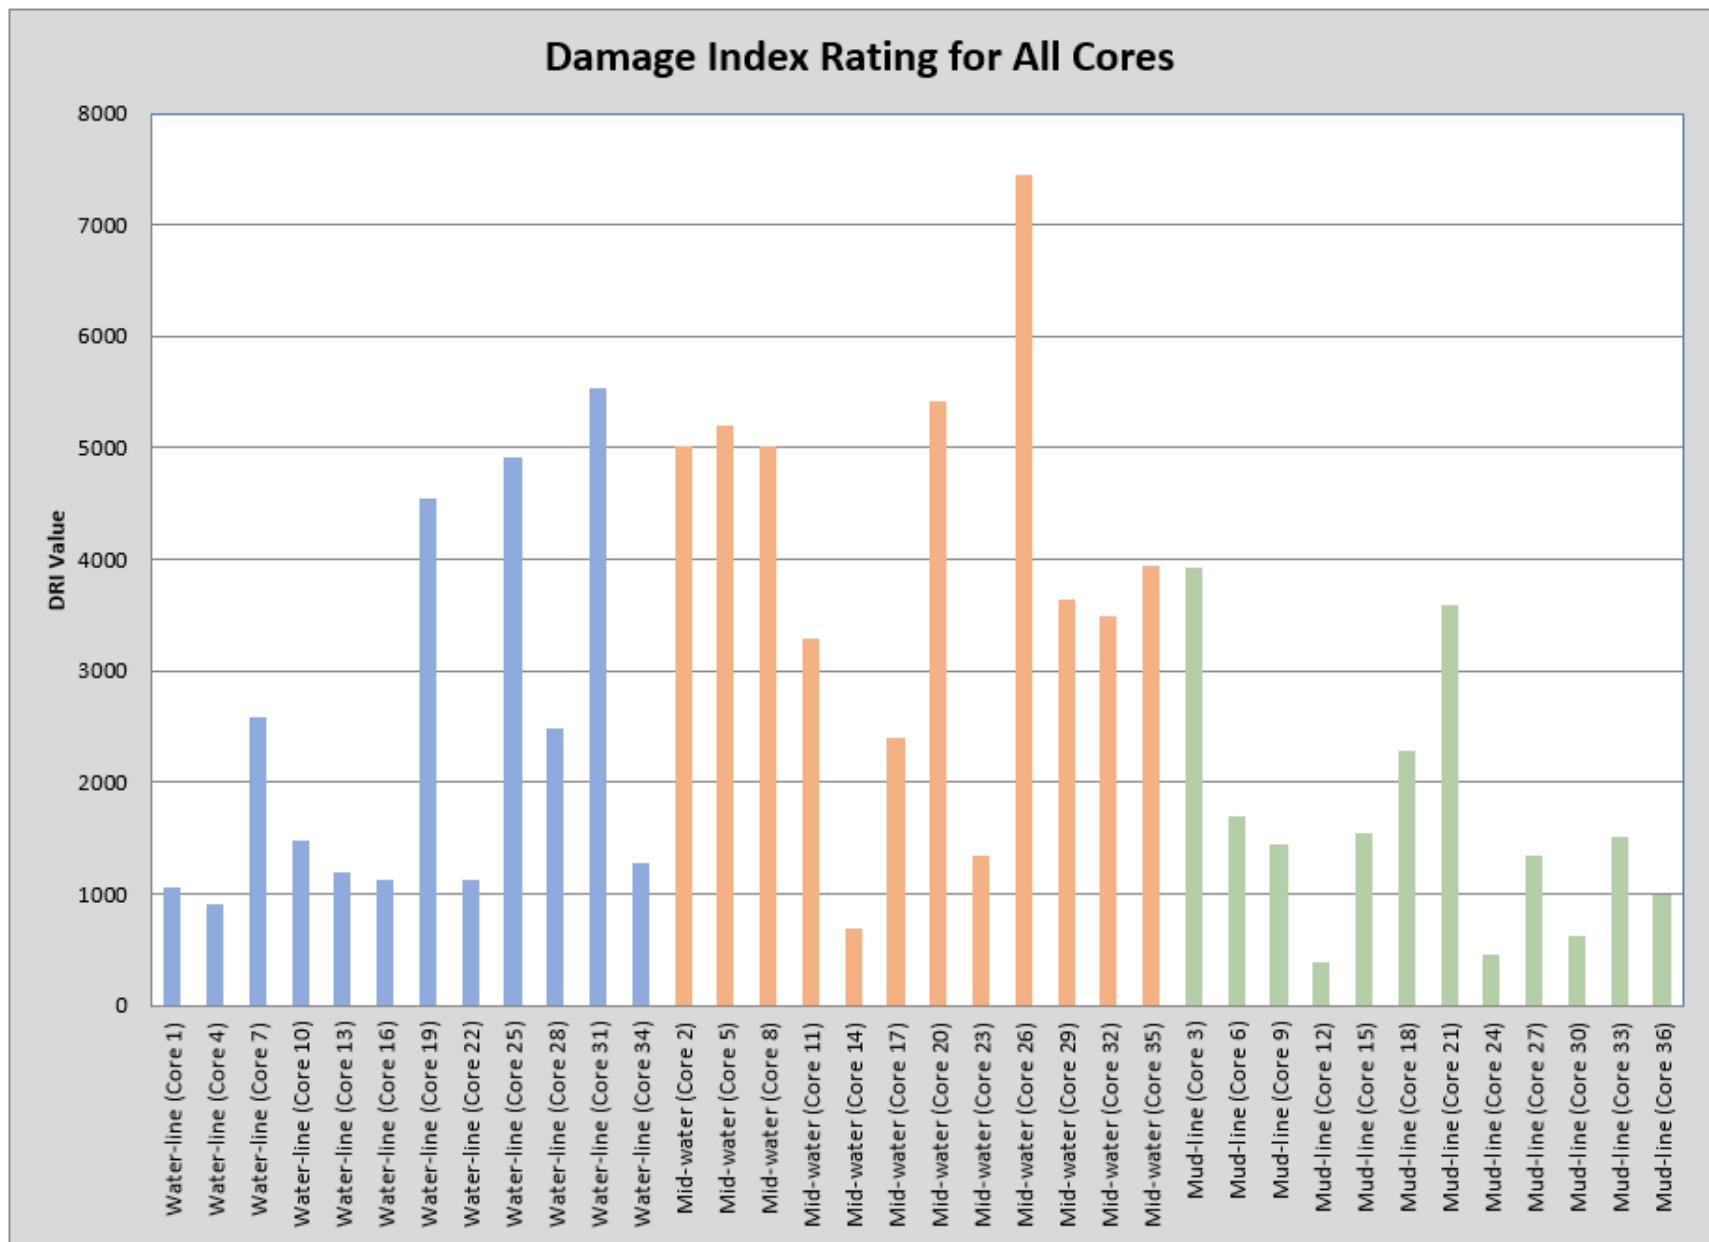
- f) Deterioration was most prominent in the mid-water cores; less, but still significant, in the water-line cores; and diminished, but still present, in the mud-line cores. Figure 1 is a graph showing the DRI values for all the core samples. Note the increase in the damage rating at mid-water. Figure 2 shows the normal distribution of the DRI for the cores taken from the water-line, mid-water and mud-line locations. The DRI is typically applied to alkali-silica reactivity, but was found to be useful in rating the degree of seawater attack.

Figure 1. Damage Rating Index (DRI) for all the pile cores
