Summary Report
On Interim
Inspection,
Testing, and
Preliminary
Analysis of
Alameda Piers 1,
2, and 3

26 May 2017

SGH Project 167543

SIMPSON GUMPERTZ & HEGER

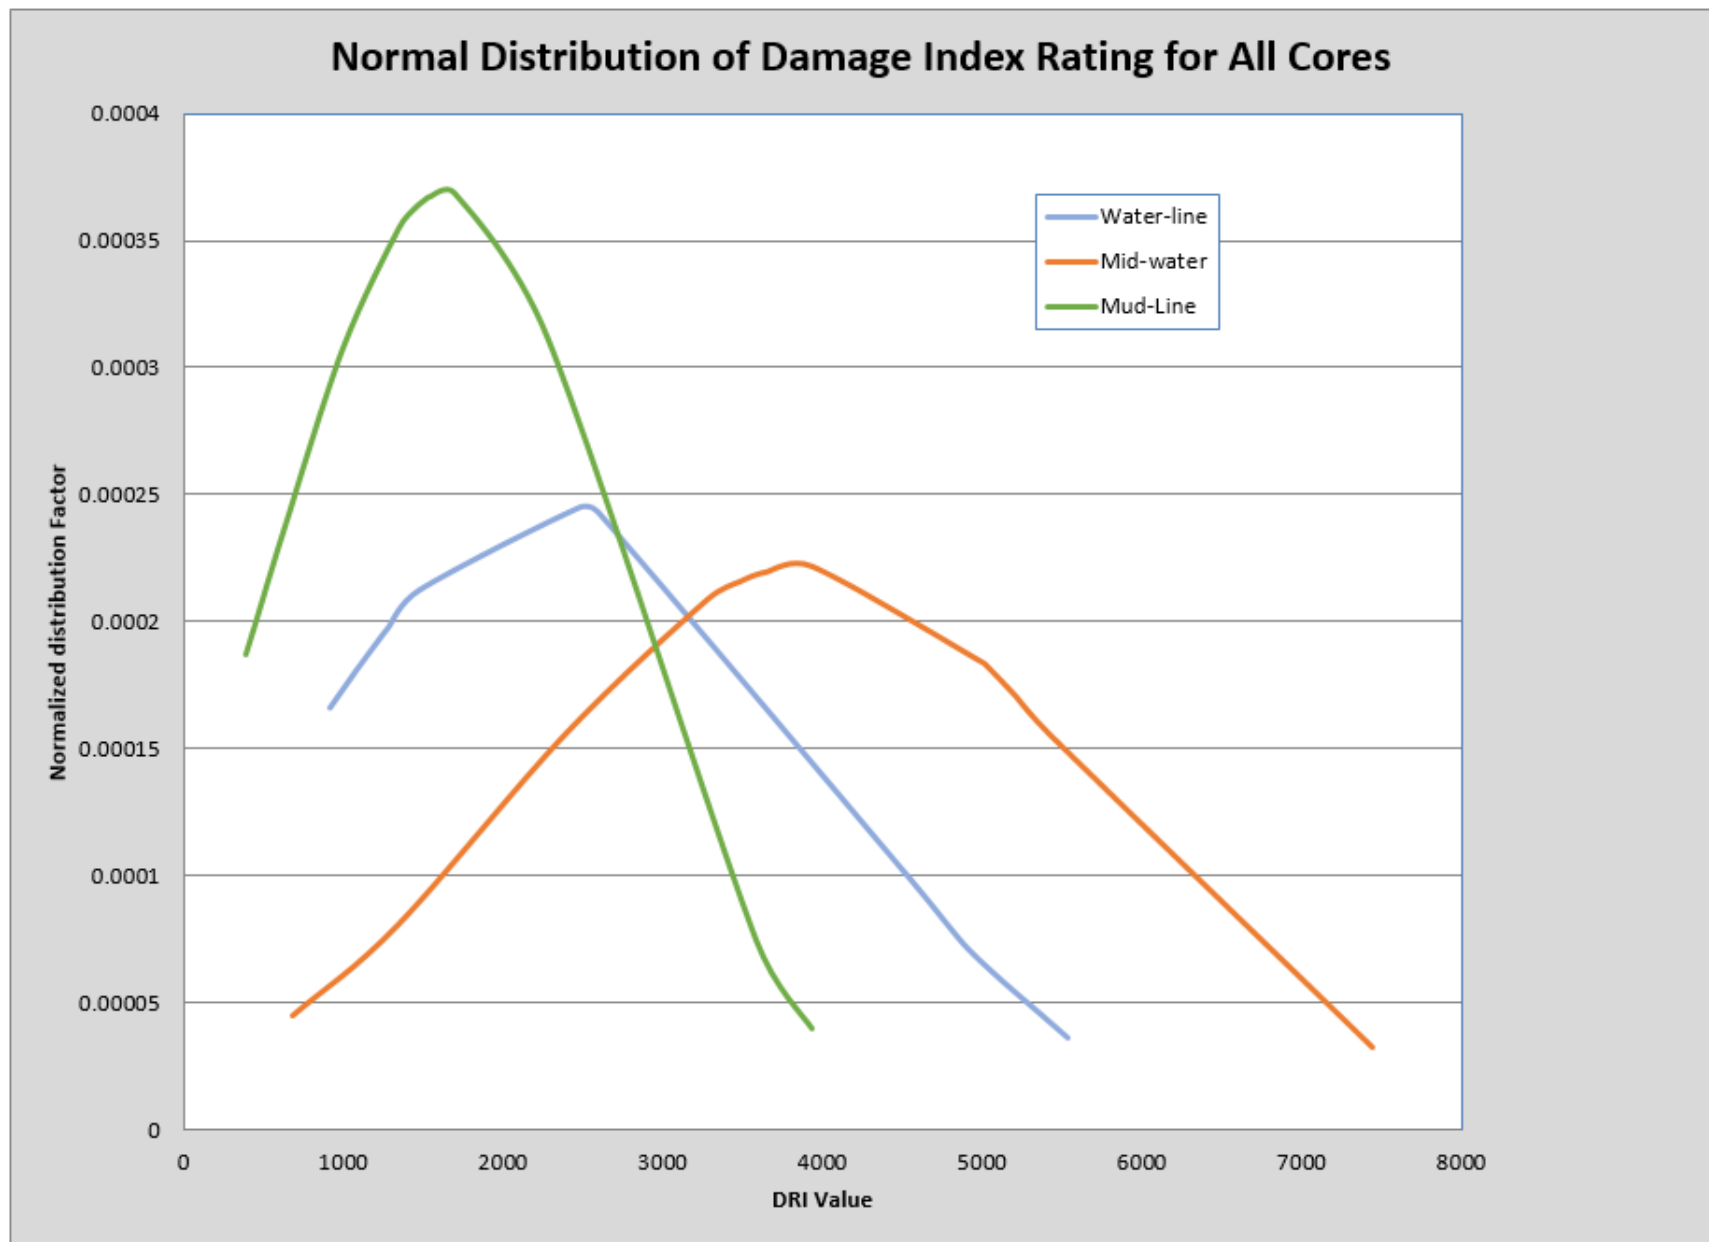
Figure 2. Normal distribution of Damage Rating Index values for the pile core samples. The frequency of DRI occurred with the mid-water core samples.

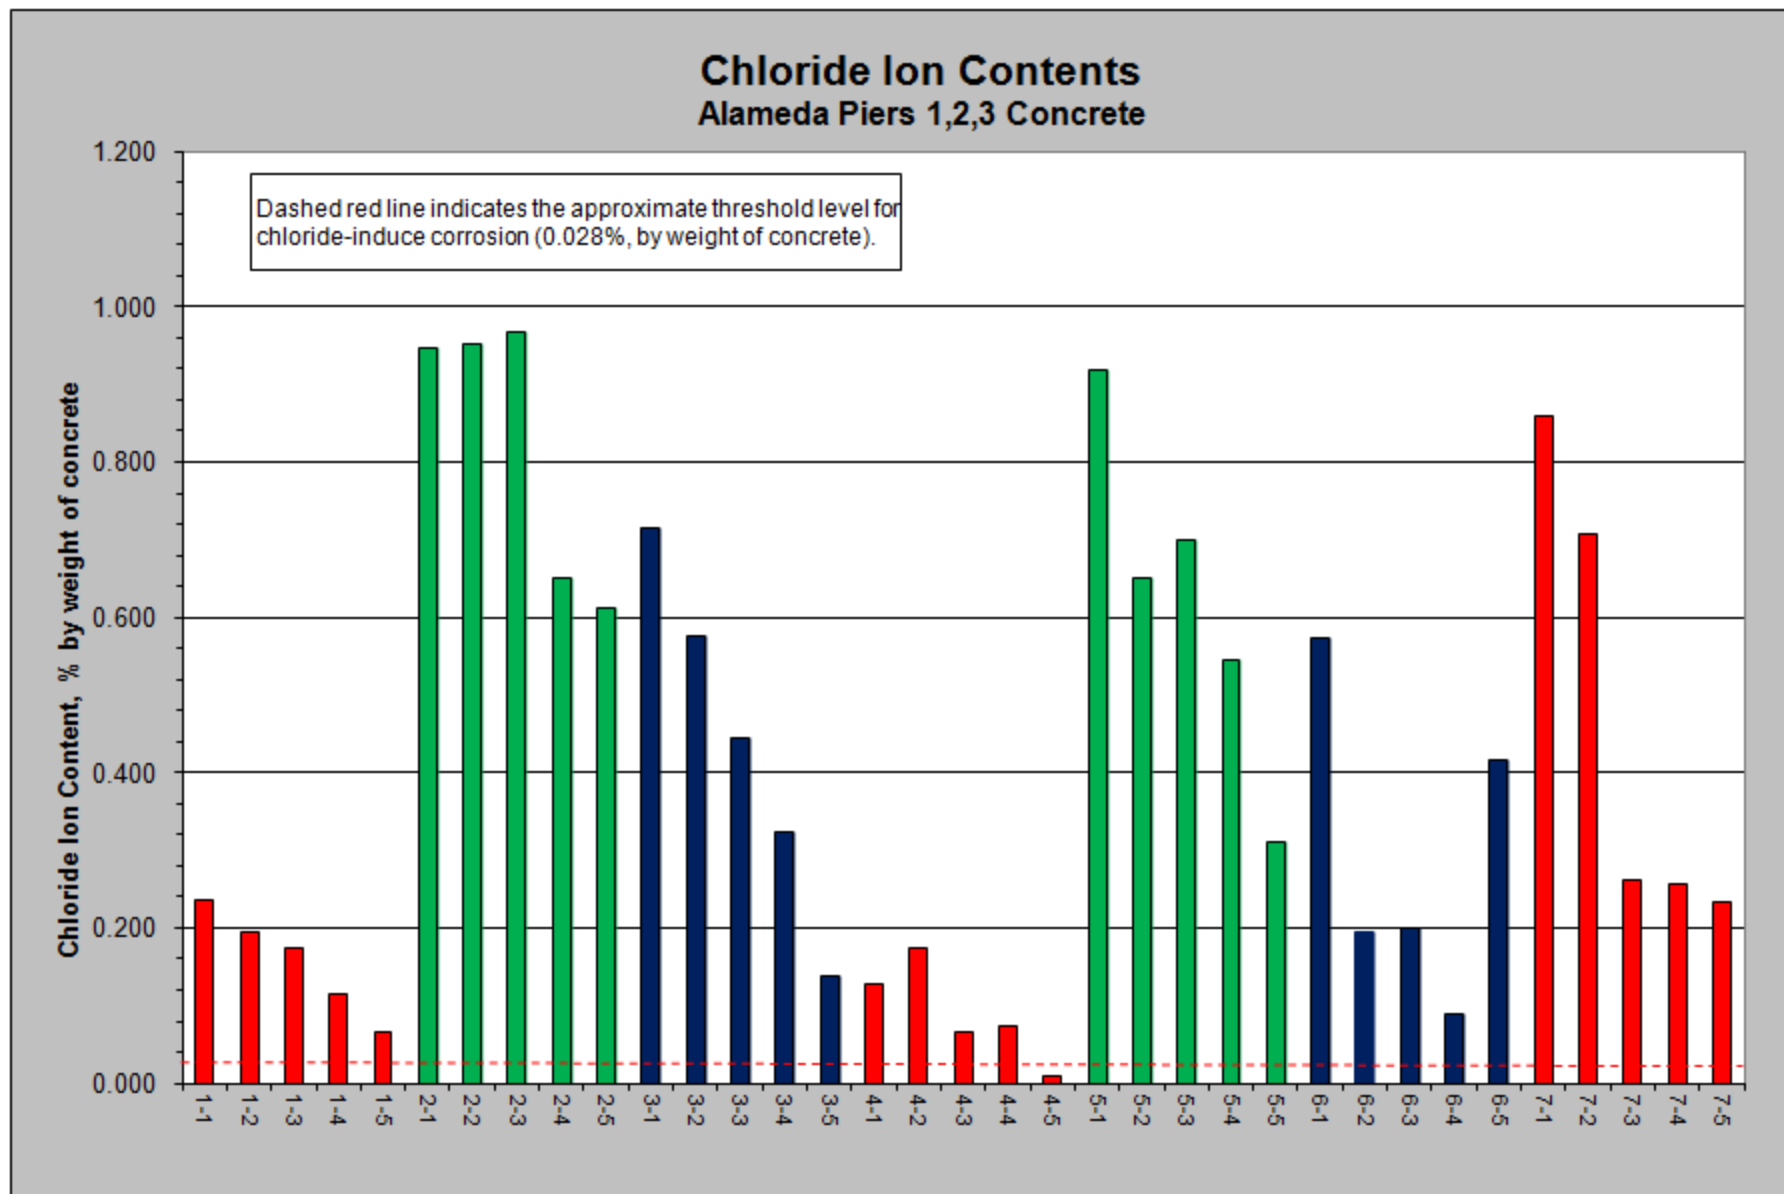
The chloride ion contents of the concrete were determined at incremental depths of 1" starting at ½" from the outer exposed surface. The results of the chloride ion profile testing are given in Tables XIX through XXI. The chloride ion contents are shown graphically in Figures 3 through 7. The individual test results are also included in the petrographic examination summary tables.

Figure 3. Chloride Contents for Set 1, Cores 1 through 7

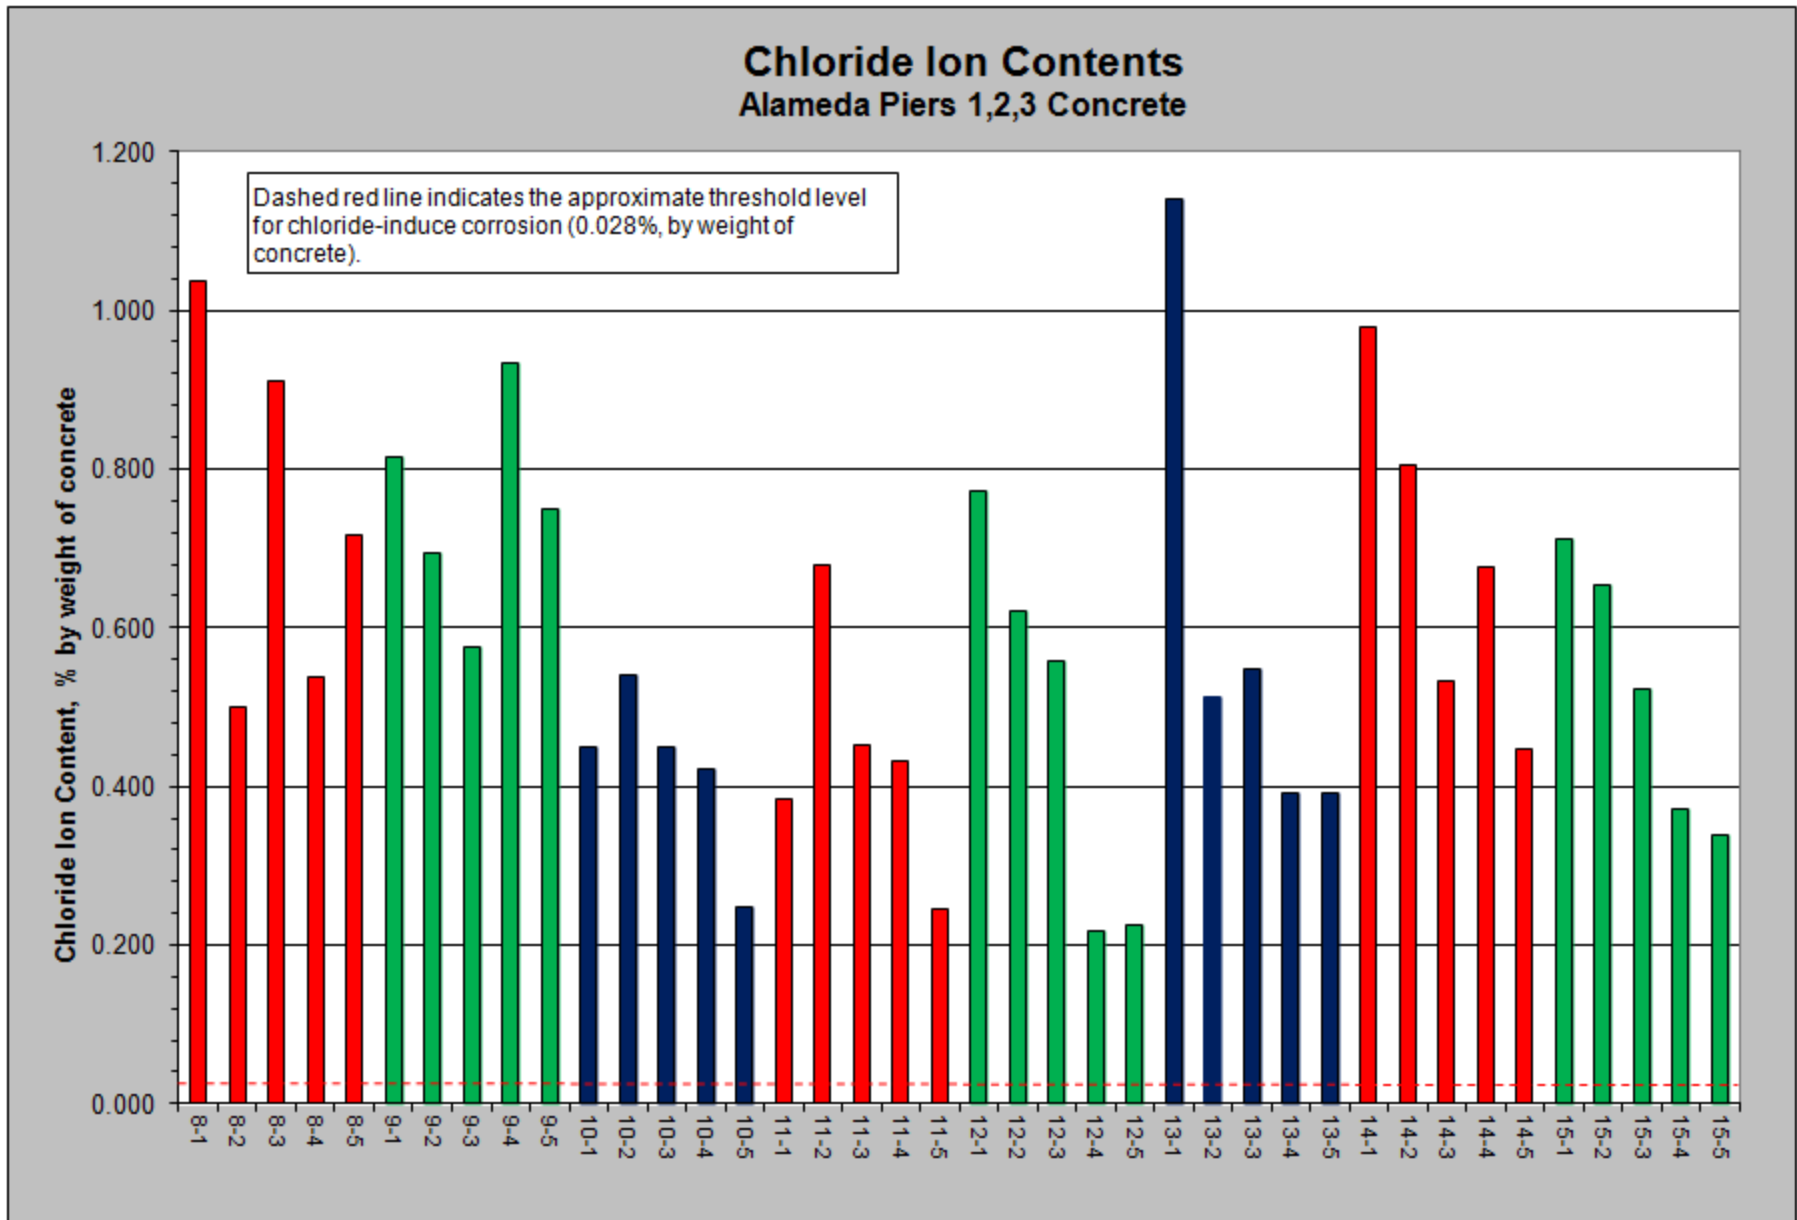
Figure 4. Chloride Contents for Set 1, Cores 8 through 15

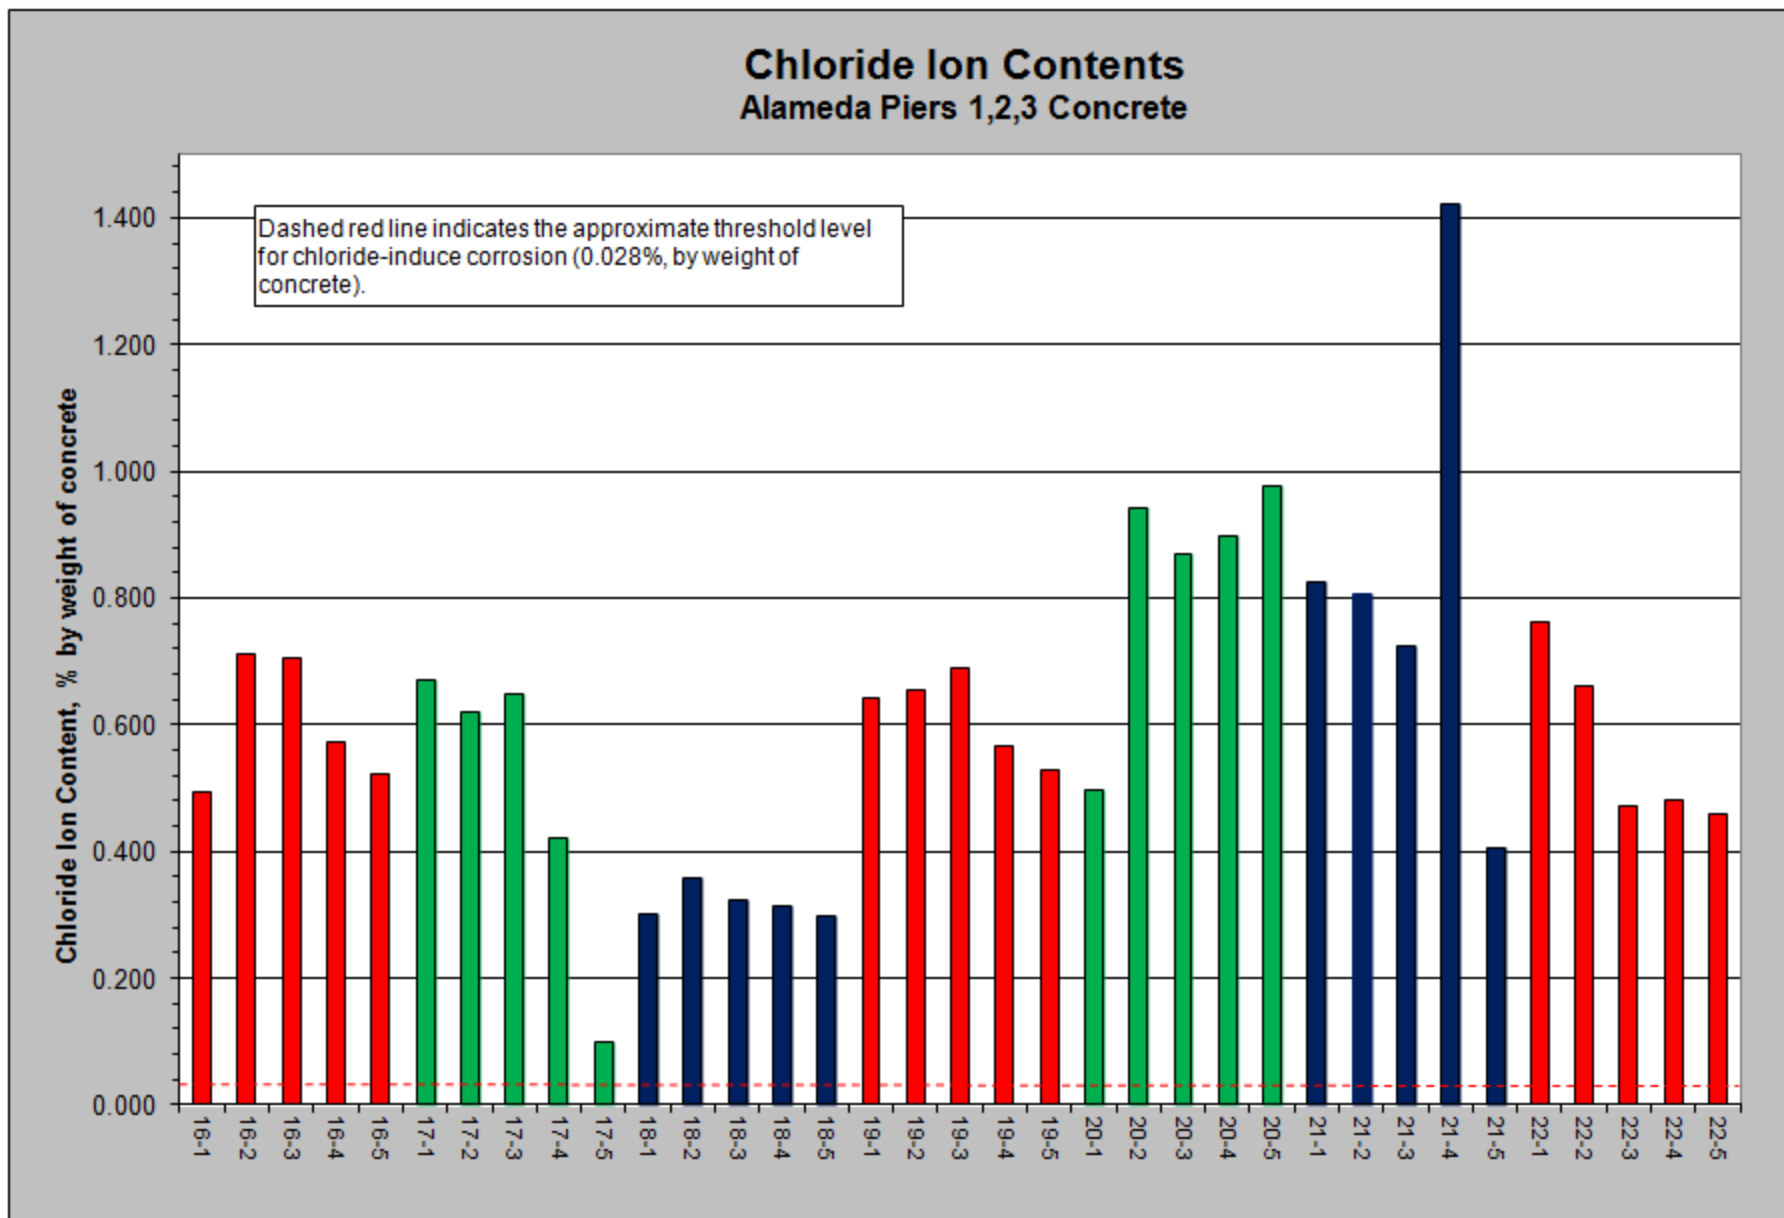
Figure 5. Chloride Contents for Set 2, Cores 16 through 22

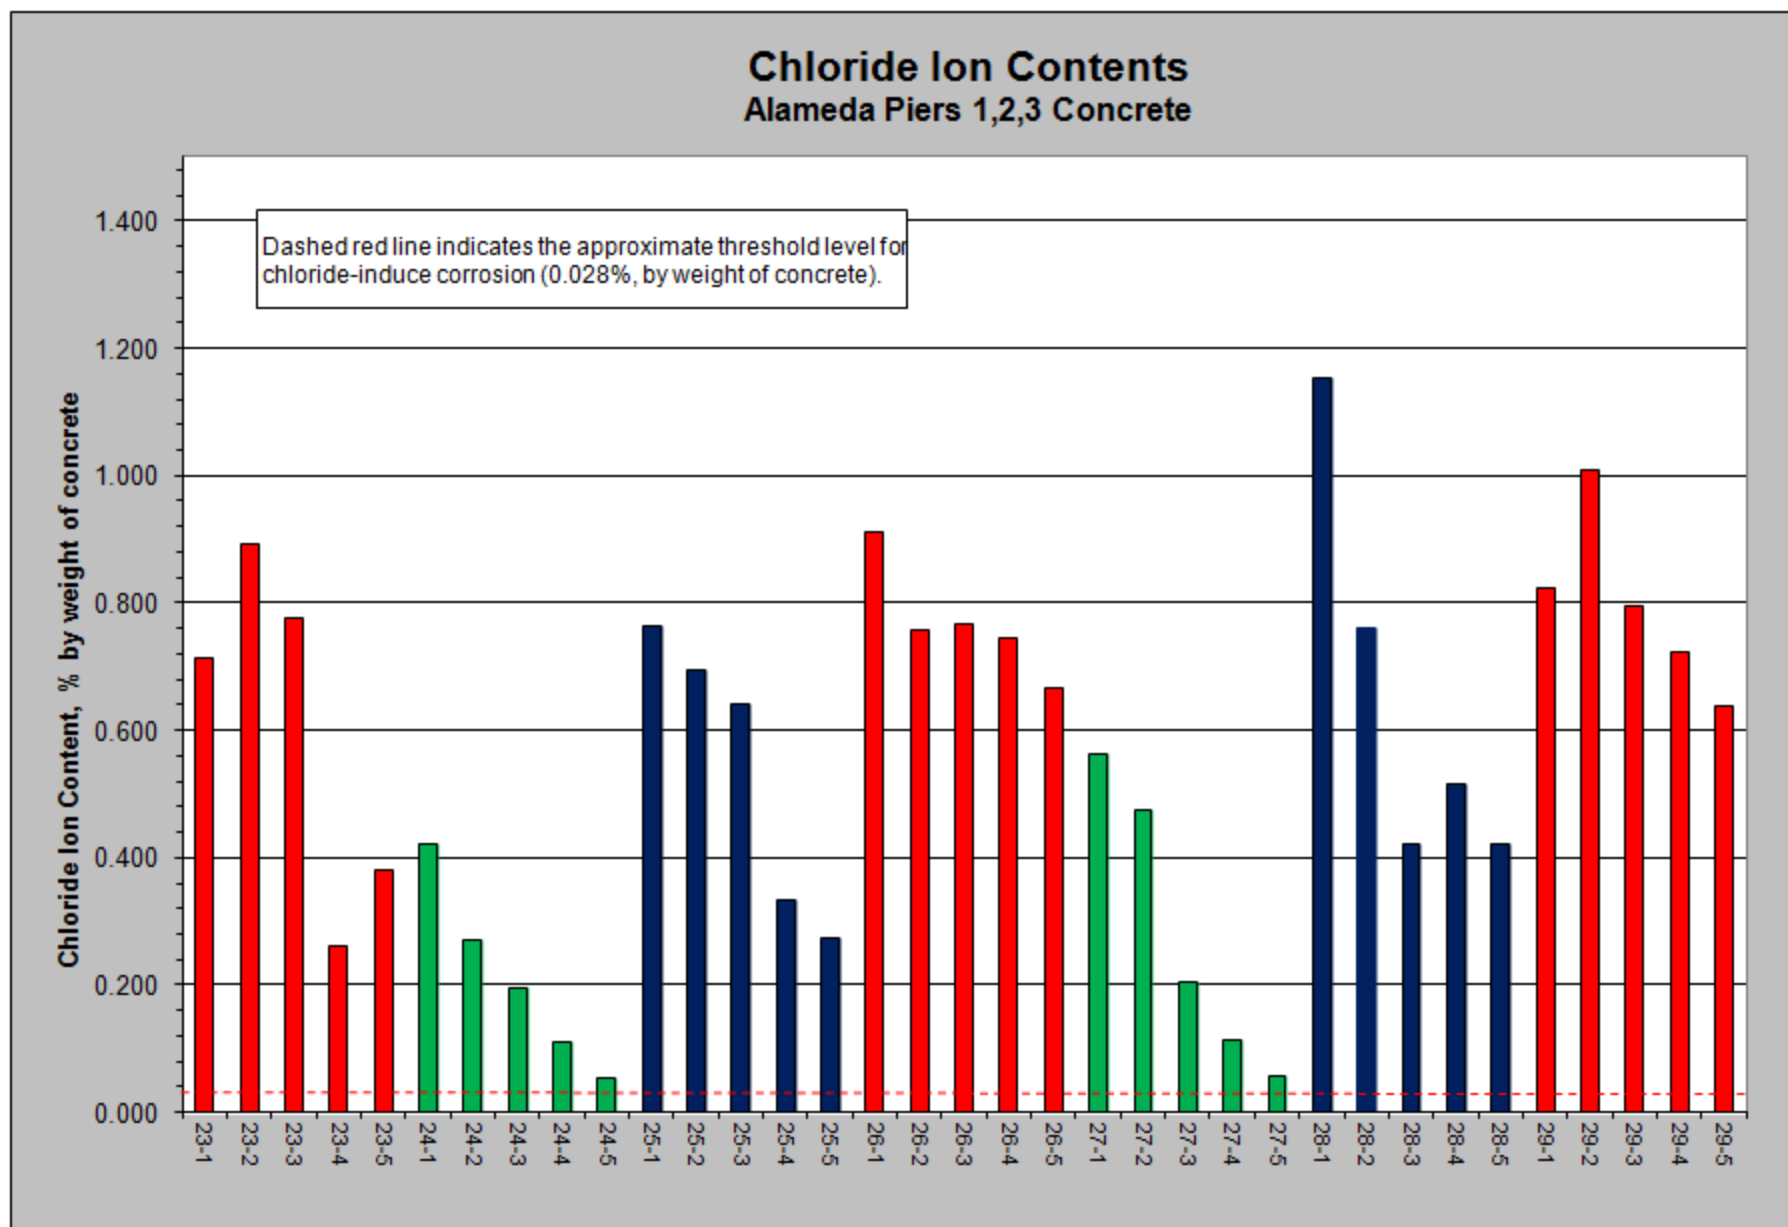
Figure 6. Chloride Contents for Set 2, Cores 23 through 29

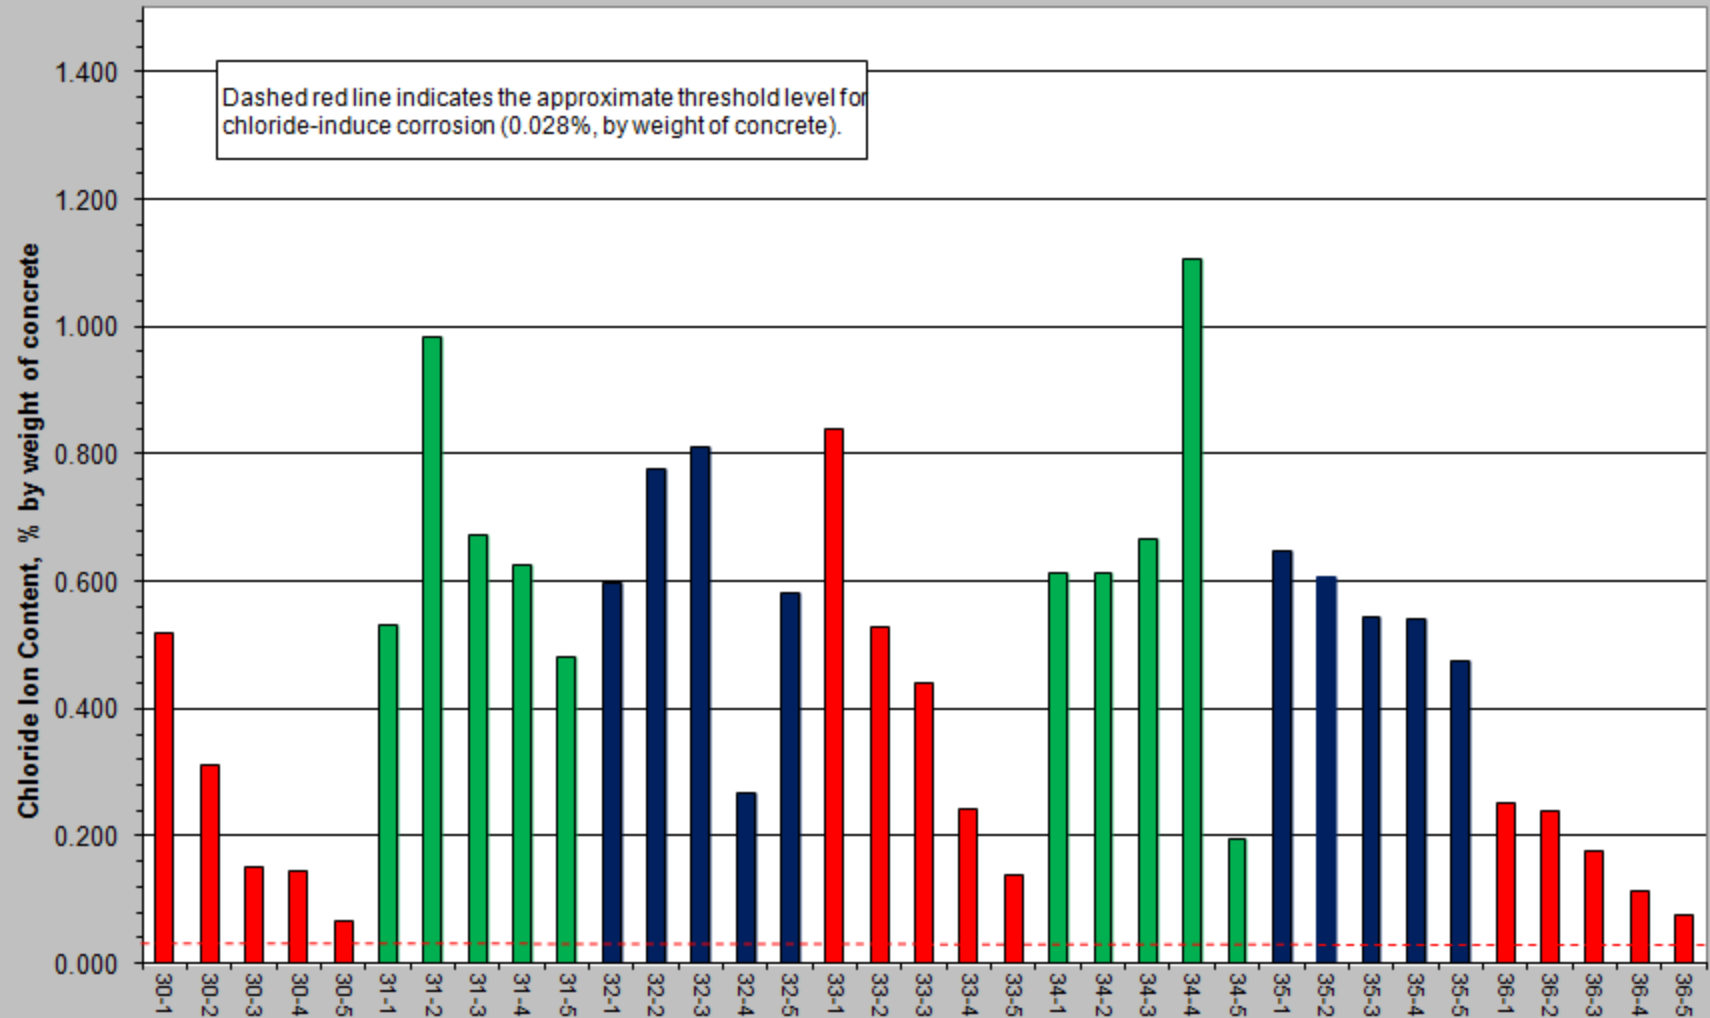
Figure 7. Chloride Contents for Set 2, Cores 30 through 36

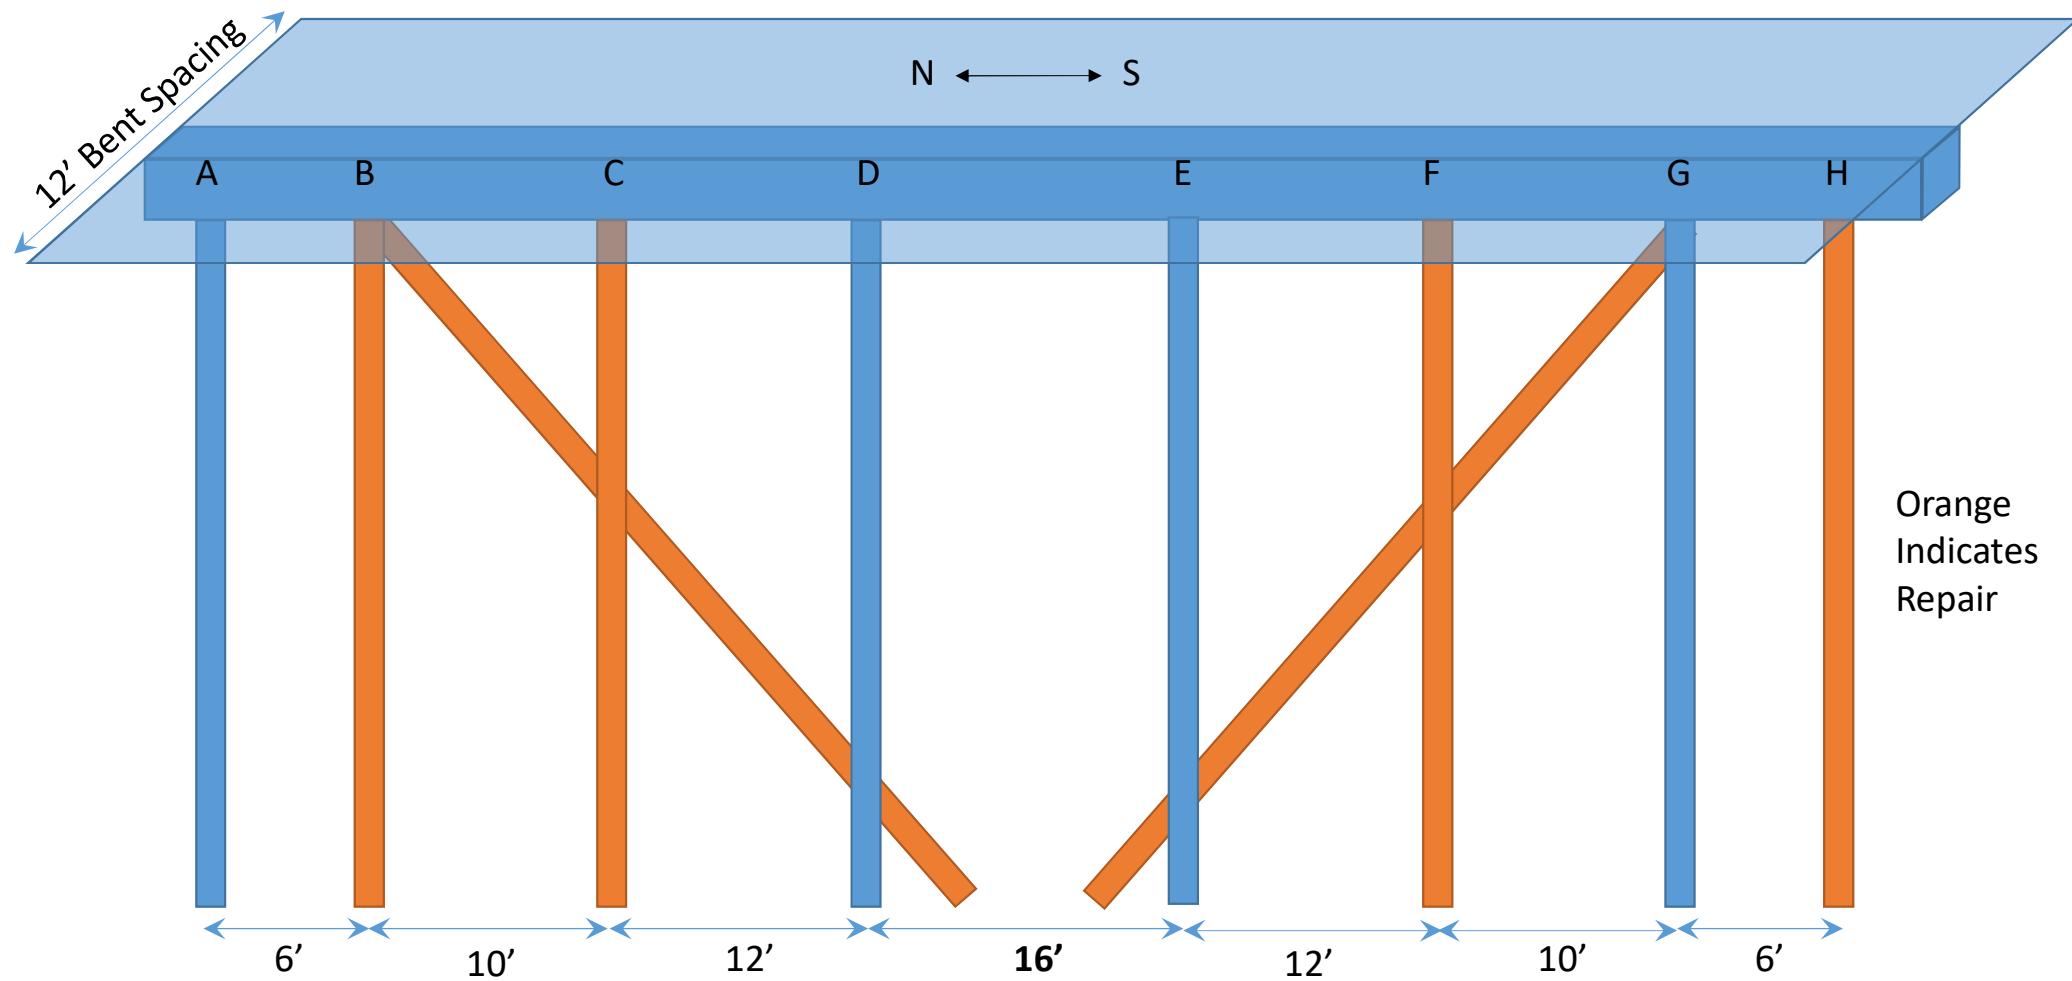
Option 2

Example Major and Severe
pile layout

Orange
Indicates
Repair

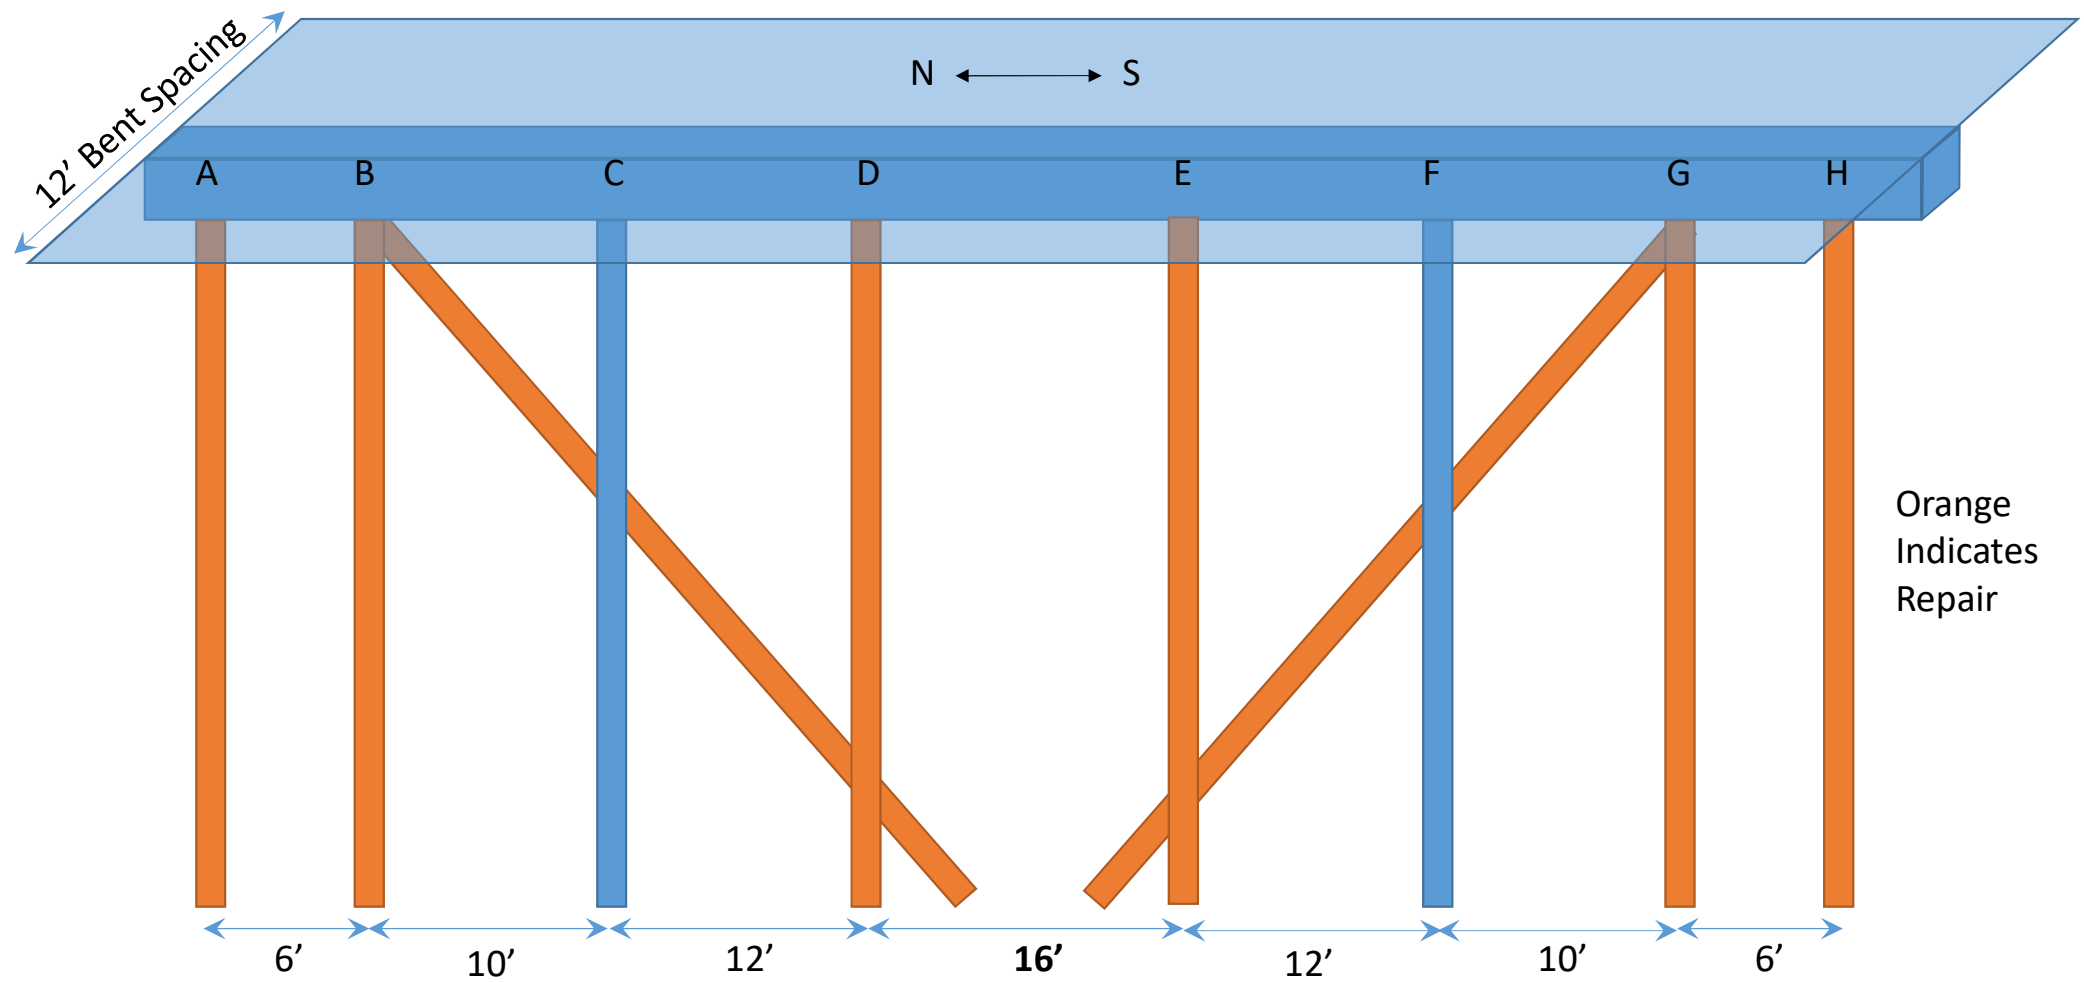
Option 3

Example Major and Severe
pile repair (excluding C and F)

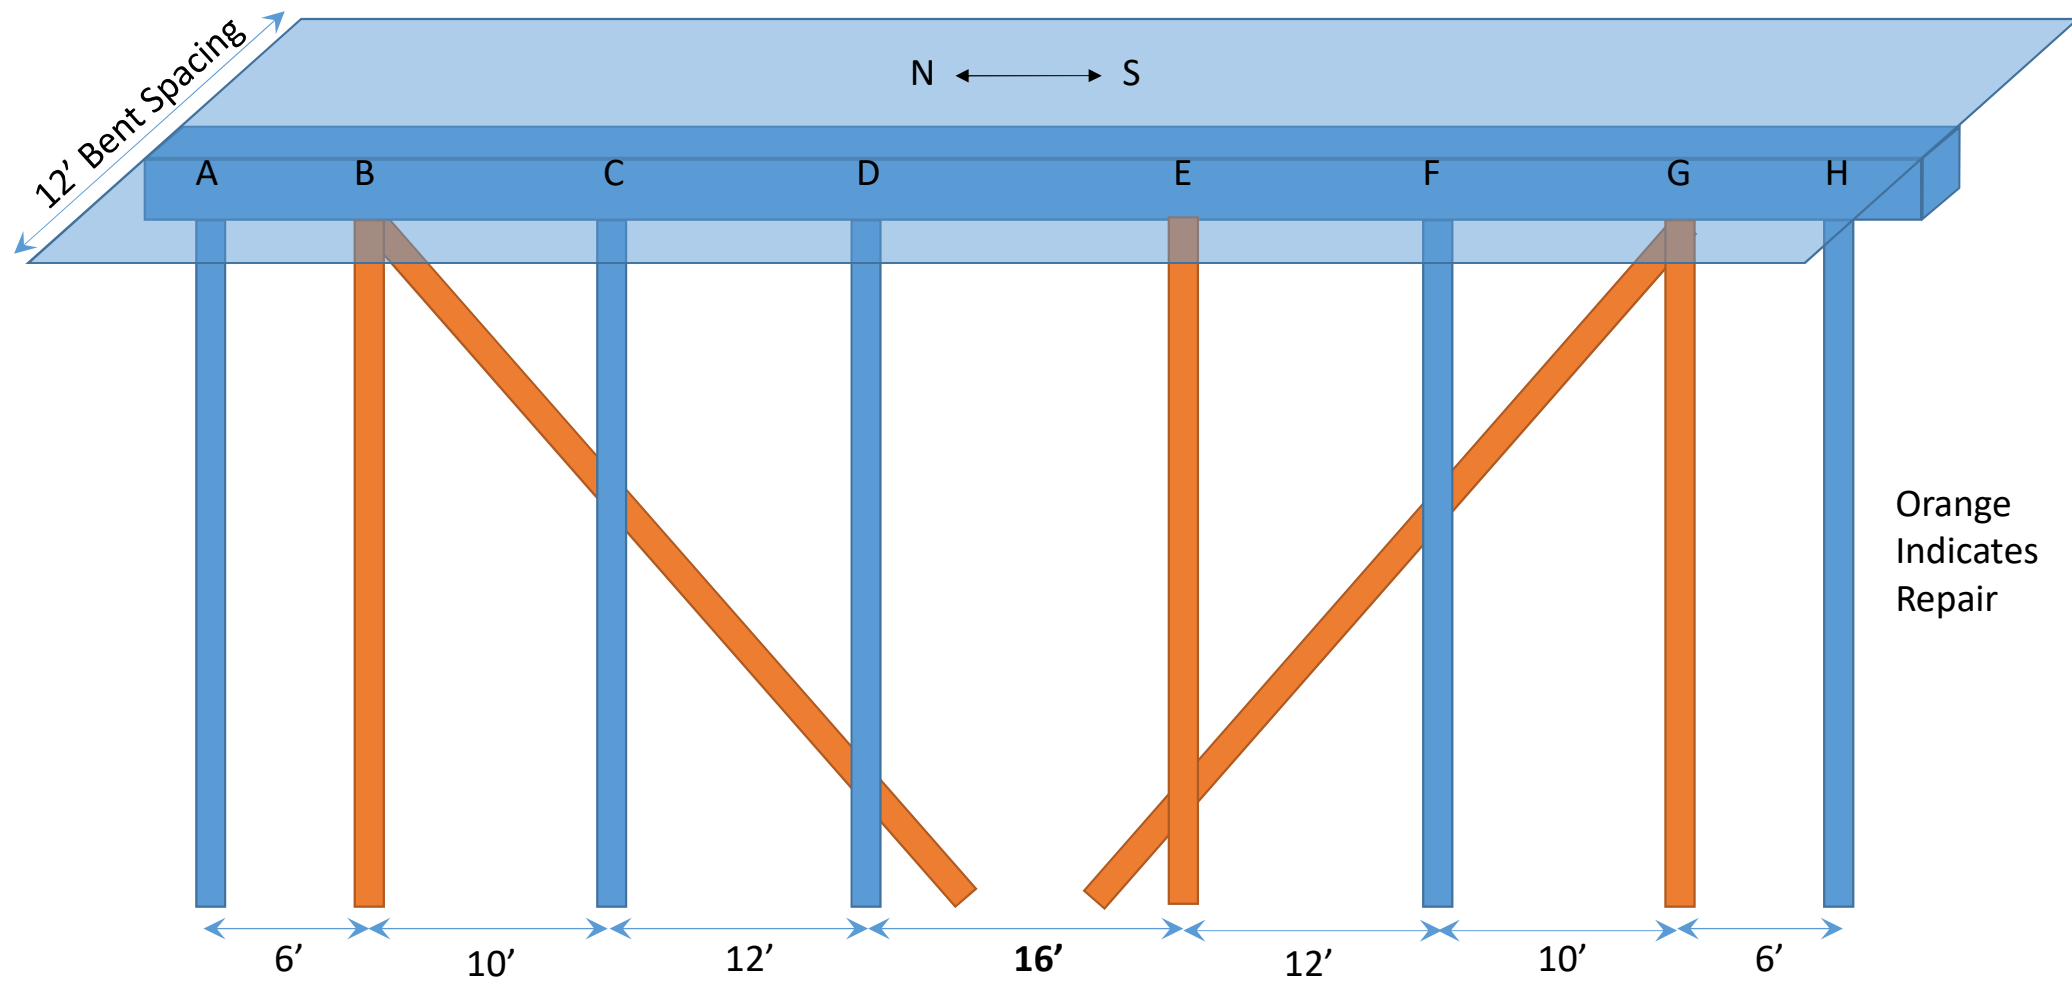
Option 4

Example Severe pile repair
(excluding C and F)

Orange
Indicates
Repair

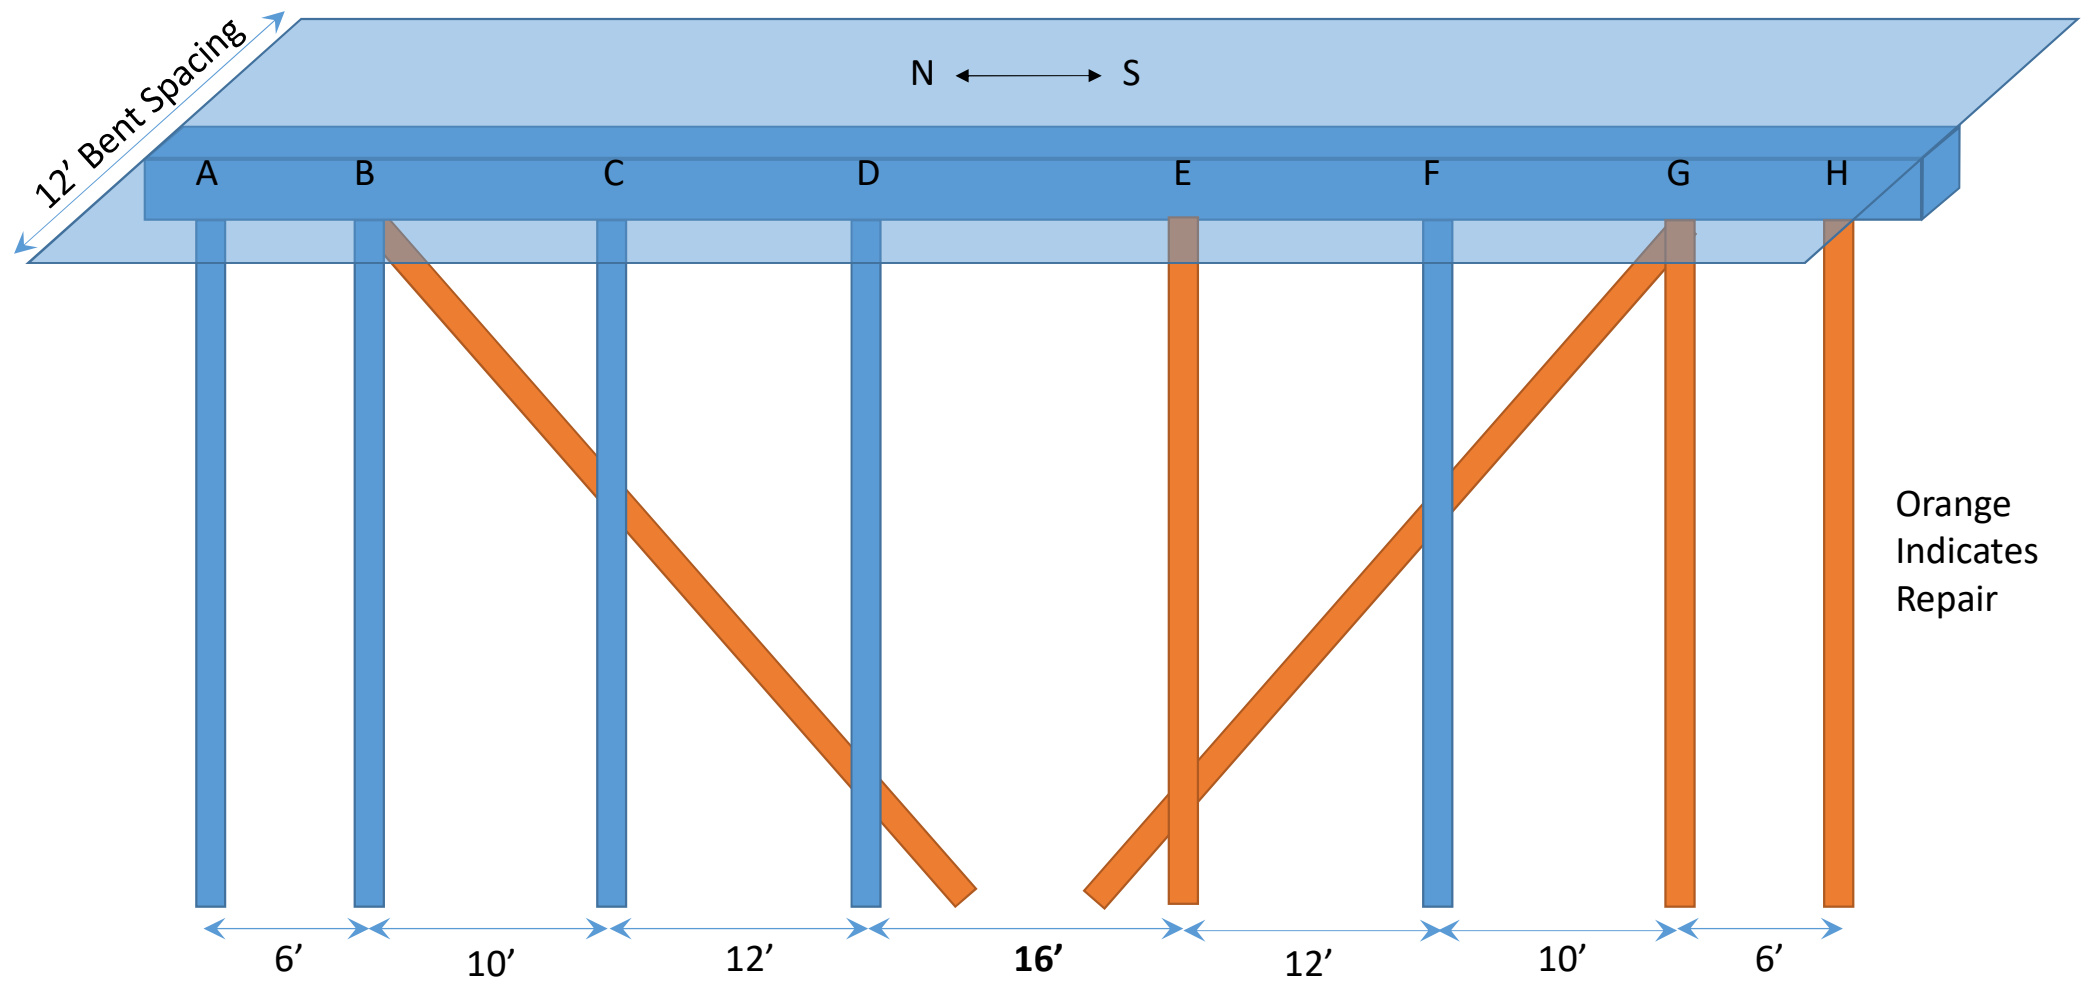
Option 5

Example all Southern Pile
repair (excluding F)

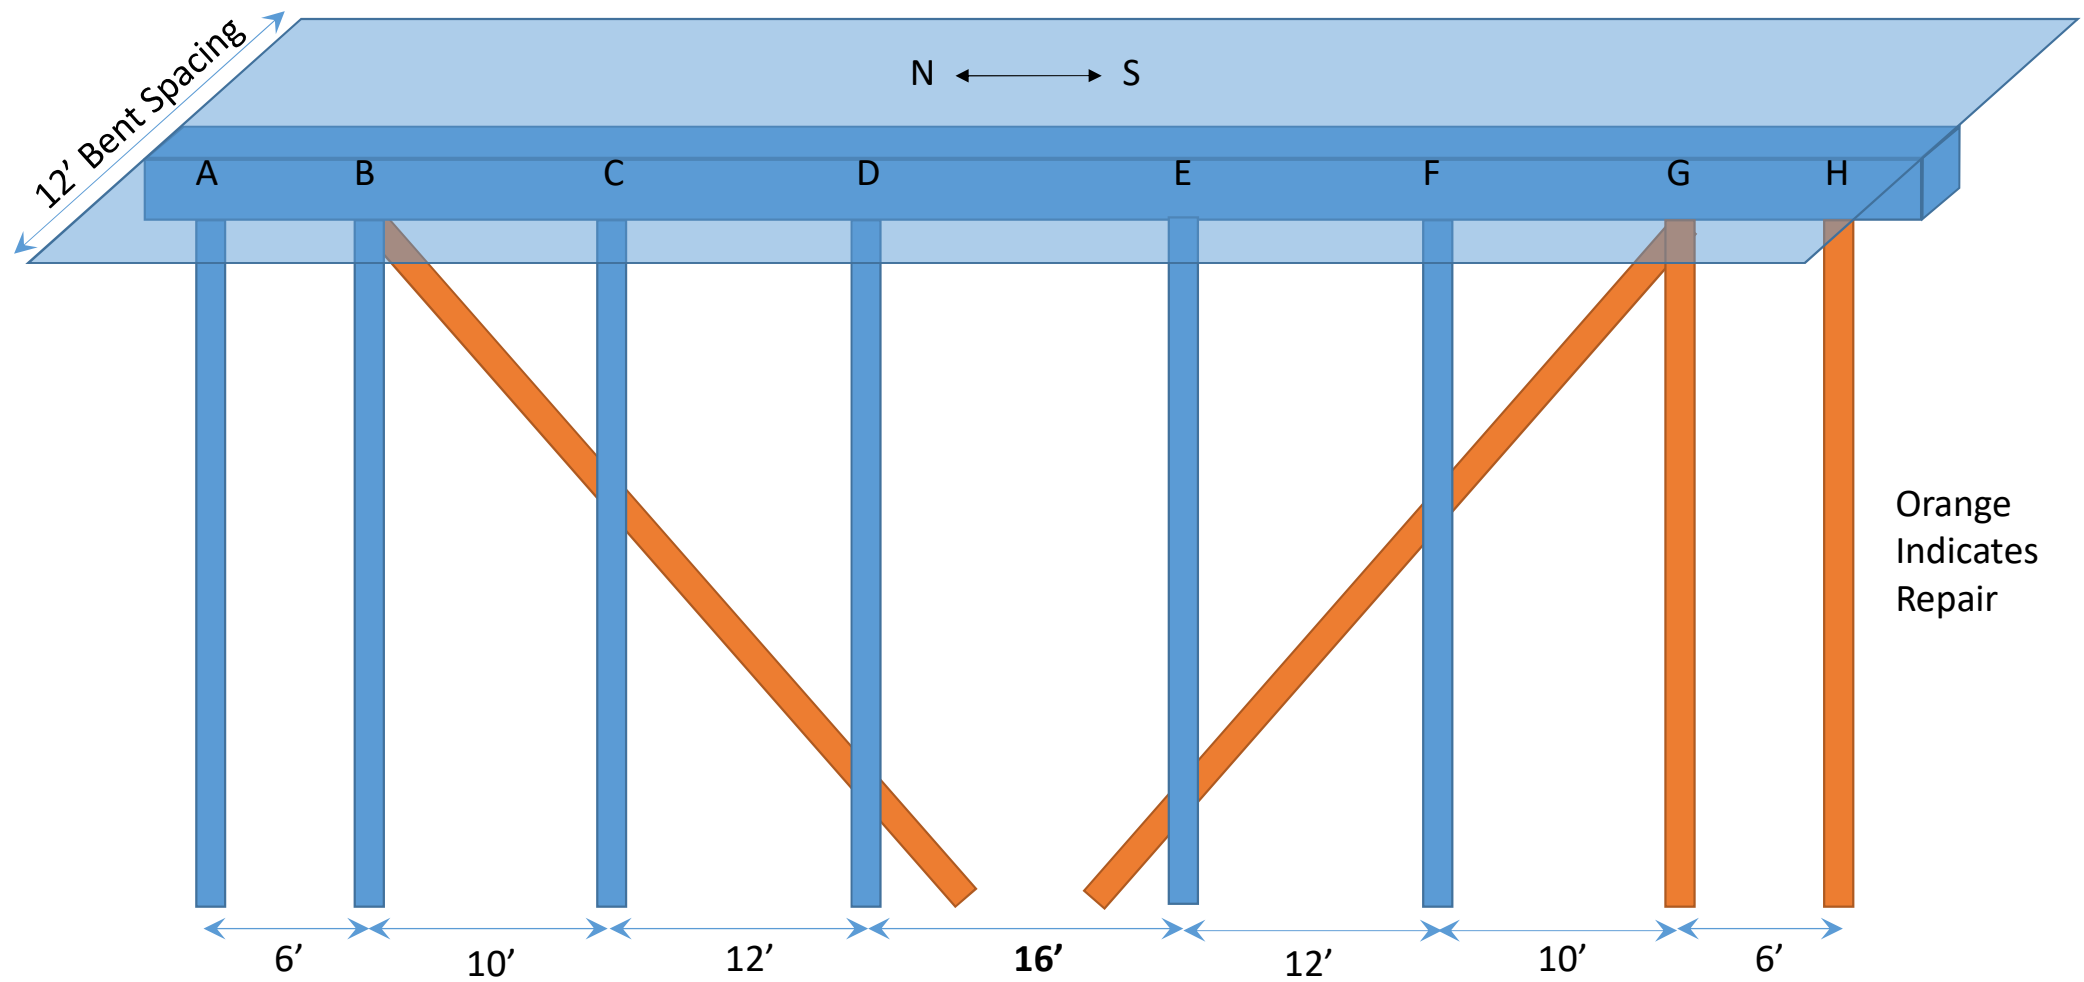
Option 6

Example all Severe Southern
Pile repair (excluding F)

Orange
Indicates
Repair
