Project Results: Inspection, Testing, Analyses, and Reporting Services, Alameda Point Piers 1, 2, & 3

January - 2018

Overall Summary

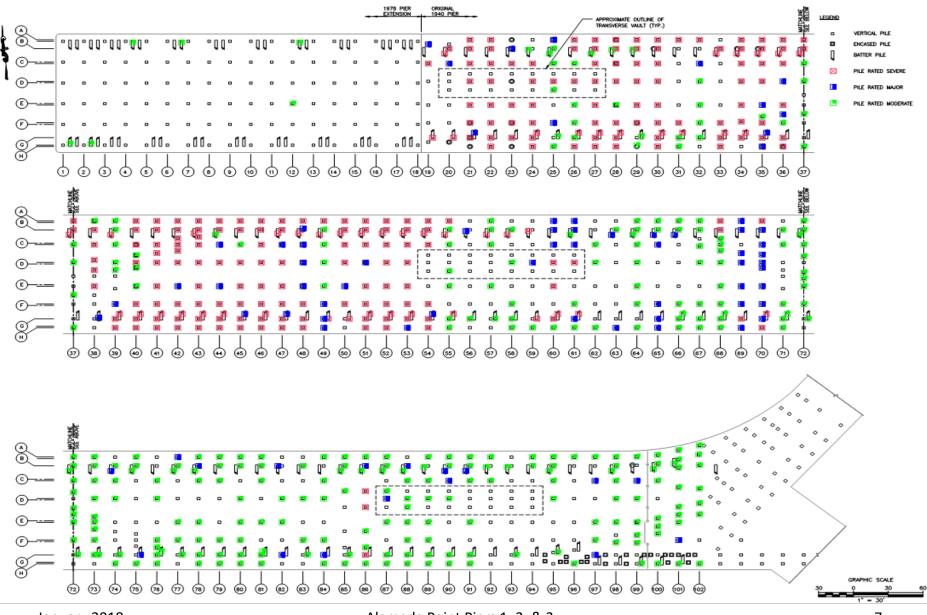
STRUCTURAL CRACKS WIDERN THAN 1/4 IN.

ND COMPLETE BREAKAGE

COMPLETE LOSS OF

TO CORROSION OF

REINFORCING STEEL

CONCRETE COVER DUE

CHEMICAL DETERIORATION CRACKS UP TO 1/16 IN; ROUNDING OF CORNERS

MULTIPLE CRACKS AND DISINTEGRATION DUE TO CHEMICAL DETERIORATION

LOSS OF CONCRETE COVER (EXPOSED STEEL) DUE TO CHEMICAL DETERIORATION

Note: Severe is a very broad category; Exposed rebar to missing pile!

- More advanced damage Spalls/Cracking
- Severe
- Exposed rebar

- SEVERE
- Significant concrete loss
