“Birth” Sculpture

Conservation Assessment and Recommendations

Prepared for
Amanda Gehrke
Economic Development
City of Alameda
Community Development Department

July 30, 2020

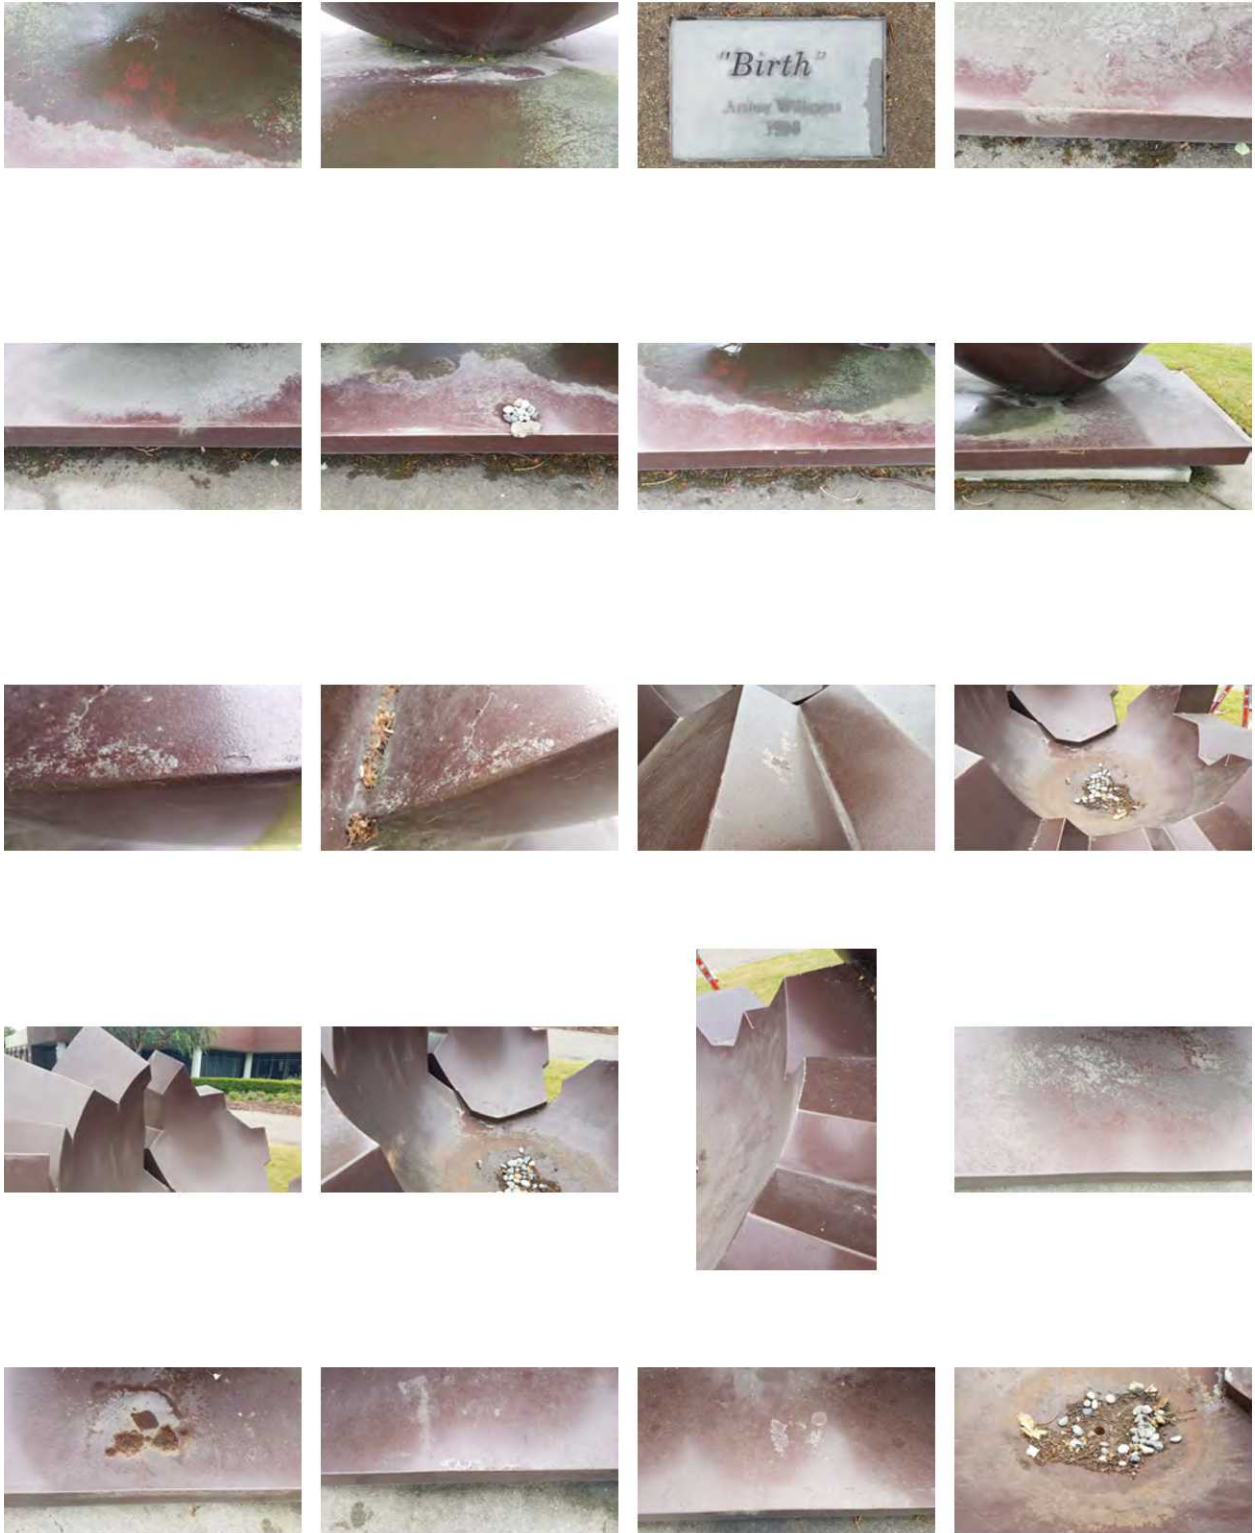
"Birth" Sculpture Condition Images

2. There are scrapes through the paint along the base edges that appear to be from skateboarders.
3. The NW corner of the concrete plinth is broken off and the broken piece (approximately 6" x 8" x 6") is still sitting under the corner of the bronze base.

4. There was a pile of small stones sitting on the edge of the base and stones and debris inside the "eggshells" blocking the drainage.
5. The top of the base and framing is slightly warped or sunken, preventing water from running off the top of the base. There is iron rust colored staining and some metal spalling in areas where water has collected and cannot drain sufficiently, including in areas on top of the base, inside the "eggshells" and inside the drain pipes in the centers of the "eggshells".

6. The underside of the base is uncoated and corroded as are the two drain pipes extending down from the bottom of each "eggshell".
7. The top clear coat has failed and is either peeled and missing, blistering, or beginning to peel on approximately 70% of the sculpture. Most of the prime and metallic color paint layers remain intact except for scraped or corroded areas, and along most convex corner edges.

8. There are a few areas that appear to have been previously filled (possibly an epoxy or polyester type epoxy often used in the automotive industry) that have since spalled off or are currently lifting away from the metal surface.

Prior to repairing the sculpture, skateboard deterrent design and installation should occur. Options might include a series of bollards surrounding the sculpture. Deterrents should not be attached directly to the sculpture.
