# APPENDIX

# APPENDIX A

## A - FACILITY ASSESSMENT CONDITION FORMS

The City of Alameda has requested a structural assessment of Alameda Fire Station No. 1. This report represents the results of an ASCE 41 seismic assessment and general structural condition review of the building. Alameda Fire Station No. 1 is located at 2401 Encinal Avenue, Alameda, California. The fire station consists of a single-story apparatus bay and an office and dormitory wing with both one-story and two-story portions initially constructed in 1968. The team was not provided with any data or information regarding pending or past modernizations or retrofits for this building.

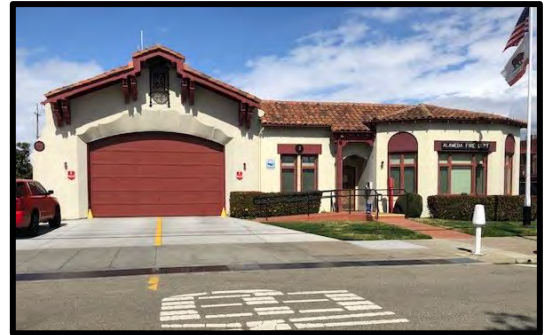
**Figure 3: AFD Station 2**

One major issue identified in the CRA/SOC is the size and layout of Station 2, as well as the significant facility-maintenance needs at Station 5. Station 2 is not designed with the safety and operational requirements of a modern fire service in mind. When the station was built, little was known about the carcinogenic nature of firefighting or the evolving risks associated with petroleum-based products, whether from vehicle exhaust or from the products themselves when burned. There was also concern about the firefighters' health and fitness. Station 2 lacks adequate decontamination facilities, separation of contaminated equipment and uniforms from living quarters, and sufficient shower facilities for firefighters after exposure to these contaminants. It is also crowded with personnel and equipment, forcing the ambulance to exit the building in a complex and inefficient manner.

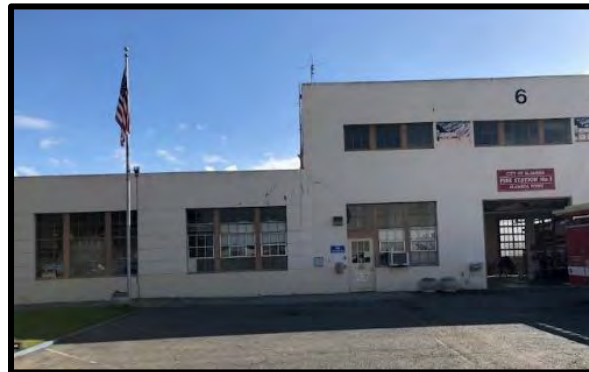
**Figure 4: AFD Station 5 (Training)**

Station 5, built as a pre-World War II military fire station, is similarly inadequate. It also needs significant upgrades and maintenance to provide a living environment for firefighters. Plumbing, electrical, heating, and air conditioning were all found to be inadequate.

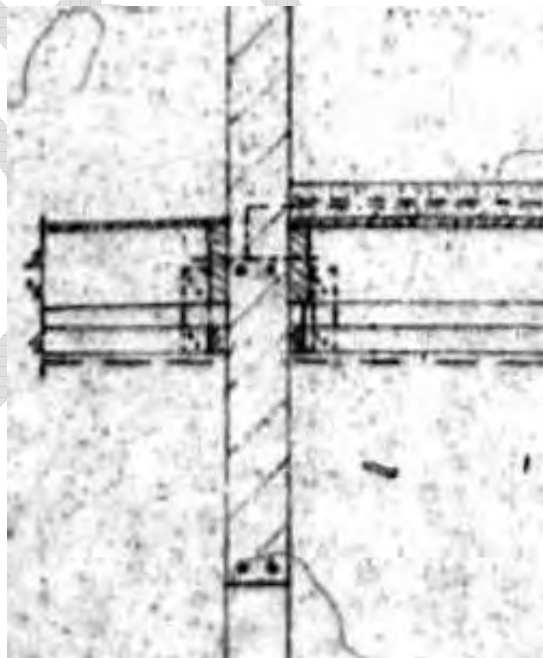
At the office and living quarters portion of the building, the lateral load resisting system for the low and high roof consists of wood diaphragms constructed of  $\frac{1}{2}$ " ag plywood sheathing. The plywood sheathing delivers seismic loads to the masonry walls through the diaphragm nailing and into the ledgers, and then into the 8 or 12-inch-thick reinforced masonry walls. The seismic loads are transferred from the shear walls into the foundations through reinforcing dowels.

**Figure 2: Diaphragm to wall attachment at Low Roof and Level 2 Floor**

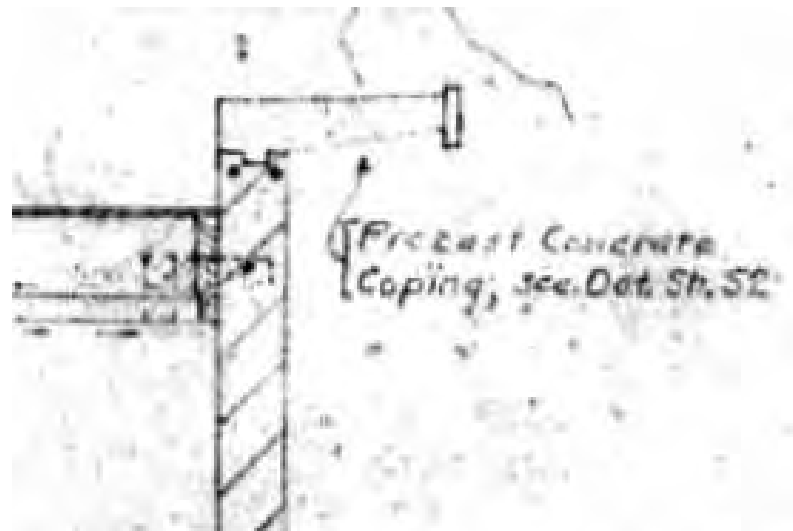
**Figure 3: Diaphragm to wall attachment at High Roof**

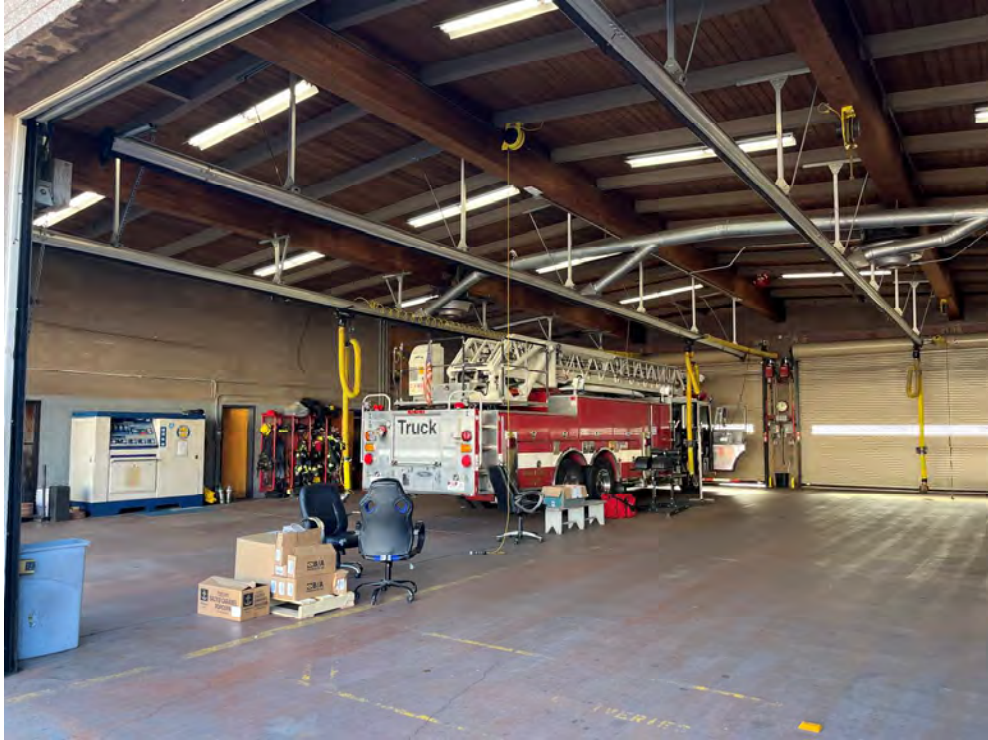
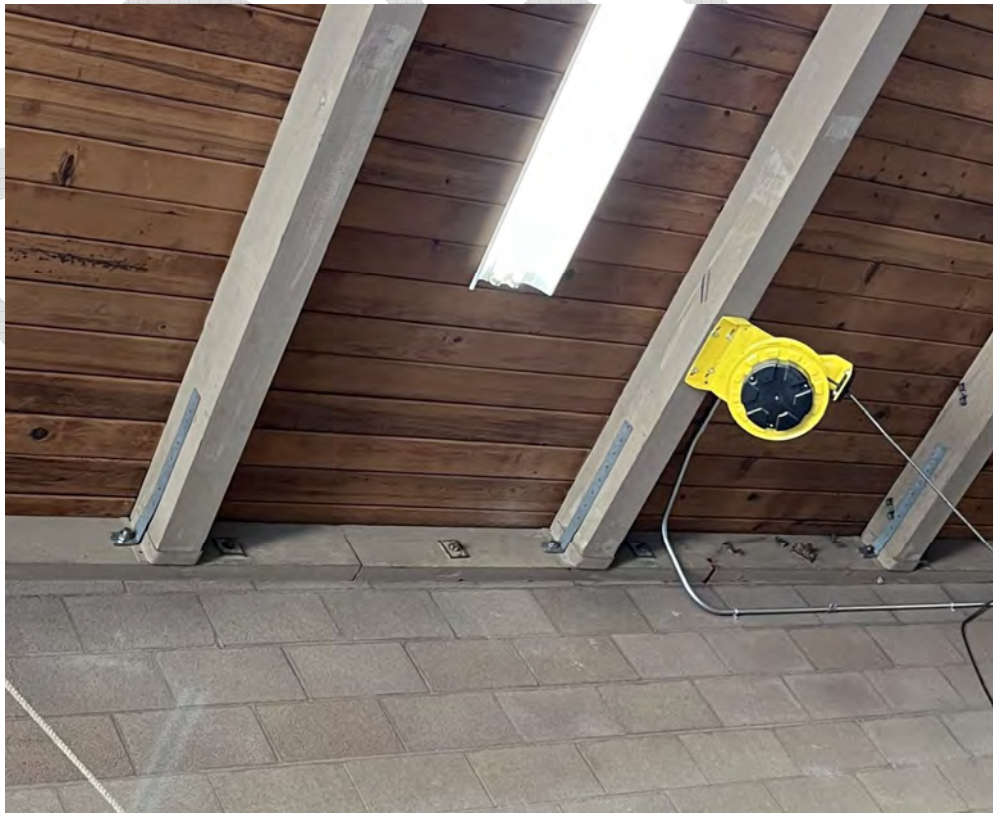
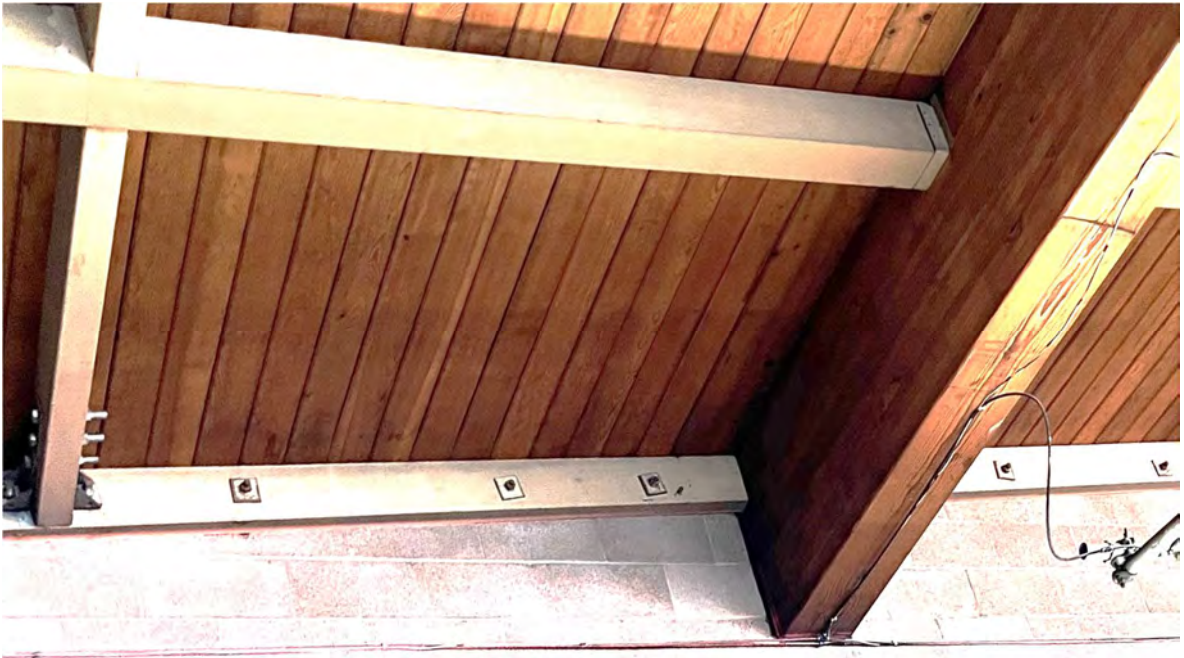
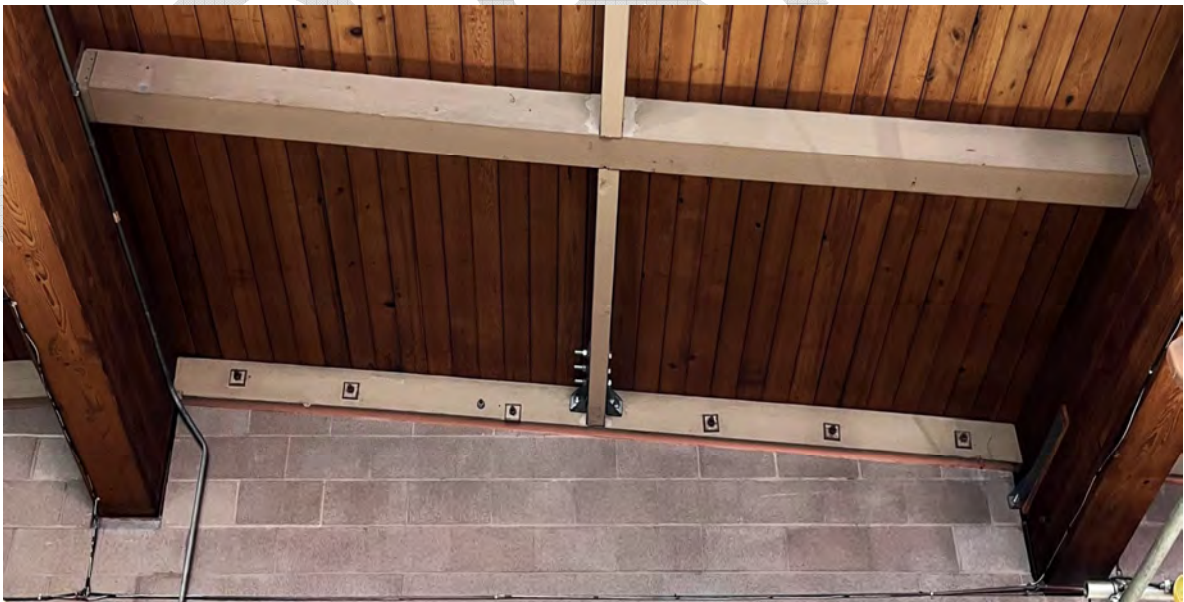
**Photo 3: Apparatus Bay Roof Framing**

**Photo 4: Apparatus Bay – Beam/Ledger to Wall Connection**

**Photo 5: Apparatus Bay – Glulam to Wall Connection**

**Photo 6: Apparatus Bay – Roof Framing Connections**

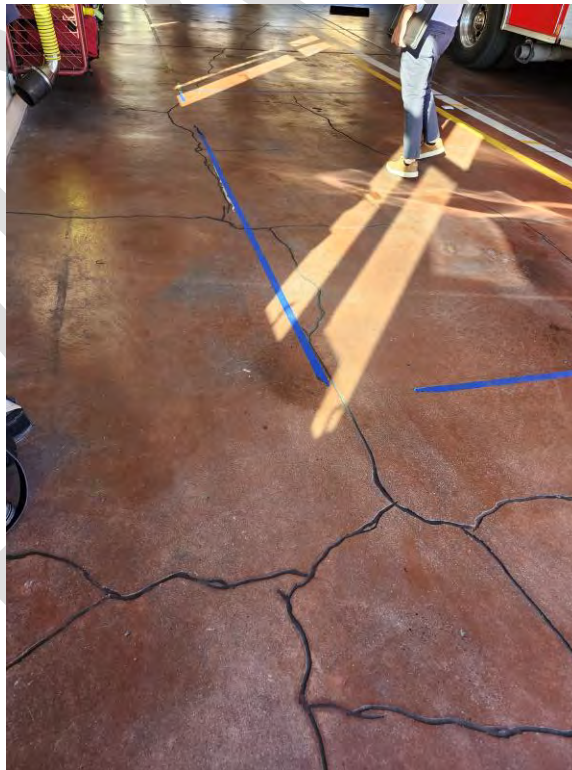
- Cracks at main apparatus bay slab [See Appendix Photos 8-10]
- Minor cracks in stucco walls [See Appendix Photos 11]

**Photo 10: Cracking in Main Apparatus Bay Slab**

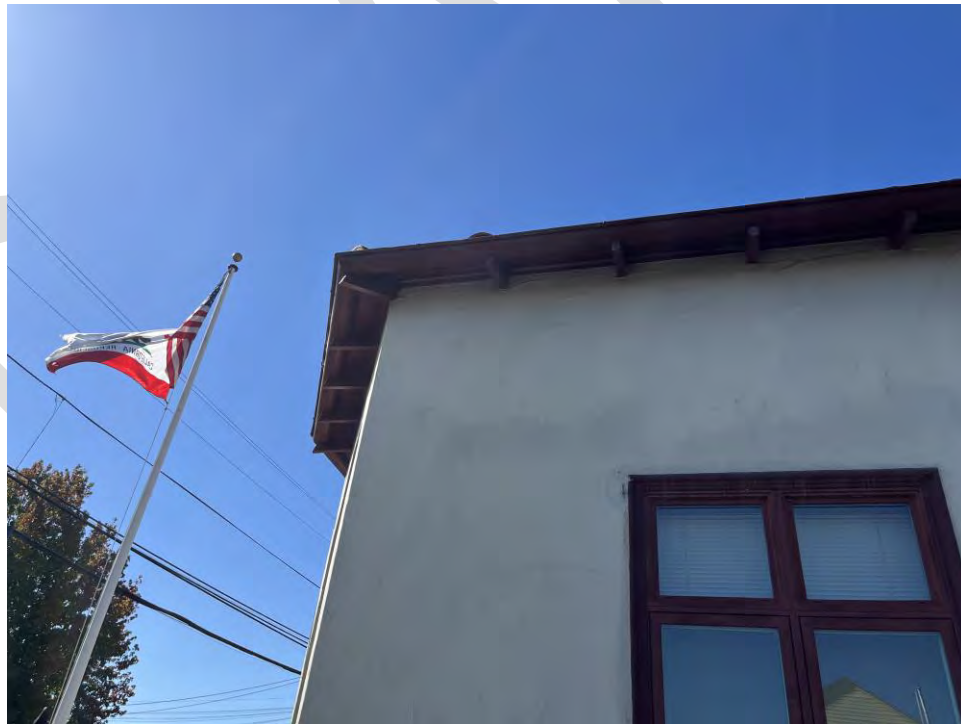
At the apparatus bay, the gable roof likely consists of a wood framed roof system, constructed of wood trusses spanning in the east-west direction supporting 1x diagonal or straight sheathing. Wood trusses likely frame into wood stud walls which transfer the vertical load to the foundation. Ceiling finishes prevent visual access to framing and connections. Wood framed outriggers rafter extensions are visible at the exterior eave soffit (see Appendix Photo 12).

**Photo 12: Exterior Soffit at Clay Tile Roof Overhang**

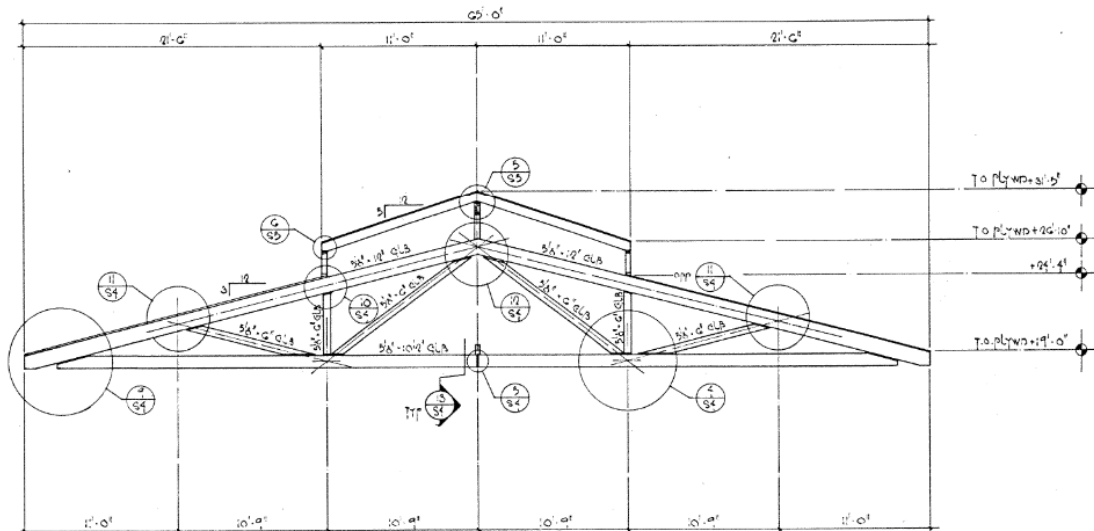
The apparatus bay is constructed of glulam trusses equally spaced in the east-west direction, with a continuous elevated roof clerestory portion at the center. 2x10 joists at 24 inches on center span from truss-to-truss supporting plywood sheathing. The joists are connected to the top of the wood shear walls to transfer the vertical loads to wood shear walls and into the foundations. The trusses are supported at each end by HSS steel columns.

**Figure 1: Apparatus Bay Truss Elevation**

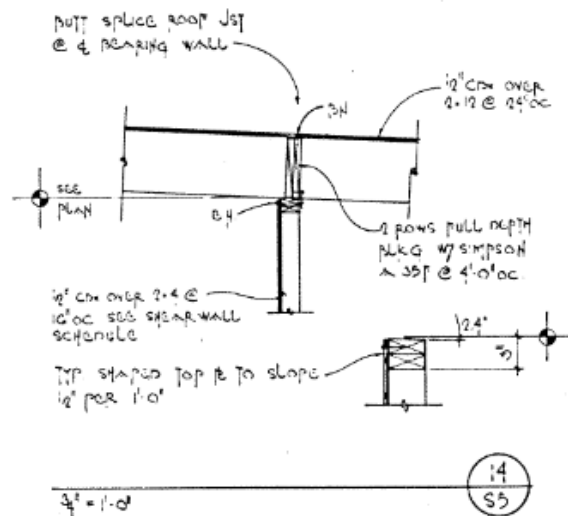
**Figure 1: Diaphragm Attachment to Shear Wall Through Blocking**

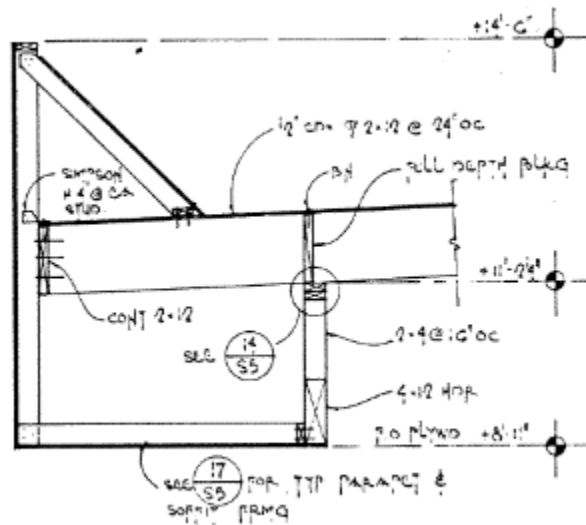
**Figure 2: Diaphragm Attachment to Shear Wall Through Ledger**

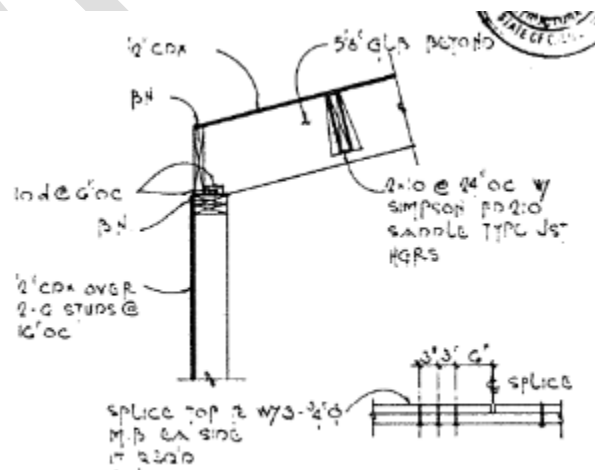
**Figure 3: Diaphragm attachment at the Apparatus Bay – Wood Shear Wall Condition**

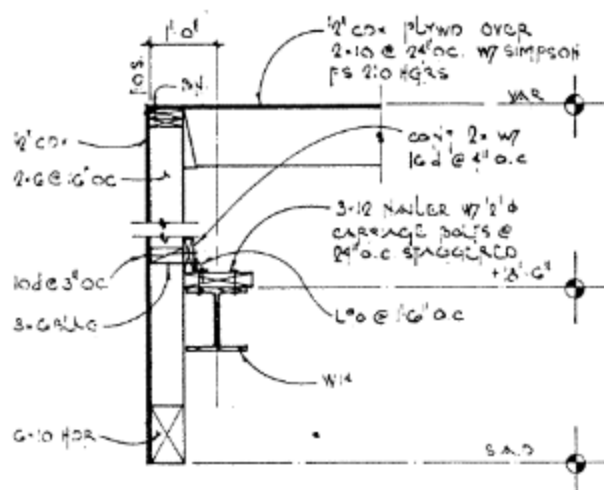
**Figure 4: Diaphragm attachment at the Apparatus Bay – Steel Moment Frame Condition**

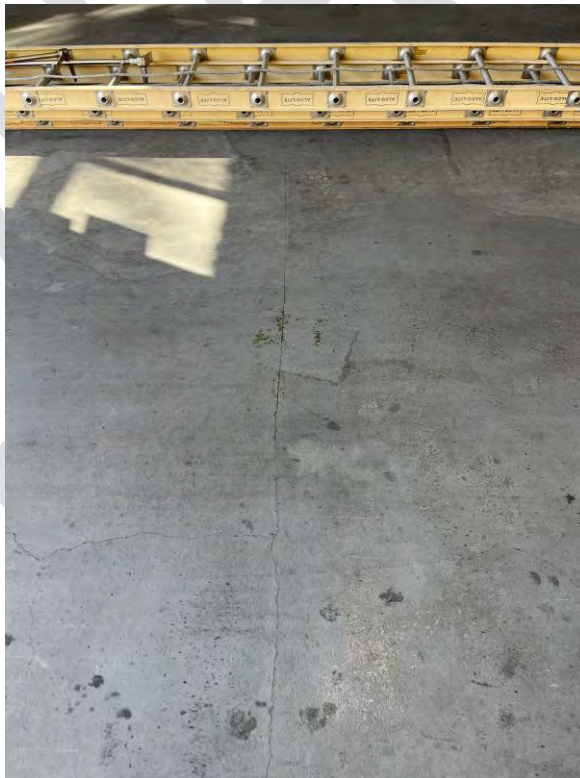
- Minor cracking at main apparatus bay slab [See Appendix photo 6]

**Photo 6: Interior of Apparatus Bay – Cracks in Slab**

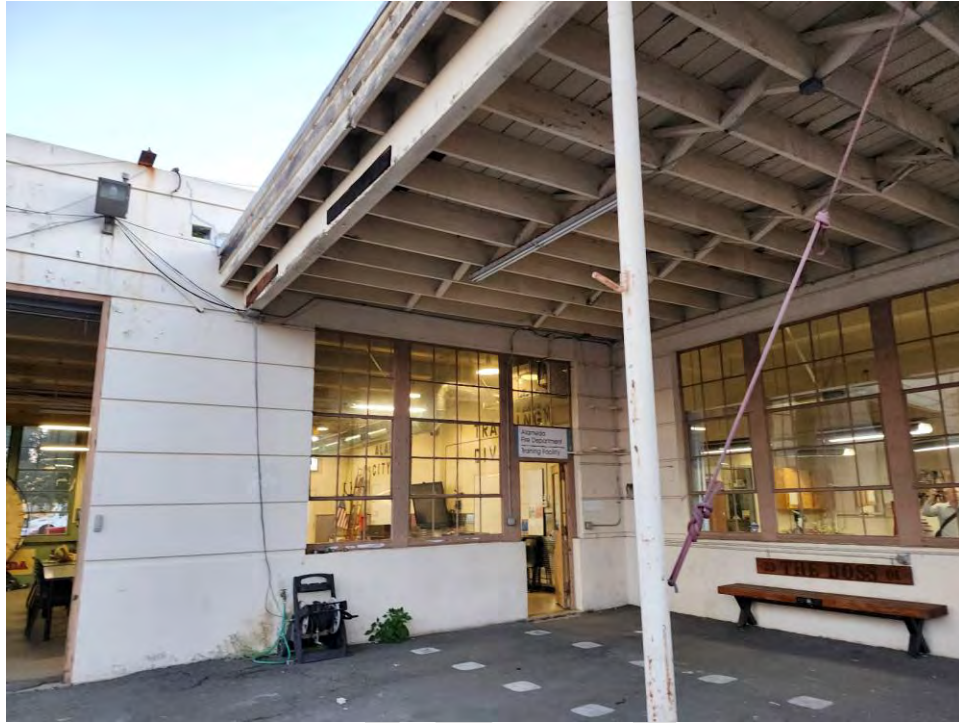
The building consists of a concrete roof system with concrete beams approximately spaced at approximately 6 feet on center supporting a concrete slab of unknown thickness. There are intermittent concrete girders supporting the beams as shown in Photo 5. Concrete girders frame into concrete columns which transfer the vertical load to the foundation.

The floor framing likely consists of the first-floor concrete slab over concrete beams supported by concrete columns and concrete bearing walls. Concrete walls and columns transfer the vertical load into the foundation. See Photo 5.

**Photo 5: Wood Shade Structure**

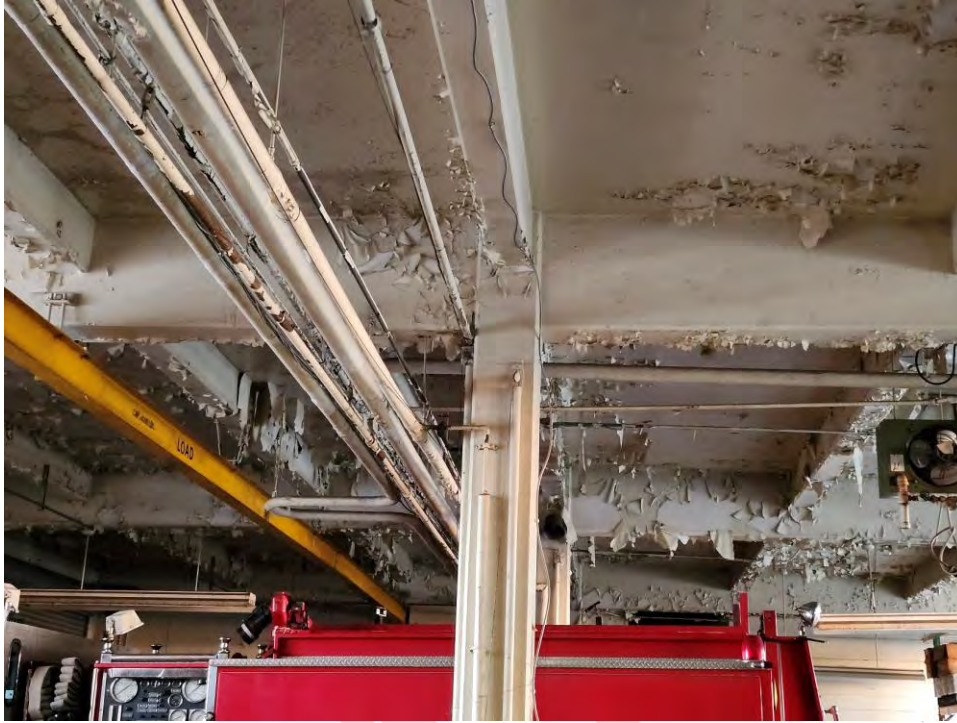
- Cracks and chipping at the exterior concrete [Photos 8, 9, 19, 20, 21]
- Paint peeling and water damage at storage apparatus bay ceilings [Photo 7]
- Cracks at ceiling slab concrete by apparatus door [Photo 10]
- Water damage at concrete roof slab and wall [Photos 11, 12]
- Crack at concrete wall at bearing connection to roof beam [Photo 13]
- Cracks at infill concrete wall [Photo 14]
- Cracks at interior concrete wall [Photo 16]
- Cracks at window opening concrete [Photos 9, 15, 20]
- Cracks at concrete floor slab [Photo 17]
- Water damage at interior finish of conference room [Photo 18]

**Photo 7: Concrete Roof/Ceiling Framing at Storage Apparatus Bays**

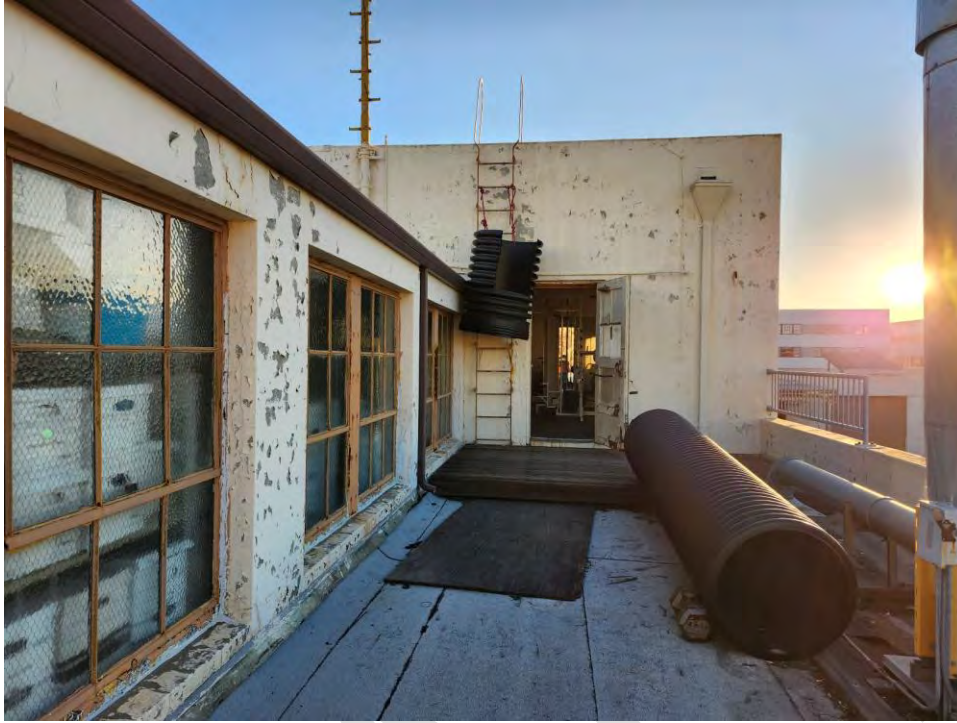
**Photo 19: Second Story and Penthouse**

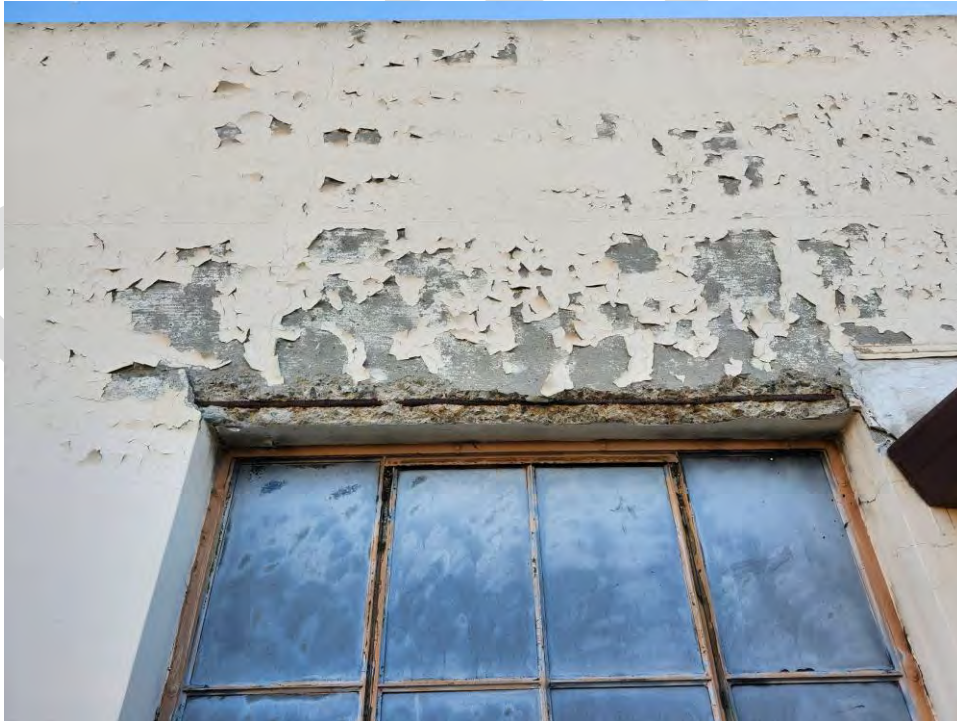
**Photo 20: Exposed Reinforcement at Penthouse Gym Window**

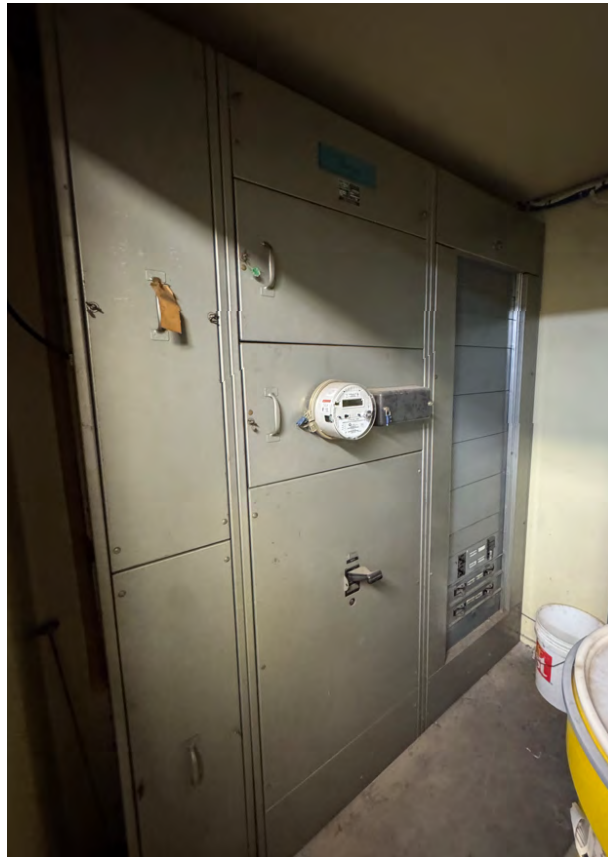
**IMAGE A - EXISTING MAIN SWITCHBOARD**

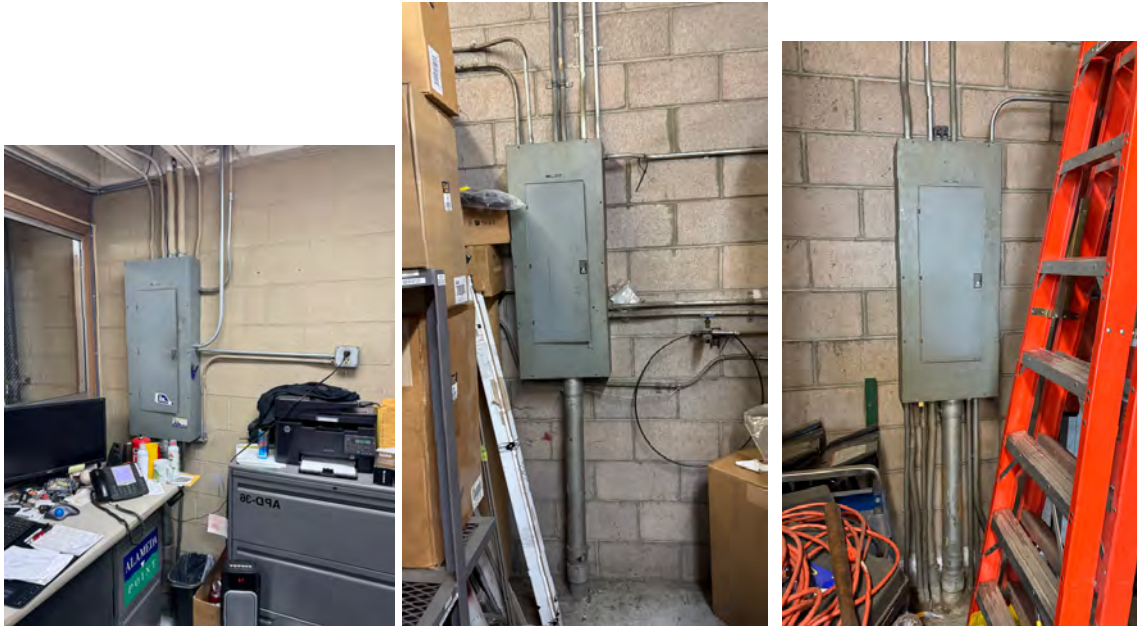
**IMAGE C – EXISTING PANELS**

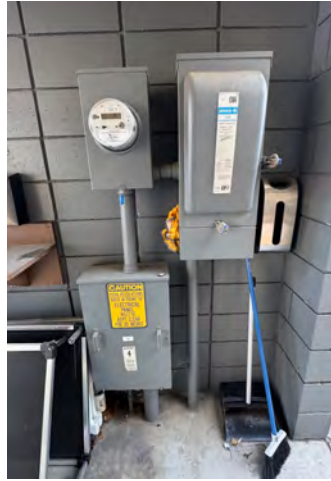
The City of Alameda Animal Shelter, built circa 1984, currently operates with a 200-amp, 120/208V, three-phase disconnect switch (see Image A). The utility meter is registered under Alameda Municipal Power, Meter #20013399. The service is presumed to be fed from the existing transformer L-222, which also supplies power to the Maintenance Service Building. Since the disconnect switch was not opened during the assessment, the service is assumed to have a 175-amp capacity.

**IMAGE A - EXISTING METER SERVICE AND SERVICE DISCONNECT**

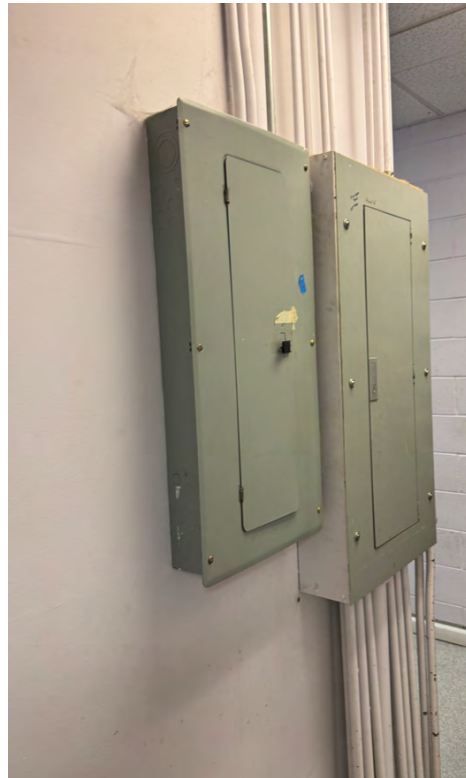
**IMAGE C – EXISTING PANELBOARDS**

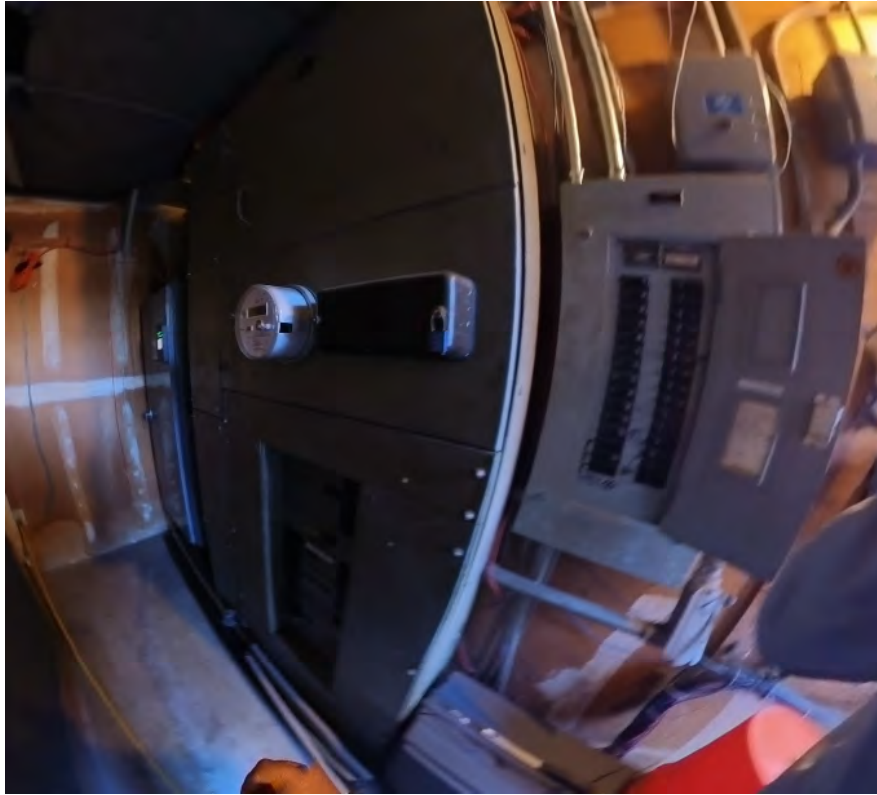
The City of Alameda's Fire Station 1, originally constructed in 1968, is a two-story building containing a fire administration area, offices, changing and storage areas, and a dormitory. The building operates with a 400-amp, 120/208V, 3-phase Main Switchboard (MSB) located in the equipment room. This includes a 400-amp Automatic Transfer Switch (ATS), Panel A, and mechanical units. The ATS is a 400-amp Kato Light model. The Alameda Municipal Power Meter is #90000331.

**IMAGE A - EXISTING MAIN SWITCHBOARD**

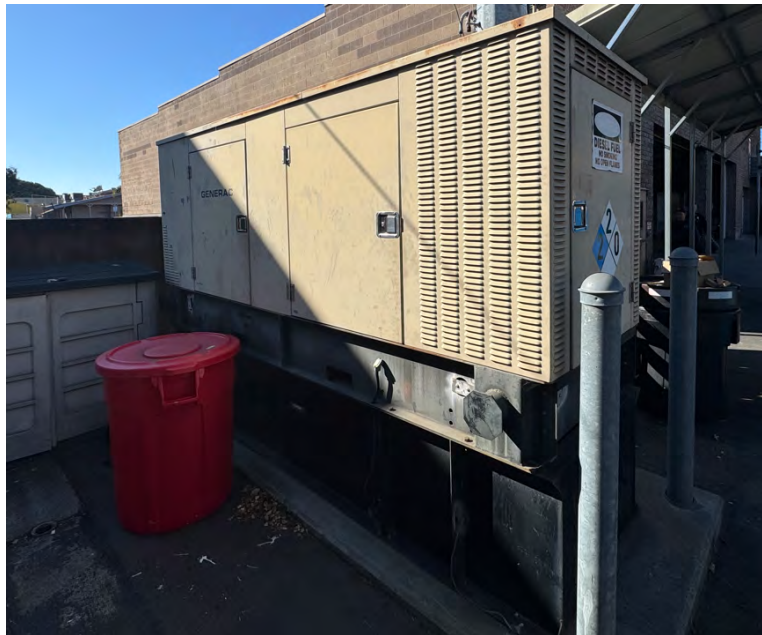
**IMAGE B - EXISTING GENERATOR**

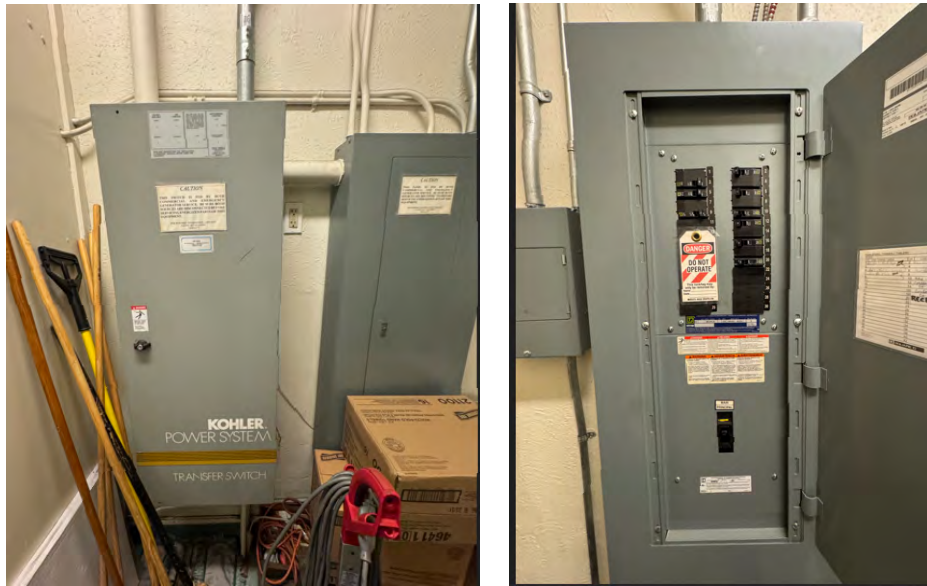
**LEFT PICTURE (ATS) AND SERVICE PANEL**  
**RIGHT PICTURE SUBPANEL WITH LOAD CENTER**  
**IMAGE B - EXISTING PANELS AND ATS**

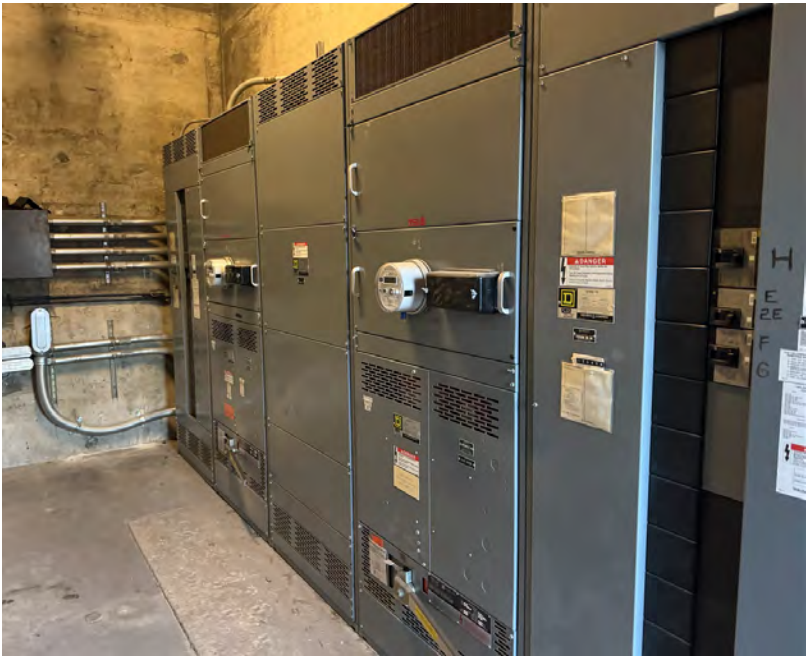
**IMAGE A - EXISTING MAIN SWITCHBOARD**

The facility is served by a 1200A, 120/208V, 3-phase, 4-wire main switchboard, located in the Electrical Room. The switchgear is a five-section Square D QED board that includes two 600A metered services. The installation date of the switchboard is unknown, but it is noted to be a newer system. See image A.

1. Electrical Panels & Breakers
  - Replace all existing panels with seismically certified panels.
  - Ensure all breakers are coordinated based on the Arc Fault Study for improved safety and reliability.

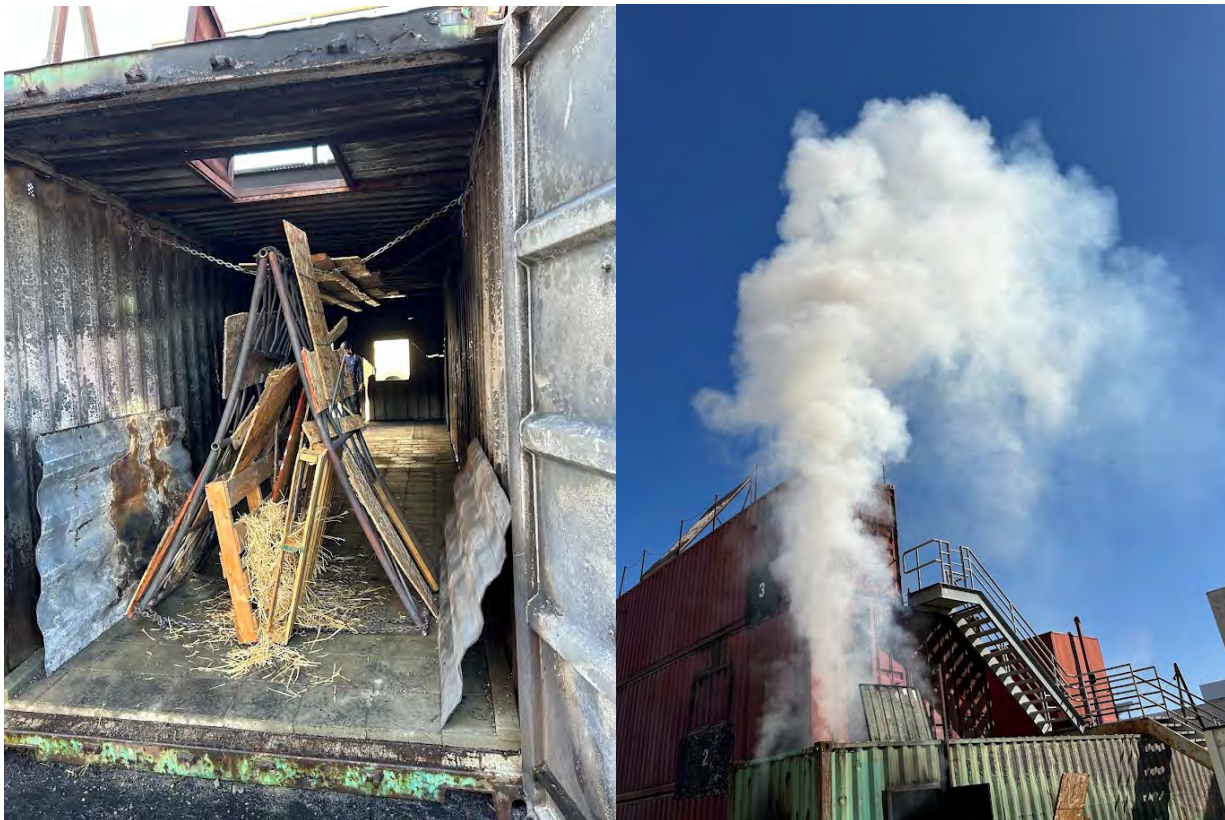
Figure 2. Smoke release through roof vent on storage container. Fan and HEPA filter recommended at this exit point as an engineering control.

Based on this analysis, a feasible solution to mitigate downwind impacts from air emissions is to install a filtration system above the roof vent of the storage container, where over 90% of the plume escapes (See Figure 2). Maintaining a centralized exit, as currently configured, allows for easier integration of an air treatment system. By incorporating an exhaust fan coupled with a HEPA filter, the burn smoke and associated odors can be effectively treated before it is released into the atmosphere. A HEPA filter with impregnated carbon would not only reduce particulate impacts but odorous molecules as well. This setup must also be able to accommodate the intense heat generated by each burn and the frequency of burns conducted each day. If a HEPA filter cannot be used due to the heat of the effluent, stainless steel filters can be utilized at reduced effectiveness.

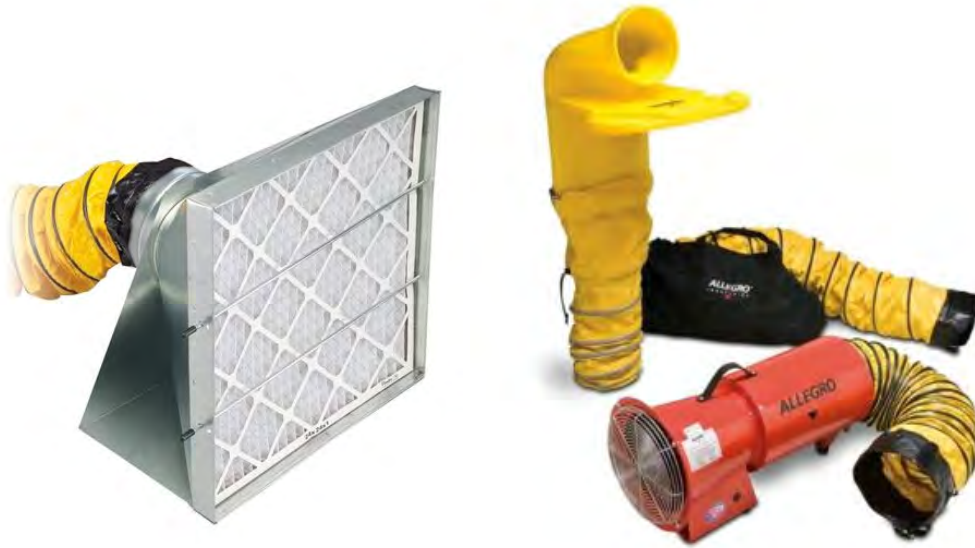
Figure 3. Blower Filter Box with Blower System Example

Alternatively, a blower filter box (or multiple), can be placed adjacent to the roof vent outlet (See Figure 3). This system would reduce odor and particulate impacts but would be less effective than a system ducted to roof vent. This system is proposed as an alternative because ducting a filtration system to the roof vent location may be logistically not practical. This system would be fairly inexpensive to implement.

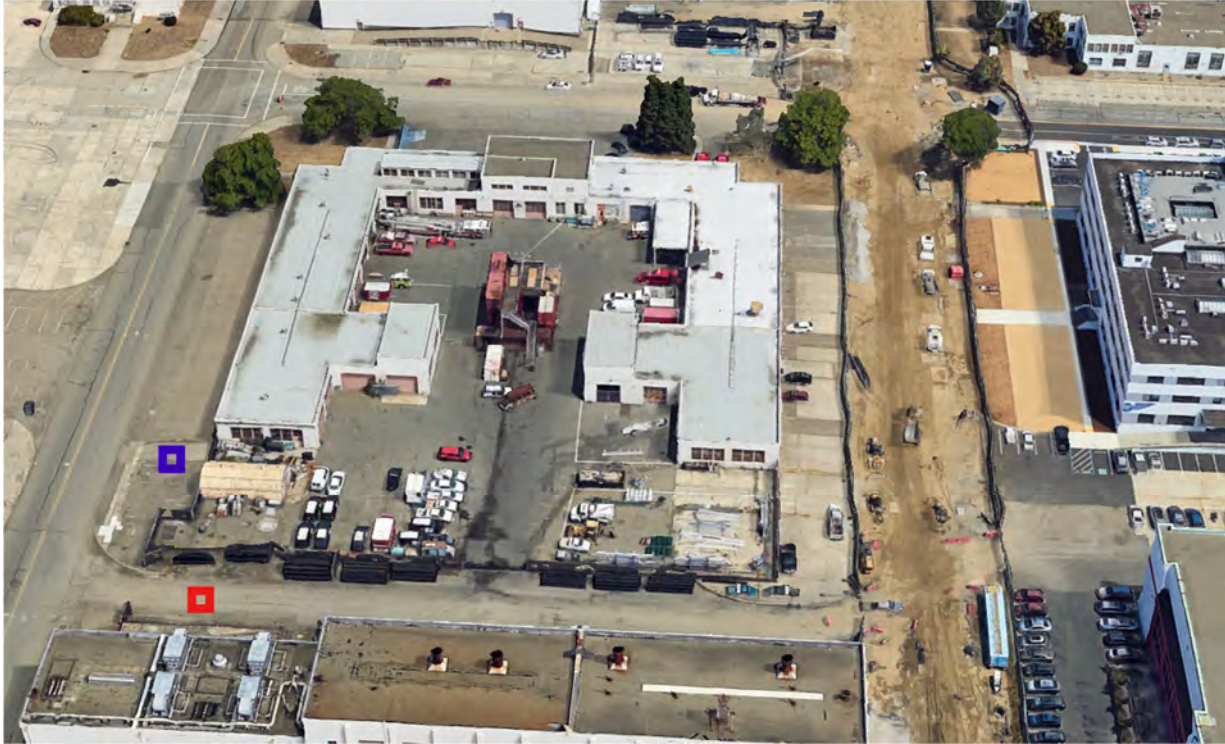
Figure 4. Blue (preferred) and Red squares represent the two (2) sites within the property that could serve as alternatives. Existing burn site is seen in center of property.

Another potential solution is to relocate the burn site to another spot within the same property. Currently, there are two (2) sites within the property and one (1) additional site on a neighboring property that could serve as alternatives. Among these three (3) options, we observed dumpster burns at the two (2) on-site locations. One (1) of these sites demonstrated greater effectiveness in creating distance between the odor source and sensitive receptors, while also benefiting from topographical features that could help diffuse smoke and odors (See Figure 4). Anecdotal evidence suggests that prevailing winds primarily travel from west to east, so adding barriers on the east side of the burn structure could further enhance diffusion. SCS did not visit the off-site location as we believe it would be more effective to address the issue at its current location rather than moving to a new site.
