Memorandum

Project Building 8 Rehabilitation

Topic Compliance with the Secretary of
the Interior's Standards

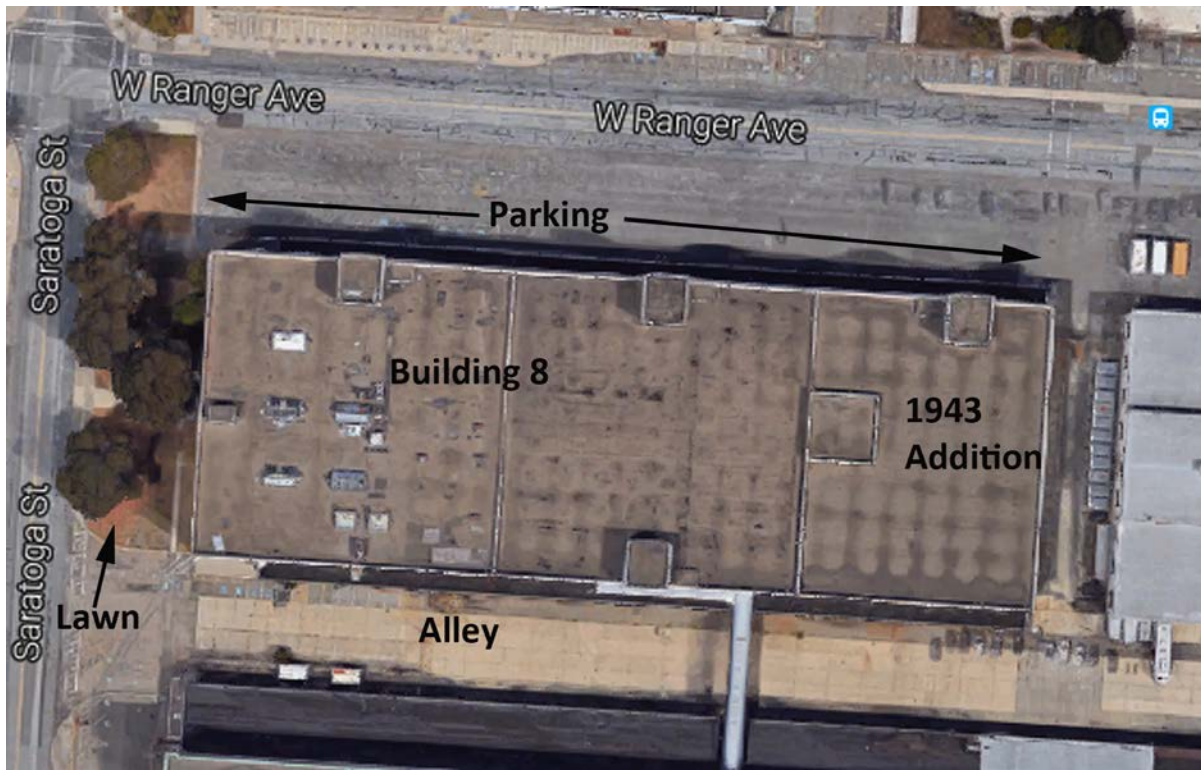
Figure 2. Aerial photograph of Building 8.
Source: Google Maps; annotated by Christopher VerPlanck

The majority of the Project Site is occupied by Building 8 (**Figure 2**). The northernmost part of the site is occupied by a parking area along the south side of West Ranger Avenue (**Figure 3**). The southern section of the site borders a paved alley between Buildings 8 and 9 (**Figure 4**). There is also a paved parking area enclosed within a chain link fence to the east of the building, between Buildings 8 and 92. There is some landscaping on the site, including three lawn panels to the west of the building along Saratoga Street (**Figure 5**). The lawn, which contains five mature black acacia trees, is the largest contiguous area of landscaping in the Shops Area. A pair of concrete-paved footpaths provide access across the lawn from Saratoga Street to the building’s main entrance. Building 8 once had foundation plantings but these were removed in 1979 when the Navy updated the original landscape. In addition to the black acacias, there are four small trees located in the foundation planting zone north of the main entrance. These

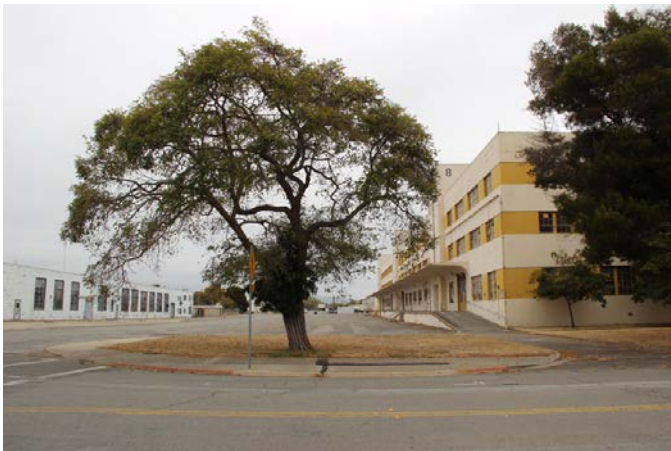
Figure 3. Parking strip behind lawn panel on Saratoga Street; view toward east.

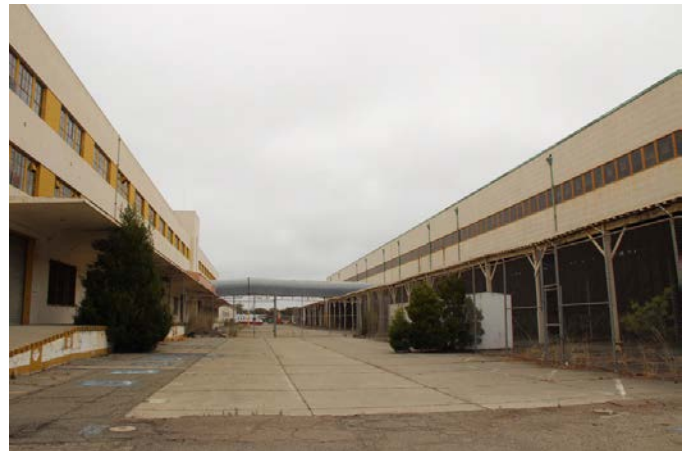
Figure 4. Paved alley between Buildings 8 and 9; view toward east.

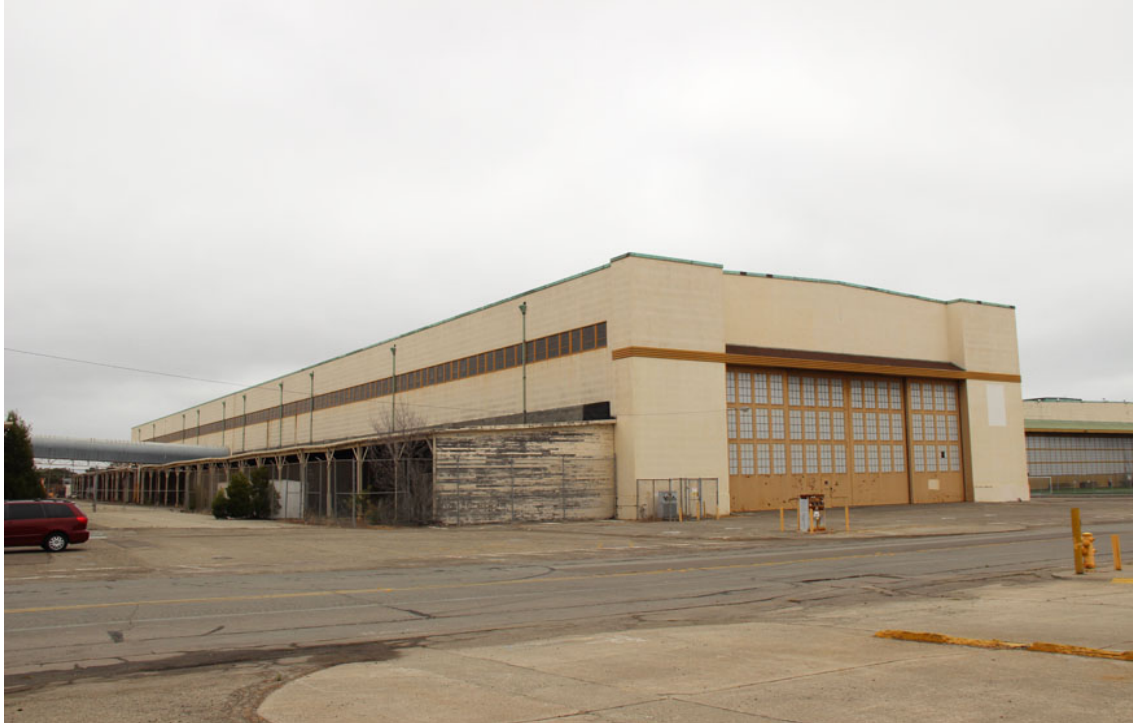
Figure 6. Building 9; view toward southeast.

Building 8 occupies the northwest corner of a rectangular “superblock” bounded by West Ranger Avenue to the north, Pan Am Way to the east, West Tower Avenue to the south, and Saratoga Street to the west. Other buildings on the block include Building 9, which is located south of Building 8 and is linked to it by a non-historic sky bridge. Built in 1941 as NAS Alameda’s Aircraft Storehouse, Building 9 is a two-story building with large hangar doors on its west façade (**Figure 6**). Though it is part of the Shops Area, Building 9 has more in common functionally and aesthetically with the adjoining Operations Area. Like Building 8, it is a contributor to the Historic District.

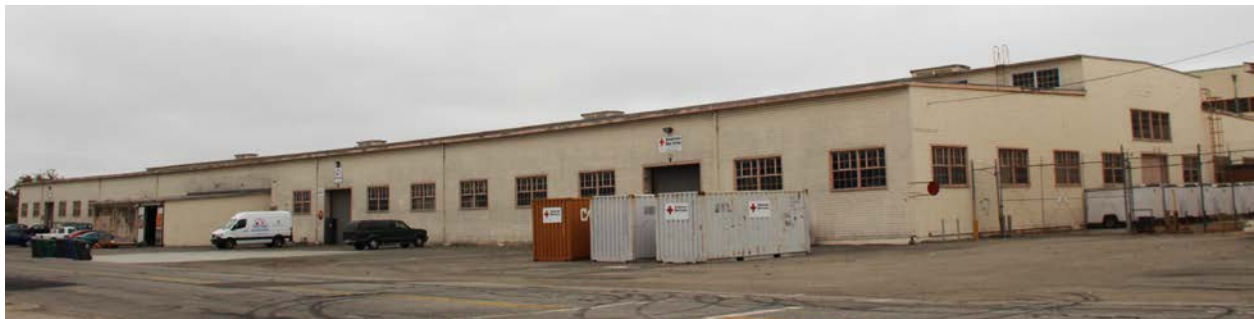
Figure 7. Building 92; view toward southeast.

To the east of Buildings 8 and 9, and occupying the eastern end of the superblock, are Buildings 91 and 92. They constitute a pair of large (53,223 and 89,019 sf, respectively) wood-frame, wood-clad warehouses constructed in 1942. Because they were constructed after the U.S. entry into World War II, they were built of wood, which unlike concrete and steel were not subject to any wartime building restrictions. Buildings 91 and 92 are both utilitarian structures clad in drop siding and they do not have any Streamline Moderne design elements like Buildings 8 or 9 do (**Figure 7**). Nonetheless, they are both contributors to the Historic District because they were constructed during the period of significance.

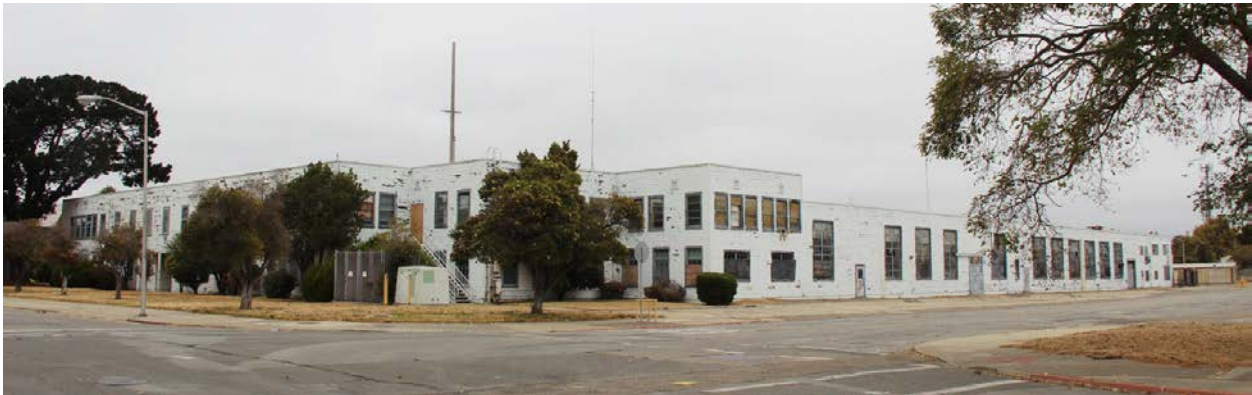
Figure 8. Building 114; view toward northeast.

91 and 92, Buildings 114 and 191 were constructed after the U.S. entry into the war (1944), and so they are utilitarian wood-frame building without any Streamline Moderne ornament (**Figure 8**). Also like Buildings 91 and 92, Buildings 114 and 191 are clad in drop siding. They both appear to be in poor condition. Building 114 has a landscaped lawn facing Saratoga Street, which serves as a continuation of the main north-south mall. Building 114 is a contributor to the Historic District but Building 191 is not.

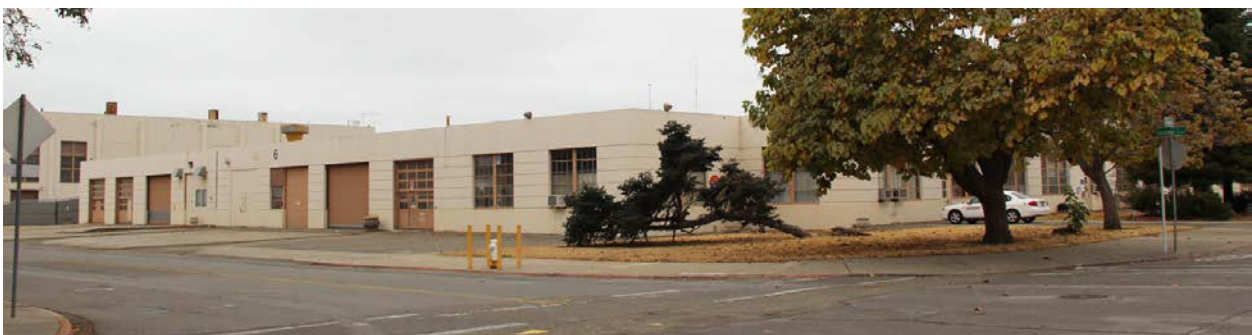
Figure 9. Building 6; view toward southwest.

Building 6, the former Public Works Garage and Firehouse, is located to the west of Building 8, on the west side of Saratoga Street. It is a one-and partial two-story, reinforced concrete garage building with a flat roof and a U-shaped plan (**Figure 9**). Constructed in 1940, Building 6 was part of the original 1938 masterplan and it shares the same Streamline Moderne styling as Buildings 8 and 9. Building 6 has two separate lawn panels – one at the corner of West Ranger Avenue and Lexington Street and the other at the corner of West Ranger Avenue and Saratoga Street. It is a contributor to the Historic District.

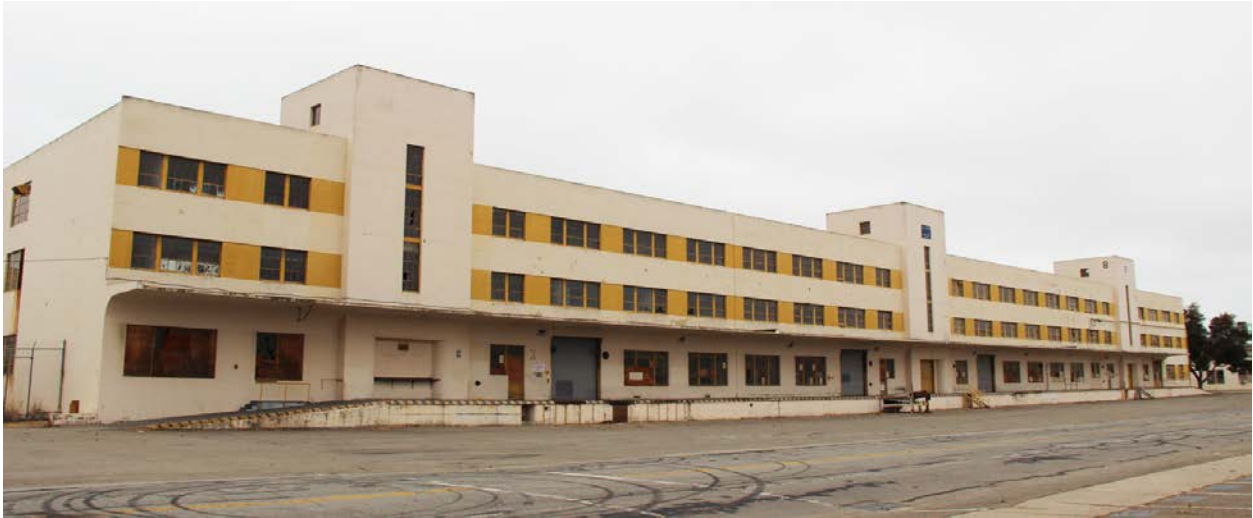
Figure 10. North façade of Building 8; view toward southwest.

Building 8, the General Storehouse, is a three-story, reinforced-concrete warehouse with a rectangular footprint and a flat roof. It contains 270,000 square feet of space. The primary façade, which faces north toward West Ranger Avenue, is punctuated at semi-regular intervals by three four-story towers (**Figure 10**). The south façade, which is otherwise identical to the north façade, has only one tower (**Figure 11**). Each tower has an overhead loading door at its base and a vertical strip of fenestration at the second, third, and fourth floor levels (**Figure 12**). The cargo doors are recessed within rectangular openings with

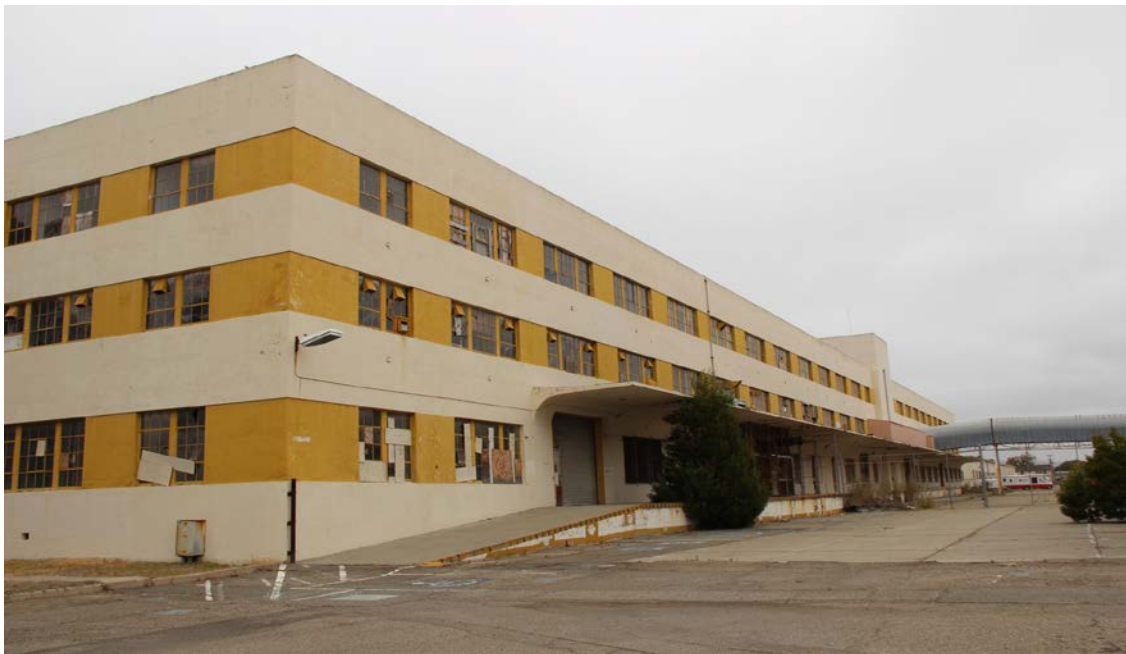
Figure 11. South façade of Building 8; view toward northeast.

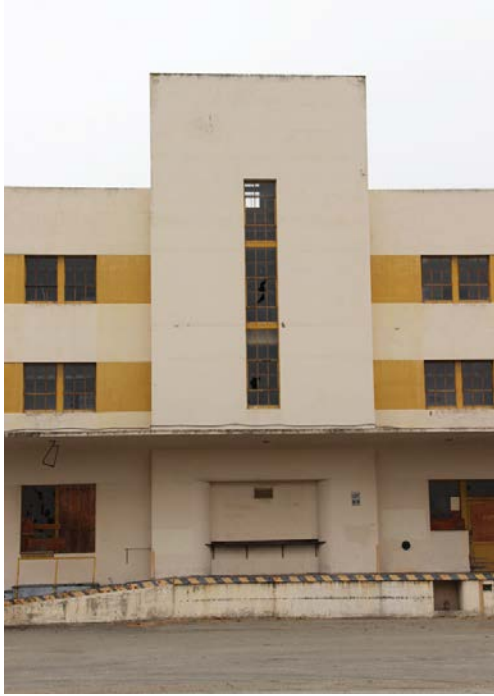
Figure 12. Tower on north façade of Building 8; view toward south.

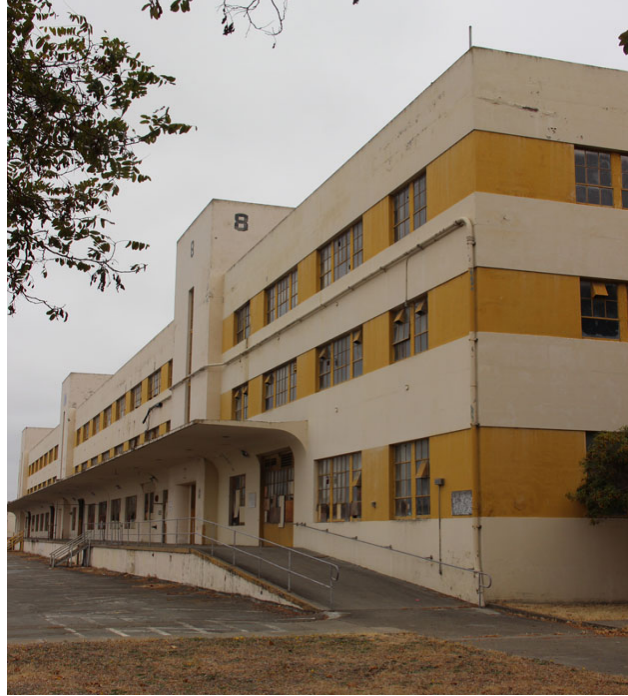
Figure 13. Loading dock on north façade of Building 8; view toward east.

curved sides. The fenestration pattern of the first floor level of the north and south façades is similar, with a mixture of freight doors interspersed among multi-lite, steel industrial windows. The doors open onto concrete loading docks sheltered beneath concrete canopies with curved supports (**Figure 13**). The loading docks are accessed by sloped ramps. The second and third floor levels of Building 8's exterior are articulated as horizontal bands of steel industrial windows alternating with simple, planar spandrels (**Figure 14**). The fenestration bands, which are painted a contrasting color to the rest of the building, are separated from the spandrels by incised lines and are slightly recessed.

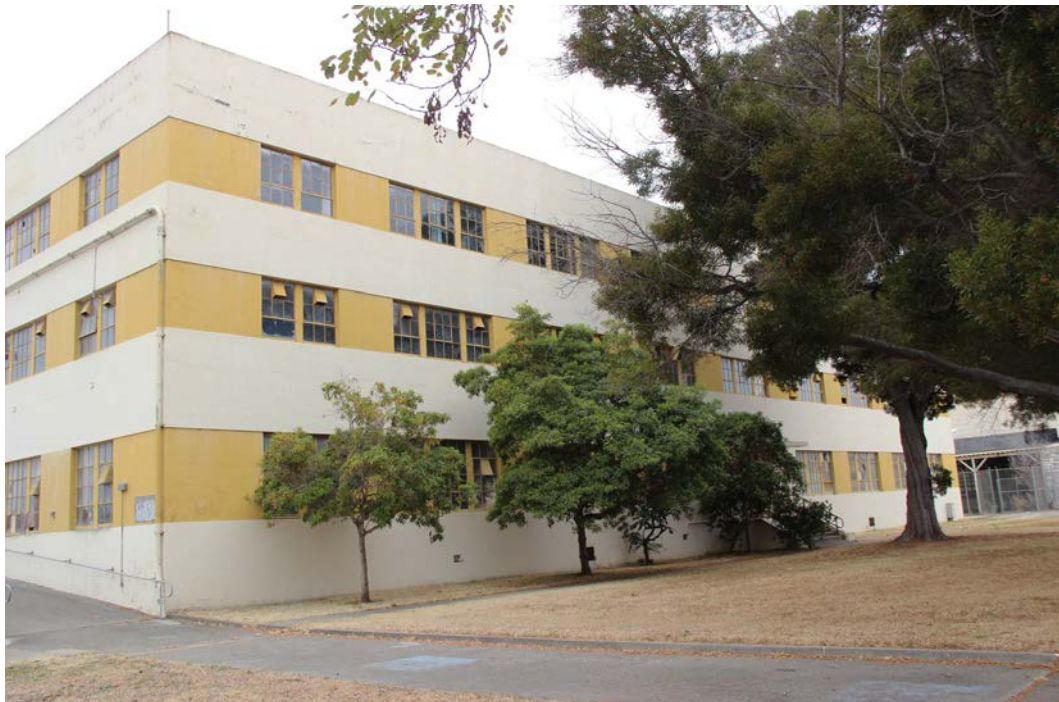
Figure 14. Detail of west façade of Building 8; view toward southeast.

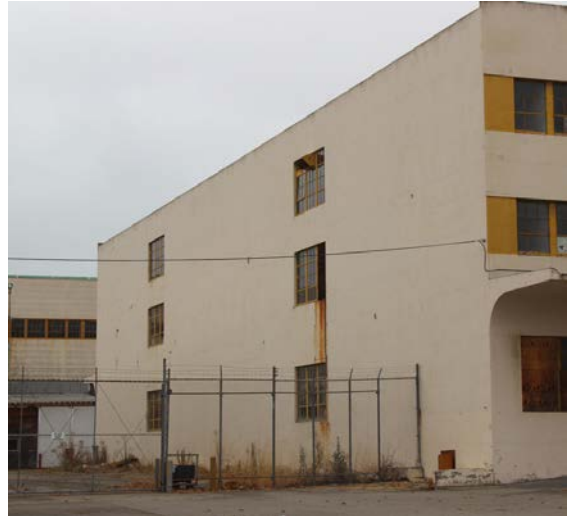
Figure 15. East façade of Building 8; view toward south.

The Navy built the western two-thirds of Building 8 in 1940 as part of the original 1938 plan. In 1943, the Navy's Bureau of Yards and Docks constructed a major addition on the east side of the building, increasing its square footage by approximately one-third. The original east wall remains inside the building, where it has been modified to connect the two sections of the building. With the exception of the utilitarian east façade, the 1943 addition matches the original building in regard to materials, design, and detailing. The east façade of Building 8 is board-formed concrete without any Streamline Moderne detailing. It is articulated by six, multi-lite steel industrial windows (Figure 15).

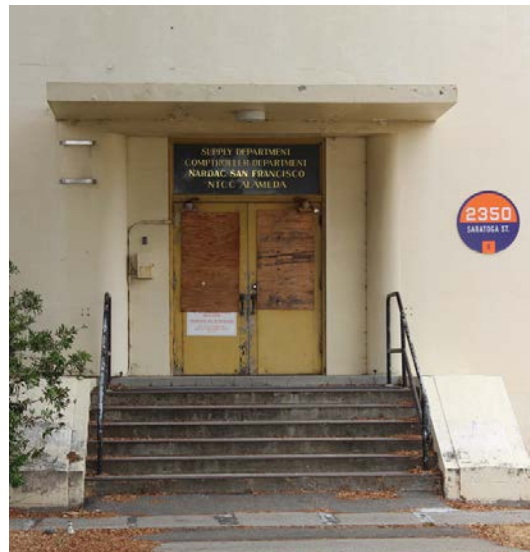
Figure 16. Main entrance at 2350 Saratoga Street.

Building 8's primary entrance is located on the west façade, which faces Saratoga Street (Figure 16). It consists of a pair of single-panel metal doors inset within a rectangular opening with curved sides. The doors are capped by a large transom emblazoned with painted signage that reads:

The signage does not date to the World War II era, and it was most likely added when the Navy built offices in the building during the 1970s or 1980s. Still, it will likely be kept as part of the proposed project. The main entrance is sheltered beneath a cantilevered canopy and is accessed by a concrete stair flanked by large concrete cheek walls. Metal pipe railings serve as handrails.
