City of Alameda

Staff Report

PLN15-0232 - 1208 St. Charles Street - Applicant: Paula Mathis and Tom Ellerbe. The Planning Board will hold a Public Hearing to consider Design Review for a project consisting of the demolition of a two car garage and the construction of an accessory structure that will have a three car garage and an artist studio. The proposed accessory structure is approximately 880 square feet which is less than 40% of the required rear yard allowed for accessory structures per Alameda Municipal Code (AMC) Section 30-4.1(d).7. This project is categorically exempt from further environmental review pursuant to the California Environmental Quality Act (CEQA) Guidelines, Section 15303 - New Construction of Small Structures. (Continued from January 9, 2017)

NEW GARAGE: REPLACE EXISTING GARAGE

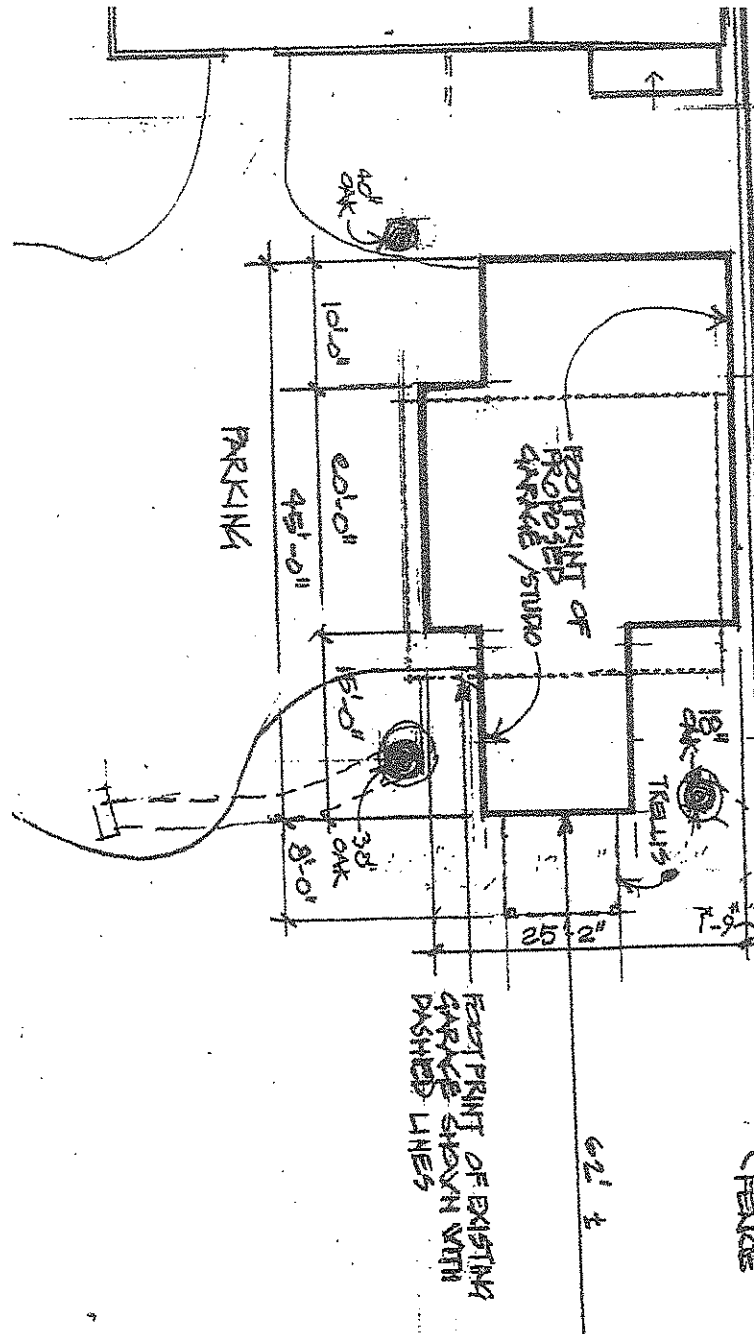
This site sketch pdf file, blown up from the drawing provided by you on 9/15/16, shows the solid lines of the proposed new garage relative to the three oaks that will require protection. Tree #1 is shown above, near the path to the swimming pool gate. Tree #2 is below on the left, near the paved area. The large lower limb on it, extending toward the house, is indicated with dashed lines. Tree #3 is below on the right, near the fence to the property.

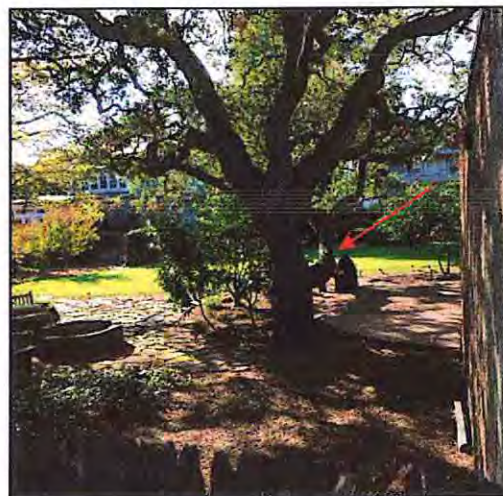
Photo 1. Tree #2 was in good condition with a long lateral limb that extended out into the yard (arrow).

The oaks were mature with diameters of 36" and 33", respectively. Both oaks were in good condition, with full crowns and spreading forms. Oak #2 had a long lateral limb extending out to the east and held up by a prop (Photo1). Both trees had been over pruned and lion tailed within the past year. Lion tailing is a form of pruning that greatly reduces the green foliage, leaving growth only at the ends of each branch. Lion tailing is particularly detrimental to coast live oaks because they are susceptible to sunscald and sunburn.

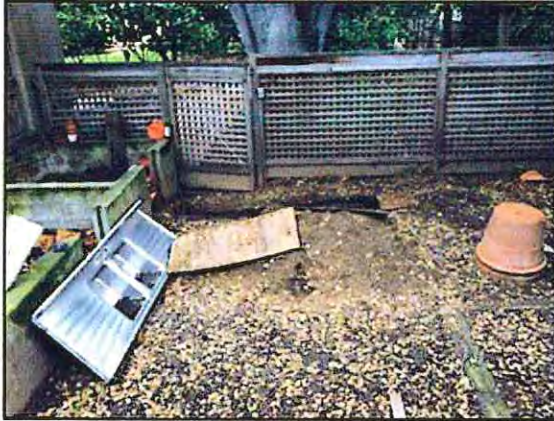
Photo 2, left. Tree #1 with the trench in the location of the proposed building.

Two exploratory trenches were dug with an air spade adjacent to trees 1 and 2. The trenches were 1' wide and 36" deep. The trench dug for tree #1 runs north-south and was excavated where the footprint of the building is proposed (Photo 2 and 3, next page). The trench dug for tree #2 runs east

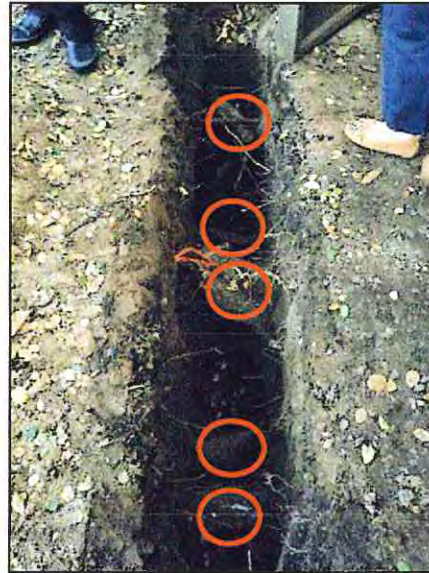
Photo 3, right. Looking into the trench adjacent to tree #1.

The trench adjacent to tree #1 had five roots larger than 2" that can be seen in Photo 3. I do not recommend any work be done in this area, cutting of roots this large and this close to the tree has the potential to impact health, compromise stability.

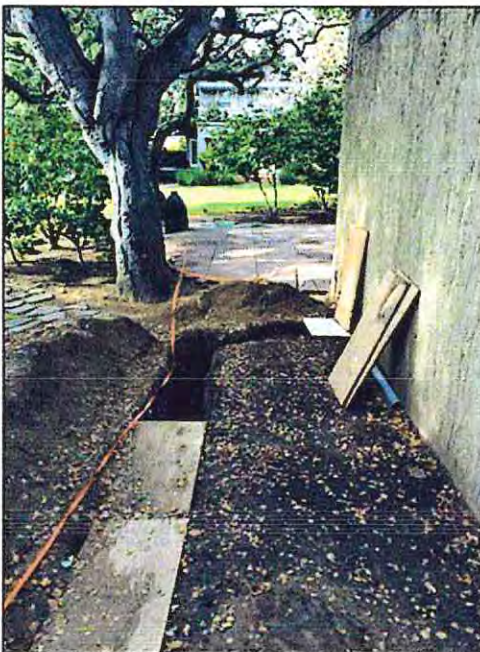
Photo 4, left. Trench adjacent to tree #2.

west and was placed where the footprint of the proposed building will be constructed (Photo 4 and 5).

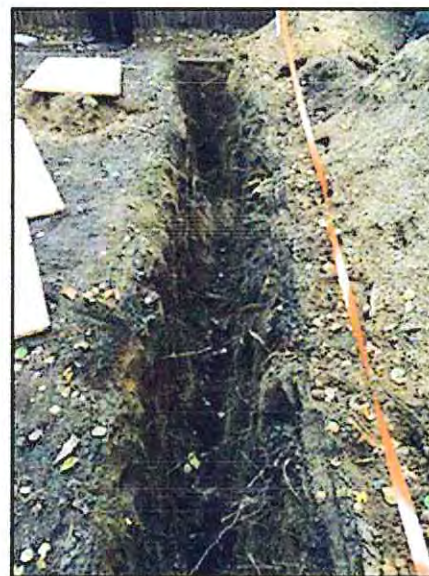
Photo 4, right. Close up of the trench adjacent to tree #2.

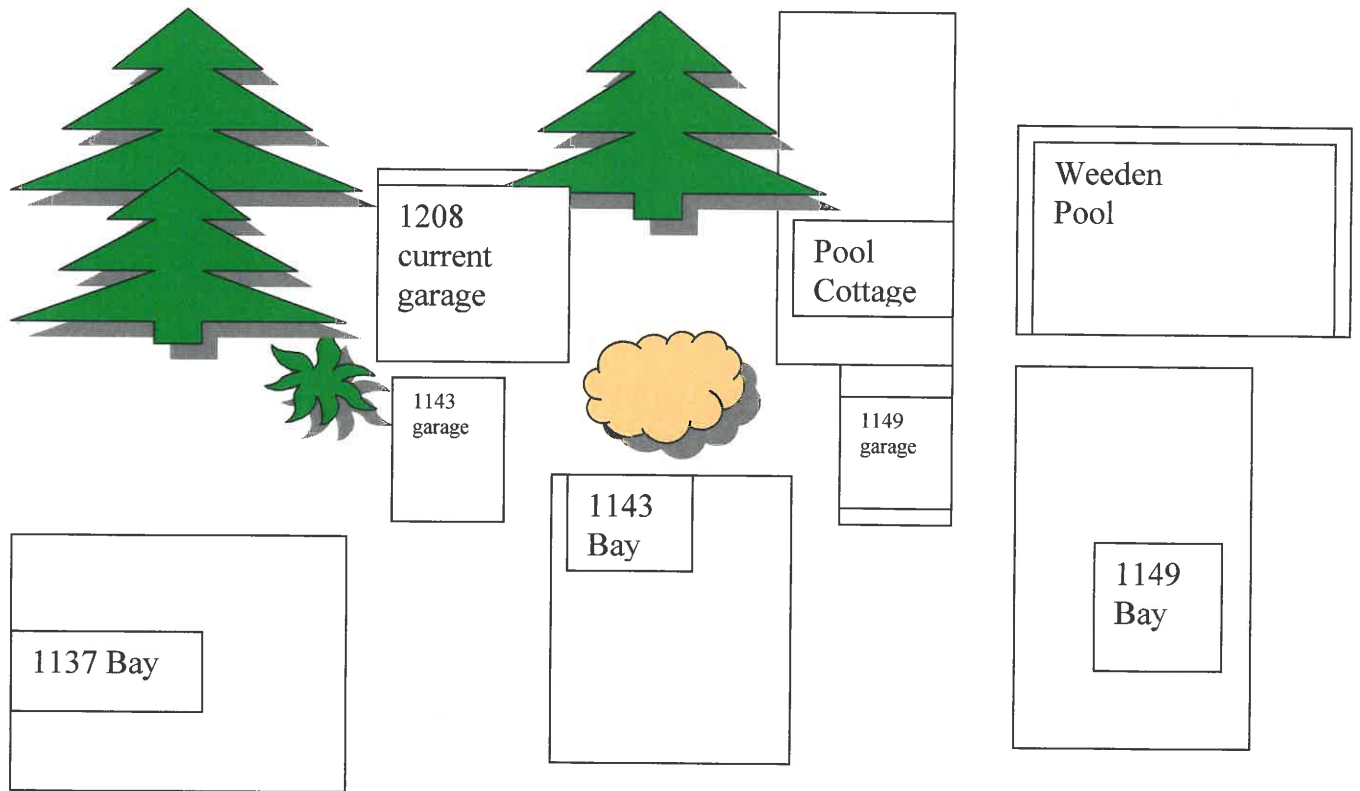
1208 St. Charles, a 28,000 sf property, borders 4 properties on Bay St. On the property, a two car garage backs up to the garage at 1143 Bay St. This garage sits less than 21 ft from its pool cottage, a garage at 1149 Bay St, the back entrance to the kitchen and dining rooms at 1143 Bay St, and less than 4ft from the garage at 1143 Bay St. It is surrounded by the trunks of the 3 Coastal Oaks and sits under their canopy.

Key:

Coastal Oak
