Memorandum

Project Building 8 Rehabilitation

Topic Compliance with the Secretary of
the Interior's Standards

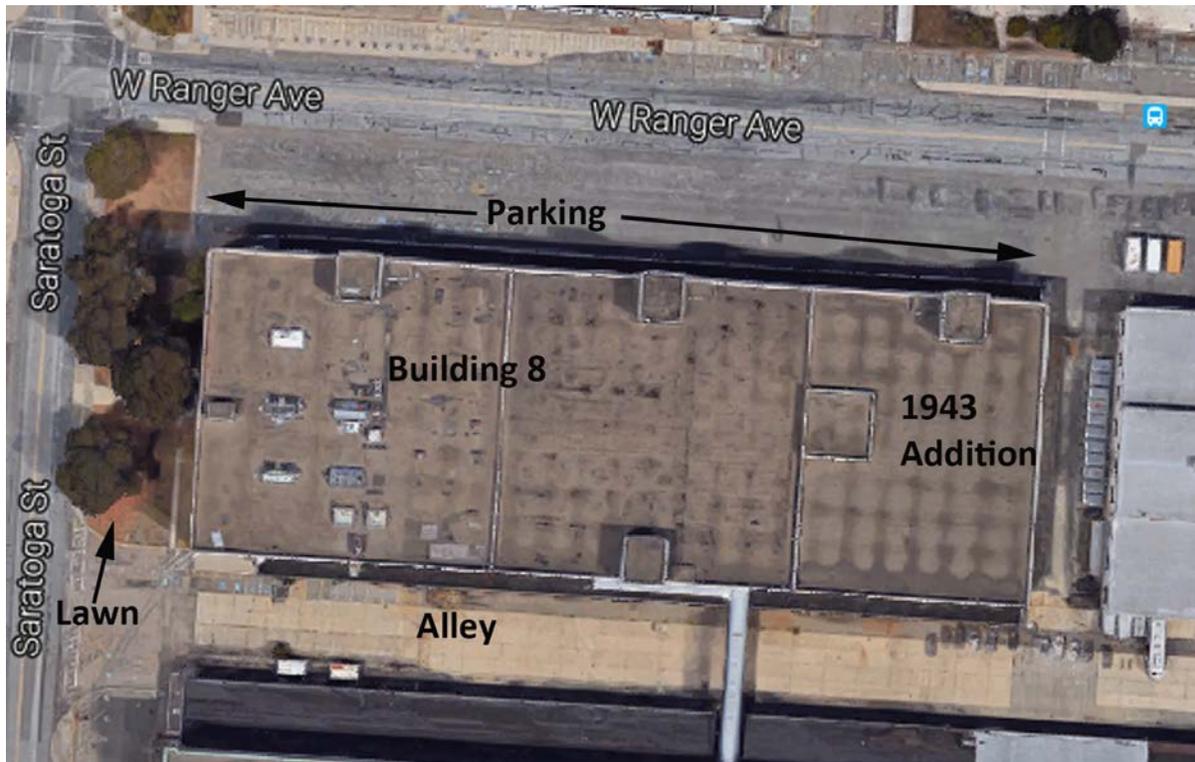
Figure 2. Aerial photograph of Building 8.
Source: Google Maps; annotated by Christopher VerPlanck

The majority of the Project Site is occupied by Building 8 (**Figure 2**). The northernmost part of the site is occupied by a parking area along the south side of West Ranger Avenue (**Figure 3**). The southern section of the site borders a paved alley between Buildings 8 and 9 (**Figure 4**). There is also a paved parking area enclosed within a chain link fence to the east of the building, between Buildings 8 and 92. There is some landscaping on the site, including three lawn panels to the west of the building along Saratoga Street (**Figure 5**). The lawn, which contains five mature black acacia trees, is the largest contiguous area of landscaping in the Shops Area. A pair of concrete-paved footpaths provide access across the lawn from Saratoga Street to the building’s main entrance. Building 8 once had foundation plantings but these were removed in 1979 when the Navy updated the original landscape. In addition to the black acacias, there are four small trees located in the foundation planting zone north of the main entrance. These

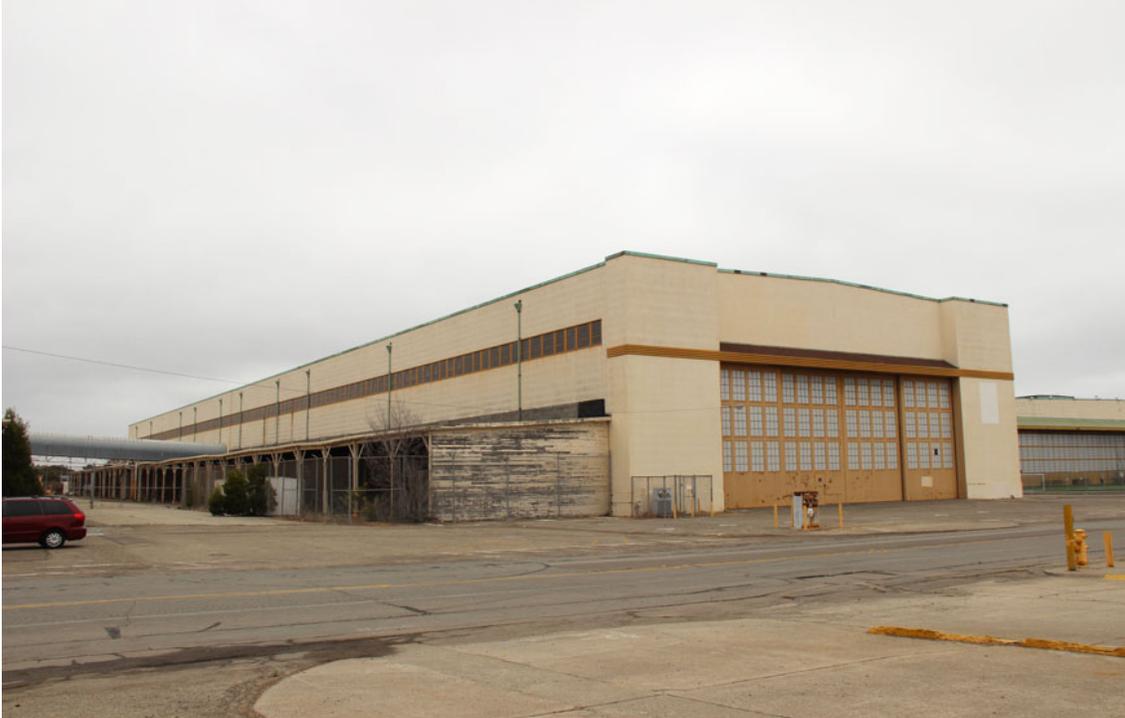
Figure 6. Building 9; view toward southeast.

Building 8 occupies the northwest corner of a rectangular “superblock” bounded by West Ranger Avenue to the north, Pan Am Way to the east, West Tower Avenue to the south, and Saratoga Street to the west. Other buildings on the block include Building 9, which is located south of Building 8 and is linked to it by a non-historic sky bridge. Built in 1941 as NAS Alameda’s Aircraft Storehouse, Building 9 is a two-story building with large hangar doors on its west façade (**Figure 6**). Though it is part of the Shops Area, Building 9 has more in common functionally and aesthetically with the adjoining Operations Area. Like Building 8, it is a contributor to the Historic District.

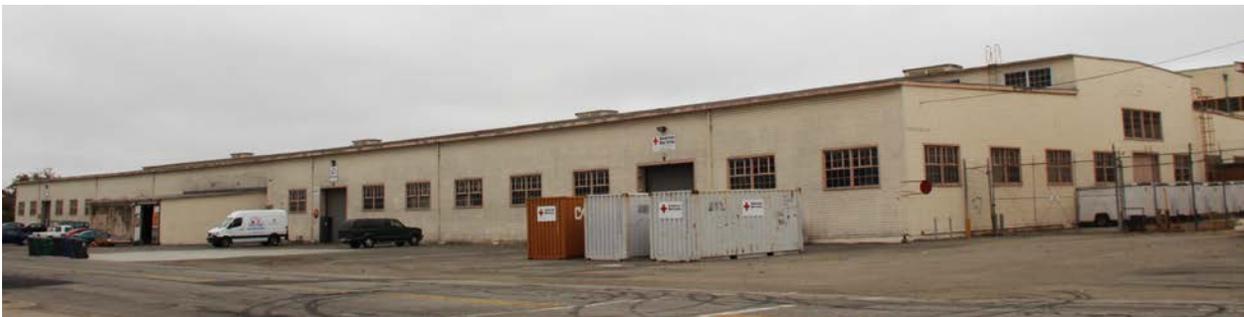
Figure 7. Building 92; view toward southeast.

To the east of Buildings 8 and 9, and occupying the eastern end of the superblock, are Buildings 91 and 92. They constitute a pair of large (53,223 and 89,019 sf, respectively) wood-frame, wood-clad warehouses constructed in 1942. Because they were constructed after the U.S. entry into World War II, they were built of wood, which unlike concrete and steel were not subject to any wartime building restrictions. Buildings 91 and 92 are both utilitarian structures clad in drop siding and they do not have any Streamline Moderne design elements like Buildings 8 or 9 do (**Figure 7**). Nonetheless, they are both contributors to the Historic District because they were constructed during the period of significance.

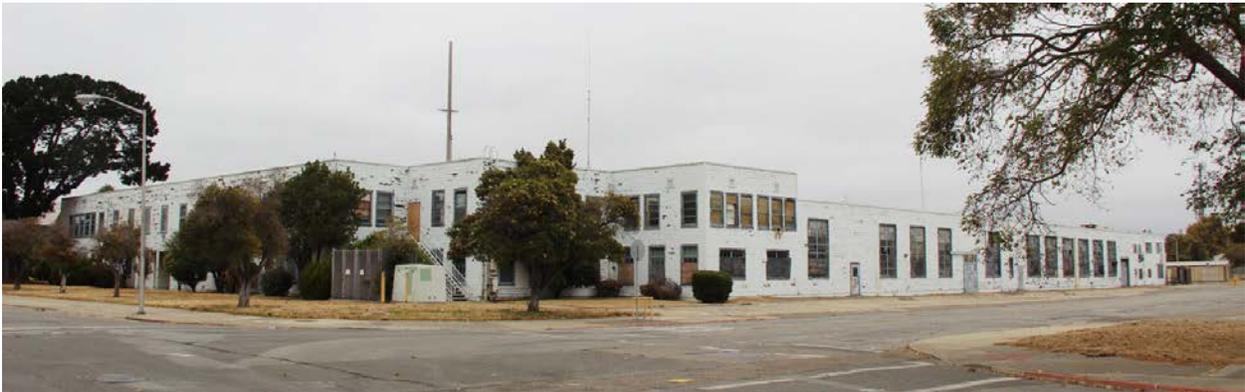
Figure 8. Building 114; view toward northeast.

91 and 92, Buildings 114 and 191 were constructed after the U.S. entry into the war (1944), and so they are utilitarian wood-frame building without any Streamline Moderne ornament (**Figure 8**). Also like Buildings 91 and 92, Buildings 114 and 191 are clad in drop siding. They both appear to be in poor condition. Building 114 has a landscaped lawn facing Saratoga Street, which serves as a continuation of the main north-south mall. Building 114 is a contributor to the Historic District but Building 191 is not.

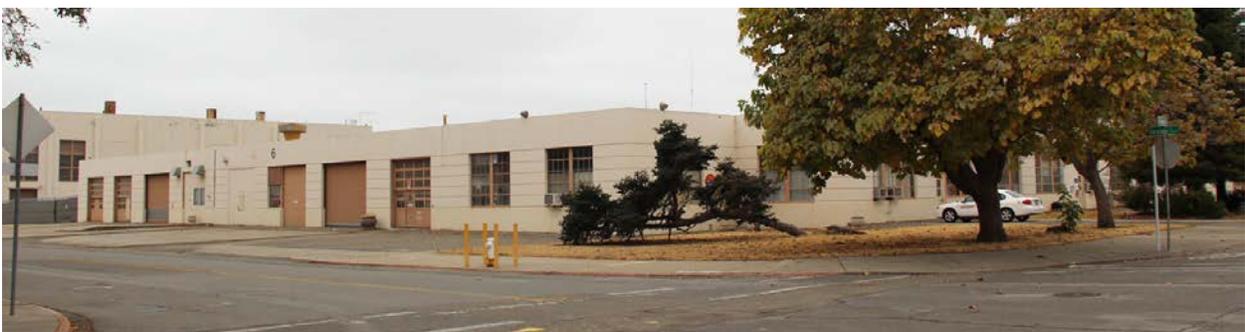
Figure 9. Building 6; view toward southwest.

Building 6, the former Public Works Garage and Firehouse, is located to the west of Building 8, on the west side of Saratoga Street. It is a one-and partial two-story, reinforced concrete garage building with a flat roof and a U-shaped plan (**Figure 9**). Constructed in 1940, Building 6 was part of the original 1938 masterplan and it shares the same Streamline Moderne styling as Buildings 8 and 9. Building 6 has two separate lawn panels – one at the corner of West Ranger Avenue and Lexington Street and the other at the corner of West Ranger Avenue and Saratoga Street. It is a contributor to the Historic District.

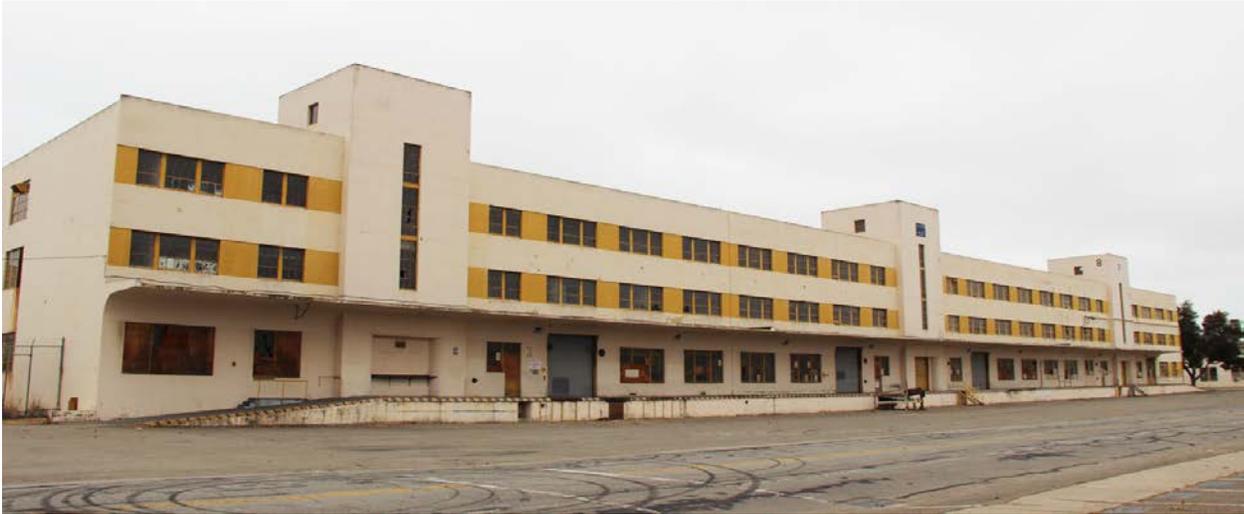
Figure 10. North façade of Building 8; view toward southwest.

Building 8, the General Storehouse, is a three-story, reinforced-concrete warehouse with a rectangular footprint and a flat roof. It contains 270,000 square feet of space. The primary façade, which faces north toward West Ranger Avenue, is punctuated at semi-regular intervals by three four-story towers (**Figure 10**). The south façade, which is otherwise identical to the north façade, has only one tower (**Figure 11**). Each tower has an overhead loading door at its base and a vertical strip of fenestration at the second, third, and fourth floor levels (**Figure 12**). The cargo doors are recessed within rectangular openings with

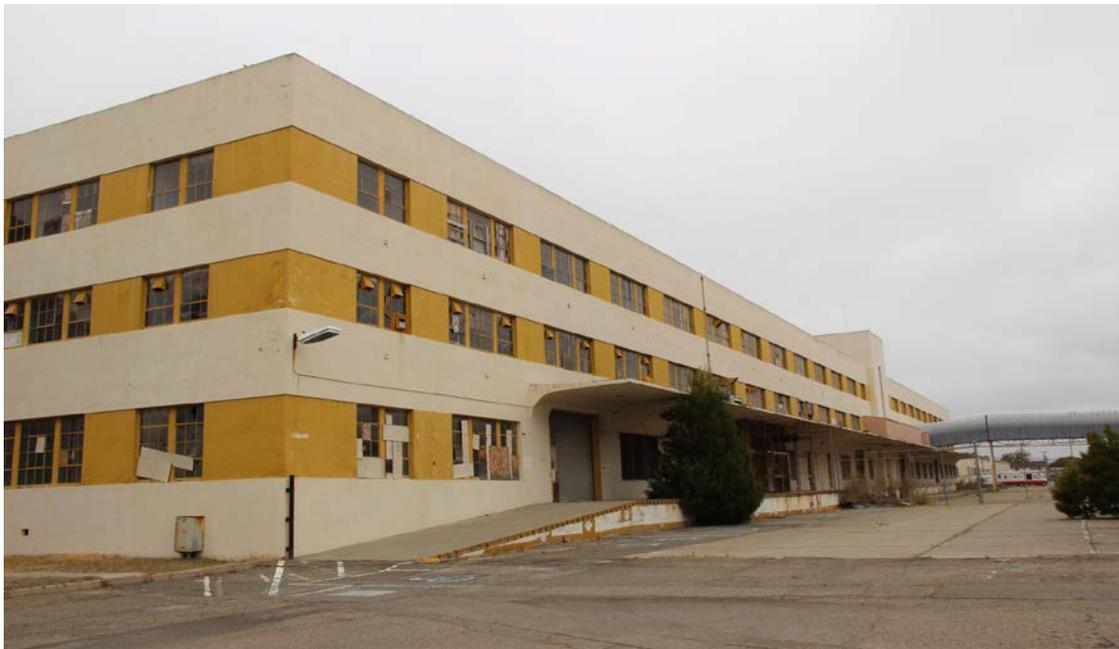
Figure 11. South façade of Building 8; view toward northeast.

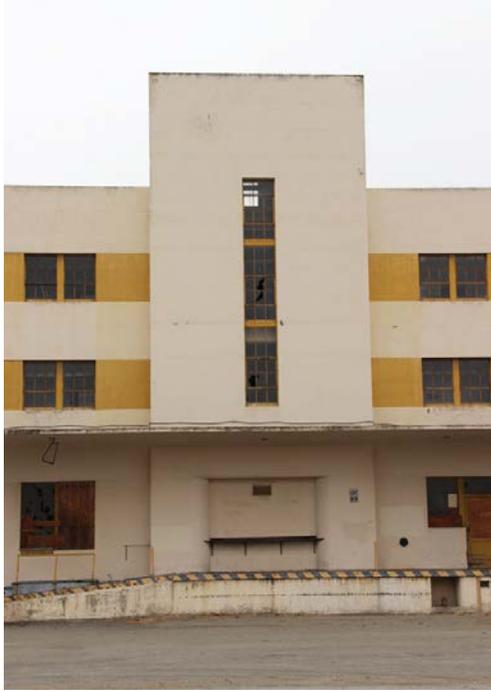
Figure 12. Tower on north façade of Building 8; view toward south.

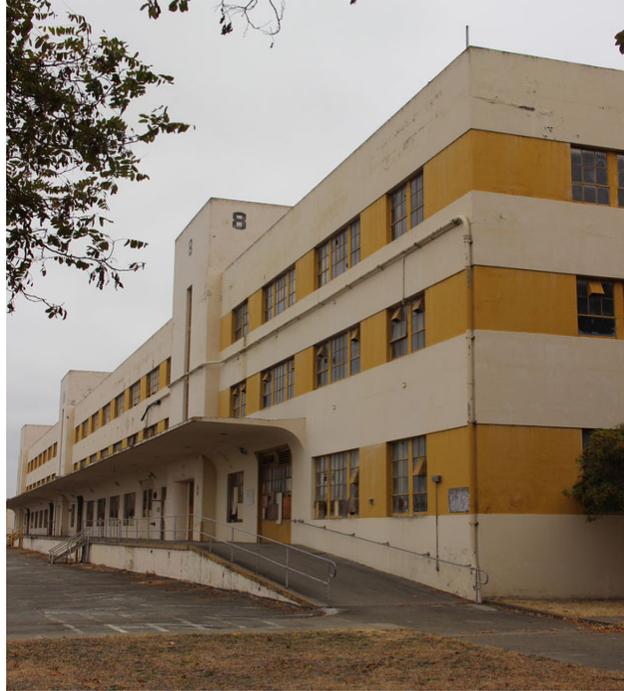
Figure 13. Loading dock on north façade of Building 8; view toward east.

curved sides. The fenestration pattern of the first floor level of the north and south façades is similar, with a mixture of freight doors interspersed among multi-lite, steel industrial windows. The doors open onto concrete loading docks sheltered beneath concrete canopies with curved supports (**Figure 13**). The loading docks are accessed by sloped ramps. The second and third floor levels of Building 8's exterior are articulated as horizontal bands of steel industrial windows alternating with simple, planar spandrels (**Figure 14**). The fenestration bands, which are painted a contrasting color to the rest of the building, are separated from the spandrels by incised lines and are slightly recessed.

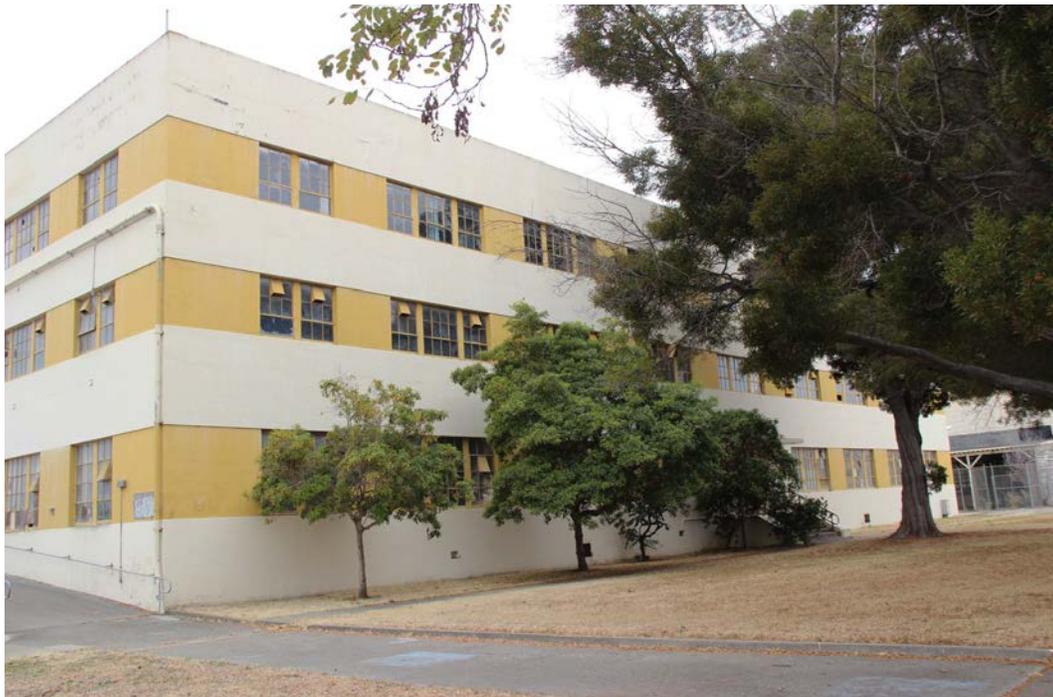
Figure 14. Detail of west façade of Building 8; view toward southeast.

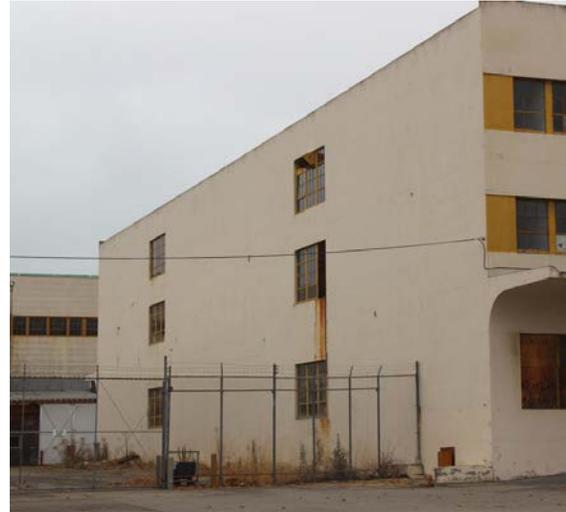
Figure 15. East façade of Building 8; view toward south.

The Navy built the western two-thirds of Building 8 in 1940 as part of the original 1938 plan. In 1943, the Navy's Bureau of Yards and Docks constructed a major addition on the east side of the building, increasing its square footage by approximately one-third. The original east wall remains inside the building, where it has been modified to connect the two sections of the building. With the exception of the utilitarian east façade, the 1943 addition matches the original building in regard to materials, design, and detailing. The east façade of Building 8 is board-formed concrete without any Streamline Moderne detailing. It is articulated by six, multi-lite steel industrial windows (Figure 15).

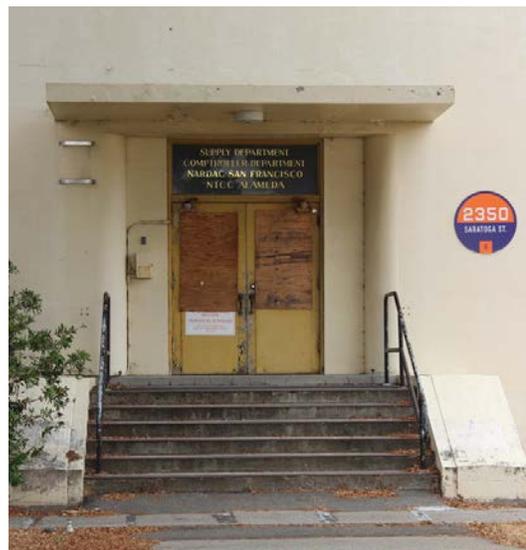
Figure 16. Main entrance at 2350 Saratoga Street.

Building 8's primary entrance is located on the west façade, which faces Saratoga Street (Figure 16). It consists of a pair of single-panel metal doors inset within a rectangular opening with curved sides. The doors are capped by a large transom emblazoned with painted signage that reads:

The signage does not date to the World War II era, and it was most likely added when the Navy built offices in the building during the 1970s or 1980s. Still, it will likely be kept as part of the proposed project. The main entrance is sheltered beneath a cantilevered canopy and is accessed by a concrete stair flanked by large concrete cheek walls. Metal pipe railings serve as handrails.
