HISTORIC RESOURCES INVENTORY

1. Historic name Kaliski, Louis, Building-or-The Marti-Rae Apartments

11 PRESERVATION BRIEFS

Rehabilitating Historic Storefronts

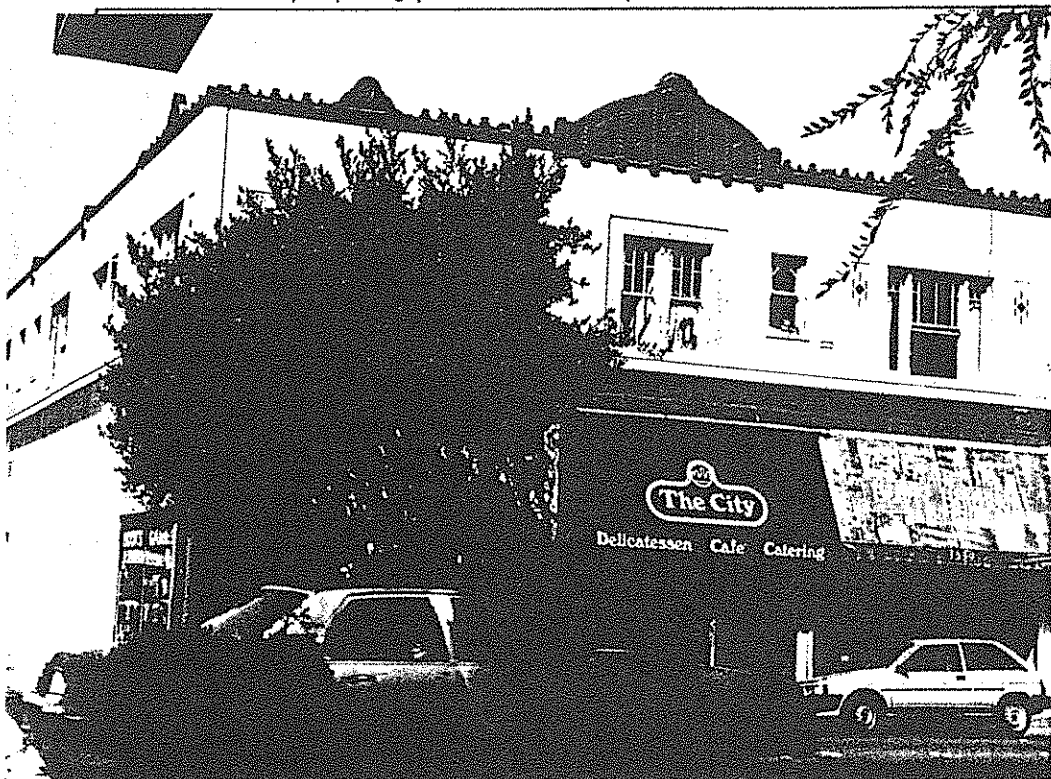
This two-story commercial/apartment building, of reinforced-concrete construction, is located at the northwest corner of Park Street and Alameda Avenue, with the principal facades facing east to Park Street and south to Alameda Avenue. The building contains seven commercial spaces at street level (consolidated into five) and eight apartments on the upper story. It is of reinforced-concrete construction; the unadorned north side and rear display painted concrete. The building has a rectangular plan measuring approximately 50' x 120', with the long side facing Alameda Ave. The level roof is concealed behind parapets. The street facades are clad in smooth cement stucco and adorned with cast-concrete ornament (pilasters, frieze, coping, parapet panels) based on Renaissance/Baroque sources. The symmetrical Park Street facade displays heavy ornament with a floral/shield motif on the storefront frieze and on the high central parapet panel (containing a shield with the letter "K"). Smaller and simpler panels flanking the central panel continue along the Alameda Avenue facade, interspersed with a second type of panel. The upper story contains tripartite and double-hung windows, the former more numerous, the latter of varying size. The tripartite windows (narrow casements flanking a wide double-hung section) have applied lathed ornament on vertical members; casements and upper lights of double-hung windows are adorned with thin mullions in a variety of patterns. End bays are accentuated by bar molding and by recessed panels highlighted with black and yellow ceramic tile. The four original storefronts along Alameda Avenue have recessed entries with mosaic tile paving and display windows with black and yellow ceramic tile in a checkerboard pattern; the recessed apartment entry (2323 Alameda Ave.) is bordered in similar ceramic tile, with a larger polychrome tile over the entry depicting jousting knights. Of the three Park Street storefronts, two (1335 and 1337) have been rebuilt; the third (1339) retains a central recessed entry flanked by display windows with green marble base. All storefront transoms have been stuccoed over. Two interiors (1337 and 1339) are largely intact, each with a high ceiling and an open mezzanine with twin arches springing from a short, tapering post with Ionic capital.

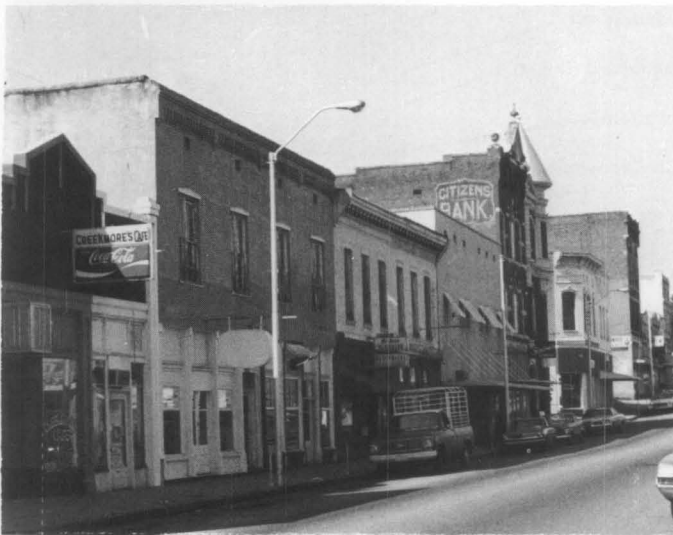
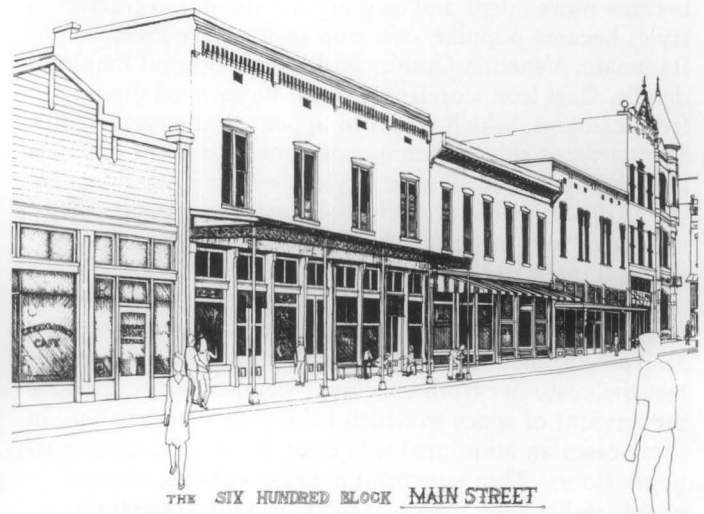
Figure 1. Inappropriate storefront alterations over the years—metal cladding, oversized signs and canopies—have detracted from the character of this historic district in Van Buren, Arkansas. A carefully considered rehabilitation plan for Main Street, including the removal of poorly designed signs, false fronts and the selection of an appropriate exterior paint color palette, serves to enhance the visual environment and preserves the district's sense of time and place. Photo above: Bob Dunn; Drawing, David Fitts

As more and more people come to recognize and appreciate the architectural heritage of America's downtowns, however, a growing interest can be seen in preserving the historic character of commercial buildings. The sensitive rehabilitation of storefronts can result not only in increased business for the owner but can also provide evidence that downtown revitalization efforts are succeeding (see figure 1).

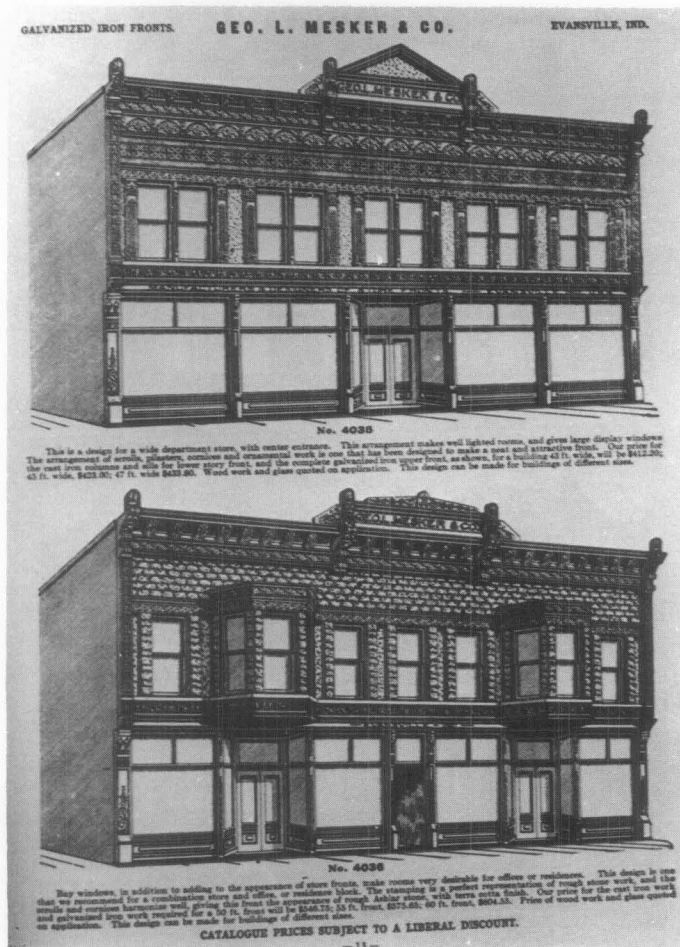
Figure 2. These 19th century galvanized iron storefronts could be purchased from George L. Mesker & Co. in Evansville, Indiana.

The first cast iron fronts were simple post-and-lintel construction with little decoration. As iron craftsmen became more adept and as more ornate architectural styles became popular, cast iron fronts were given Italianate, Venetian Gothic, and French Second Empire details. Cast iron storefronts could be selected directly from catalogs, which began to appear in the early 1850's. Standardized sills, columns, and lintels could be arranged to create fronts of all sizes, styles and configurations. In the 1870's sheet metal storefronts became popular; they were also sold in standardized sizes and configurations through manufacturers' catalogs (see figure 2).

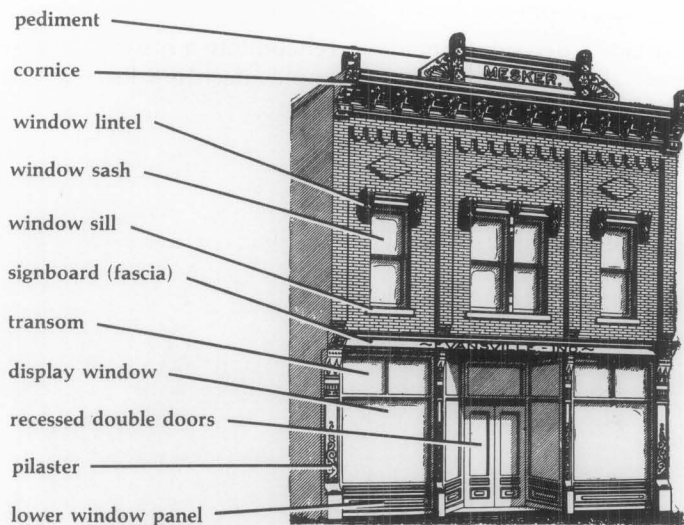
Figure 3. Become familiar with the architectural features typical of historic commercial buildings. A close look at a storefront's construction materials, features and relationship to the upper stories will help in determining how much of the original facade remains.

This particular storefront is No. 4016 in the George L. Mesker and Company catalog of 1905. One of Mesker's most popular designs, it featured cast-iron sills, columns and lintels, galvanized iron lintel and main cornice, window caps and pediment.

The typical 19th century storefront consisted of single or double doors flanked by display windows (see figure 3). The entrance was frequently recessed, not only to protect the customer from inclement weather but to increase the amount of space in which to display merchandise. In some cases an additional side door provided access to the upper floors. Thin structural members of cast iron or wood, rather than masonry piers, usually framed the storefront. The windows themselves were raised off the ground by wood, cast iron or pressed metal panels or bulkheads; frequently, a transom or series of transoms (consisting of single or multiple panes of glass) were

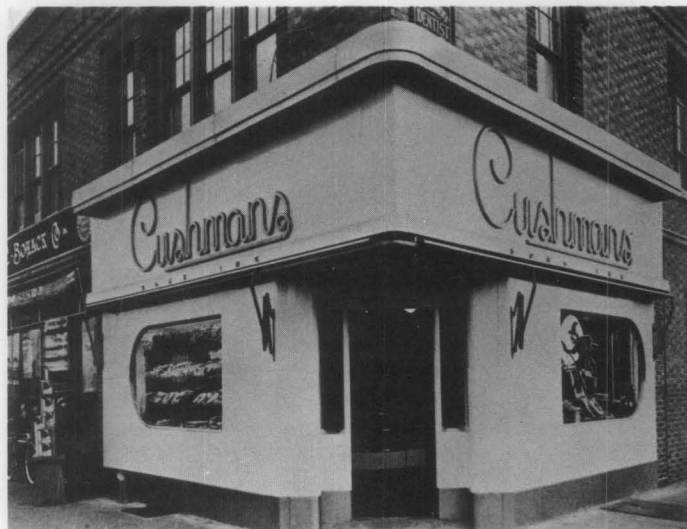
Figure 4. This storefront in New York City designed by Raymond Loewy typifies the streamlined look of the 1930's. Added to an earlier building, the front utilizes glass, stainless steel and neon to make a modern statement. This is a good example of a later storefront which has acquired significance and should be retained in any rehabilitation.

The first decades of the 20th century saw the growing use of decorative transom lights (often using small prismatic glass panes) above display windows; in some cases, these transoms could be opened to permit air circulation into the store. Electric incandescent lights enabled storeowners to call attention to their entrance and display windows and permitted nighttime shopping. In the 1920's and 1930's a variety of new materials were introduced into the storefront, including aluminum and stainless steel framing elements, pigmented structural glass (in a wide variety of colors), tinted and mirrored glass, glass block and neon. A bewildering number of proprietary products also appeared during this period, many of which went into storefronts including Aklo, Vitrolux, Vitrolite, and Extrudalite. Highly colored and heavily patterned marble was a popular material for the more expensive storefronts of this period. Many experiments were made with recessed entries, floating display islands, and curved glass. The utilization of neon lighting further transformed store signs into elaborate flashing and blinking creations. During this period design elements were simplified and streamlined; transom and signboard were often combined. Signs utilized typefaces for the period, including such stylized lettering as "Broadway," "Fino" and "Monogram." Larger buildings of this period, such as department stores, sometimes had fixed metal canopies, with lighting and signs as an integral component of the fascia (see figure 4).

In evaluating whether the existing storefront is worthy of preservation, recognize that good design can exist in any period; a storefront added in 1930 may have greater architectural merit than what is replaced (see figure 4). In commercial historic districts, it is often the diversity of

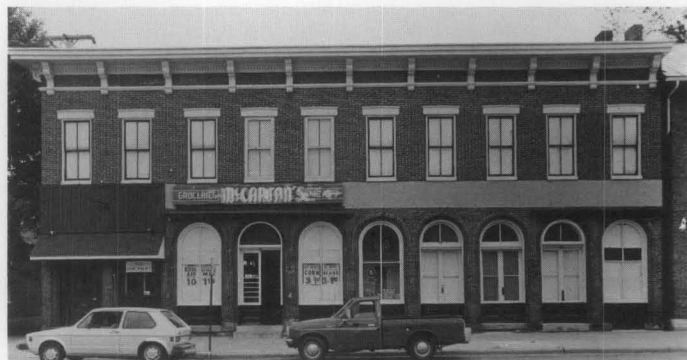
Figure 5. In some cases, as in the storefront on the extreme left, it is a simple matter to determine original appearance by looking at neighboring storefronts. Removal of the board and batten fasciabord, pent roof, and "colonial" style door, all of which could be undertaken at minimal cost, would restore the original proportions and lines of the building. Photo: Day Johnston

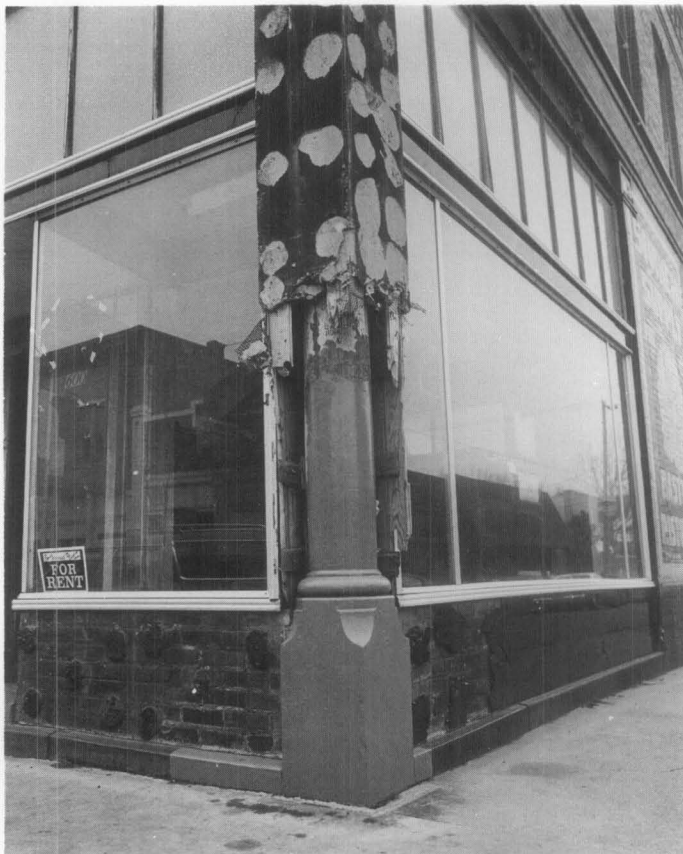
Figure 6. Storefronts of the 1940's, 50's, and 60's were frequently installed by attaching studs or a metal grid over an early front and applying new covering materials. If the existing storefront is a relatively recent addition with little or no architectural merit, begin by removing the covering materials in several places as was done here. If this preliminary investigation reveals evidence of an earlier front, such as this cast-iron column, carefully remove the later materials to assess the overall condition of the historic storefront. The black mastic visible on the lower masonry panels was used for installing pigmented structural glass. Some attachment methods for modern facings, such as mastic or metal lath, may have seriously damaged the original fabric of the building, and this must be taken into account in the rehabilitation process. Photo: Bob Dunn

tent and nature of rehabilitation work needed (see figure 6). In most cases, this examination is best undertaken by a qualified professional.

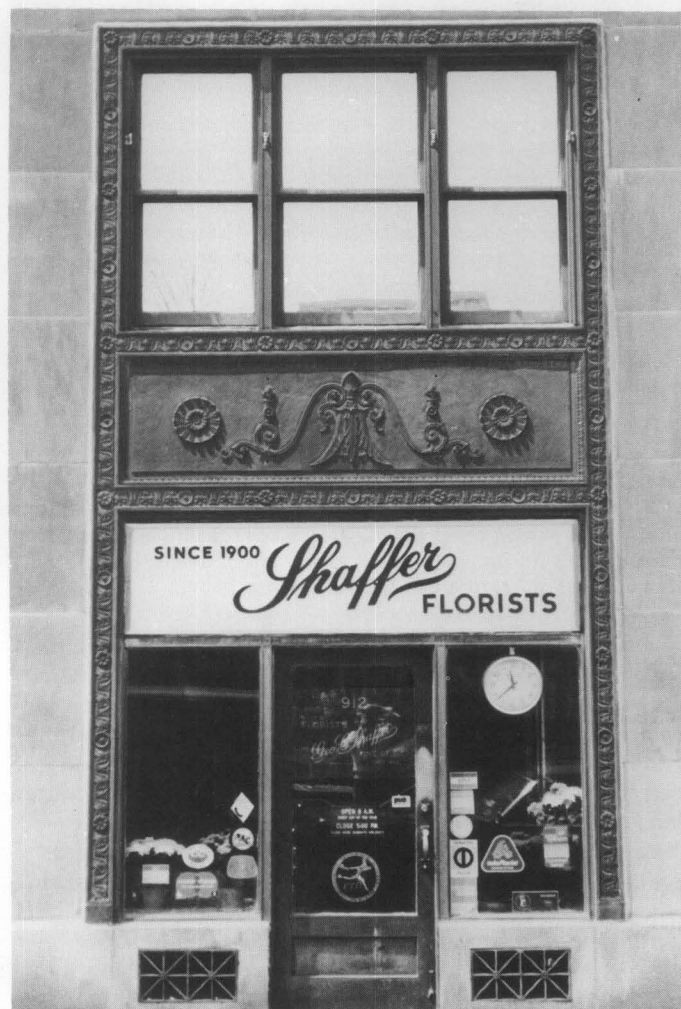
Figure 7. Part of a large office building constructed in Washington, D.C. in 1928, this finely detailed bronze storefront is typical of many constructed during this period. It should be noted that the original grilles, spandrel panel and window above are all intact. Photo: David W. Look, AIA

Bronze and brass—nonmagnetic, abrasive-resistant alloys combining copper with varying amounts of zinc, lead, or tin. These copper alloys, more commonly found in office buildings or large department stores, range in color from lemon yellow to golden brown to green depending on their composition and are well suited for casting (see figure 7).

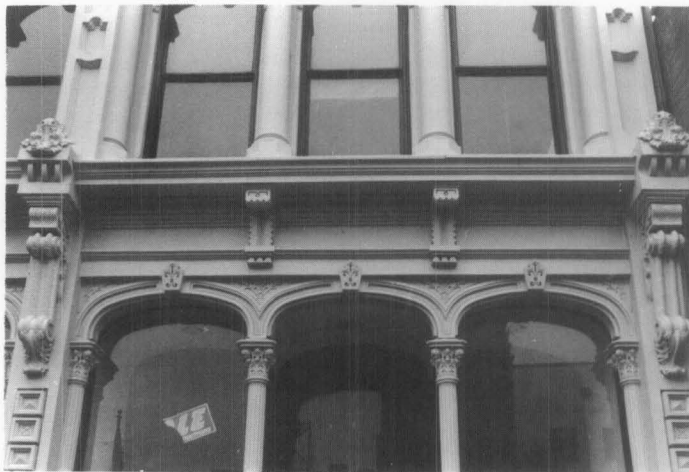
Figure 8. When the Grand Opera House in Wilmington, Delaware, was rehabilitated, missing cast-iron columns were cast of aluminum to match the original; in this particular case, because these columns do not carry great loads, aluminum proved to be successful substitute. Photo: John G. Waite

If metal components have deteriorated to a point where they have actually failed (or are missing), replacement is the only reasonable course of action. If the components are significant to the overall design of the storefront, they should be carefully removed and substituted with components that match the original in material, size and detailing (see figure 8).

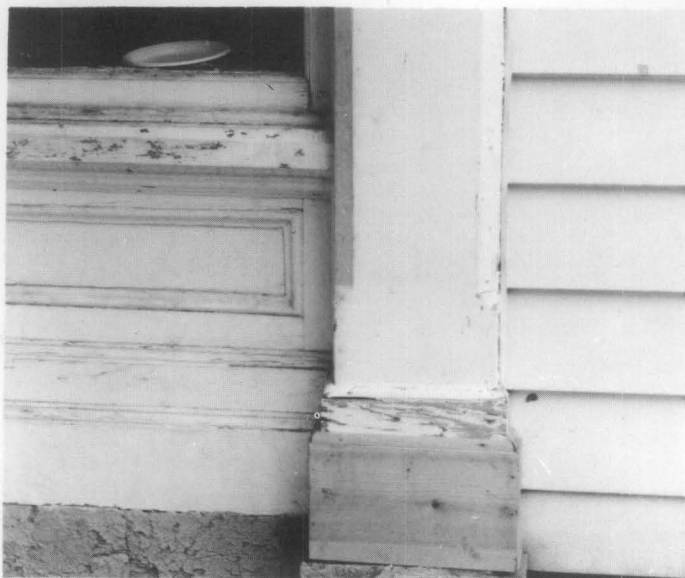
Figure 9. Rather than replace an entire wooden storefront when there is only localized deterioration, a new wooden component can be pieced-in, as seen here in this column base. The new wood will need to be given primer and top coats of a high quality exterior paint—either an oil-base or latex system. Also wood that is flaking and peeling should be scraped and hand-sanded prior to repainting. Photo: H. Ward Jandl

Where components of wood storefronts are so badly deteriorated that they cannot be stabilized, it is possible to replace the deteriorated parts with new pieces (see figure 9). These techniques all require skill and some expense, but are recommended in cases where decorative elements, such as brackets or pilasters, are involved. In some cases, missing edges can be filled and rebuilt using wood putty or epoxy compounds. When the epoxy cures, it can be sanded smooth and painted to achieve a durable and waterproof repair.

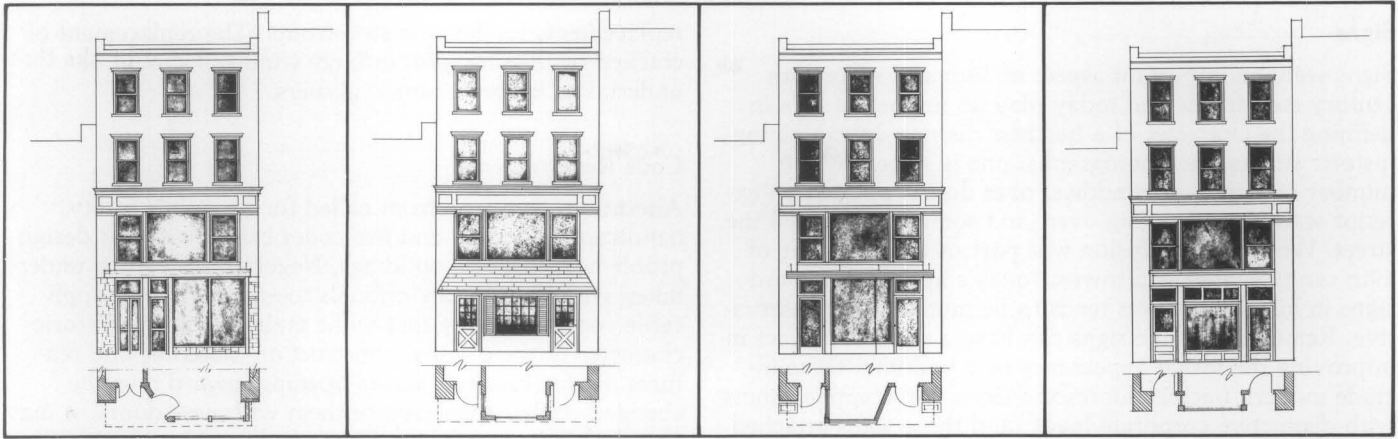
Figure 10. (A) This existing storefront, added in the 1950's to a late 19th century brick building, extends beyond the plane of the facade; faced with anodized aluminum and permastone, it does not contribute to the architectural and historic character of the building. (B) This replacement design uses "lumberyard colonial" detailing, such as barn-type doors, shutters, small paned windows, and a wood shake pent roof. The design, detailing, and choice of materials are clearly inappropriate to this commercial building. (C) This replacement design retains the 1950's projecting canopy but symmetrical placement of the doors relates well to the second floor windows above; this contemporary design is compatible with the scale and character of the building. (D) This replacement design accurately restores the original appearance of the building; based on historical research and physical evidence, it too is an acceptable preservation approach. Drawings: Sharon C. Park, AIA

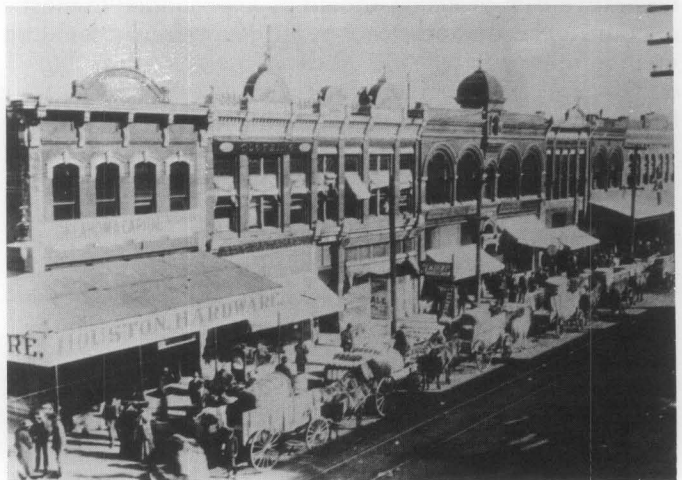
Figure 11. Try to locate old photographs or prints to determine what alterations have been made to the storefront and when they were undertaken. Awnings were common elements of storefronts at the turn of the century. They can be equally useful today.

Where based on historic precedent, consider the use of canvas awnings on historic storefronts (see figure 11).

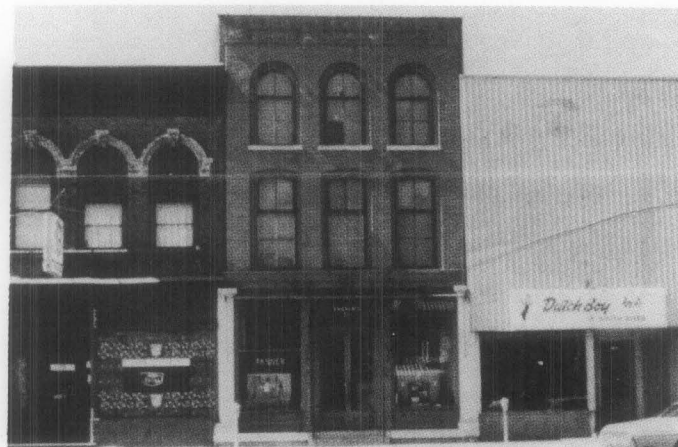
Figure 12. This photograph of three late 19th century commercial buildings clearly shows the impact of preserving and rehabilitating storefronts. The one on the right has been totally obscured by a "modern" front added in the 1950's. Although inappropriate alterations have taken place on the left storefront, it is still possible to determine the original configuration of the doors and display windows. The storefront in the middle has remained intact. Although in need of some minor maintenance work, the appeal of the original design and materials is immediately apparent.

A key to the successful rehabilitation of historic commercial buildings is the sensitive treatment of the first floor itself (see figure 12). Wherever possible, significant storefronts (be they original or later alterations), including windows, sash, doors, transoms, signs and decorative features, should be repaired in order to retain the historic character of the building. Where original or early storefronts no longer exist or are too deteriorated to save, the commercial character of the building should nonetheless be preserved—either through an accurate restoration based on historic research and physical evidence or a contemporary design which is compatible with the scale, design, materials, color and texture of the historic building. The sensitive rehabilitation of historic storefronts will not only enhance the architectural character of the overall building but will contribute to rejuvenating neighborhoods or business districts as well.
