**From:** Allen Tai  
**Sent:** Monday, July 29, 2019 10:27 AM  
**To:** David Sablan; NANCY McPeak; ERIN GARCIA  
**Subject:** FW: 2070 Lincoln on current HAB agenda  
**Attachments:** 2070 Lincoln grocery 1934.jpg

**Subject: PLN18-0405--Certificate of Approval and Historic Sign Designation--2070 Lincoln Ave.  
(Item 7-A on Historical Advisory Board's August 1, 2019 Agenda)**

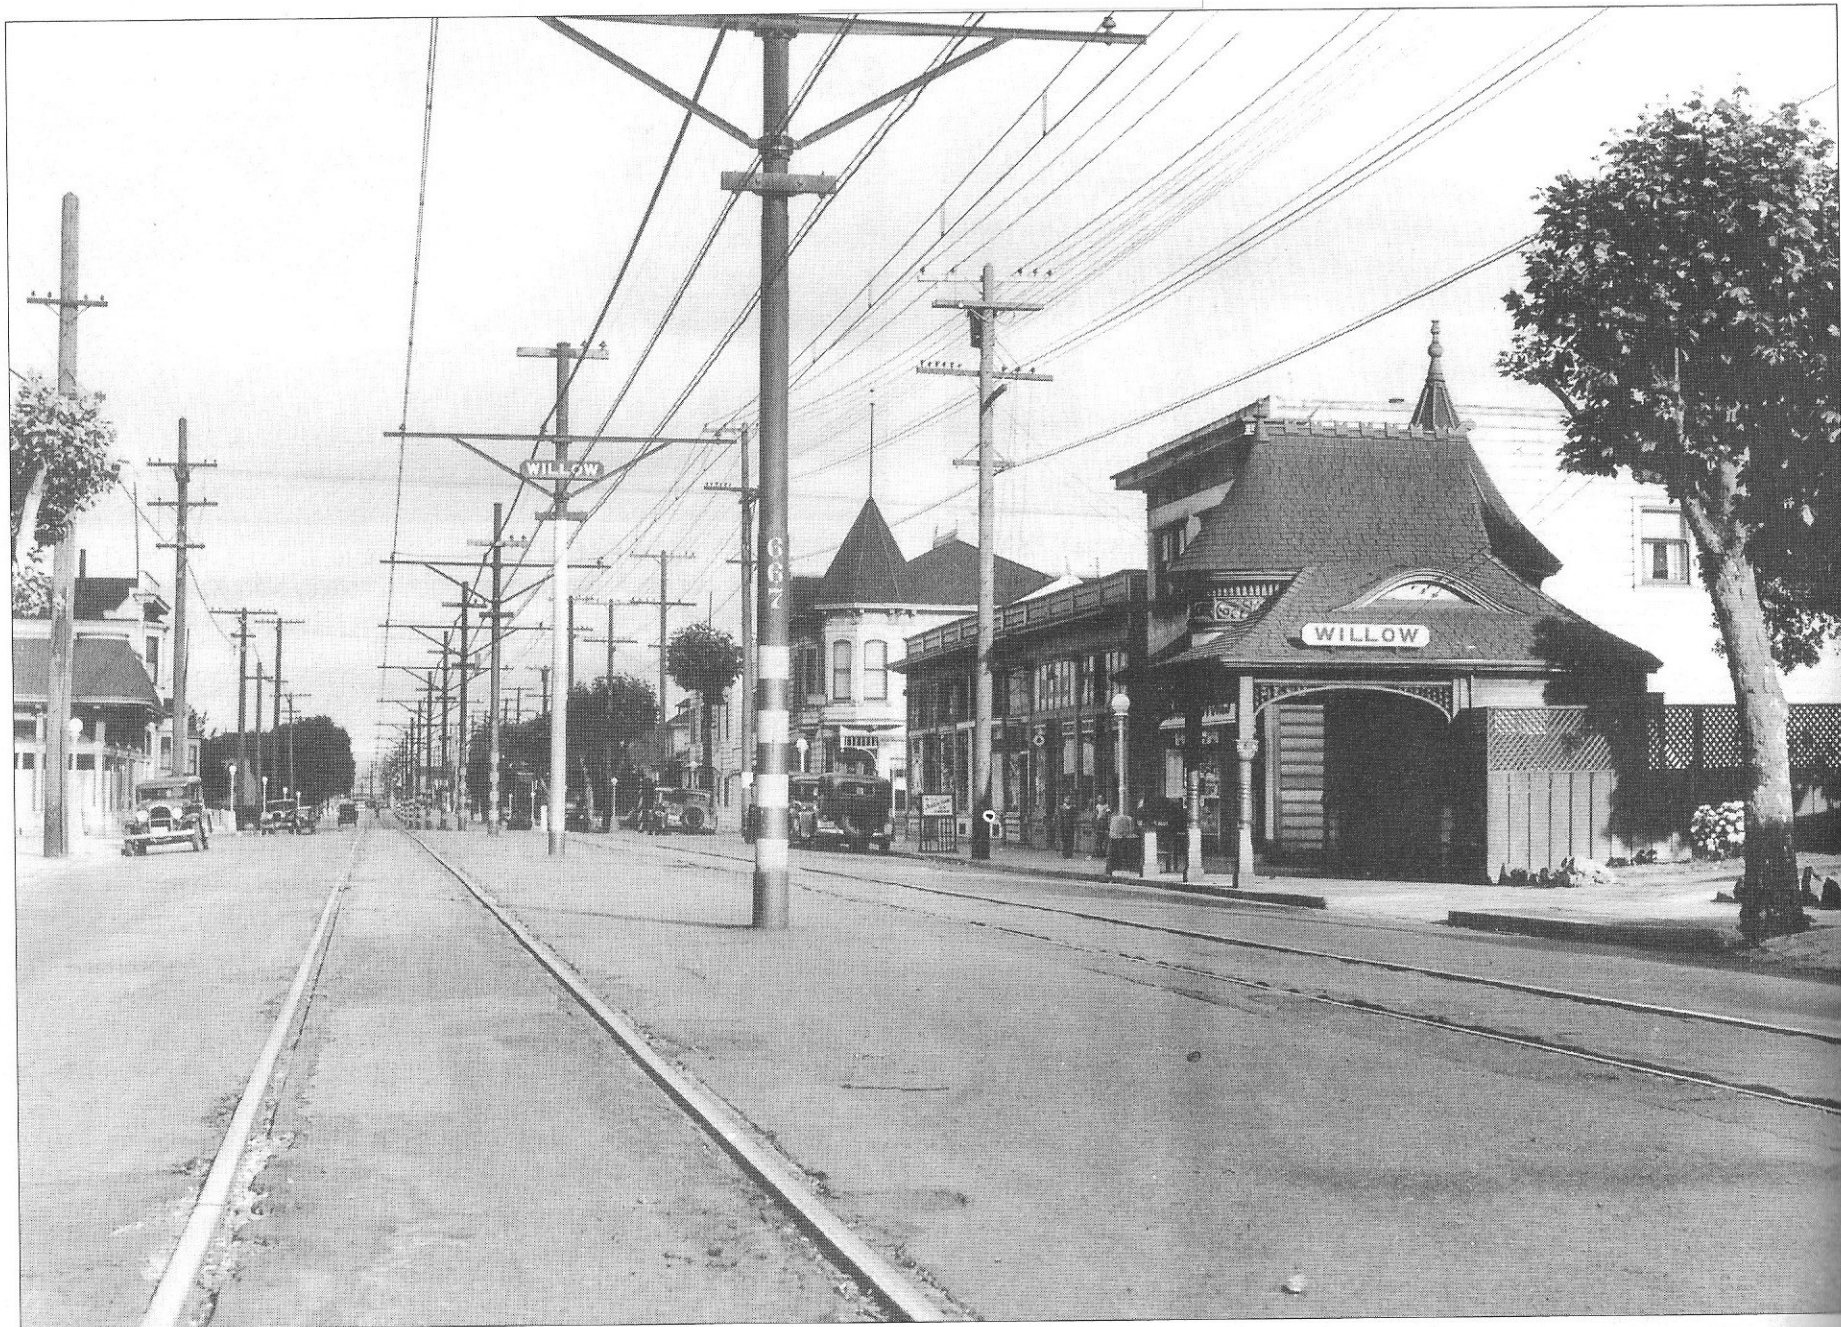
Willow Station, looking east on Lincoln Avenue, 1934. Charles Shaner's 1891 shelter adjoins the Boehn Building. (Courtesy Vernon J. Sappers.)

Good morning Gents and Thomas I send this to you as you are the only person on the current board I have met. Valerie Turpen already alerted us to the 1934 image showing the commercial facade at that time of 2070 Lincoln. on page 40 of Taking Care of Business. Flip back a page to see (upper right) a 1990s image of the same place, shorn of decor but showing its 1953 neon sign. (permit history says sign added in 1954). I know we are not to second guess but if this image had been available when the "study list" was organized its former facade would have been added given its intact nature at least at that point. As you can tell I am interested in the sign itself and would hate for the sign to be dismissed because information we have now was not available in 1970s. Chris and PAC and others are commenting on the facade changes, I would just like to see a potentially historic neon sign kept in some way. Thanks for your attention, Judith (Lynch)

We assume that the project team did not have access to the 1934 photograph or other historical photographs and therefore were not able to incorporate more of the historic design's architectural elements. Although, it is good that the proposed design seeks to use a traditional architectural idiom reflective of Alameda's turn of the 20th century commercial buildings, the following clarifications and recommended modifications are needed to achieve an effective result:

1. The expansive undifferentiated wall surfaces between the cornice and the upper floor windows causes the building to look top-heavy and poorly proportioned. One remedy would be to reduce the height of the 3 foot parapet as much as possible (which would also allow the proposed building to be more in scale with the adjacent Whales and Friends Building to the west) and/or to lower the cornice so it is perhaps approximately 2 feet below the top of the parapet (which was a common configuration in late 19th and early 20th century commercial buildings and was the design approach shown in the 1934 photograph for this building).
