Subject: [EXTERNAL] please add to Historical Advisory Board meeting 4C.Historic Guidelines

Third, I have also attached the 2005 Page and Turnbull report, "HISTORIC DISTRICT ASSESSMENT AND HISTORIC PRESERVATION STRATEGY" and the 2012 JRP Cultural Landscape Report. You should definitely read those.

This report was prepared by Page & Turnbull at the request of the Alameda Reuse and Redevelopment Authority (ARRA). The purpose of this report is to describe the existing conditions present at the Alameda Naval Air Station (NAS Alameda) prior to its redevelopment as a mixed-use project area consisting of new market rate and affordable housing, commercial and light industrial facilities and public open space. This report will primarily concentrate on the relative significance of resources on the former naval air station, as well as provide a baseline level of information about NAS Alameda. Following the Introduction, Section II includes a brief description of NAS Alameda and discusses the proposed project. Section III summarizes the current historic status of NAS Alameda and Section IV discusses the history of the former base. Section V describes the historic district and character-defini

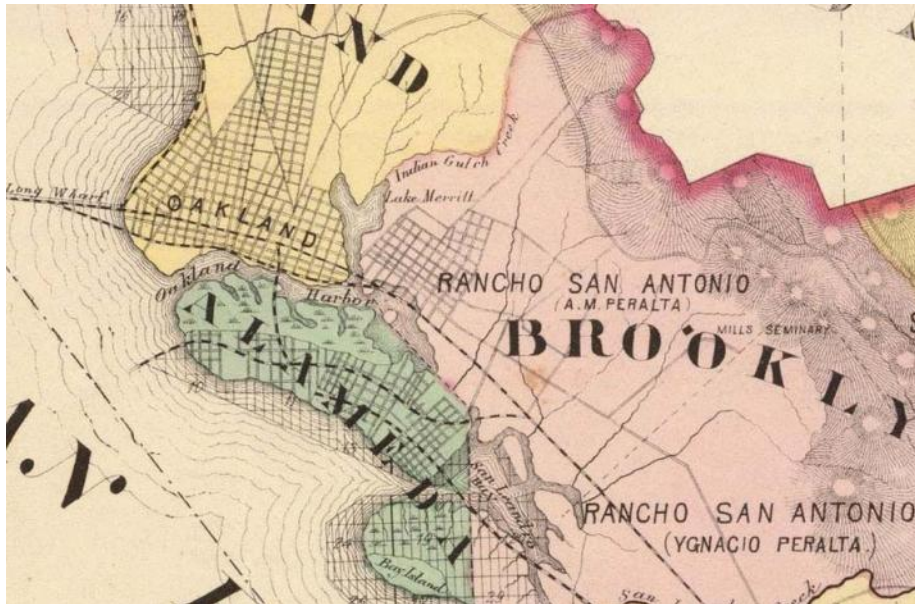
Figure 3. Map showing northern Alameda County in 1878.
Courtesy Bancroft Library, UC Berkeley

In 1872, the City of Alameda incorporated, encompassing the entire peninsula historically known as Bolsa de Encinal, encompassing the communities of Encinal, Alameda and Woodstock (**Figure 3**). According to the 1870 U.S. Census, the population of the new city remained very small, with only 1,557 residents. Nevertheless, major transportation projects undertaken during the 1870s set the stage for Alameda to eventually assume a

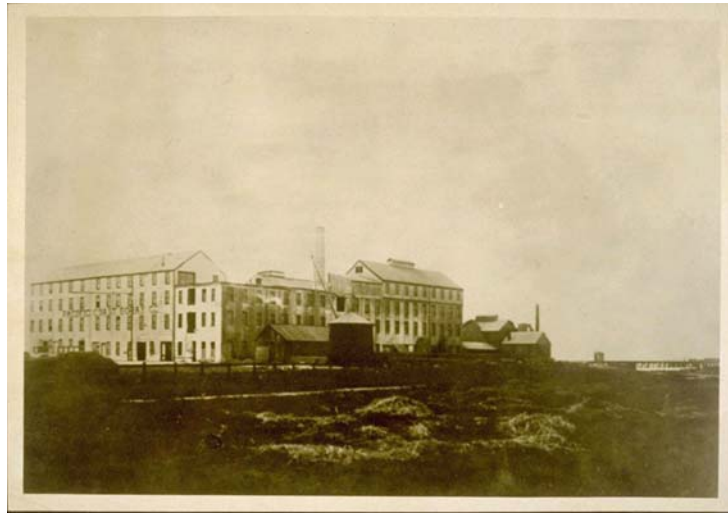
Figure 6. Pacific Coast Borax Refinery, n.d.
Courtesy of the Bancroft Library, UC Berkeley

One of the most illustrious industries to relocate to Alameda Point was Pacific Coast Borax Company, constructed in 1893 by Francis “Twenty Mule Team” Smith, the famous Death Valley borax miner. Although far from his Death Valley mines, Smith chose Alameda Point for its convenient rail connections and access to San Francisco Bay. Smith constructed a huge wood-frame and concrete refinery complex on what is presently the site of the Engine Overhaul Shop (Building 360) and a wharf and coal storage warehouse on what is now the location of the Engine Test Cell complex (Building 14). When it was completed, Pacific Coast Borax Company was the largest borax refinery in the world and reportedly one of the first to make use of reinforced-concrete in the United States (**Figure 6**).²¹ The refinery was closed in 1930 after the exhaustion of the borax mines in Death Valley and the main four-story refinery building was subsequently dynamited. The Navy spared at least one building from the borax plant when they began grading and filling NAS Alameda in 1938. This building, Building 163, still exists as a small brick maintenance shed in the southeastern corner of the base.

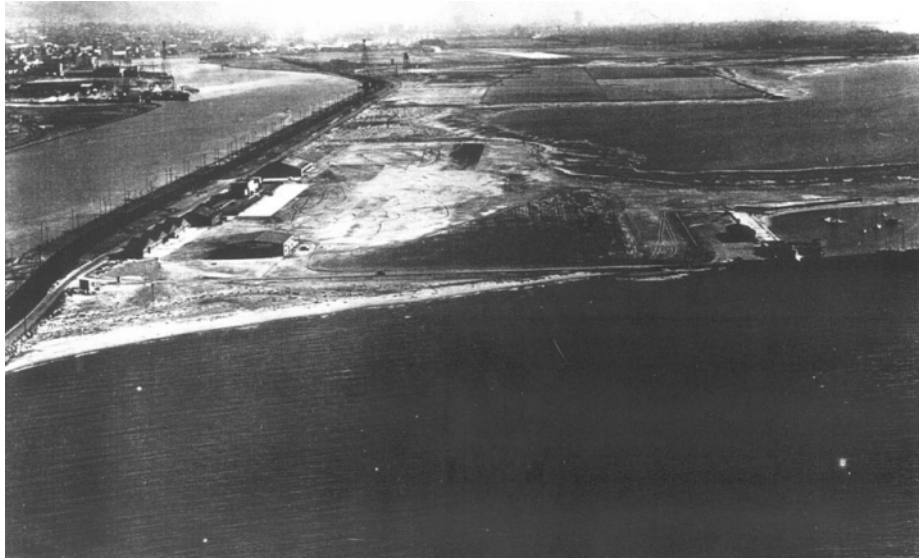
Figure 7. View of Alameda Municipal Airport, 1934.
Courtesy National Archives Pacific Region, San Bruno

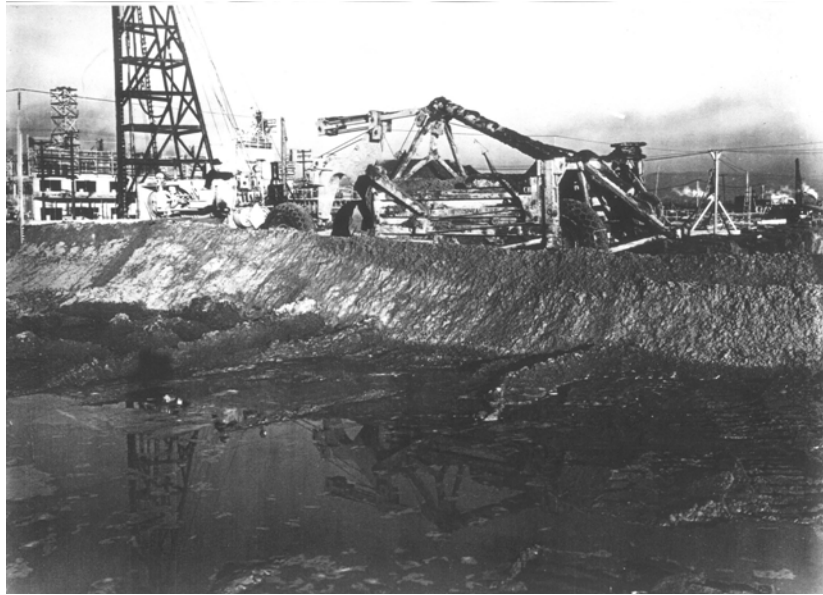
**Figure 9. Filling underway at NAS Alameda, 1940.
Courtesy of National Archives Pacific Region, San Bruno**

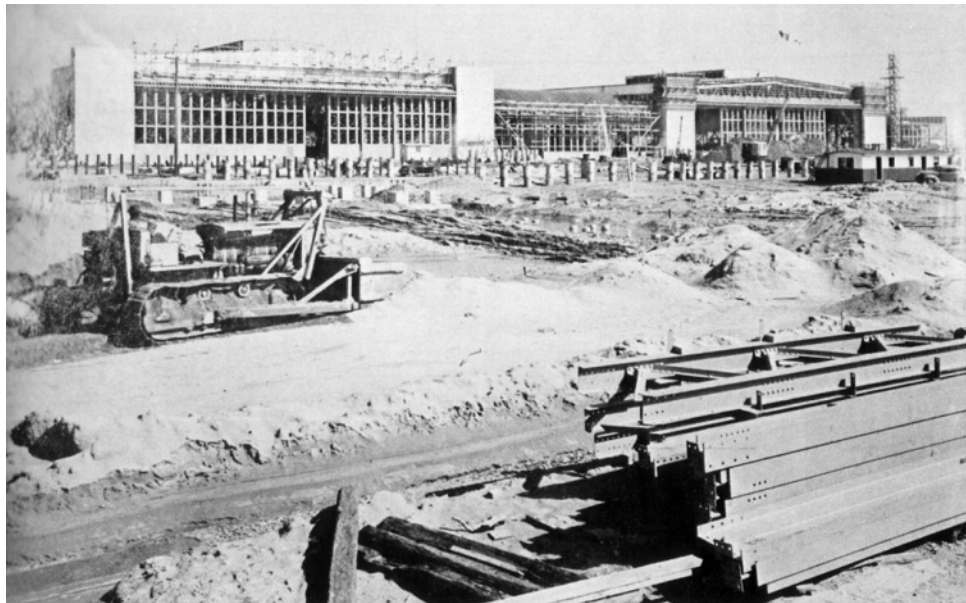
**Figure 10. Building 5 under construction, April 1940.
Courtesy of the National Archives Pacific Region, San Bruno**

After dredging and filling were completed, contractors installed underground utilities and constructed the following buildings in order: Building 90 (Garage), Building 1 (Administration Building), Building 2 (Bachelor Enlisted Men's Quarters), Building 3 (Mess Hall), Building 18 (Post Office/Theater), Building 6 (Public Works Garage and Firehouse), Building 5 (Assembly and Repair Shop), Building 10 (Power Plant), Building 8 (General Storehouse), Building 9 (Aircraft Storehouse), Building 13 (Paint and Oil Storage), Building 14 (Engine Test Stands), Buildings 11 and 12 (Seaplane Hangars), Buildings 20, 21, 22 and 23 (Land Plane Hangars), Building 19 (Operations Building), Building 15 (Boathouse), Building 17 (Bachelor Officers' Quarters) and ten Married Officers' Quarters. The first building completed, Building 90, was built in 1938 as a garage. This building has been moved several times and is currently located near the East Gate, where it was most recently used as the Civilian Employment Office. In November 1938, Building 1, the Administration Building, had been completed and was ready for occupation. By 1940 the main base buildings were well underway, including the massive hangars on the north side of Seaplane Lagoon (**Figure 10**).³⁸

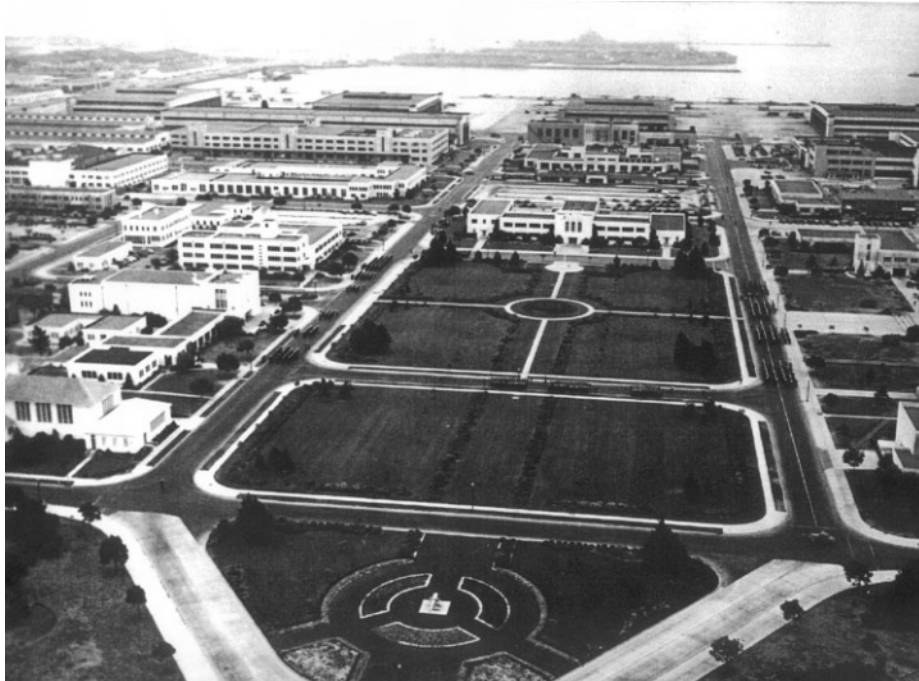
Figure 11. View from north of the central Mall at NAS Alameda, 1950.
Courtesy of the National Archives Pacific Region, San Bruno

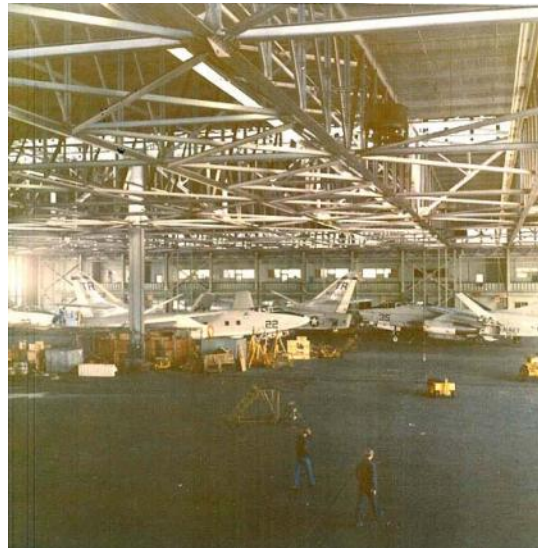
Figure 13. Interior of Hangar 20, 1960s.
Courtesy of Richard Rutter

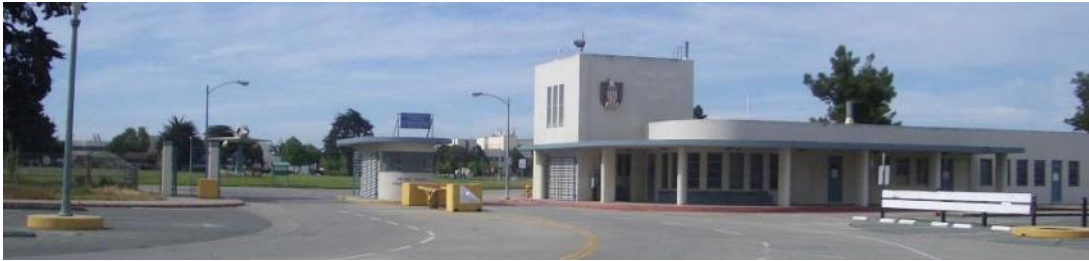
Figure 14. Main Gatehouse and Sentry House (Buildings 30 and 31), NAS Alameda, 2004.

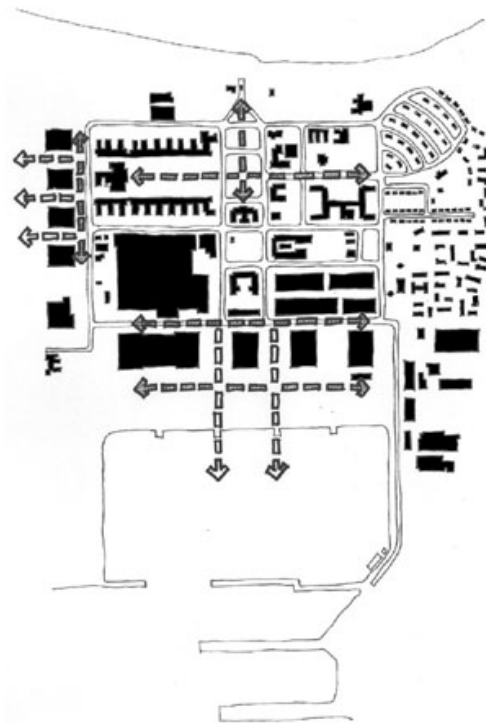
Figure 20. View corridors

As discussed above, the two principal malls serve as important view corridors, providing vistas or glimpses of primary features of the base plan (**Figure 20**). The corridors focus attention on symbolically and architecturally significant structures. The main north-south mall begins north at the Gatehouse (Building 30) and terminates at the Administration Building (Building 1) at the south. Visitors standing at any point along the mall enjoy dramatic views of both buildings at either end of the mall. The buildings lining the mall defer to the Administration Building, although their design is compatible. Landscaping, in particular mature Monterey Cypress trees, also direct the attention of the visitor to the Administration Building with the flagpole in front of it. In this way, planning, architecture and landscape architecture work in concert to direct strangers to the central nerve center of the base, as well as promote public interaction with the elements that embody the highest degree of architectural interest.

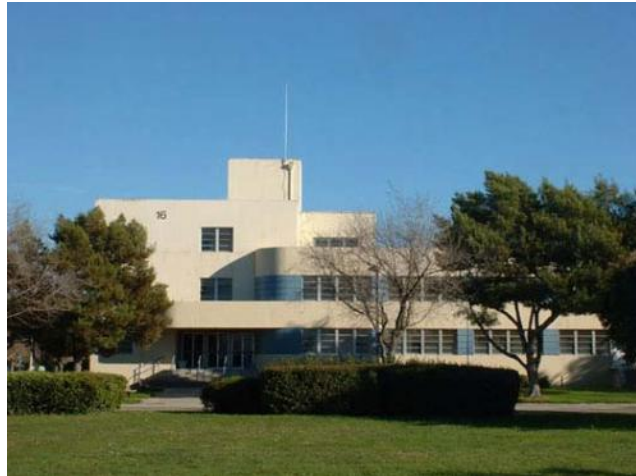
Figure 22. Building 16, Administrative Core

To that end, each sub-area of NAS Alameda is unique and distinguished from other sub-areas by different building massing, architectural treatment and landscaping. As the center of command and ceremonial nucleus of the base, the Administrative Core is located at the heart of the base. The most architecturally significant buildings are located here, including Buildings 1, 2, 3, 4, 16, 17 and 18. These buildings are symmetrically arranged on either side of broad, intersecting landscaped malls. The buildings are consistently two to three stories in height and have stepped massing, often consisting of a central pavilion flanked by two one-story wings (**Figure 22**).

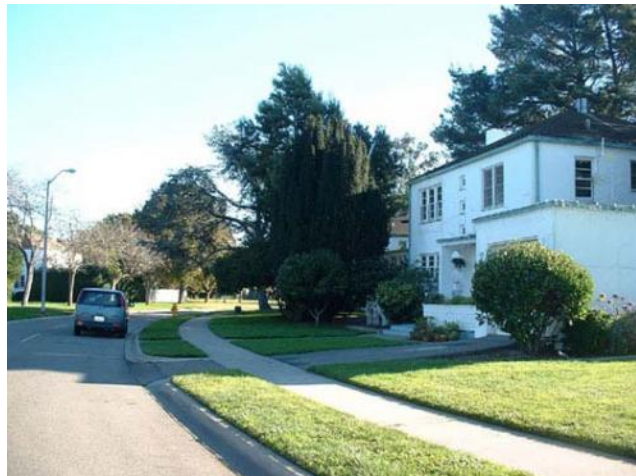
Figure 23. “Big White,” Officers’ Housing in the Residential Area

The Residential Area is located just east of the Administrative Core. Nestled into a landscaped area of lawns and mature street trees in the northeast corner of the base, the Residential Area is segregated from through-traffic by a network of curvilinear streets that do not connect to major through-streets. The Residential Area is comprised of two separate clusters of family housing: relatively large, hip-roofed, single-family houses intended for officers; and a secondary cluster of less-elaborate, small, flat-roofed bungalows intended for non-commissioned officers. Although quite different, reflecting discrepancies in rank, the scale and detailing of the architecture in the Residential Area is decidedly smaller and more “domestic” in nature than any of the other four sub-areas (**Figure 23**).

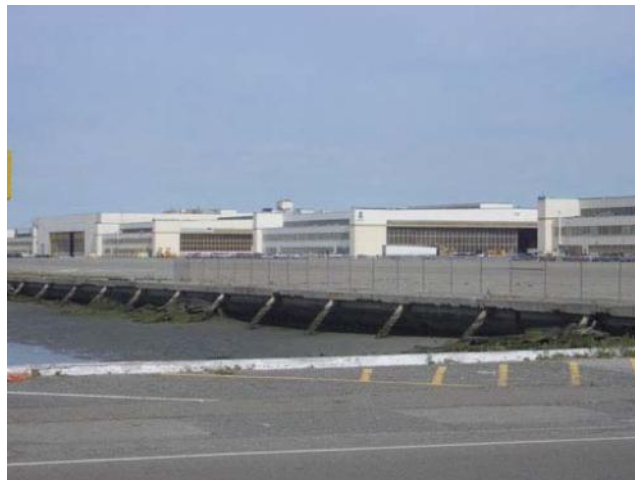
Figure 24. Seaplane Hangars north of Seaplane Lagoon, 2004

Similar to the structures of the Shops Area, the buildings of the two Hangars Areas are designed in a utilitarian mode. However, the hangars are substantially different from the Shops Area by virtue of their cohesive design (apparently by Detroit architect Albert Kahn) and repetitive arrangement in rows along the south and west sides of the Historic District. Visible from much of the inner Bay Area, the massive hangars visually summarize in an iconic fashion the mission of NAS Alameda. Built in proximity to the Seaplane Lagoon and Nimitz Airfield, the hangars define the edges of the runways and taxiways that dominate much of the base. The only building in the Hangars Areas that departs from the overall utilitarian character of the sub-area is Building 77, the Passenger Terminal. Built somewhat later than the hangars, Building 77 conforms to the Streamline Moderne aesthetic of the Administrative Core. Although not landscape features in the traditional sense, the tarmac taxiways alongside the bay side of both rows of hangars create important open spaces that serve as transitional zones between the Historic District, Nimitz Field and the Seaplane Lagoon (**Figure 24**).

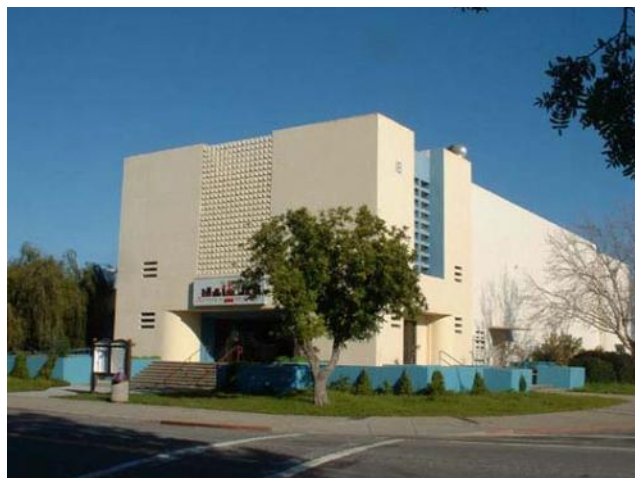
Figure 25. Building 18 (Theater), 2004

In the years leading up to the Second World War, the Navy began to build new bases under the provisions of the Hepburn Act. A handful of these new bases departed from the historicist and regional vocabularies typically used by the Navy and embraced a more modern design aesthetic influenced by the contemporary Art Deco and Streamline Moderne movements. Alternately called “Stripped” or “Starved Classicism,” or “Works Progress Administration Moderne,” the modern styling developed by the Navy’s Bureau of Yards & Docks was generally more conservative than civilian works of the same era. Due in part to the fact that the military relied on standardized plans, Navy buildings constructed during the late 1930s continued to retain strict axial plans and symmetrical facades dominated by colonnades or porticos. However, instead of using traditional Neoclassical architectural detailing, the “new” modern buildings incorporated simple, stylized decorative details and massing typical of the Streamline Moderne style. Characteristics of the style evident at NAS Alameda include: smooth stucco walls, curved parapets, incised “speed lines,” stacked window elements, glass-block or horizontal ribbon windows, and stylized sculpture depicting traditional military motifs such as eagles, or in the case of the Navy, anchors or figures of Pegasus (Figures 25 & 26).

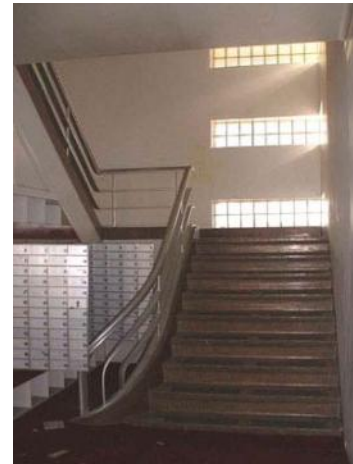
Figure 28. Interior stair, Building 17, 2004

As the nerve center of the former base, and the area most often encountered by visitors, the Administrative Core is home to the most architecturally significant buildings at NAS Alameda. Many of the most important contributors to the Historic District are located here and most are designed in the Streamline Moderne style. The Administrative Core also contains a handful of World War II-era “semi-permanent” buildings constructed during wartime, such as Buildings 94 (Chapel), 130 (Medical Lab), 135 (Community Facilities) and 137 (Recreation Storage Facility). Contributors in the Administrative Core include Buildings 1 (Administration Building), 2 (Bachelor Enlisted Men’s Quarters), 3 (General Services/Commissary), 4 (Bachelor Enlisted Men’s Quarters), 16 (Medical Clinic), 17 (Bachelor Officers’ Quarters), 18 (Post Office and Theater), 30 (Main Gatehouse), 31 (Sentry House) and 94 (Chapel). Most are low-slung buildings with smooth stucco walls, curved corners and parapets, pronounced entry blocks, aluminum ribbon windows, glass block accent windows, “speed lines,” colonnades with curved canopies, and occasional sculptural elements, including Pegasus figures on Buildings 2 and 4 and eagles on Building 3. Interior detailing is often quite fine, featuring terrazzo flooring, glass block and nickel-plated stair balustrades (**Figure 28**)

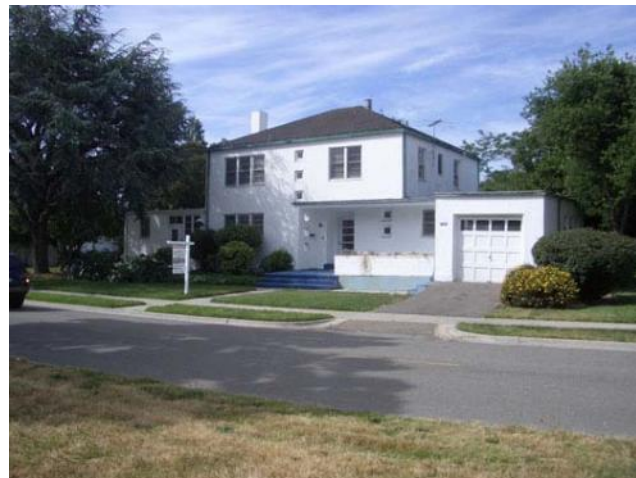
Figure 29. Officers’ Quarters, “Big White,” 2004

Comprised of eighteen two-story Officers’ Quarters and thirty one-story Non-commissioned Officers’ Quarters, the Residential Area has a greater number of buildings than the other four sub-areas. However, unlike the other sub-areas, there are only two variants of contributing buildings in the Residential Area: the Married Officers’ Quarters, also known as the “Big Whites,” and the Non-Commissioned Officers’ Quarters (NCO Quarters). The Big Whites are located in the distinctive beehive shaped network of curvilinear streets in the northeastern corner of the Historic District. Set down in a landscaped park-like setting, the Big Whites are large, two-story, hip-roofed structures with projecting sun room and

garage wings. Based largely on standardized military plans, the Big Whites closely resemble the classic American “foursquare” house. Typically rendered in the Neoclassical style on military installations in other parts of the country, the design of the Officers’ Quarters at NAS Alameda was modified to blend in with the Streamline Moderne character of the base. Coated in smooth, white-painted stucco, the Big Whites feature distinctive Moderne elements, such as vertical bands of small rectangular windows and the absence of applied ornament. Instead, ornamental detailing is provided by geometric features, such as the circular openings punched into the portico canopy supports. The NCO Quarters, also based on standardized Navy plans, are much smaller and more utilitarian than the Officers’ Quarters. Located on both sides of Corpus Christi Road and along the south side of Pensacola Lane, the NCO Quarters feature shallow-pitched hipped roofs (which appear flat), recessed porches and broad roof overhangs. All buildings have double-hung wood windows and wood doors. Few alterations have taken place over time to either the buildings or to the landscaping, resulting in a high level of integrity in the Residential Area.

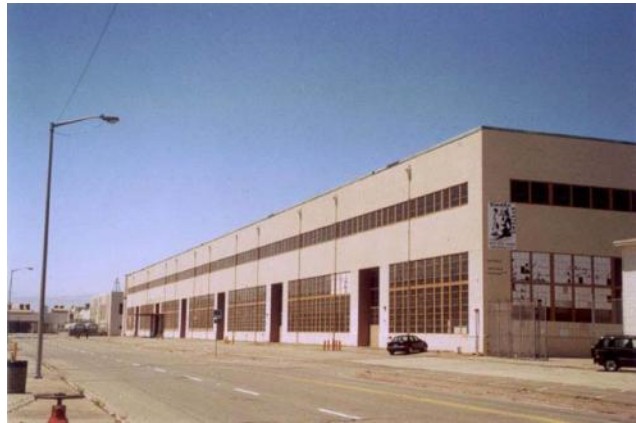
Figure 30. Building 9, 2004

Sandwiched between the Hangars Areas and the Administrative Core, the Shops Area is a support zone for the the Hangars. As utilitarian buildings used primarily for machining aircraft parts or storing goods intended for shipment overseas, the buildings of the Shops Area received comparatively little attention in regard to their appearance. The Shops Area has also undergone more ad hoc alterations than any other sub-area. During the Second World War, the area was subjected to massive new construction projects that infilled the formerly open east-west axis and added large additions to Building 5 (Repair and Assembly Shop). Contributing buildings in the Shops Area includes Buildings 6 (Public Works Garage and Firehouse), 8 (General Storehouse), 9 (Aircraft Storehouse), 42 (Fuel Chemical Lab and Office), 43 (Weapons Building), 44 (unknown), 91 (Shipping Storehouse), 92 (Packing/Shipping), 102 (Ordnance Building) and 114 (Machine Shop). Six of these structures (Buildings 6, 8, 9, 42, 43, and 44) are concrete or steel-framed permanent buildings that were part of the original 1938 plan. The rest are semi-permanent wood-frame structures that were not part of the original plan but were built to serve for the duration of the Second World War. On axis with the north-south mall, Building 6 shares architectural design elements in common with the buildings of the Administrative Core. Unique in the Shops Area, Building 9 is a steel-frame warehouse that resembles the nearby hangars in its construction and appearance. Buildings 8 and 9 are massive concrete structures with sparse ornamentation (**Figure 30**). Buildings 91, 92, 102 and 114 are semi-permanent wood-frame buildings with flat or gable roofs, rustic channel siding and no ornamentation. Steel or wood industrial sash and sliding or hinged doors are nearly

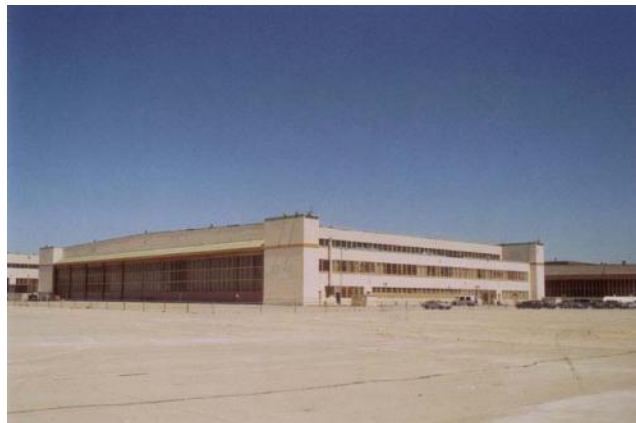
Figure 31. Building 40 (Seaplane Hangar), 2004

Despite their functional purpose, the two rows of massive identical hangars along the southern and western boundaries of the Historic District comprise an indispensable character-defining feature of NAS Alameda. Although otherwise purely functional buildings, the hangars incorporate elements of the Streamline Moderne style, in particular in the stepped massing of their stucco exteriors. Contributors within the Hangars Area include Hangars 20, 21, 22, 23, 39, 40, 41 and Building 77 (Passenger Terminal). All of the hangars are large, steel-framed buildings with massive concrete bulkhead foundations; the hangars are based on standardized plans developed by Detroit architect Albert Kahn (**Figure 31**). Additional character-defining features include large telescoping doors, the stepped massing of the corner pylons (which serve as door pockets), monitor roofs, open central workspaces bridged over by rows of steel trusses and steel industrial windows. The only building that departs from this function and aesthetic is Building 77. Constructed to serve as a passenger terminal, Building 77 is designed in a mode similar to the buildings of the Administrative Core.

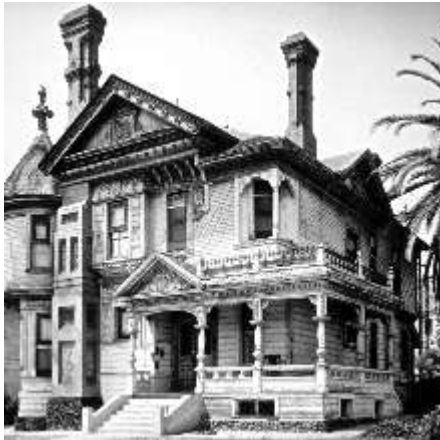
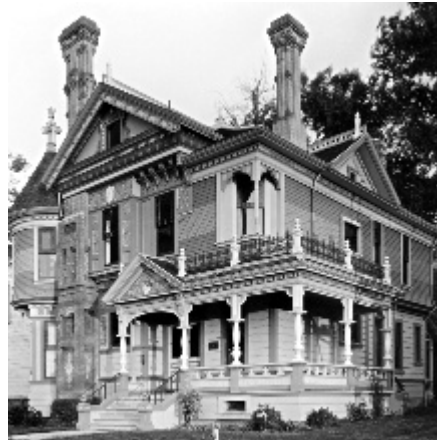
Preservation of the exterior of the Hale House, Los Angeles, California, involved repainting the exterior walls and decorative features in historically appropriate colors. In excellent example of the Preservation treatment focused upon the ongoing maintenance of historic materials and features. Photo: Before, NPS files; After: Bruce Bohner.

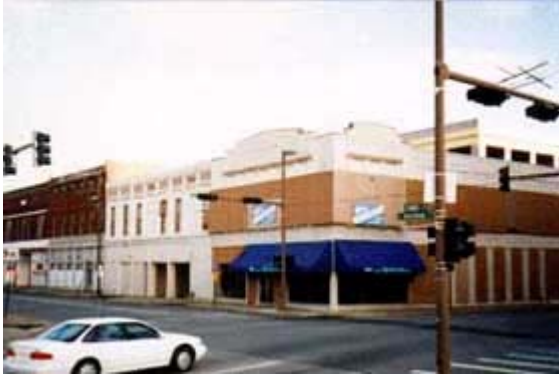
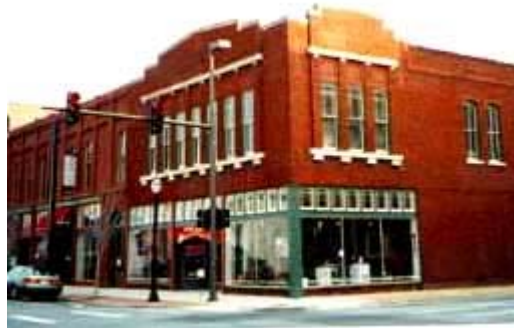
This two-story brick commercial building--with its corner storefront--was originally constructed ca. 1876, then remodeled in 1916 in the Craftsman style and given a new, distinctive roofline. It served a number of uses, including a hotel, boarding house, saloon, restaurant, liquor store, warehouse, and office furniture showroom. The red brick walls had been painted several times over the years. Rehabilitation work included removal of multiple paint layers using a chemical stripper and thorough water rinse; spot repointing with matching mortar; and appropriate interior alterations. The building is now being used as a retail shop. Photos: NPS files.

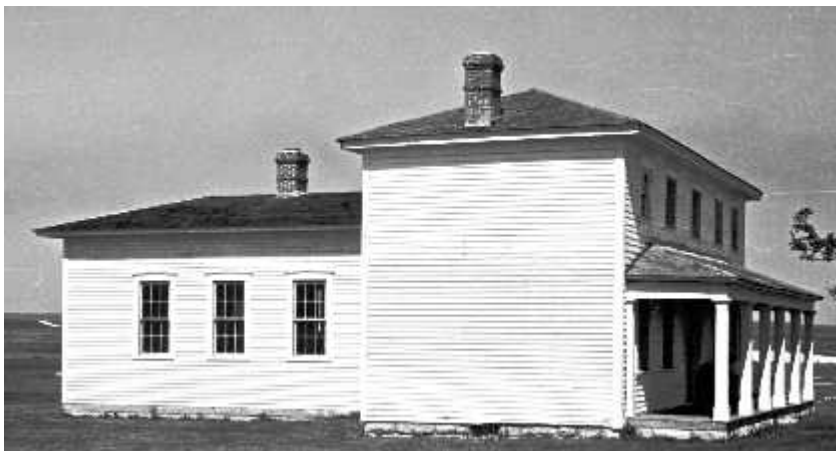
In a project at Fort Hays, Kansas, the wood frame officers' quarters were restored to the late 1860s—their period of significance. This included replacing a missing kitchen ell, chimneys, porch columns, and cornice, as well as closing a later window opening in the main block. The building and others in the museum complex is used to interpret frontier history. Photo: NPS files.

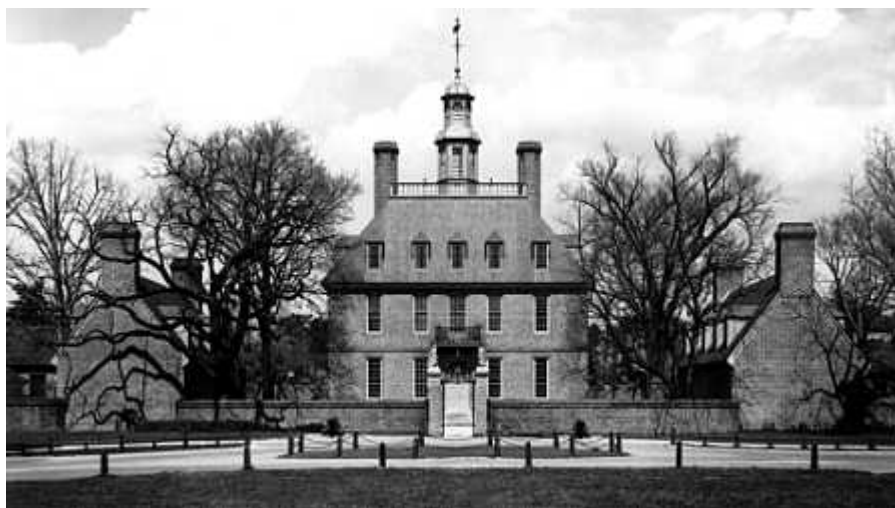
In the 1930s reconstruction of the 18th century Governor's Palace at Colonial Williamsburg, Virginia, the earliest archeological remains of the brick foundation were carefully preserved in situ, and serve as a base for the reconstructed walls. Photo: The Colonial Williamsburg Foundation.

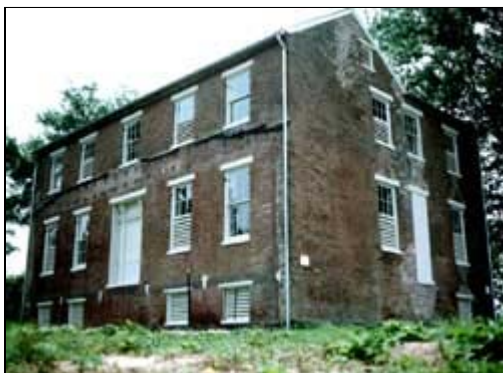
This building has been successfully mothballed for 10 years because the roof and walls were repaired and structurally stabilized, ventilation louvers added, and the property maintained. Photo: NPS files.

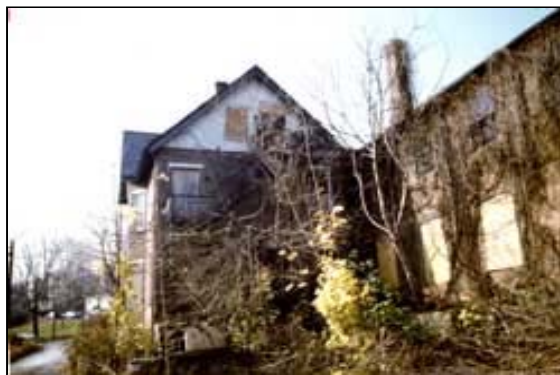
Boarding up without adequate ventilation and maintenance has accelerated deterioration of this property. Photo: NPS files.

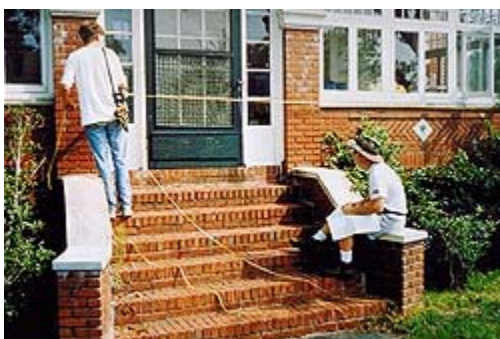
Documenting a building's history and assessing its condition provide information to set priorities for stabilization and repair, prior to mothballing. Photo: NPS files.

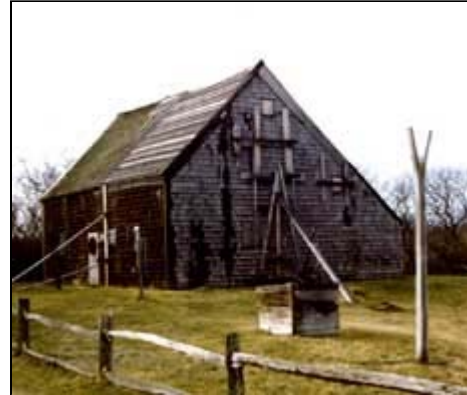
Buildings seriously damaged by storms or deterioration may need to be braced before architectural evaluations can be made. Photo: John Milner Architects. Photo: NPS files

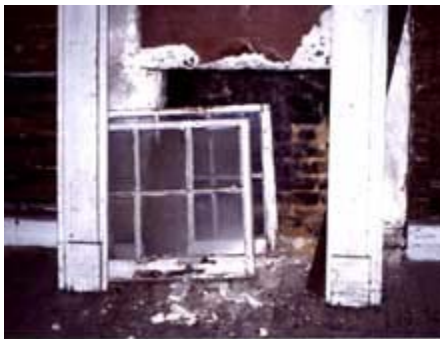
Loose or detached elements should be identified, tagged and stored, preferably on site. Photo: NPS files

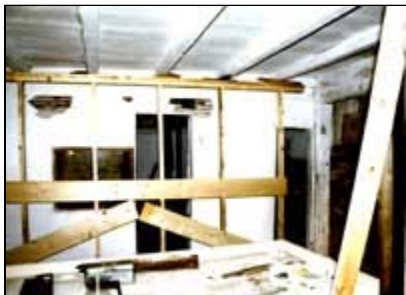
Interior bracing which will last the duration of the mothballing will protect weakened structural members. Photo: John Milner Architects.

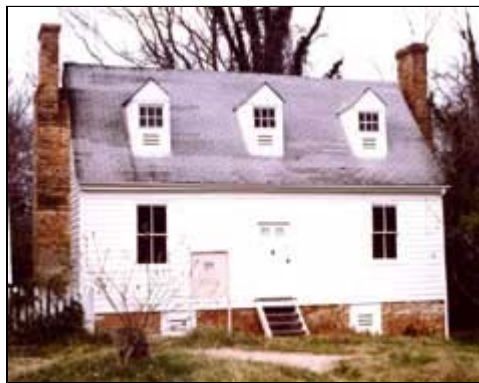
Regrading has protected this masonry foundation wall from excessive damp during its 10-year mothballing. Note the attic and basement vents, temporary stairs, and interpretive sign. Photo: NPS files.

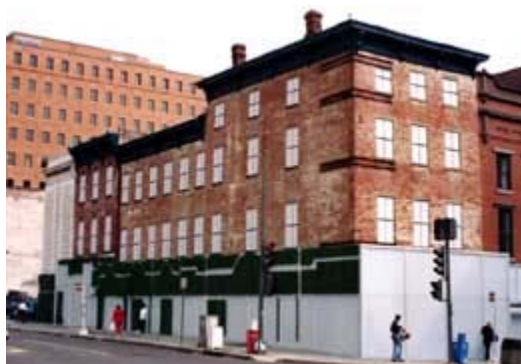
Urban buildings often need additional protection from unwanted entry and graffiti. This commercial building uses painted plywood panels to cover its glass storefronts. The upper windows on the street sides have been painted to resemble 19th century sash.

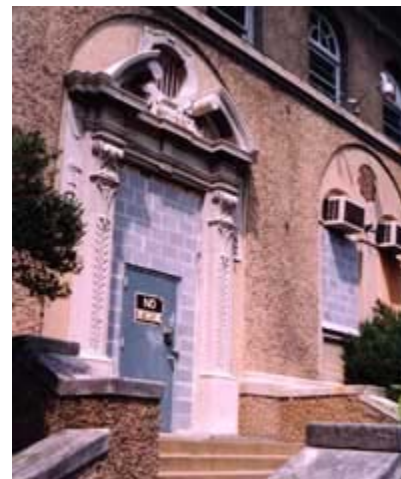
The first floor openings of this historic building have been filled with cinder blocks and the doors, window sash, and frames removed for safe keeping. The security metal door features heavy duty locks. Photo: NPS files.

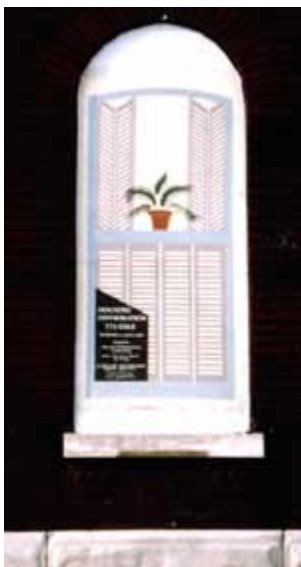
This painted trompe l'oeil scene on plywood panels is a neighborhood-friendly device. Photo: NPS files.

There are a number of ways to set insert plywood panels into windows openings to avoid damage to frame and sash. One common method is to bring the upper and lower sash of a double hung unit to the mid-point of the opening and then to install pre-cut plywood panels using long carriage bolts anchored into horizontal wooden bracing, or strong backs, on the inside face of the window. Another means is to build new wooden blocking frames set into deeply recessed openings, for example in an industrial mill or warehouse, and then to affix the plywood panel to the blocking frame. If sash must be removed prior to installing panels, they should be labeled and stored safely within the building.

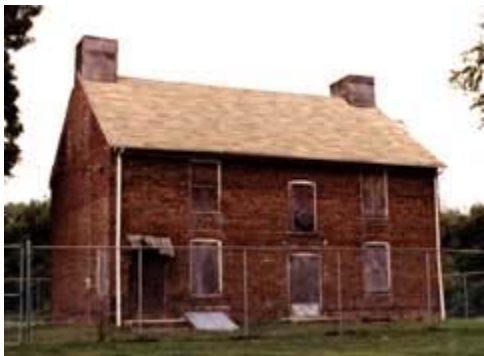
A view showing the exterior of the Brearley House, New Jersey, in its mothballed condition. Photo: Michael Mills, Ford Farewell Mills Gatsch, Architects.

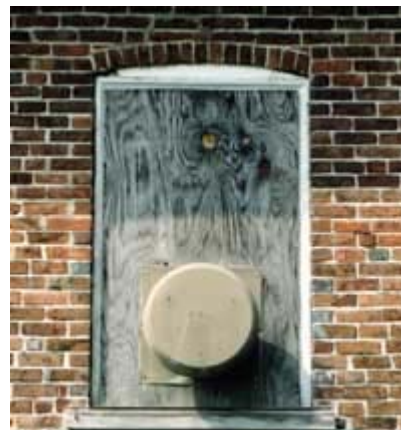
This exhaust fan has tamper-proof housing. Photo: Michael Mills, Ford Farewell Mills Gatsch, Architects.

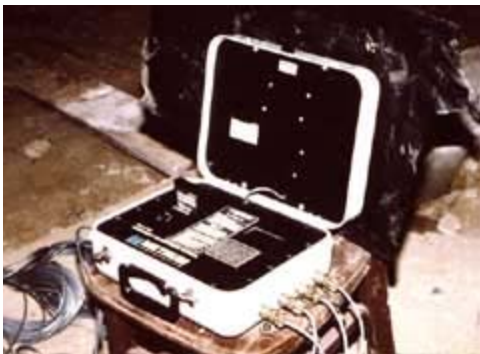
Portable monitors are used to record temperature and humidity conditions in historic buildings during mothballing. Photo: NPS files.

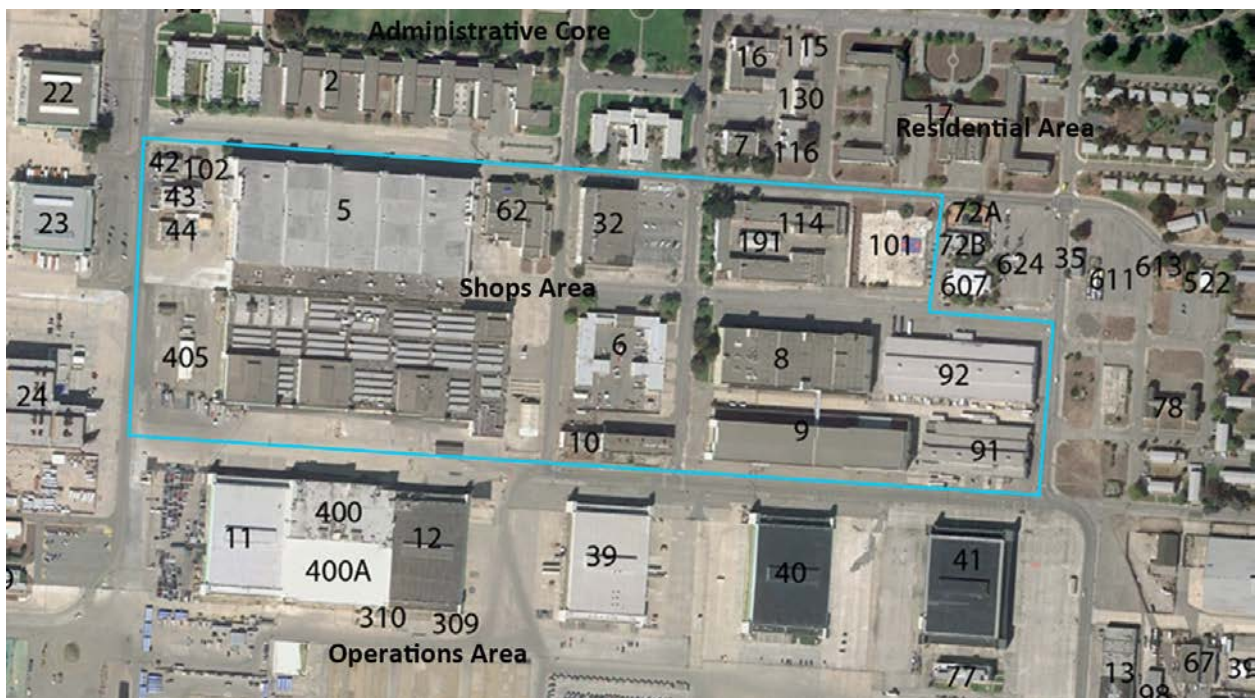
Figure 1. Aerial photograph showing location of Shops Area.
 Source: City of Alameda Planning Division; annotated by Christopher VerPlanck

The Project Site is located at the southeast corner of Saratoga Street and West Ranger Avenue, within the Shops Area. The Shops Area is bounded by West Midway Avenue to the north, Pan Am Way to the east, West Tower Avenue to the south, and Monarch Street to the west (**Figure 1**). The Shops Area is orthogonal in terms of its layout and utilitarian in regard to the design of most of its buildings. It has very little landscaping aside from several lawn panels along Saratoga and Lexington Streets. These small areas of landscaping symbolically continue the mall southward from the Administrative Core toward Seaplane Lagoon. The rest of the Shops Area is paved in asphalt and concrete.

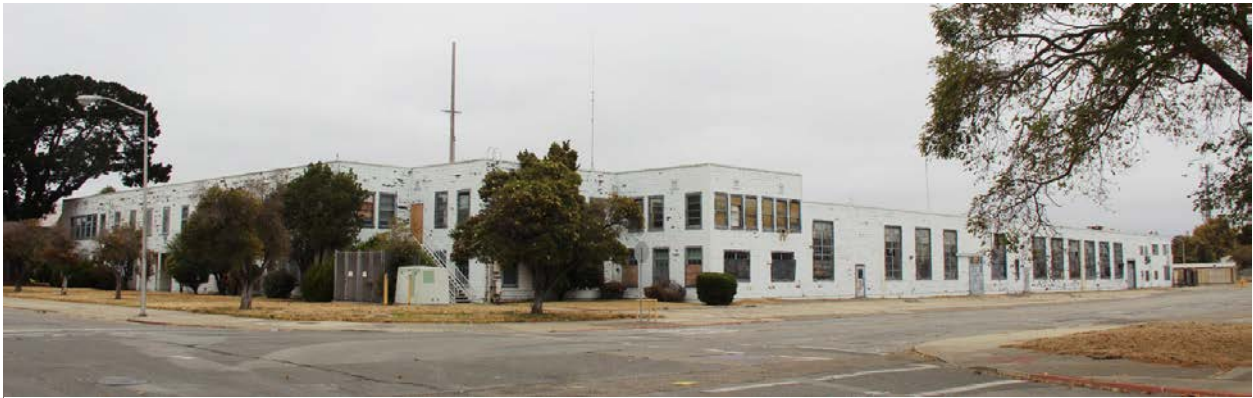
Figure 8. Building 114; view toward northeast.

- *Building 114, however, is sided in av-groove wooden board, not found elsewhere within the historic district. There appear to be no major alterations to Building 114.*

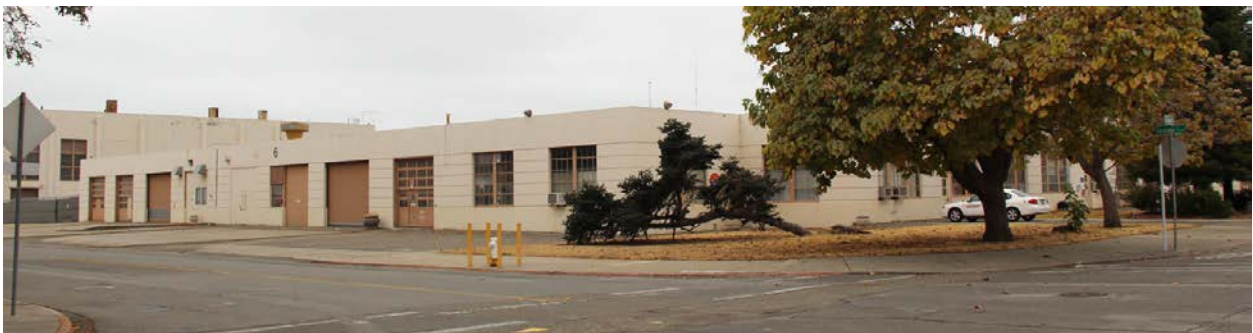
Figure 9. Building 6; view toward southwest.

Building 6, the former Public Works Garage and Firehouse, is located to the west of Building 8, on the west side of Saratoga Street. It is a one-and partial two-story, reinforced concrete garage building with a flat roof and a U-shaped plan (**Figure 9**). Constructed in 1940, Building 6 was part of the original 1938 masterplan and it shares the same Streamline Moderne styling as Buildings 8 and 9. Building 6 has two separate lawn panels – one at the corner of West Ranger Avenue and Lexington Street and the other at the corner of West Ranger Avenue and Saratoga Street. It is a contributor to the Historic District.

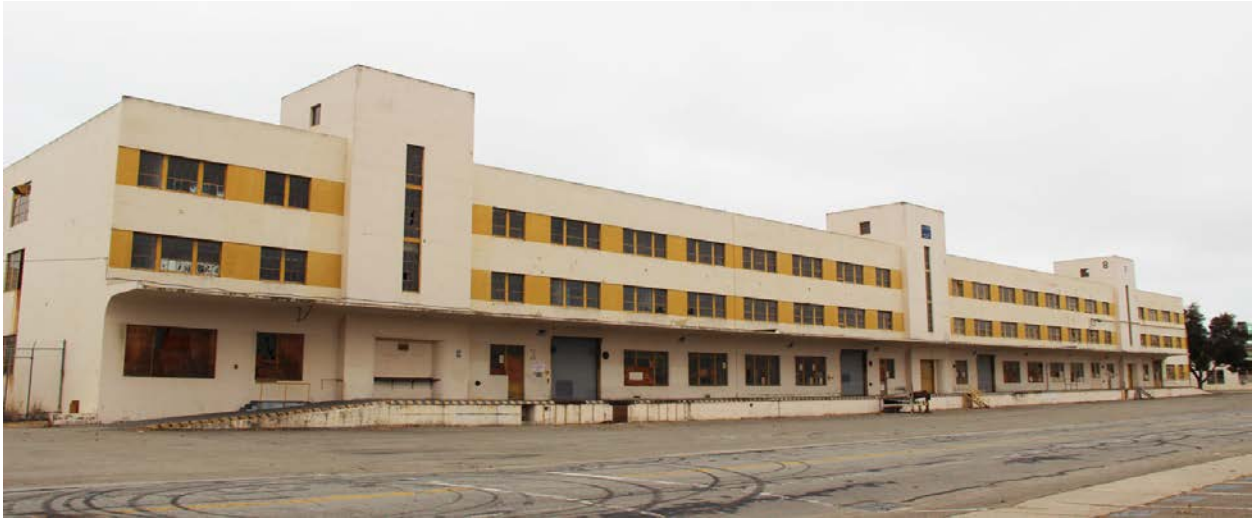
Figure 10. North façade of Building 8; view toward southwest.

Building 8, the General Storehouse, is a three-story, reinforced-concrete warehouse with a rectangular footprint and a flat roof. It contains 270,000 square feet of space. The primary façade, which faces north toward West Ranger Avenue, is punctuated at semi-regular intervals by three four-story towers (**Figure 10**). The south façade, which is otherwise identical to the north façade, has only one tower (**Figure 11**). Each tower has an overhead loading door at its base and a vertical strip of fenestration at the second, third, and fourth floor levels (**Figure 12**). The cargo doors are recessed within rectangular openings with

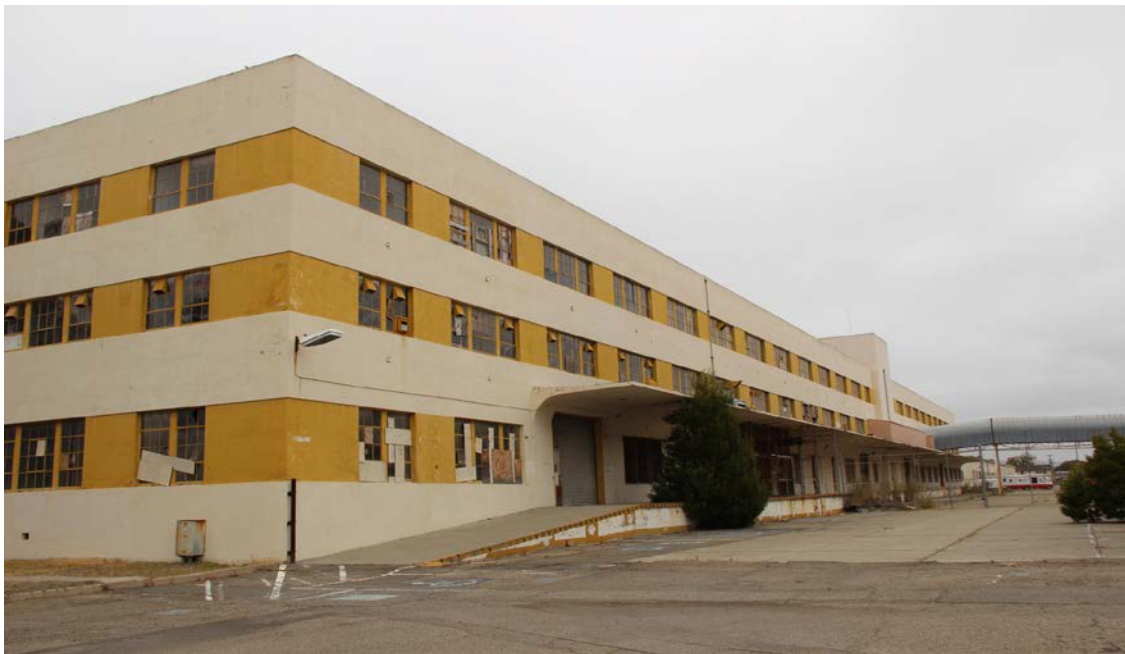
Figure 11. South façade of Building 8; view toward northeast.

curved sides. The fenestration pattern of the first floor level of the north and south façades is similar, with a mixture of freight doors interspersed among multi-lite, steel industrial windows. The doors open onto concrete loading docks sheltered beneath concrete canopies with curved supports (**Figure 13**). The loading docks are accessed by sloped ramps. The second and third floor levels of Building 8's exterior are articulated as horizontal bands of steel industrial windows alternating with simple, planar spandrels (**Figure 14**). The fenestration bands, which are painted a contrasting color to the rest of the building, are separated from the spandrels by incised lines and are slightly recessed.

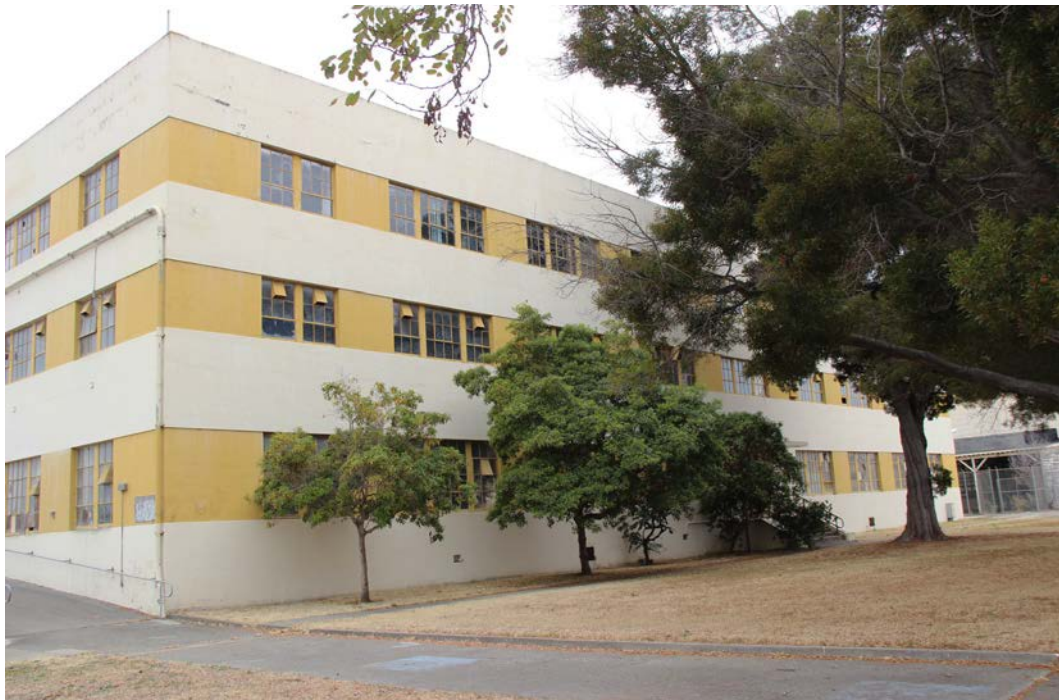
Figure 14. Detail of west façade of Building 8; view toward southeast.

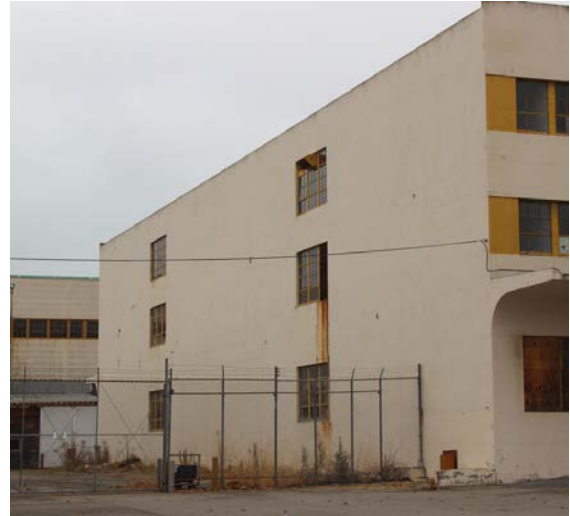
Figure 15. East façade of Building 8; view toward south.

The Navy built the western two-thirds of Building 8 in 1940 as part of the original 1938 plan. In 1943, the Navy's Bureau of Yards and Docks constructed a major addition on the east side of the building, increasing its square footage by approximately one-third. The original east wall remains inside the building, where it has been modified to connect the two sections of the building. With the exception of the utilitarian east façade, the 1943 addition matches the original building in regard to materials, design, and detailing. The east façade of Building 8 is board-formed concrete without any Streamline Moderne detailing. It is articulated by six, multi-lite steel industrial windows (Figure 15).
