BUILDING, STRUCTURE, AND OBJECT RECORD

*Resource Name or # (Assigned by recorder) Charles A. Mitchell House *NRHP Status Code 6Z
Page 2 of 17

B1. Historic Name: Charles A. Mitchell House B2. Common Name: 1711 Arbor Street

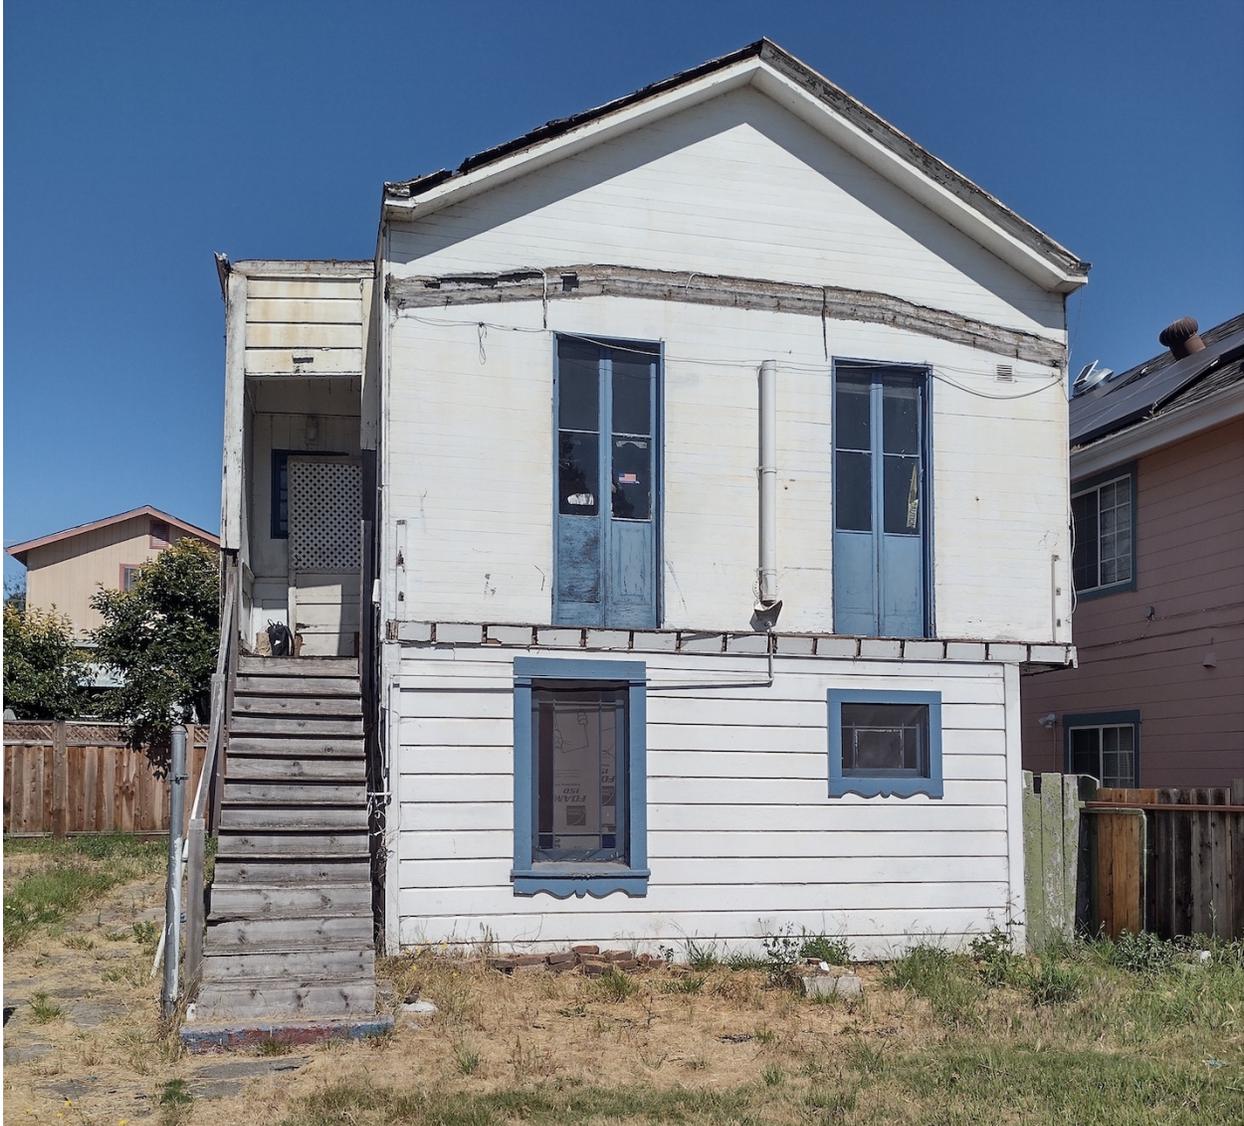
Figure 1. View of the front (East) facade of 1711 Arbor Street from Arbor Street (GA, June 2025)

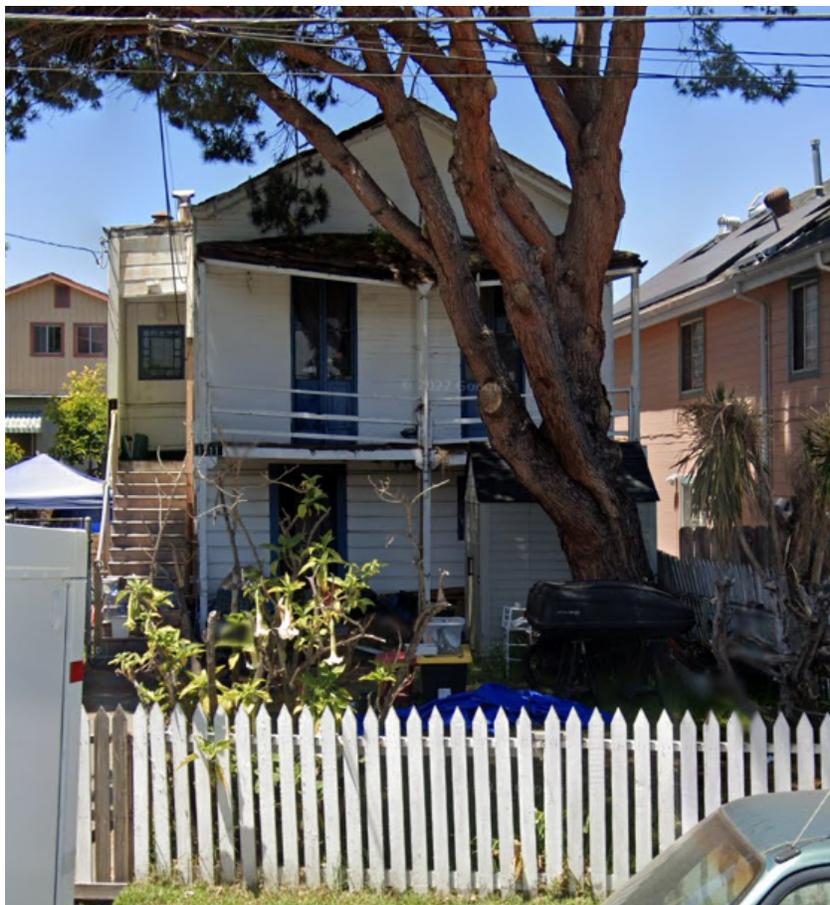
Figure 2. Front porch in 2022; note that the tree is leaning onto the porch, compromising its structural integrity (Google Maps)

1965	<ul style="list-style-type: none"> • Porch repair • Foundation replaced 	Building Index Card (Permit #220) ⁴
1967	Reroof	Building Index Card (Permit #459)
1970	Front steps replaced	Building Index Card (Permit #1292)
2024	Front porch removed (likely due to unsafe condition)	Google Maps and Google Earth imagery
Pre-2025	Rear staircase removed (likely due to unsafe condition)	Site visit observations: there is currently no rear staircase, but an outline in the paint on the rear facade indicates there was one; the presence of vine growth in this area likely led to an unsafe condition with the stairs, warranting their removal
