Master Plan Report
for the

Restoration & Preservation
of the
Alameda Carnegie Building

November 7, 2007

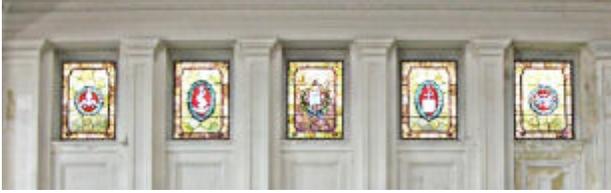
Stained glass windows. These windows have warped slightly and will be restored. Care must be taken to avoid blocking light to these windows during design of the addition.

4. The eight massive Corinthian columns. Fortunately, no potential use of the building threatens these columns.
5. The stained glass windows on the south wall, opposite the entry door. The sun illuminates these windows throughout most of the day. Care must be taken to avoid shading them by the proposed new addition or by any future construction next door.

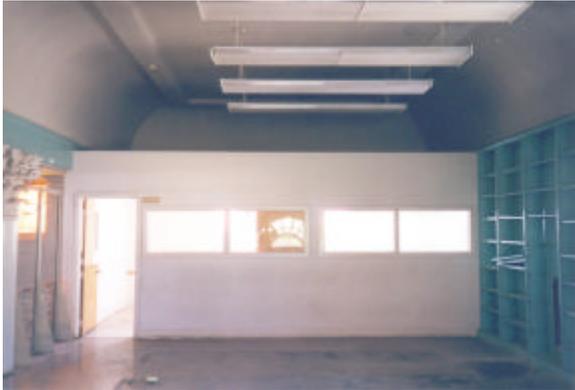
Interior walls like this one, built on the Gallery Level in 1965 to create a second private librarian's office, disrupt the open plan interior and daylighting and should be avoided.

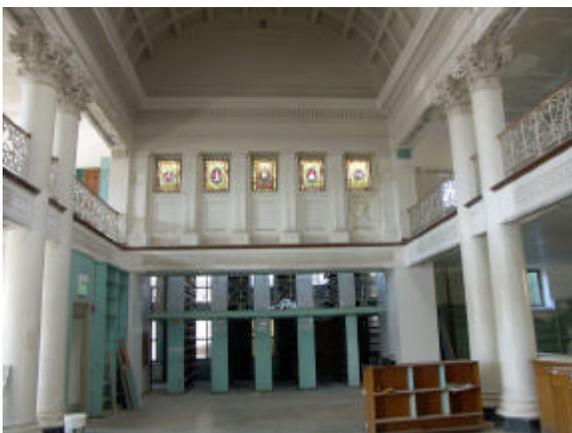
Overall photograph of stacks and relationship to the second floor and atrium.

The existing stacks, which feature load-bearing shelf-support posts that support the glass mezzanine floor as well as two floors of bookshelves, are historically significant, although less so than the features noted above. The ceiling height of the stacks main level below the gallery is 10'4", while the ceiling height of the stacks main level below the mezzanine is just 6'5". The stacks were not part of the original construction, but were

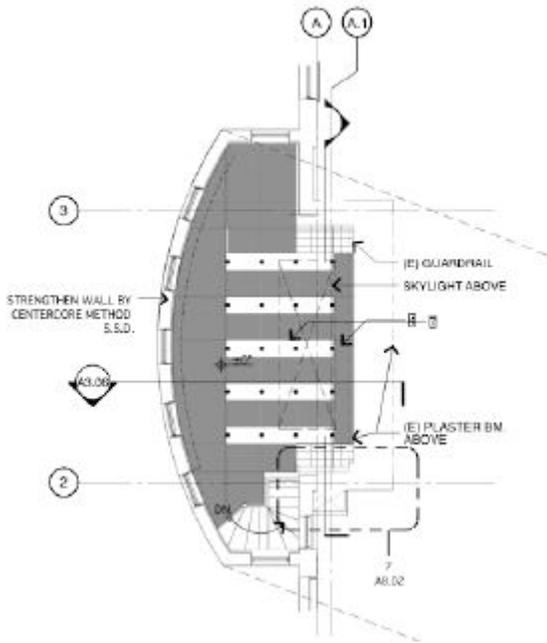
Stacks detail plan, from 1999 Construction Document for Seismic Upgrade.

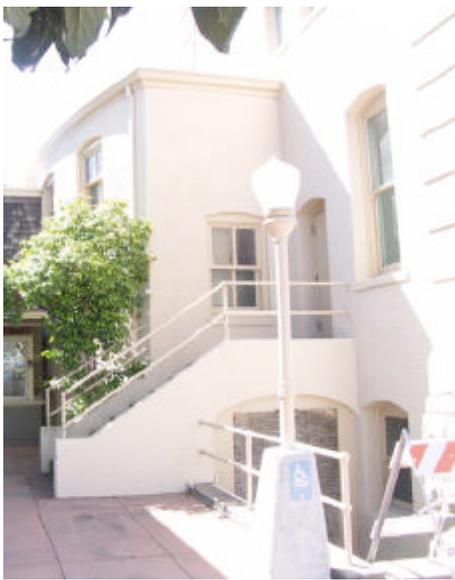
Librarian's rail (existing and original design).

The existing railing outside the Librarian's door is a simple metal pipe construction, and does not match the original construction documents, which showed two turned balusters per step and ornamental globes on top of newel posts. The railing does match the existing basement railing, which appears very similar to the "gas pipe railing" show on the construction documents. Historic photographs do not exist for this location, but the chronology indicates that the original wood stairs were replaced with concrete in 1934.

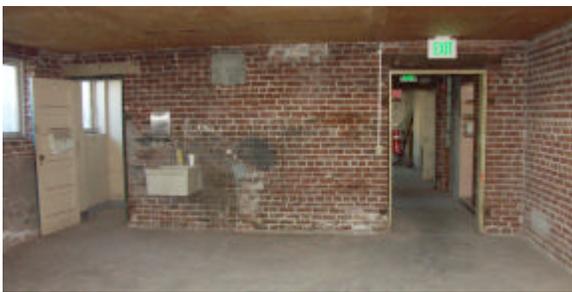
Insulation could be applied to historic exposed brick exterior walls in the basement. Interior walls would remain brick.

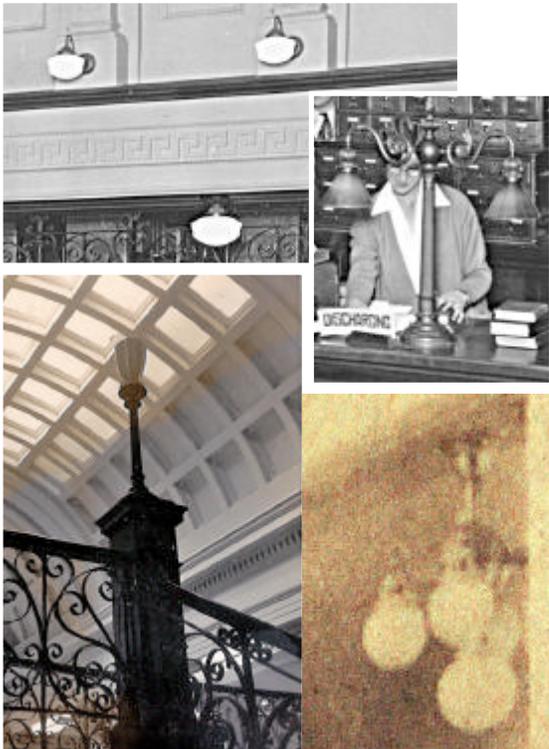
Clockwise from top left: Schoolhouse style; original desk lighting fixture; original globe-style fixture; and balustrade fixture with fluorescent system installed in 1945. Historic photographs courtesy of the Alameda Museum.

Daylight was historically augmented with electric lights. The original drawings show 2, 4, and 6-fixture lights, which appear in early (pre-1907) photographs as simple globes. In 1924, new "schoolhouse"-style fixtures were installed, replacing the original fixtures. Fluorescent fixtures replaced those in 1945. The historical architect and electrical

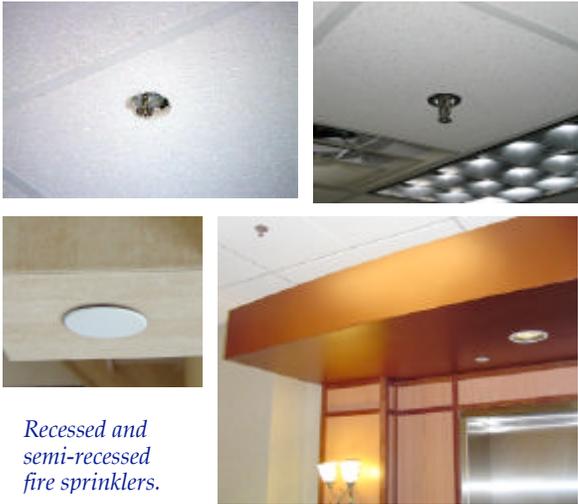
Recessed and semi-recessed fire sprinklers.

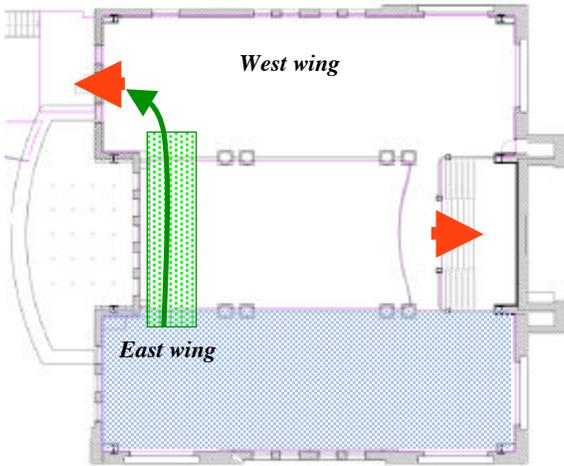
Gallery Level plan, showing exit routes if proposed addition is constructed. If occupancy stays the same, the East wing may have only one exit; if it increases, a second balcony exit (green) will be constructed.

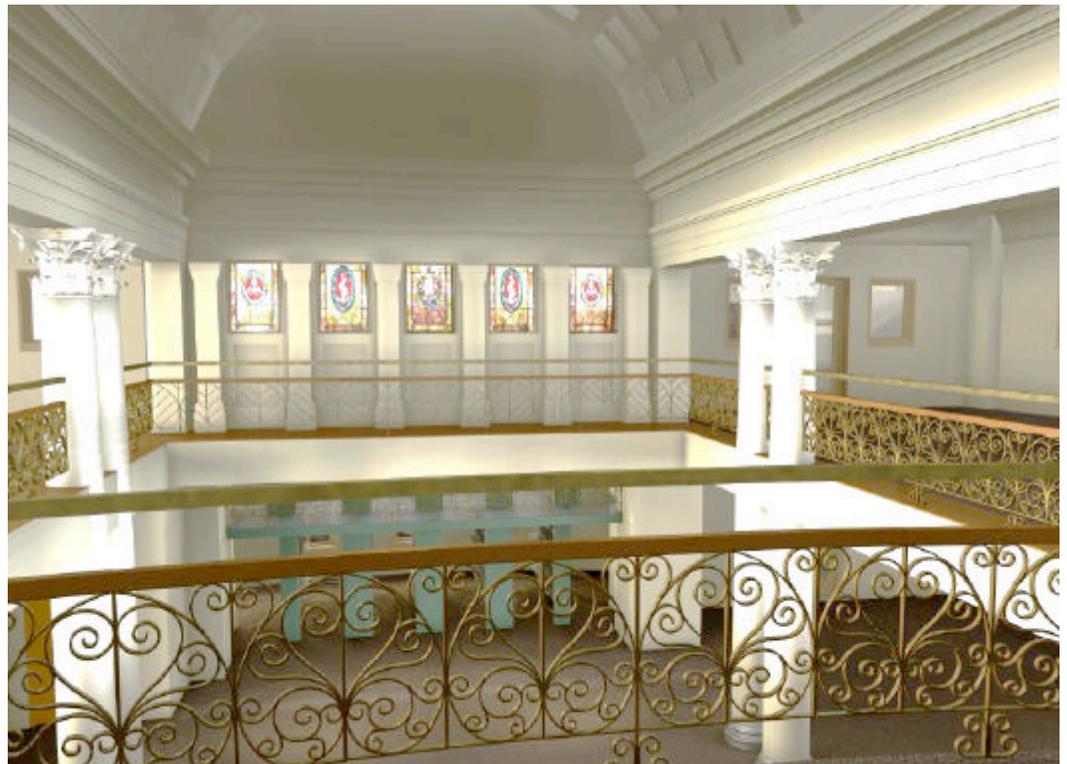
Gallery level with added balcony for exiting. Balcony rail is designed to be compatible but different from historic rail. Although the balcony introduces a new element in the main area of the building, it does not disrupt the overall feel of openness.

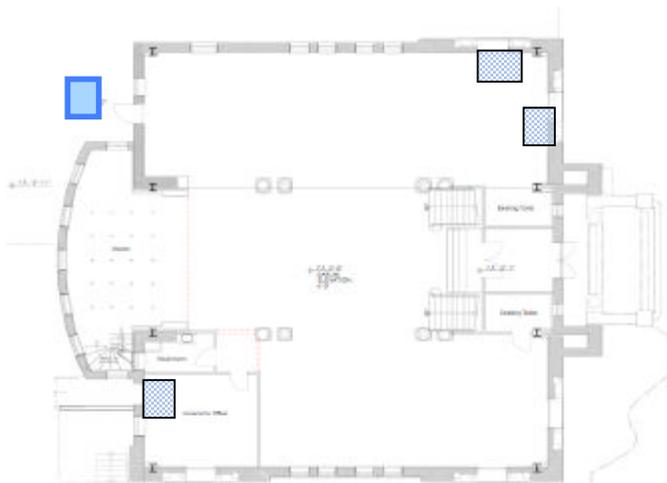
An elevator was considered for locations shown in blue.

are too close together to allow stacking the landings. It is physically impossible to access all levels of the Carnegie and both levels of the Children’s Library with a single elevator.

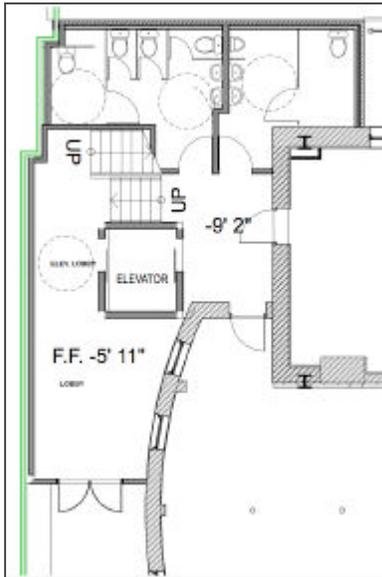
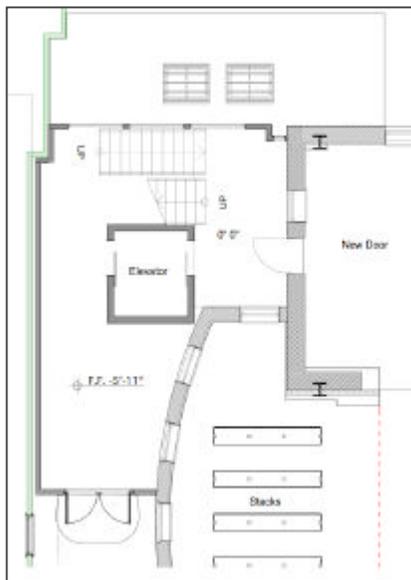
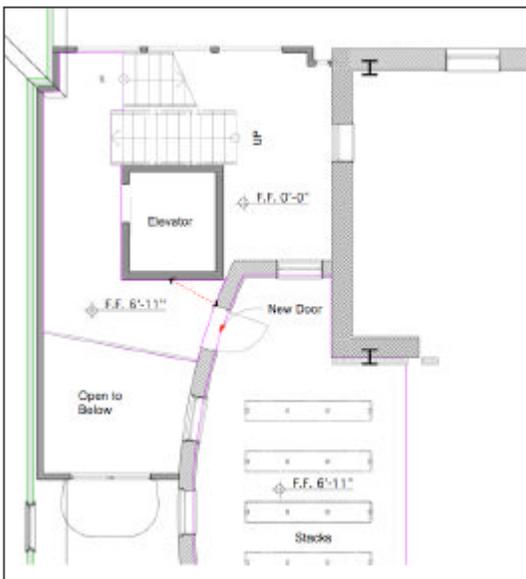
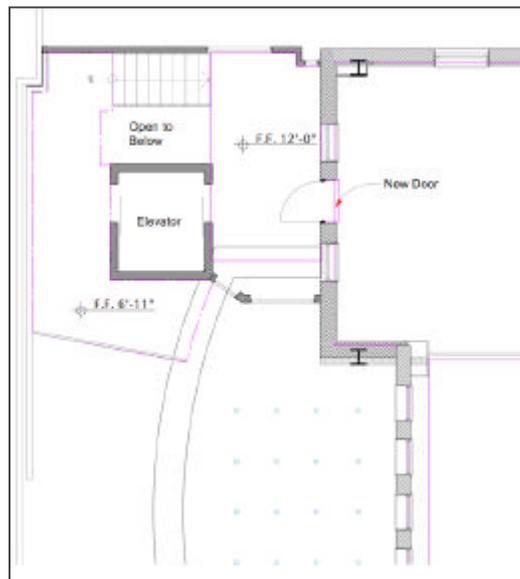
Addition floor plans. Above: basement, main level, and stacks mezzanine. Right: gallery.

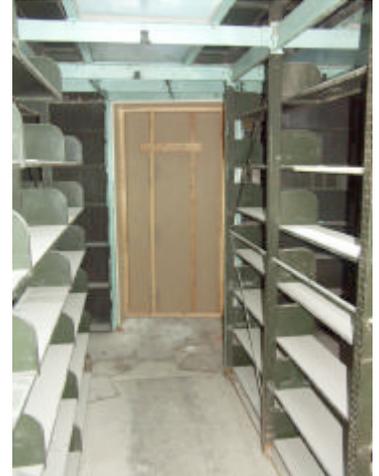
An historic window was modified to create this doorway onto the connector building during the 1995 accessibility upgrade. Shelves on the right were removed to allow access to the connector building.

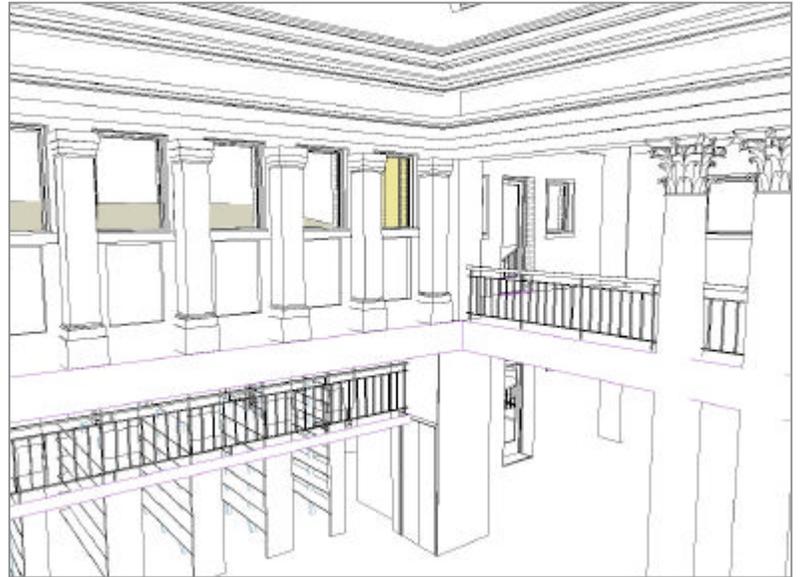
Stained glass blockage, existing.

As mentioned in the "Priorities for Preservation" section, care must be taken to avoid shading the stained glass windows on the south wall, opposite the entry door, which are currently illuminated by the sun throughout most of the day. We rejected an option for the addition roofline that was overly tall adjacent to the historic windows.

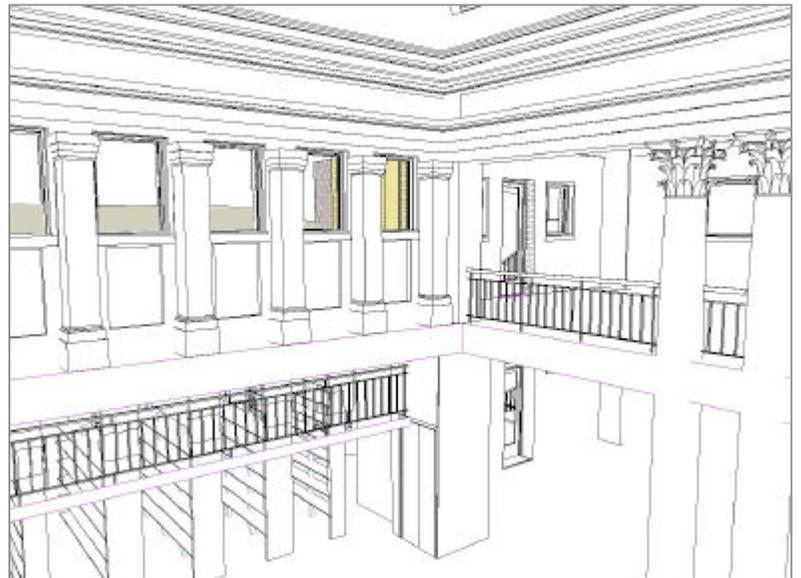
Stained glass blockage, Option 1.

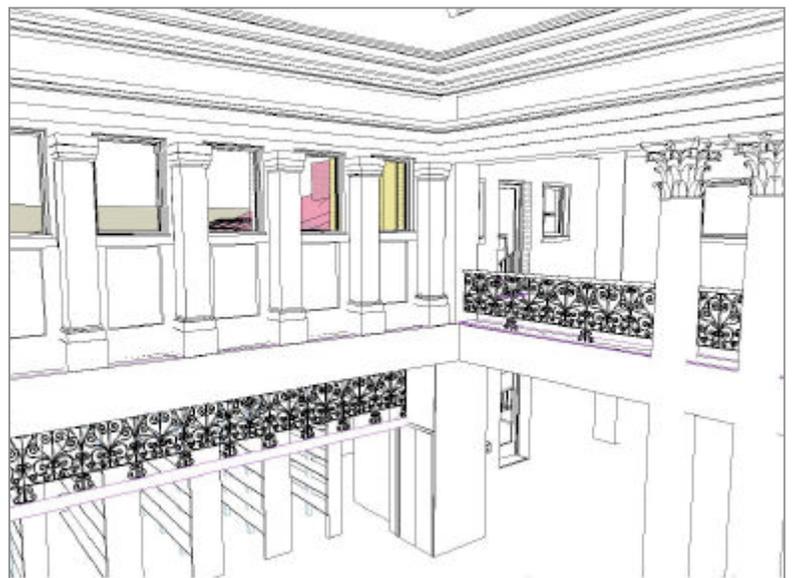
Stained glass blockage, Option 2a.

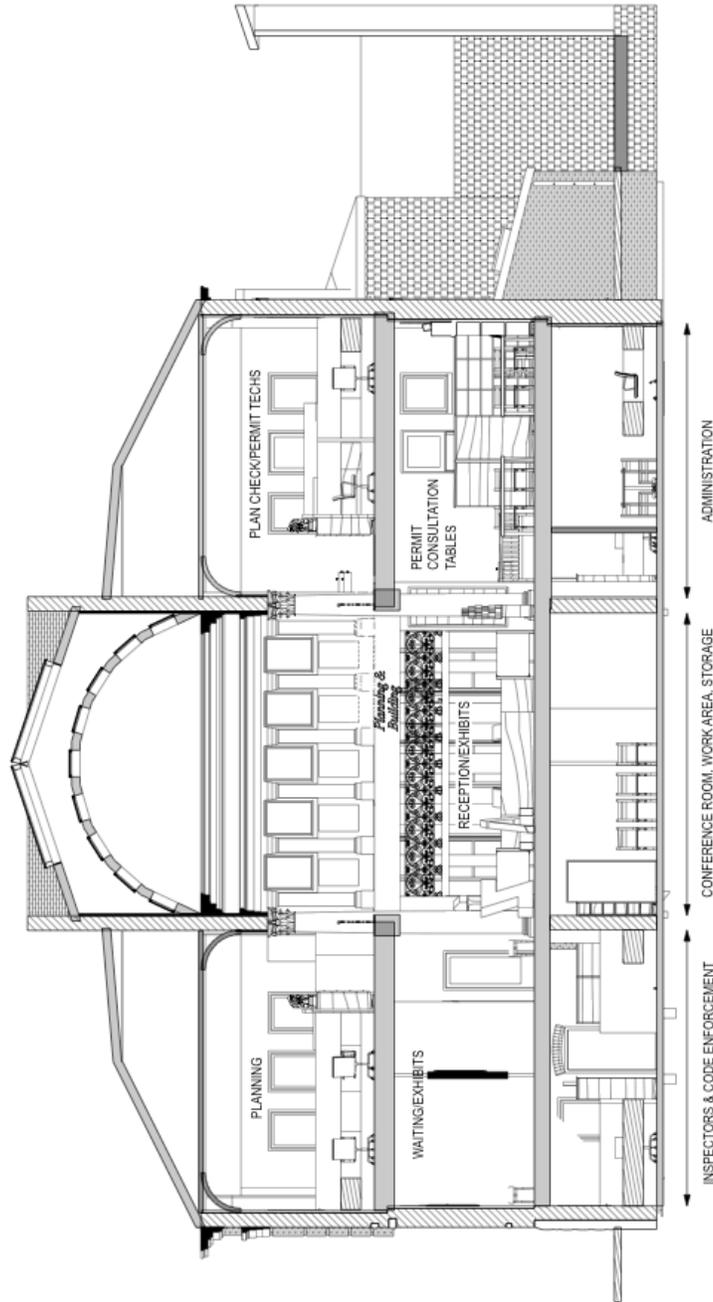
PB3.1

Historic Cross Section - Planning & Building Center

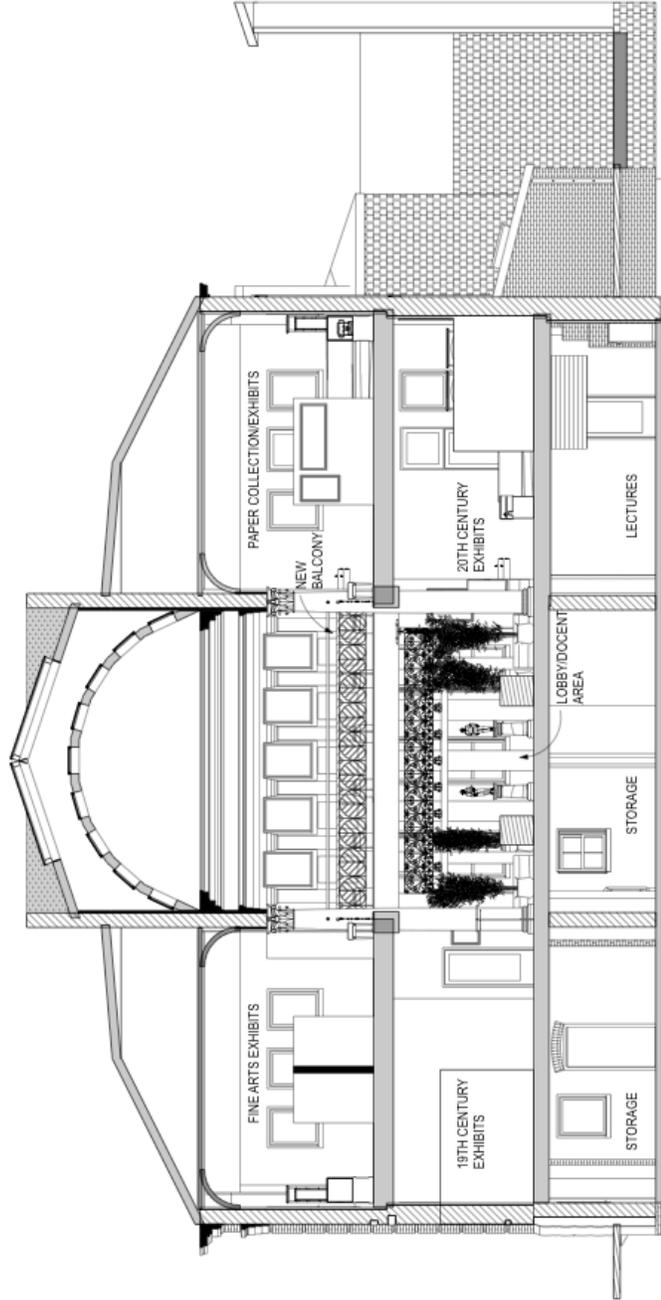
AM3.1

Historic Cross Section - Museum

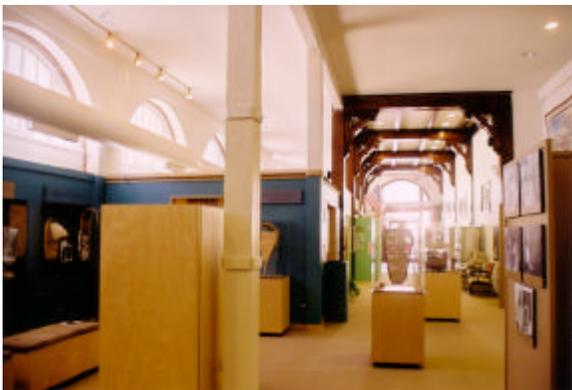
The Hayward Area Historical Society & Museum is located in a historic 1920s post office. A UV film has been applied to historic arched windows, and tall partitions block some of the visible daylight, but lighting conditions are still much brighter than desired.

The Hayward Area Historical Society and Museum occupies a historic 1920s post office. The museum uses UV film and tall partitions to block daylight into the building. Executive Director Jim DeMersman says that more complete daylight control is necessary if “you want to be considered a serious museum.” He feels the level of daylight found behind the partially blocked windows does not provide satisfactory
